FACILITY COMPLIANCE INSPECTION REPORT
Division of Waste Management
Solid Waste Section

Table with columns for unit types (Lined MSWLF, Closed MSWLF, CDLF, LCID, HHW, Tire T&P / Collection, YW, White goods, Tire Monofill, Transfer, Incin, Industrial Landfill, Compost, DEMO, SLAS, FIRM, SDTF) and a summary box for COUNTY: Onslow, PERMIT NO.: 6708-MSWLF-1997, FILE TYPE: COMPLIANCE.

Date of Inspection: 25 August 2016

MCB Camp Lejeune MSW Landfill
Piney Greene Road
Camp Lejeune, NC 28452

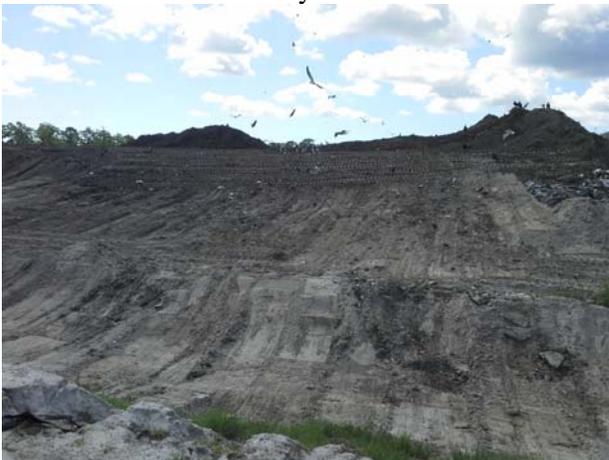
- 4) Proper signage is posted at the entrance to the Facility stating the permit number, contact information, and listing banned/excluded wastes.
- 5) Hours of operation for this Facility are Monday through Friday 7:30 AM to 3:30 PM. Ten Holidays are observed: New Year's Day, Martin Luther King Jr Day, President's Day, Memorial Day, Independence Day, Labor Day, Columbus Day, Veteran's Day, Thanksgiving Day, and Christmas Day.
- 6) This Facility screens all incoming loads for unpermitted materials. Waste screening activities are recorded in a log which is maintained in the scalehouse. On average, this Facility records the screening of approximately 10% of all incoming loads.
- 7) This Facility is approved for the use of Posi-shell as an alternate daily cover and is currently alternating soil and Posi-Shell for its daily cover.

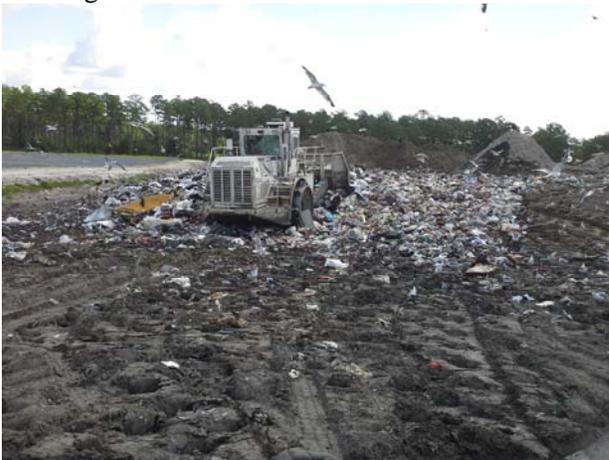
- 8) This Facility manages landfill gas through a passive venting system.
- 9) The Facility access road is of all-weather construction and is being well maintained at this time.
- 10) Edge of liner markers have been installed throughout the landfill and are being maintained as required.
- 11) This landfill is currently operating in Phase III.
- 12) This Facility is currently receiving +/-160 tons of waste per day.
- 13) Soil is stockpiled adjacent to the active working face for use as cover.
- 14) The working face is being maintained in a compact and manageable size.
- 15) The waste type was reviewed during this Facility Compliance Inspection. Only MSW was observed at the working face.

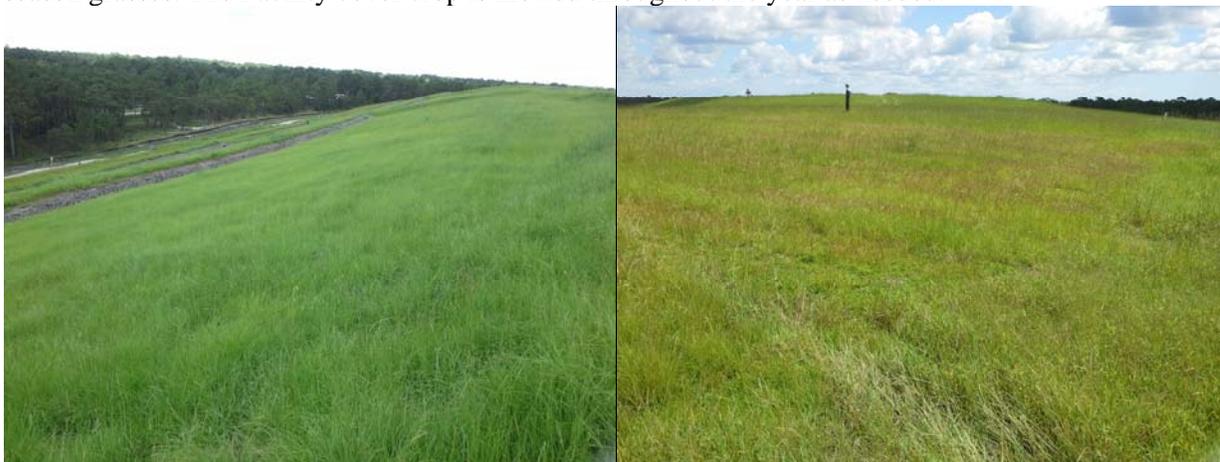
- 20) Due to differential settlement within the landfill, portions of the Southeastern sideslope of Phase II have slopes with an irregular contour. Some of these areas appear to have a slope greater than 3:1. This condition is making the proper maintenance of these areas difficult. \*As per our conversation, please fill and grade these slopes at a slope not greater than 3:1. After grading, please seed and mulch to establish a groundcover suitable to prevent erosion of your landfill cap system.

- 21) Overall, the closed areas of the landfill are well maintained with a well-established cover crop of native warm season grasses. The Facility cover crop is mowed throughout the year as needed.

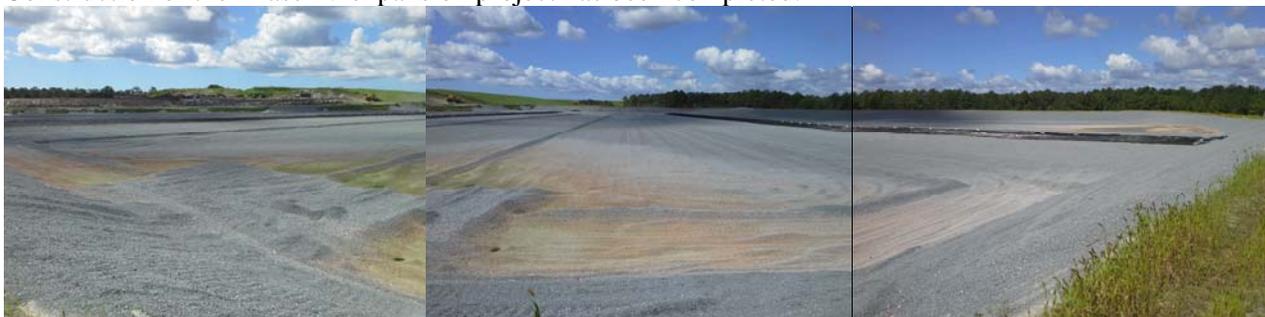
- 22) Construction of the Phase IV expansion project has been completed.

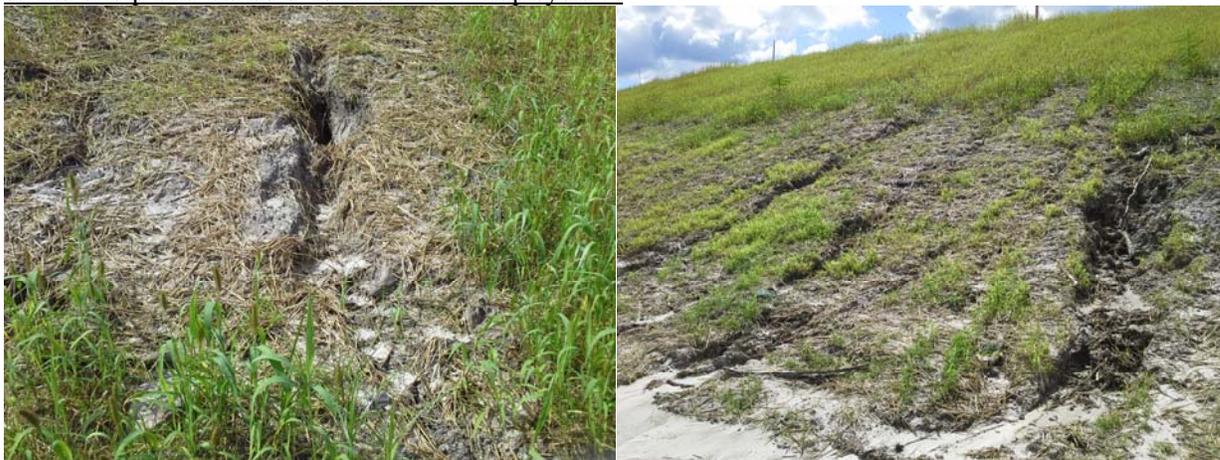
- 23) Areas of erosion were observed in various areas on the outside slopes of the Phase IV expansion area. \*Please fill and grade these eroded areas. All repaired areas should be seeded and mulched to establish a groundcover suitable to prevent erosion of the landfill cap system.

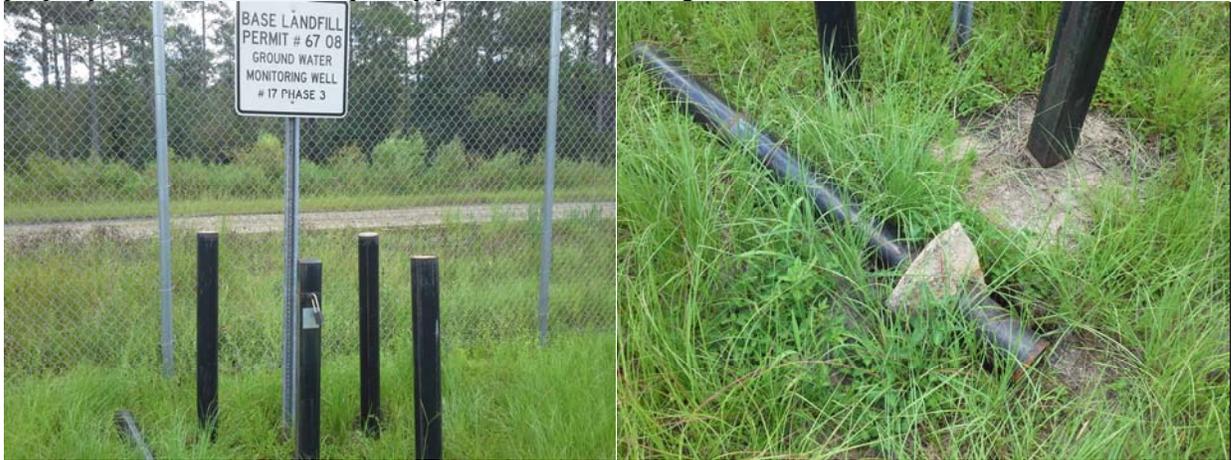
- 25) The leachate collection system cleanouts are highly visible, readily accessible, protected, and well maintained.
- 26) Facility monitoring wells were reviewed during this Facility Compliance Inspection. Overall, the wells were readily accessible, properly labeled, and secured with functioning locks. However, one of the groundwater monitoring well #17 protective bollards has been knocked down. Many of the bollards in this area along the southeastern access road appear to be insufficiently anchored to effectively protect the monitoring wells from equipment. \*Please repair this bollard and ensure that all protective bollards are sufficiently anchored and properly secured so as to adequately protect the monitoring wells.
