FACILITY COMPLIANCE INSPECTION REPORT
Division of Waste Management
Solid Waste Section

Pamlico County Landfill/Recycling Center
3291 Highway 306
Grantsboro, NC

Closed MSWLF under Subtitle D

6902_INSP_20160823

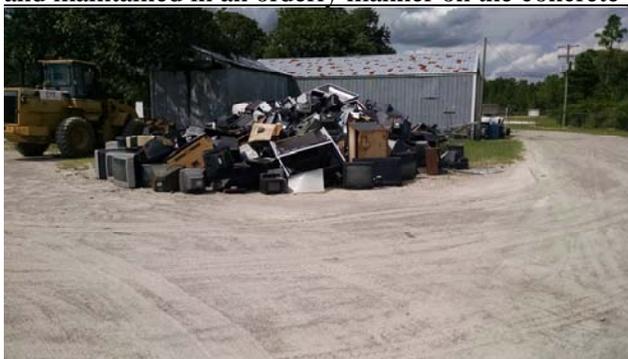
- 9) Electronics are collected and maintained on a concrete pad adjacent to the maintenance shop. *The electronics collection area is in need of attention. All recyclable electronics need to be placed on pallets, shrink-wrapped, and maintained in an orderly manner on the concrete pad until removed from the Facility for recycling.

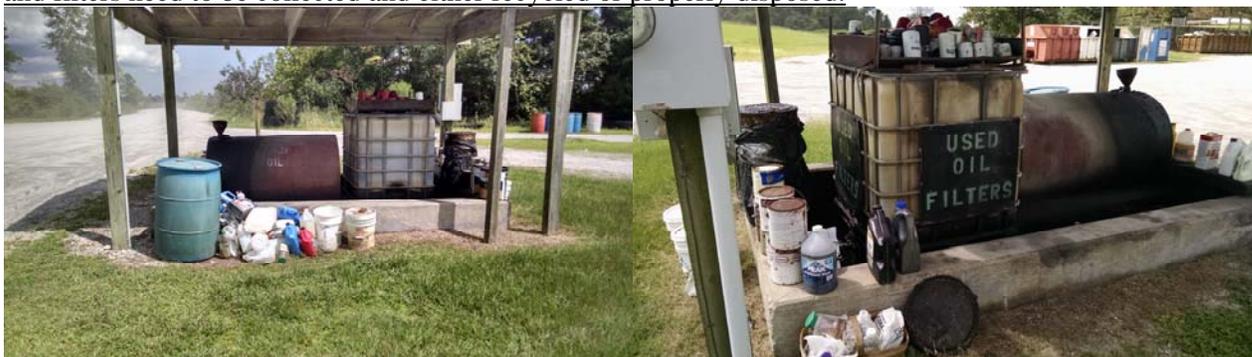
- 10) Used oil is collected and stored in a used oil drum under a shelter with secondary containment until collected by the used oil recycler. The secondary containment system appeared to be functioning properly during this Facility Compliance Inspection. *The used oil recycling area is in need of attention. The empty oil containers and filters need to be collected and either recycled or properly disposed.

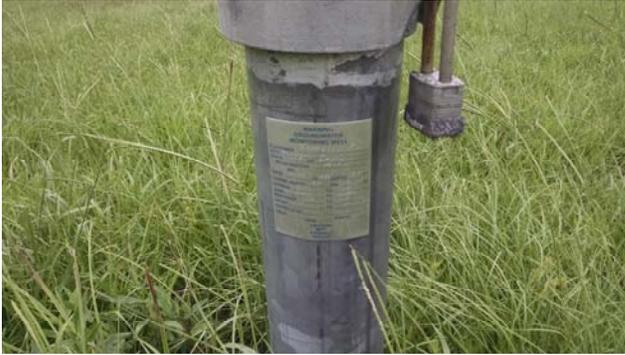
- 11) The Facility monitoring wells were reviewed. All wells were readily accessible, secured with functioning locks, and properly labeled.

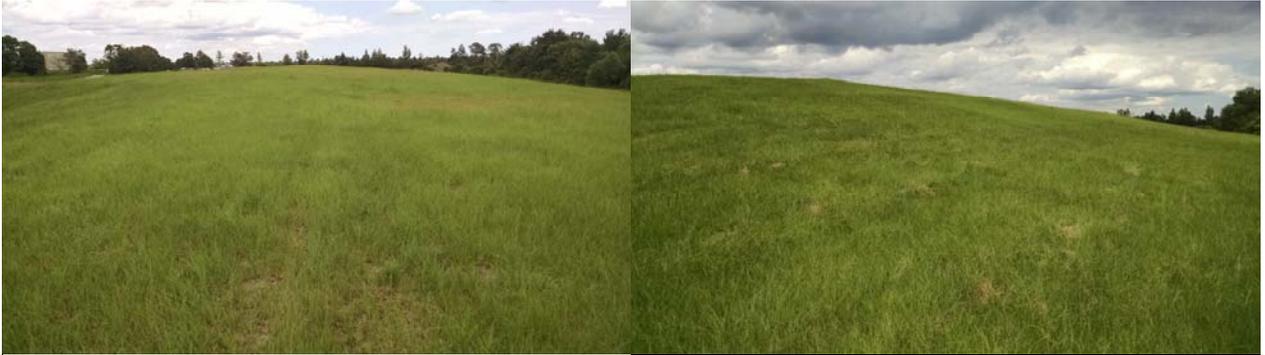
- 12) A cover-crop of native warm season grasses has been established and overall is well maintained throughout the landfill.

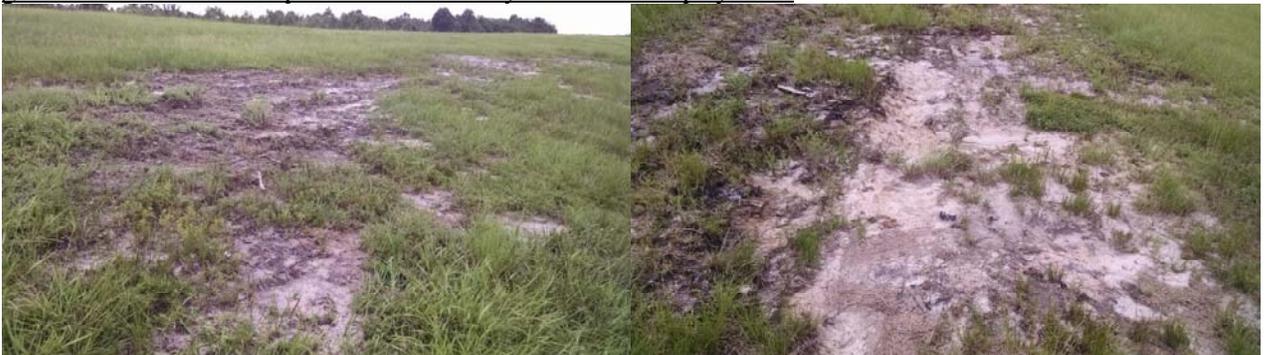
- 13) The Facility cover-crop is mowed throughout the growing season as necessary.
- 14) Several small areas of differential settlement were observed along the southern sideslope. Please continue to monitor these areas to ensure that they do not collect surface waters. *If the ponding of surface waters is observed, please fill and grade these areas at a slope not greater than 3:1, and seed and mulch to establish a groundcover suitable to prevent erosion.
- 15) Areas of sparse cover were observed along the northern sideslope of the top lift. Erosion is continuing in these areas due to a lack of a sufficient cover crop. Portions of the problem areas have been repaired. *Please continue working to repair these areas by filling and grading, and then seeding and mulching to establish a groundcover suitable to prevent erosion of your landfill cap system.
