FACILITY COMPLIANCE INSPECTION REPORT
Division of Waste Management
Solid Waste Section

Truck N Buckets VOA Landfill
VOA Site B Road
Grimesland, NC 27837

Comprehensive Facility Compliance Inspection

N0720_INSP_20160830

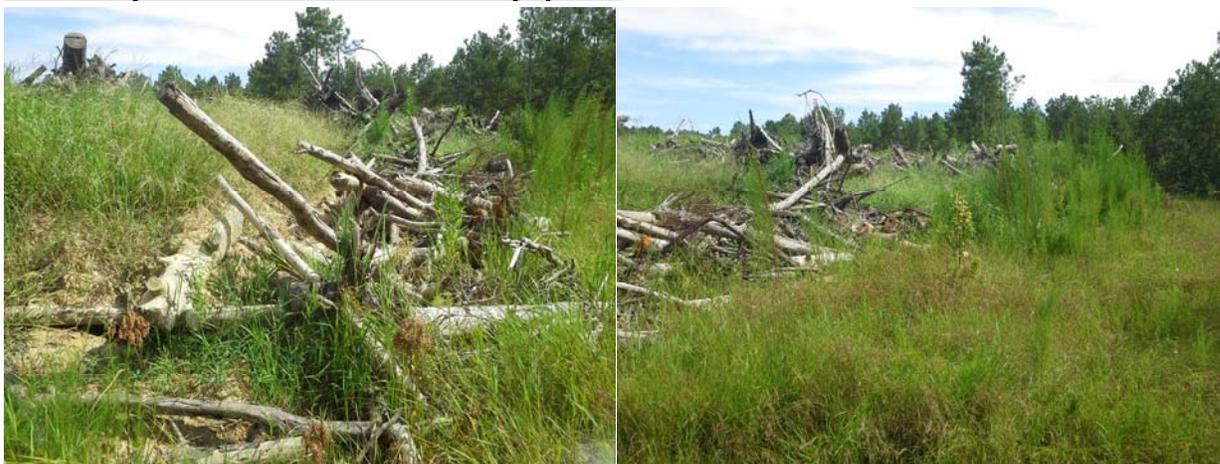
- 12) The outside slopes have not been compacted and covered as required. *Please ensure that all outside slopes are covered and graded at a slope not greater than 3:1, and are seeded and mulched to establish a groundcover suitable to prevent erosion of the landfill cap system.

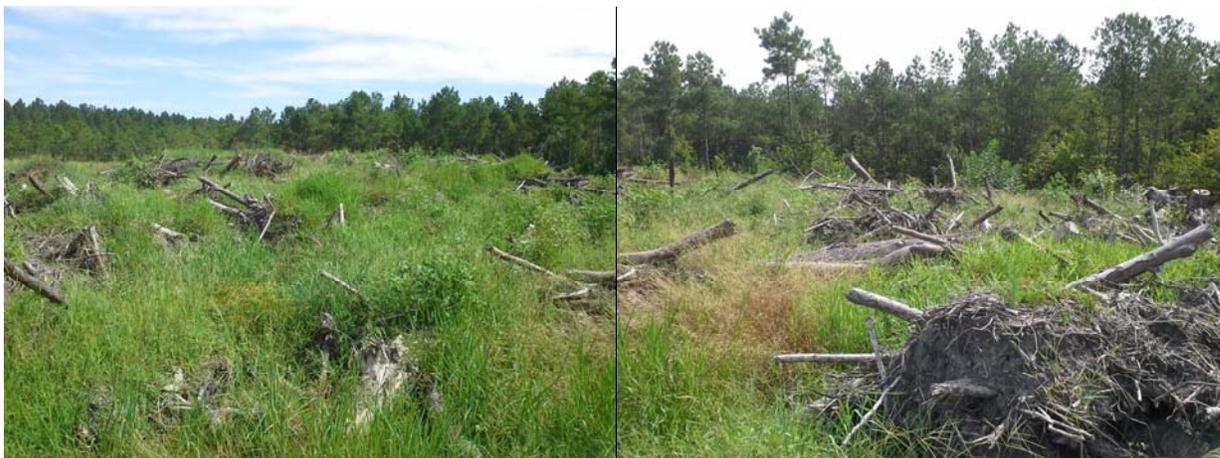
- 13) The active working area does not appear to have been covered within the last thirty days. *Please ensure the active working area is covered monthly, or when the active working area reaches 1 acre in size, whichever occurs first.

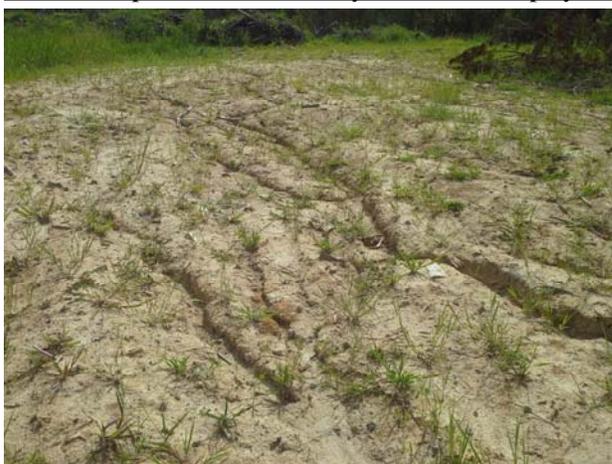
- 14) Erosion was observed in several areas on the top lift of the landfill. * Please repair this area by filling and re-grading all erosion damage at a slope not greater than 3:1 and seed and mulch to establish a groundcover suitable to prevent erosion of your landfill cap system.
