BROWNFIELDS ASSESSMENT REPORT

**UNITED METAL FINISHING
GREENSBORO, NORTH CAROLINA**

Reference: Brownfields Assessment Report
United Metal Finishing, Inc.
133/137 Blue Bell Road
Greensboro, Guilford County, North Carolina
Brownfields Project Number – 15002-11-41
ECS Project 09.11981E

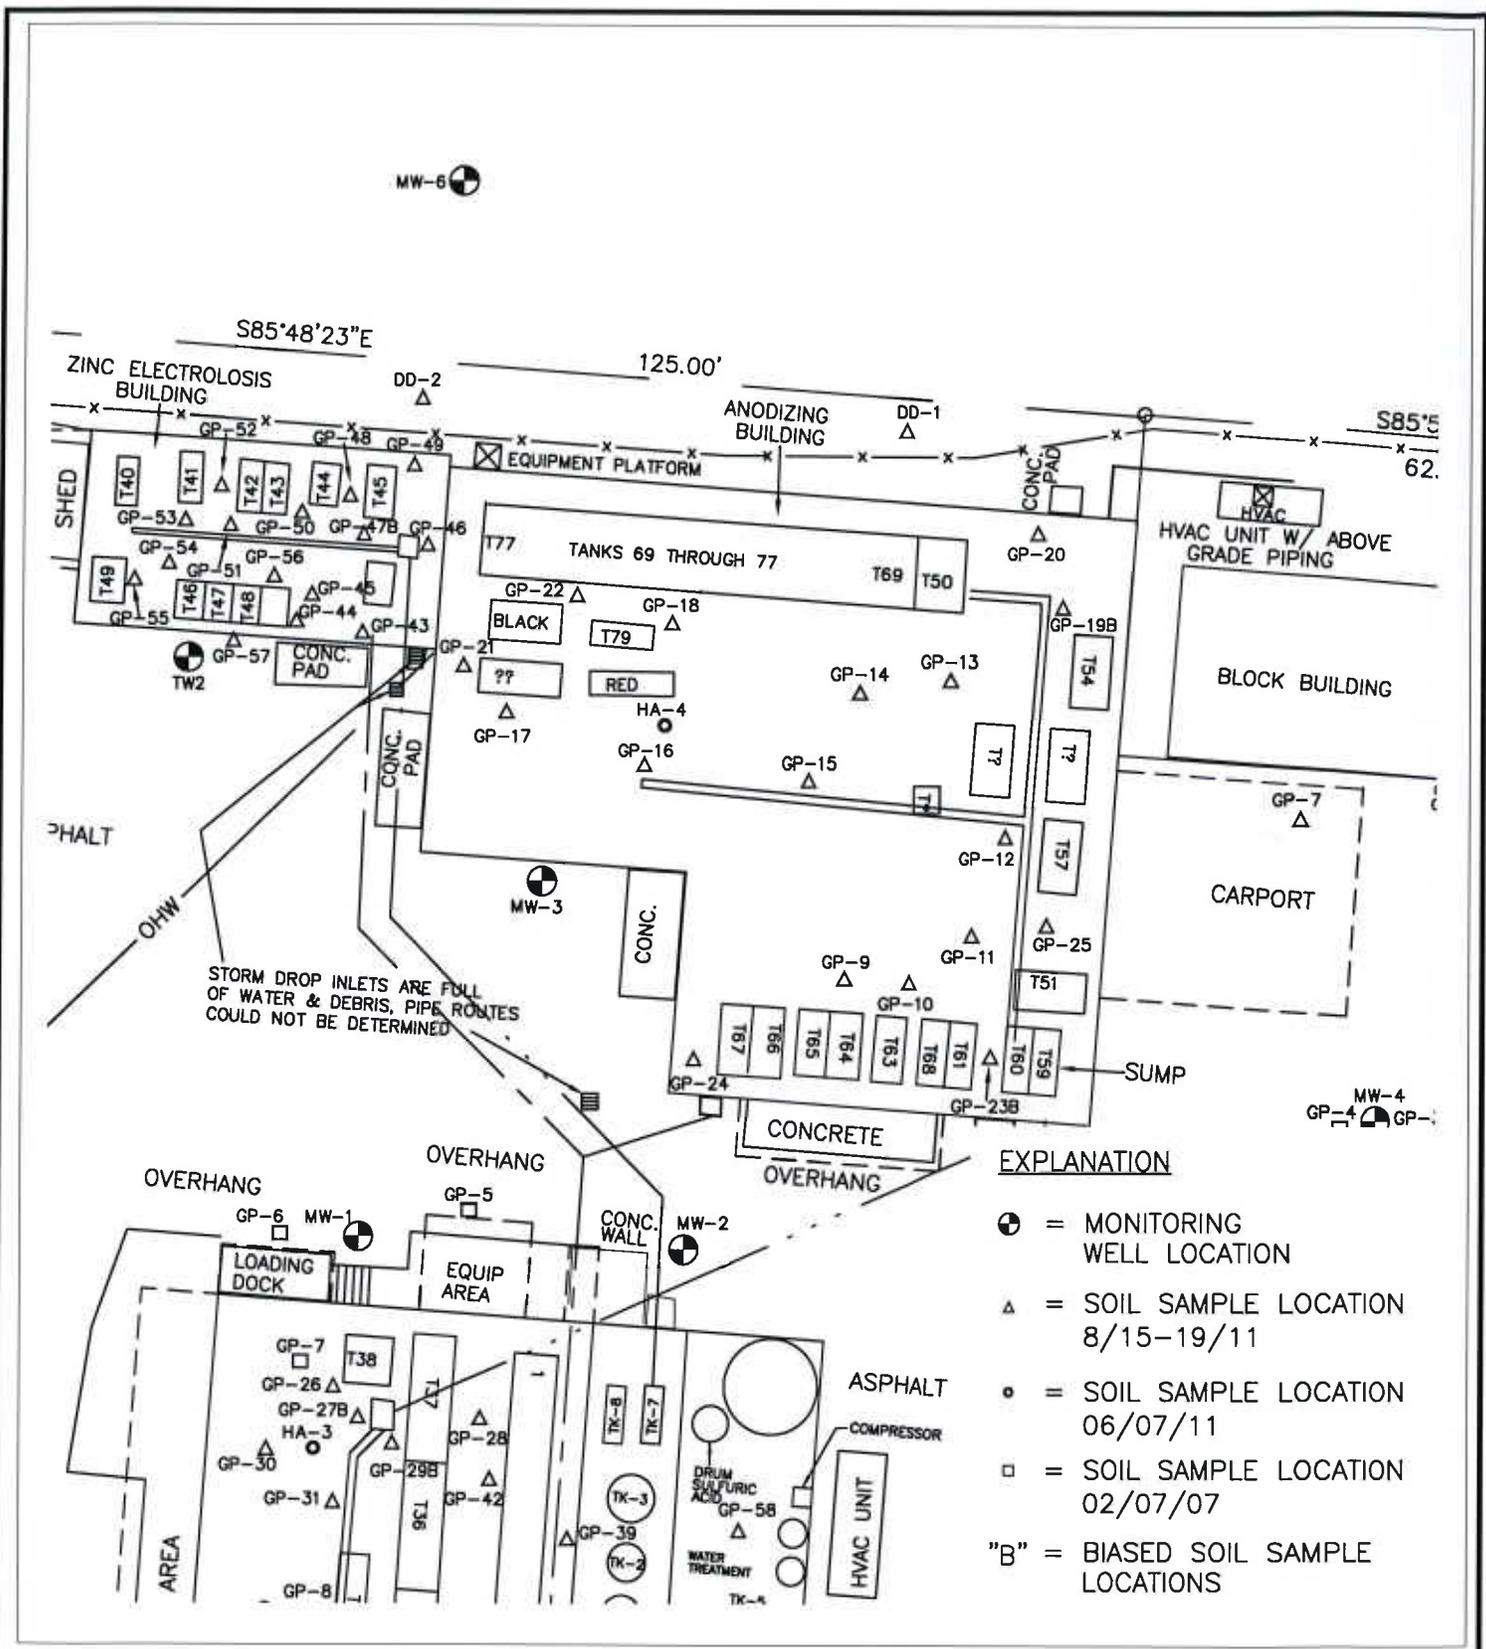
FIGURE 3
 SOIL BORING LOCATION MAP
 ANODIZING BUILDING

On August 15, 2011, Probe Technology, Inc. drilled seventeen soil borings (GP-9 through GP-25) through the concrete floor slab in the anodizing building (Figure 3). The direct push rig was used to core through the concrete where possible. A macrocore sampler was pushed to a depth of two feet bgs in areas adjacent to floor trenches and three feet bgs in areas adjacent to sumps. The bottom twelve inches of soil collected in the macrocore tube was placed in a stainless steel bowl and thoroughly mixed with a stainless steel spoon. If the Geoprobe could not be used due to access restrictions, a decontaminated hand auger was used to collect the sample. Prior to collecting the sample, a hole was cored through the concrete floor with a core drill. The sample collection procedures were the same. A portion of the composite sample was placed in a laboratory supplied bottle, logged onto a chain-of-custody, placed in a cooler, and delivered to a North Carolina certified laboratory to be analyzed for the 13 Priority Pollutant Metals, tin, and Cr^{+6} .

The soil sample locations are shown on Figure 3. The soil analytical results are summarized in Table 4 and the laboratory results are included in Appendix D.

Analysis of samples collected from the borings drilled in August 2011 in the anodizing building detected selenium in two samples and thallium in three samples, and zinc in one sample above the maximum background concentrations. Nickel was detected in eight samples above the maximum background concentration. Hexavalent chromium (Cr^{+6}) was detected above the IHSB's industrial health-based PSRGs and maximum background concentration in the sample collected from GP-25. Arsenic, beryllium, cadmium, copper, lead, tin and chromium +3 were not detected above the IHSB's industrial health-based PSRGs or maximum background concentrations. The sample from GP-25 had the highest concentration of chromium +6 and zinc. It was located near a floor trench in the southeast corner of the building.

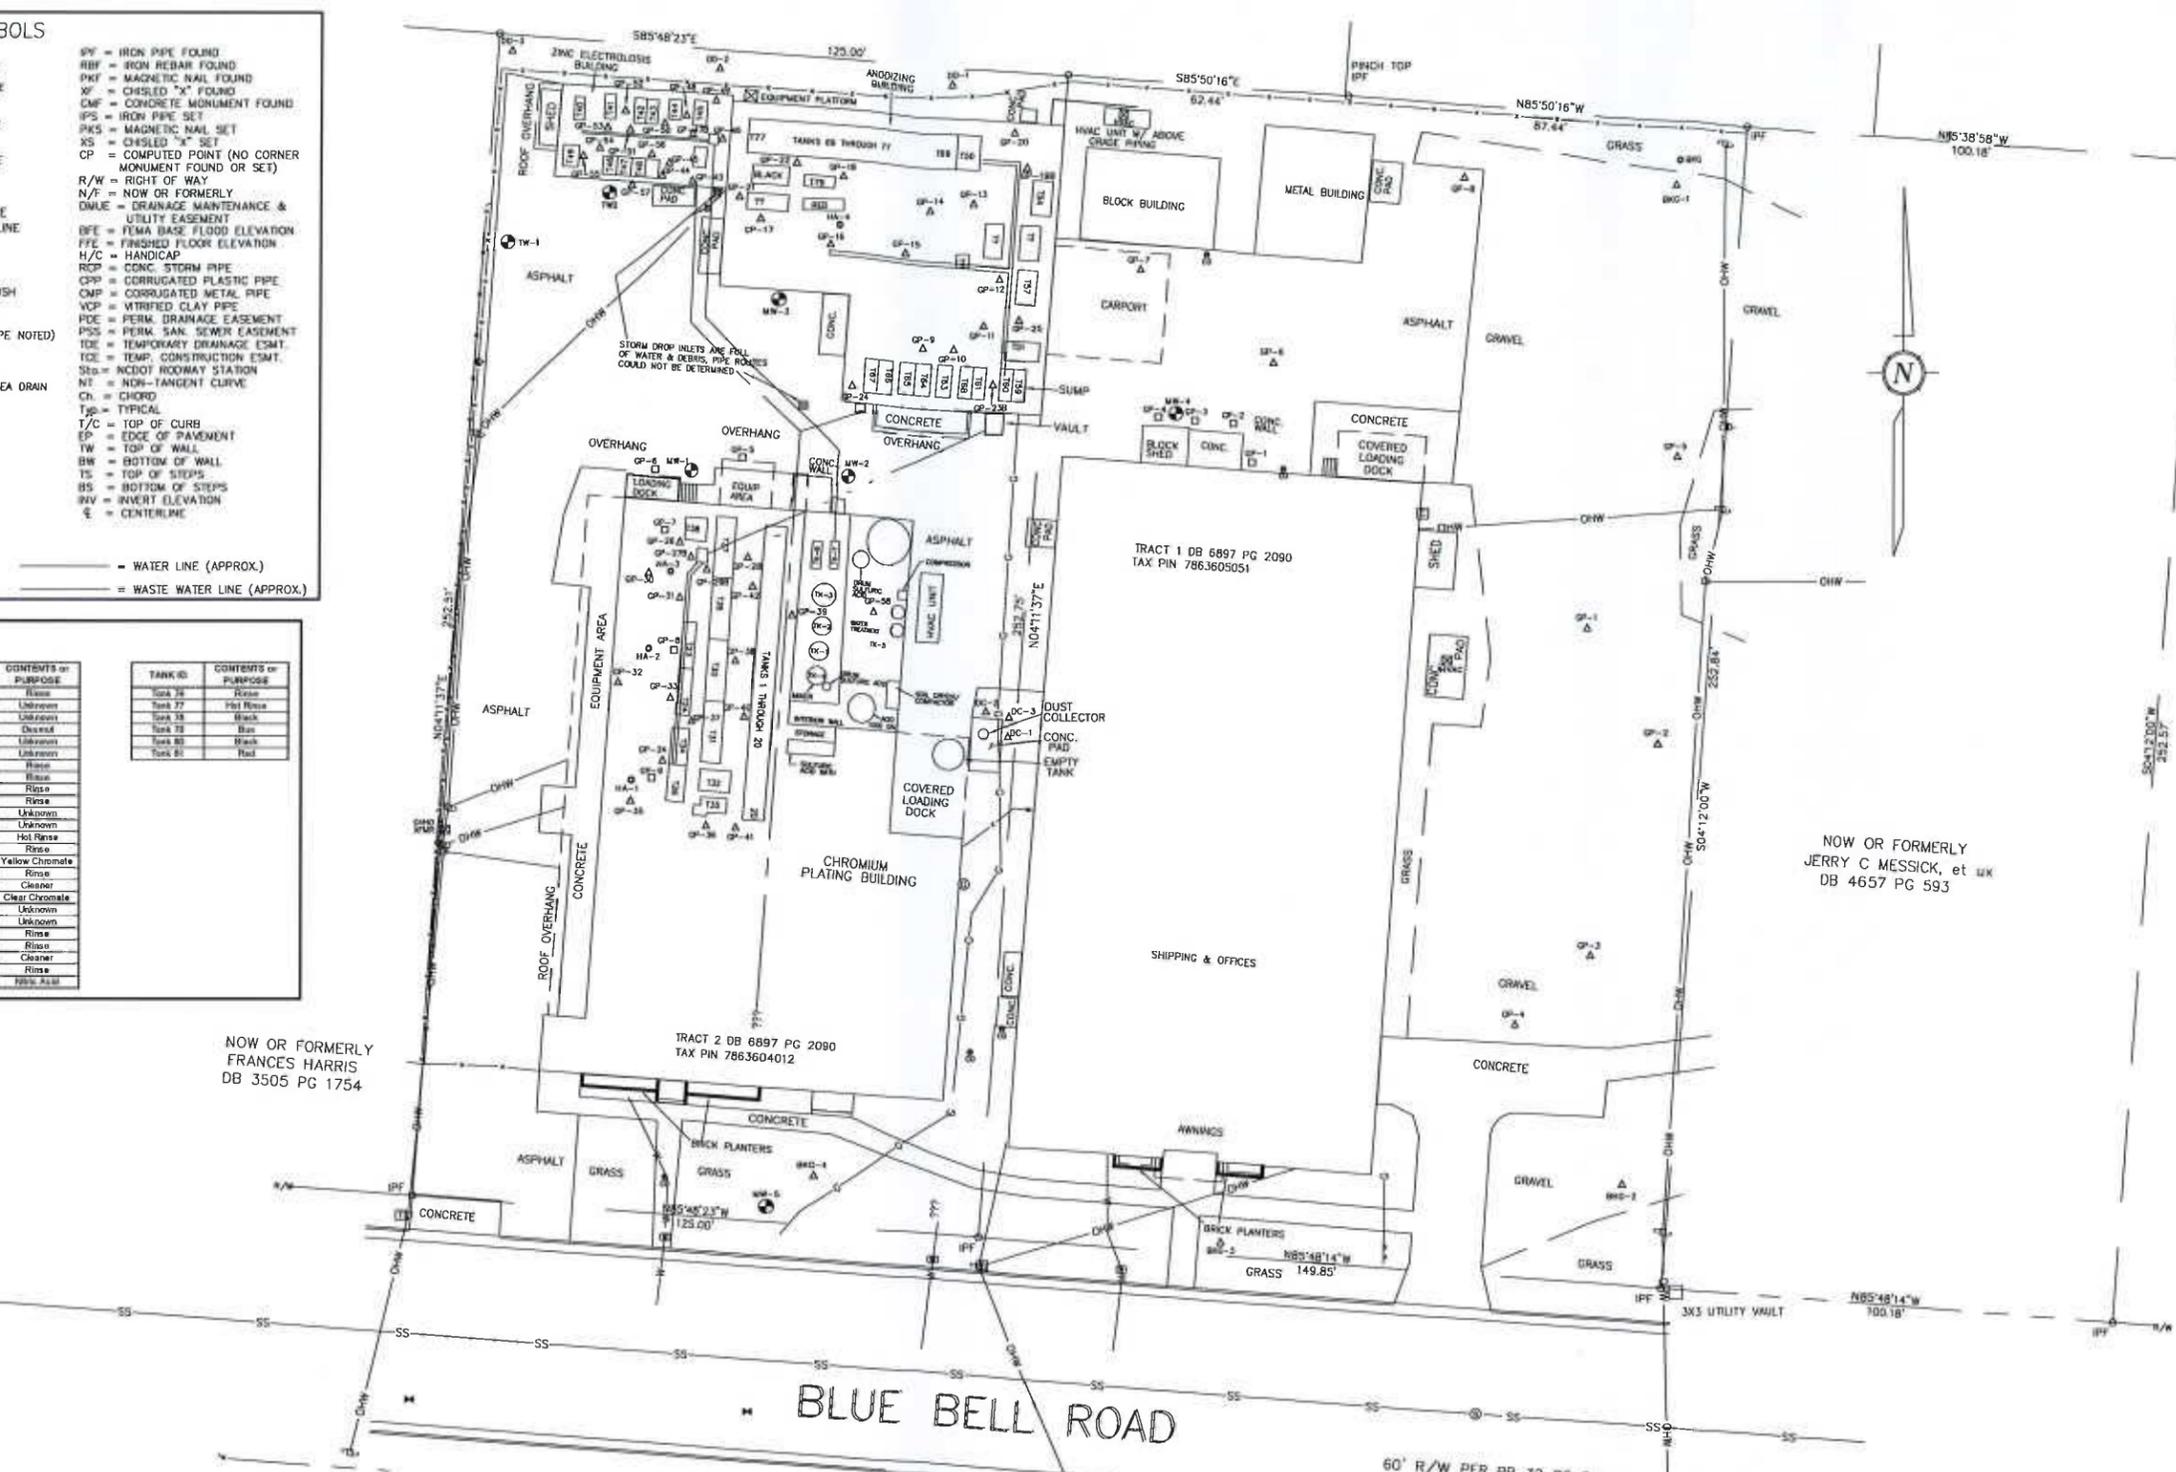
FIGURE 7
MONITORING WELL LOCATION MAP

Five permanent groundwater monitoring wells were installed on August 25, 2011 and a sixth monitoring well was installed on September 26, 2011 to assess groundwater quality at the site. The soil borings to install the wells were drilled using the Geoprobe[®] equipped with 4.0-inch O.D augers. The borings were drilled to an approximate depth of 20 feet. Soil samples were obtained starting at the land surface with a split spoon sampler to boring termination. The soil in each boring was classified and described on a boring log. The approximate locations are shown on Figure 7. A monitoring well constructed of 2-inch diameter Schedule 40 PVC screen and riser was installed in each boring. The wells were constructed with 10 feet of machine slotted PVC screen (0.01 inch slot) positioned to intersect the water table at the time of drilling. A clean sand filter pack was placed around the screen. The sand pack was capped with at least a two foot bentonite seal. The remaining well annulus was filled with cement grout. A protective steel cover was installed over each well with an approximate 1-foot by 1-foot concrete pad. A copy of the boring logs and well construction diagrams are included in Appendix B.

A North Carolina licensed surveyor surveyed the top of well casing (TOC) and land surface elevation of the newly installed monitoring wells. The well locations were located relative to site landmarks and placed on the site survey (Plate 1). Investigative derived waste (IDW) including;

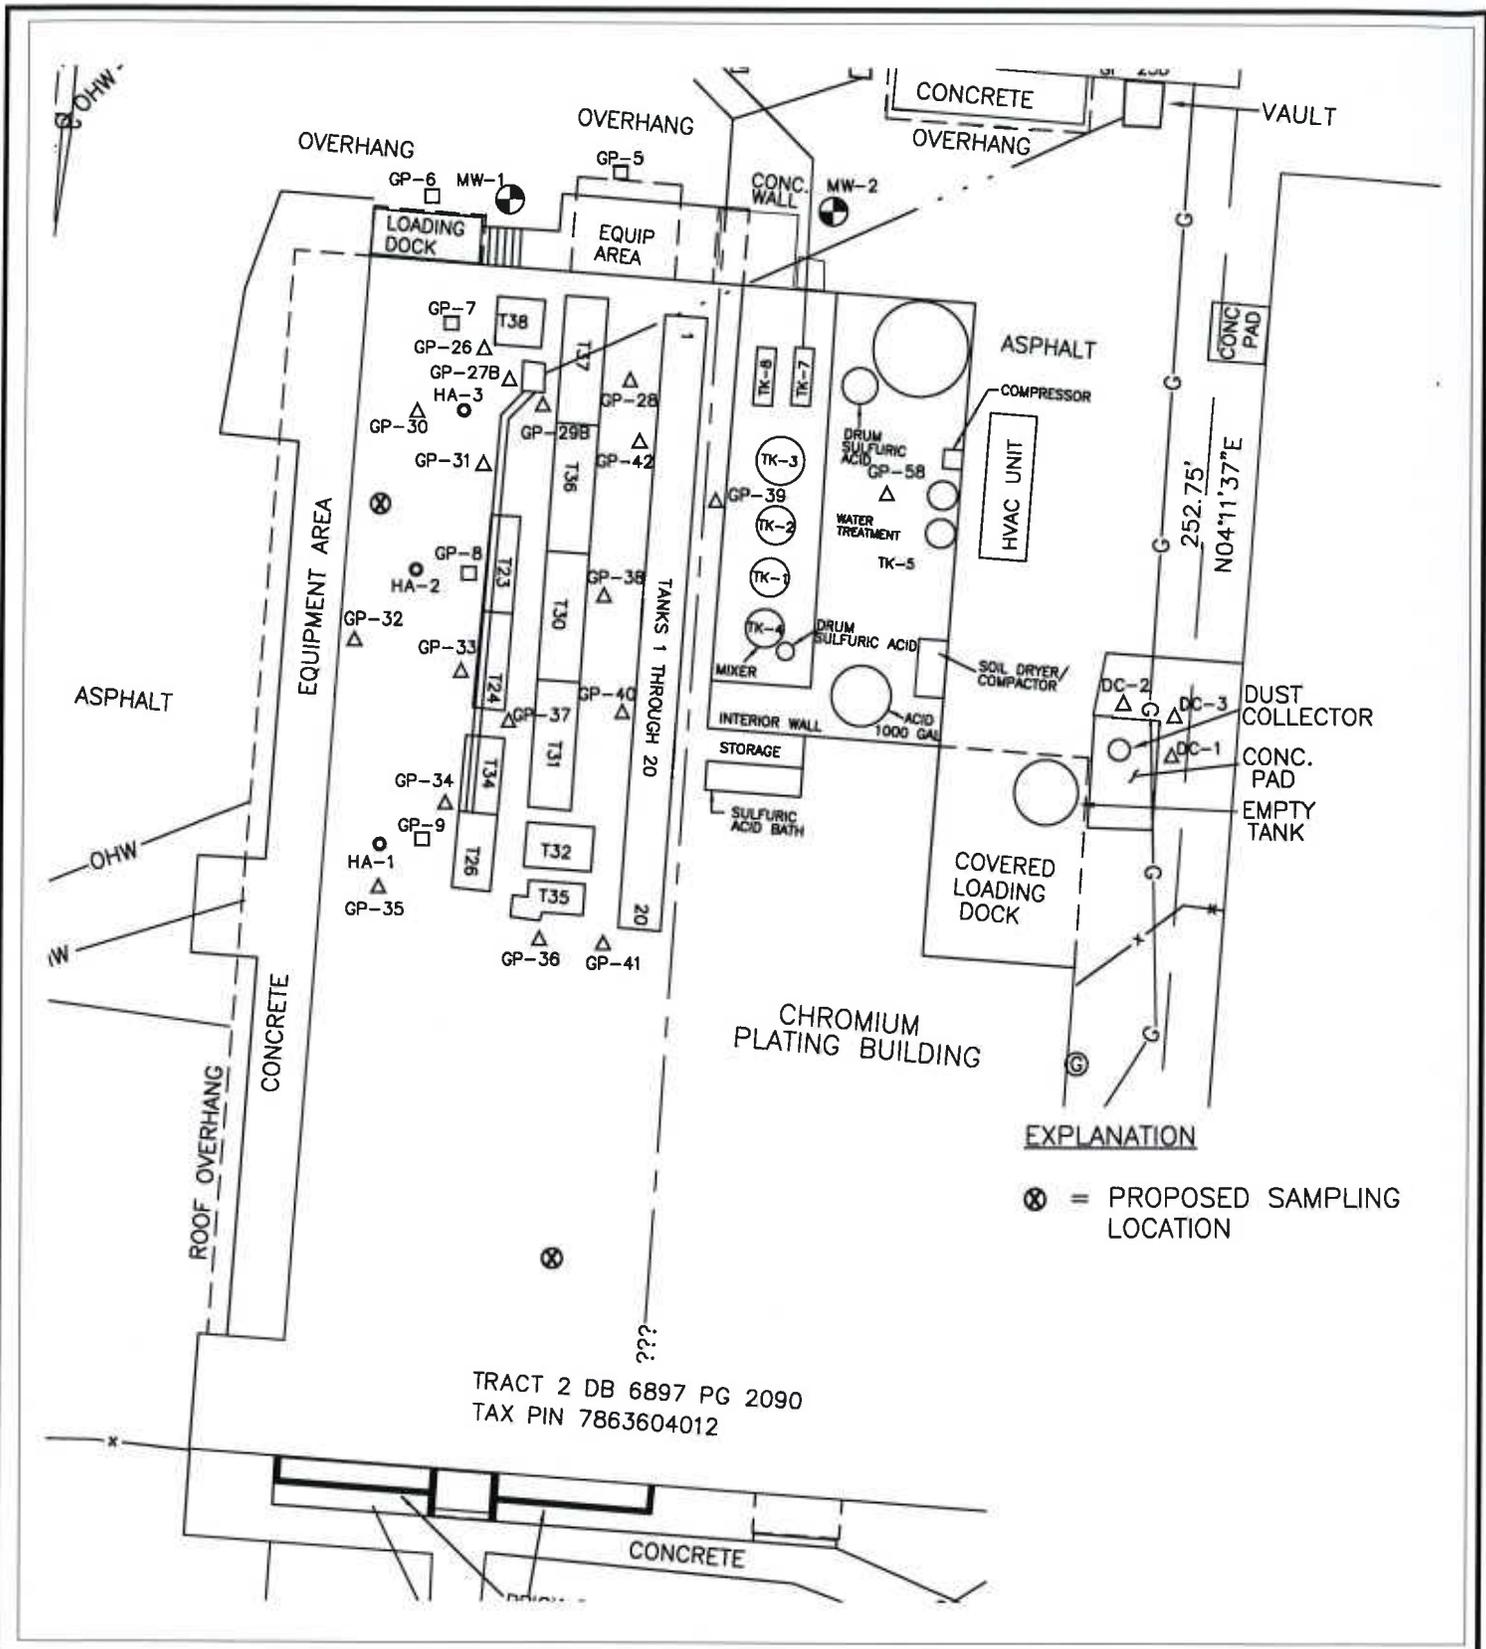
FIGURE 8
SOIL GAS SAMPLE LOCATIONS
CHROMIUM PLATING BUILDING

The chrome plating building includes an area approximately 9,600 square feet (80 feet by 120 feet). The northern portion of the building is occupied by plating tanks and the water treatment plant, while the southern portion of the building includes offices, restrooms, storage, and shipping and receiving. Samples were collected from two locations, one near the south end of the area and one near the north end of the area close to the west side of the area (away from the plating tanks). The approximate locations of the samples are shown on Figure 8.

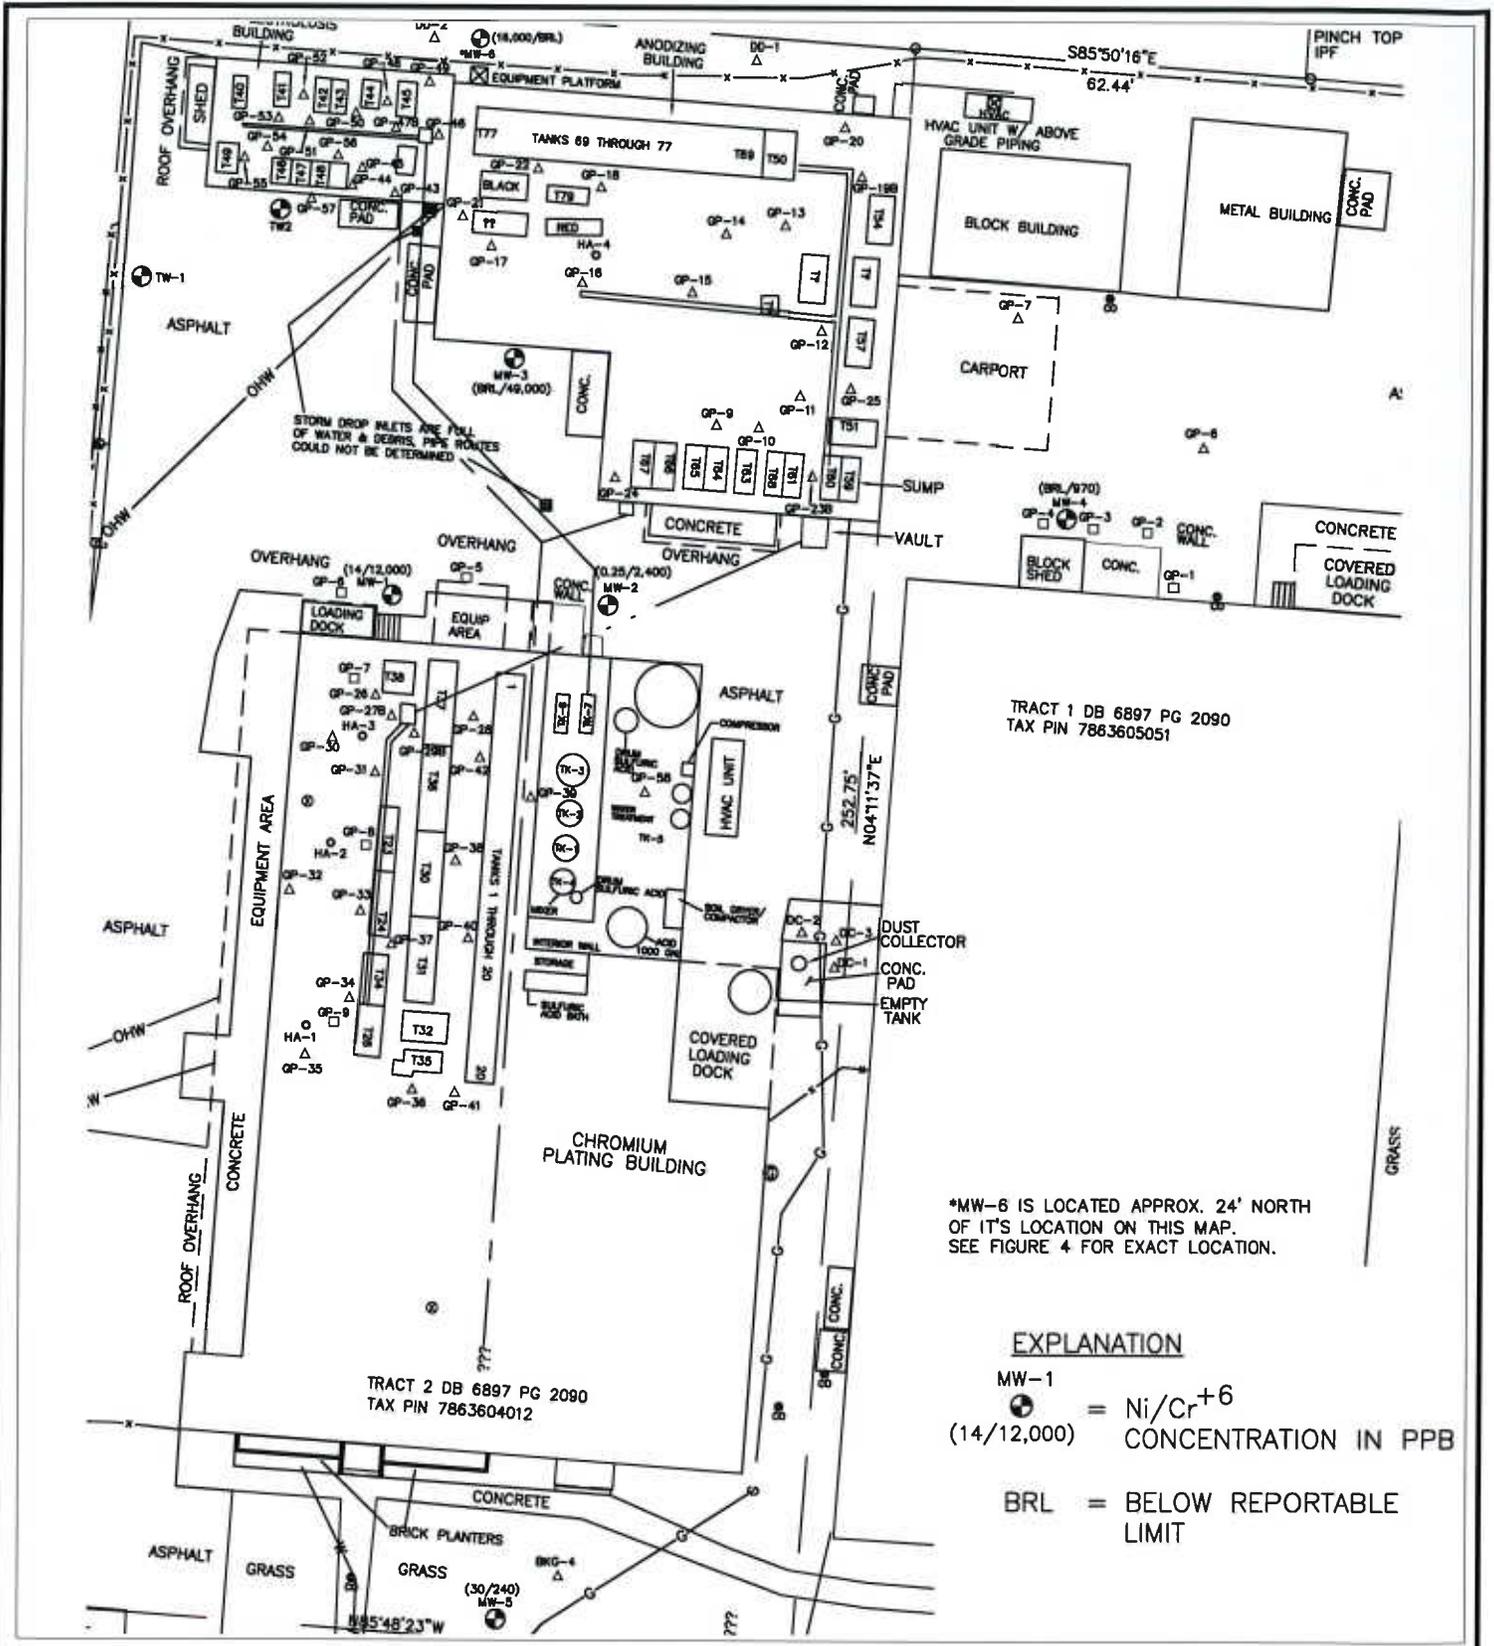
FIGURE 10
Ni/Cr⁺⁶ ISOCONCENTRATION MAP

The analysis detected antimony in MW-1 and MW-3 and nickel in MW-2, MW-4 and MW-6 above the 2L groundwater standards, and total chromium and chromium +6 above the standards in all the wells except MW-6.

The results are summarized in Table 8 and shown on Figures 10 and 11. The laboratory report is included in Appendix D. The groundwater field parameters are recorded on the well construction diagrams included in Appendix B.

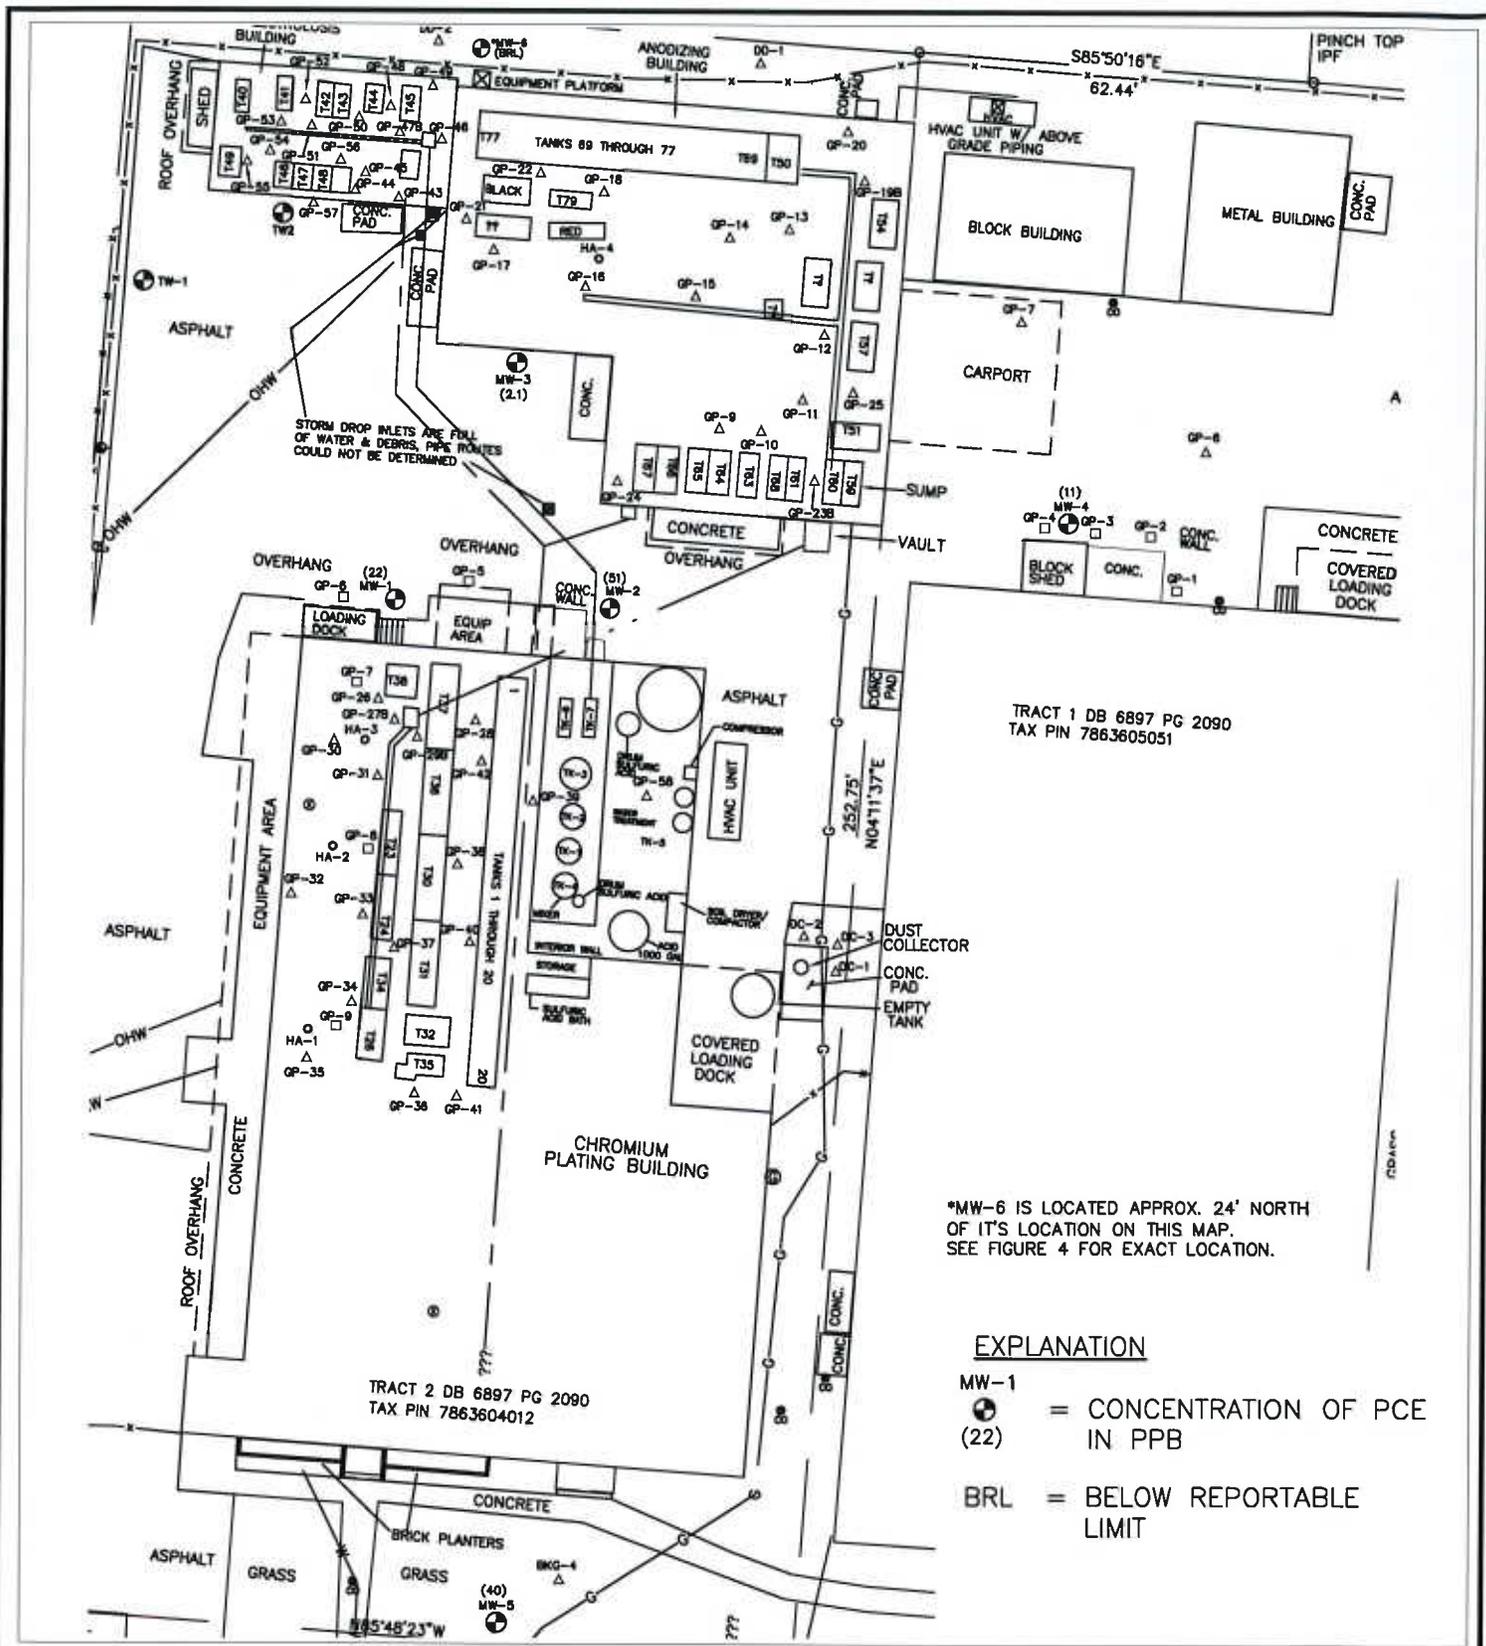
The analysis of the groundwater samples detected concentrations of tetrachloroethene (PCE) in all the samples except for monitoring well MW-6 (located on the northern property boundary behind the anodizing and zinc plating buildings) in excess of the NCDENR 2L Groundwater Quality Standards (2L Standards). The concentrations of PCE in MW-2 and MW-5 are also above the IHSB's industrial/commercial vapor intrusion screening level of 29 ppb.

- MW-1 = CONCENTRATION OF PCE IN PPB
- (22) = CONCENTRATION OF PCE IN PPB
- BRL = BELOW REPORTABLE LIMIT
