DRAFT - Technical Memorandum - Work Plan for Investigation of Lead Impacts in Soil – Former Water Tower Sites S-5, SBA-108, S-830 and LCH-4004 – MCB Camp Lejeune, North Carolina

PREPARED FOR: NAVFAC/ MCB CAMP LEJEUNE

PREPARED BY: Osage of Virginia

DATE: April 4, 2016

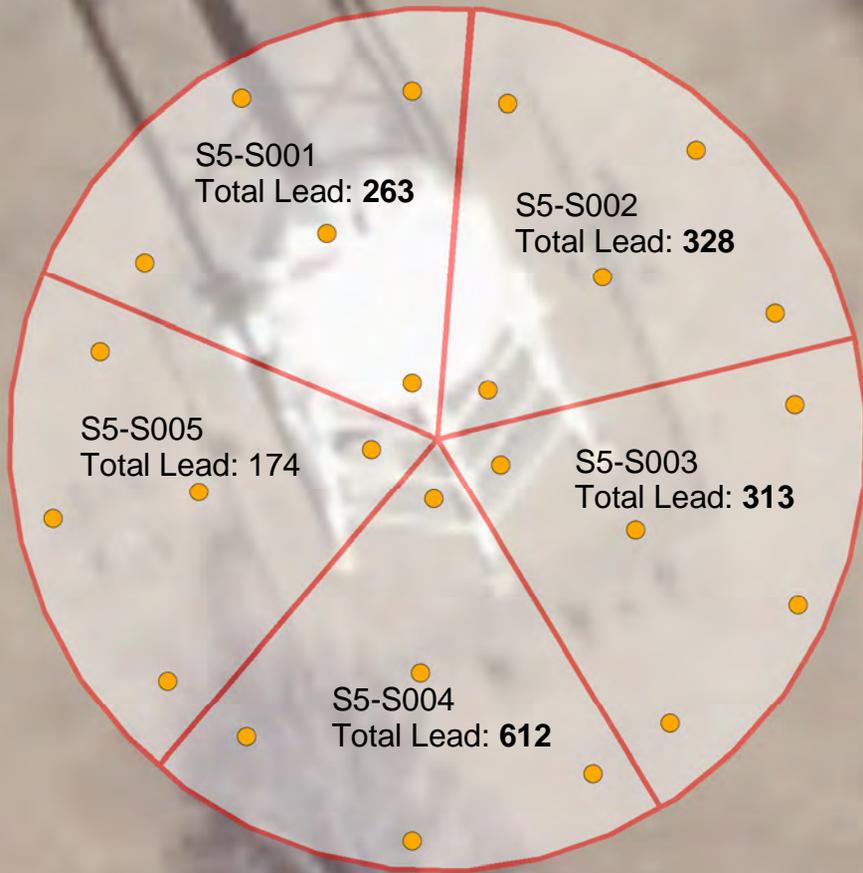
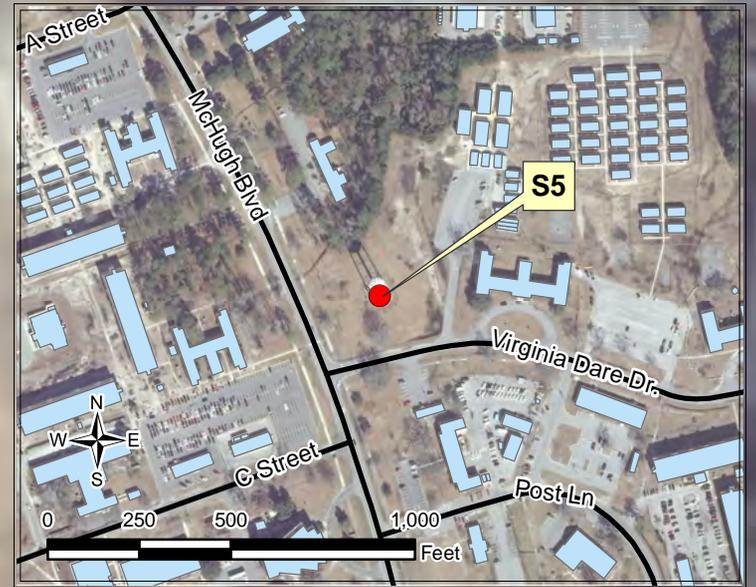
Figure 2
 S-5 Composite Sample Location Map
 MCBCAMLEJ
 North Carolina

S-5 WATER TOWER - COMPOSITE SOIL SAMPLE RESULTS – TOTAL LEAD					
EPA Industrial RSL (mg/kg)	800				
EPA Residential RSL (mg/kg)	400				
NC DEQ SSL (mg/kg)	270				
Sample ID	S5-S001	S5-S002	S5-S003	S5-S004	S5-S005
Analytical Result (mg/kg)	263	328	313	612	174

Three of the five composite samples collected from the former S-5 Water Tower site indicated concentrations of lead in excess of regulatory screening levels. Two samples (S002 and S003) indicated concentrations in excess of the NC DEQ SSL, and one sample (S004) indicated a concentration in excess of both the NC DEQ SSL and the EPA Residential RSL. Figure 2 illustrates the composite sample locations. No background samples were collected from the vicinity of the S-5 Water Tower site; however, the *Final Expanded Soil Background Study Report* for MCB CAMLEJ (CH2M Hill, 2011) has established a background threshold value (BTV) for lead of 20.2 mg/kg for similar surface soils in developed areas.

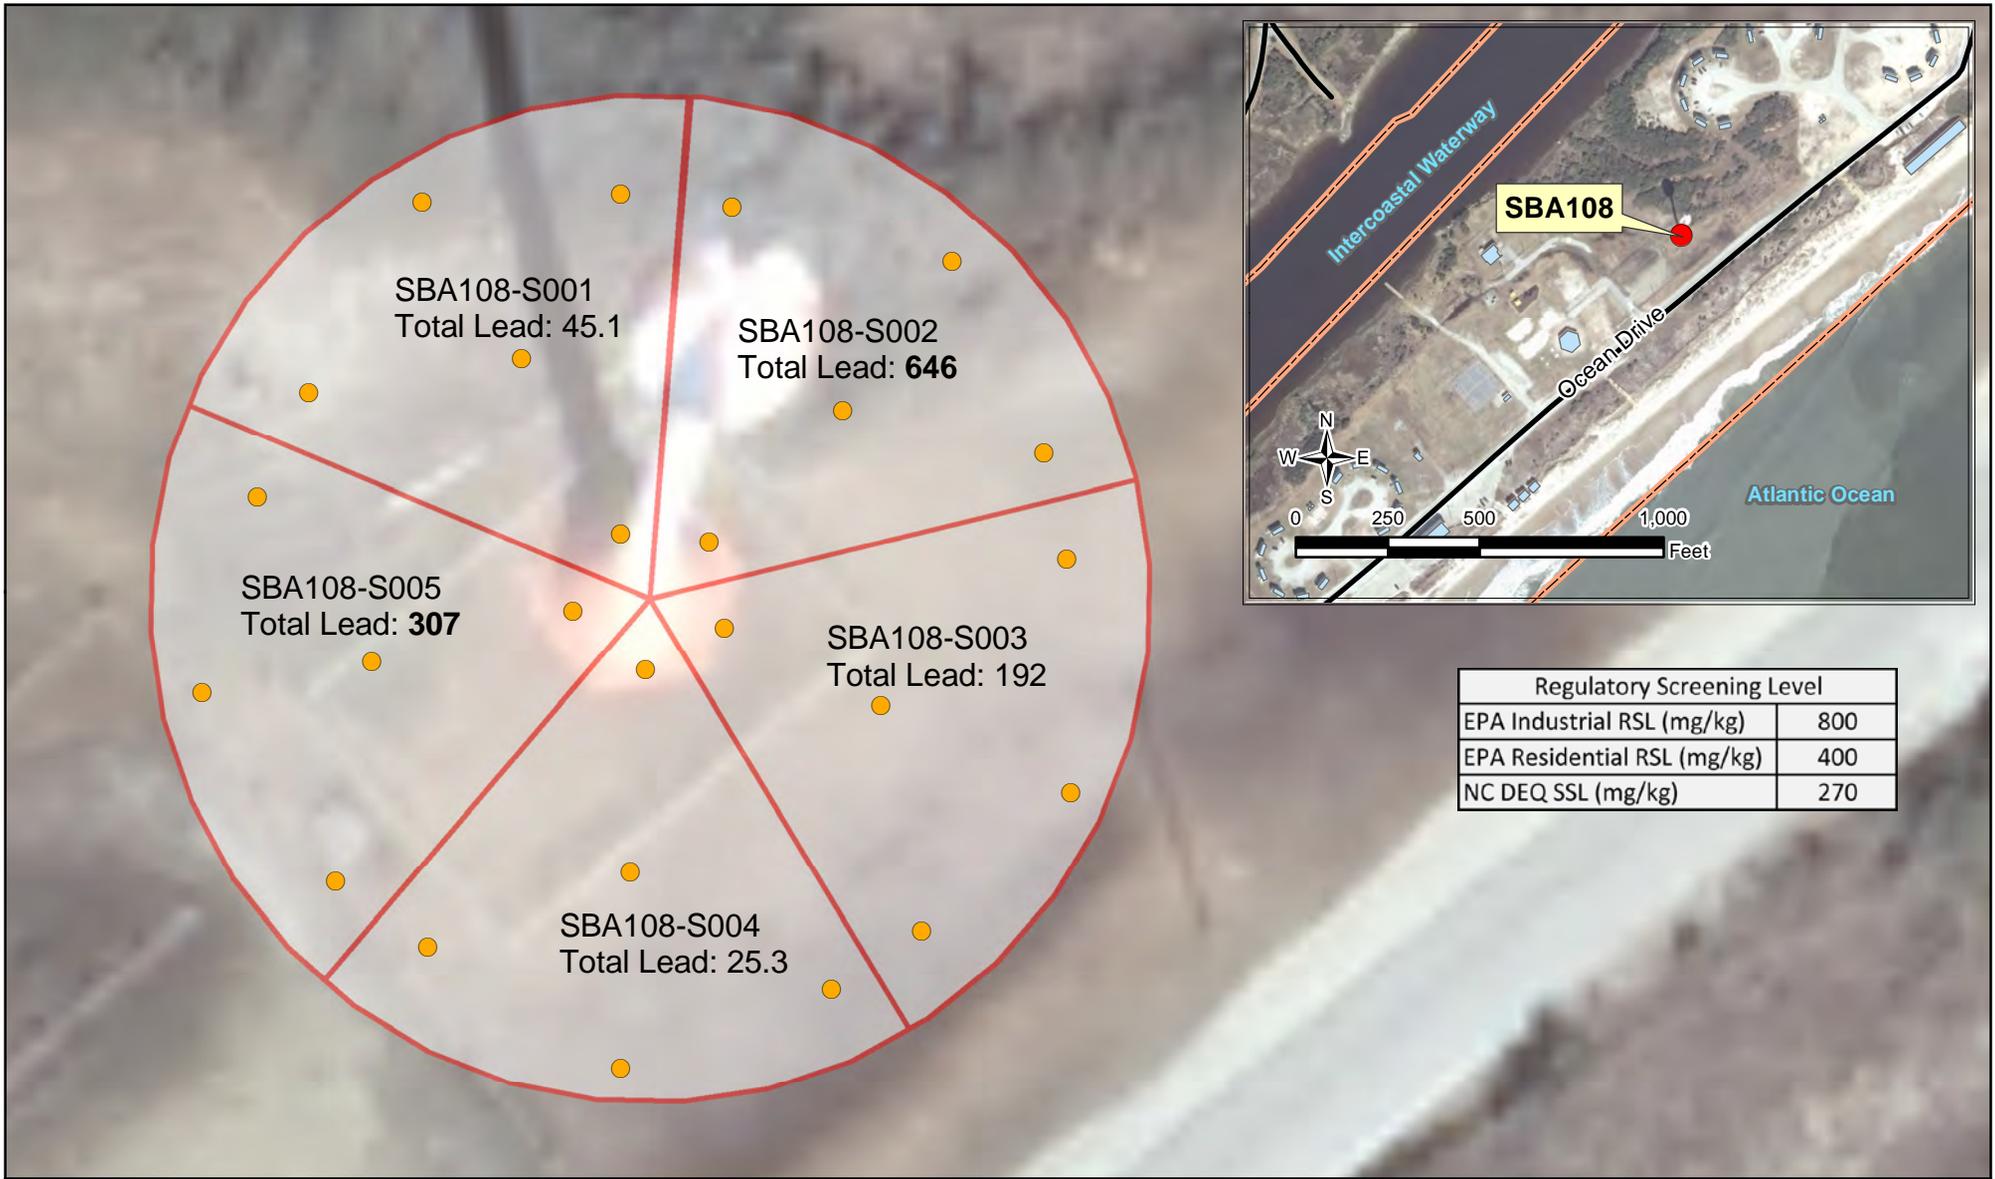
Figure 3
 SBA108 Composite Sample Location Map
 MCBCAMLEJ
 North Carolina

SBA-108 WATER TOWER - COMPOSITE SOIL SAMPLE RESULTS – TOTAL LEAD							
EPA Industrial RSL (mg/kg)	800						
EPA Residential RSL (mg/kg)	400						
NC DEQ SSL (mg/kg)	270						
Sample ID	SBA108-S001	SBA108-S002	SBA108-003	SBA108-S004	SBA108-S005	SBA108-BG01	SBA108-BG02
Analytical Result (mg/kg)	45.1	646	192	25.3	307	4.34	16.3

Two of the five composite samples collected from the former SBA-108 Water Tower site indicated concentrations of lead in excess of regulatory screening levels. One sample (S005) indicated a concentration in excess of the NC DEQ SSL, and one sample (S002) indicated a concentration in excess of both the NC DEQ SSL and the EPA Residential RSL. Figure 3 illustrates the composite sample locations. As tabulated above, background samples were substantially below all regulatory screening levels for lead.

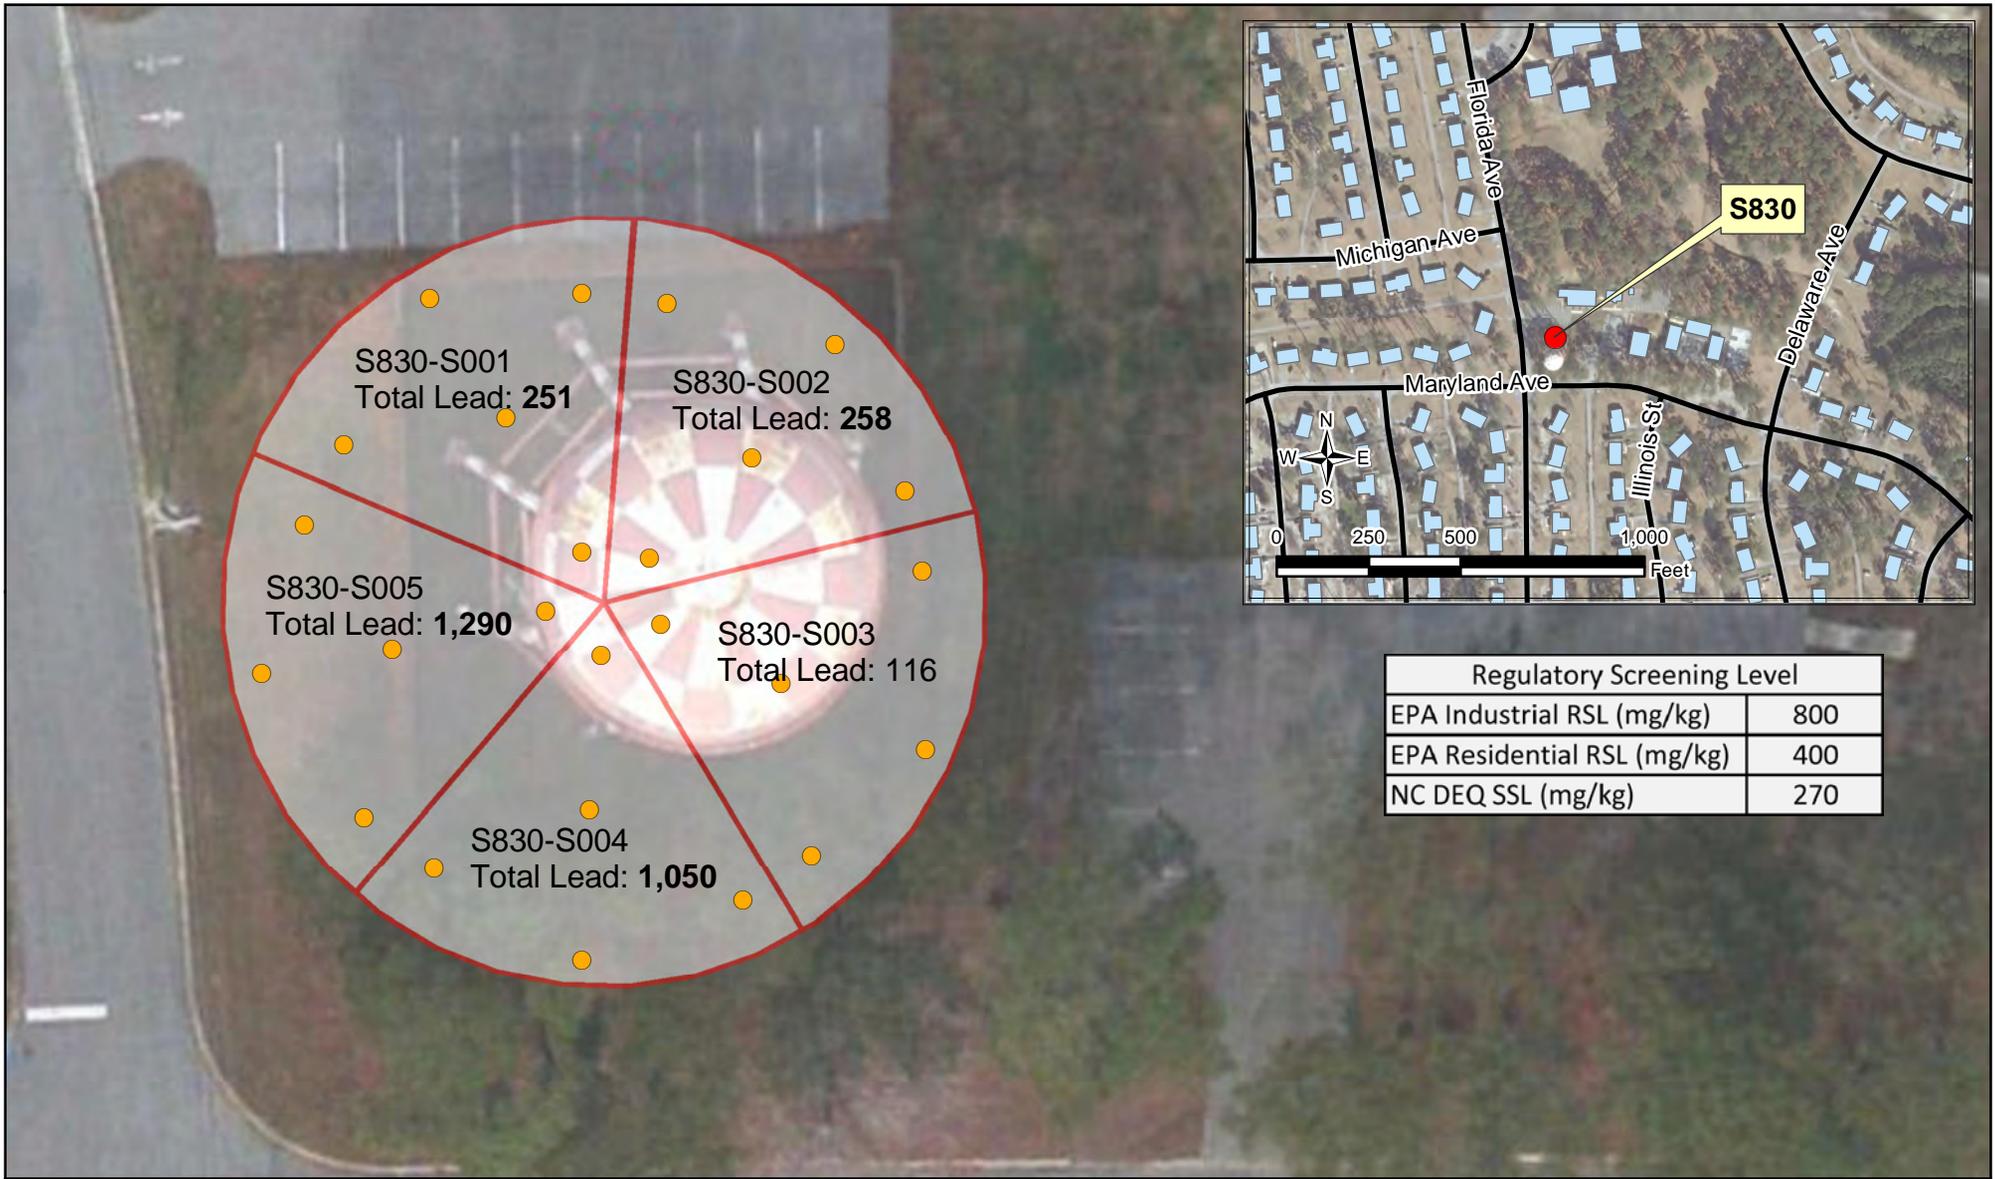
Figure 4
S830 Composite Sample Location Map
MCBCAMLEJ
North Carolina

Two of the five composite samples collected from the former S-830 Water Tower site indicated concentrations of lead in excess of regulatory screening levels. Samples S004 and S005 indicated concentrations in excess of the NC DEQ SSL, as well as both Residential and Industrial RSLs. Figure 4 illustrates the composite sample locations. As tabulated above, background samples were substantially below all regulatory screening levels for lead.

S830-S001
Total Lead: **251**

S830-S002
Total Lead: **258**

S830-S005
Total Lead: **1,290**

S830-S003
Total Lead: 116

S830-S004
Total Lead: **1,050**

SBA-830 WATER TOWER - COMPOSITE SOIL SAMPLE RESULTS – TOTAL LEAD							
EPA Industrial RSL (mg/kg)	800						
EPA Residential RSL (mg/kg)	400						
NC DEQ SSL (mg/kg)	270						
Sample ID	S830-S001	S830-S002	S830-003	S830-S004	S830-S005	S830-BG01	S830-BG02
Analytical Result (mg/kg)	251	258	116	1,050	1,290	19.8	18.3

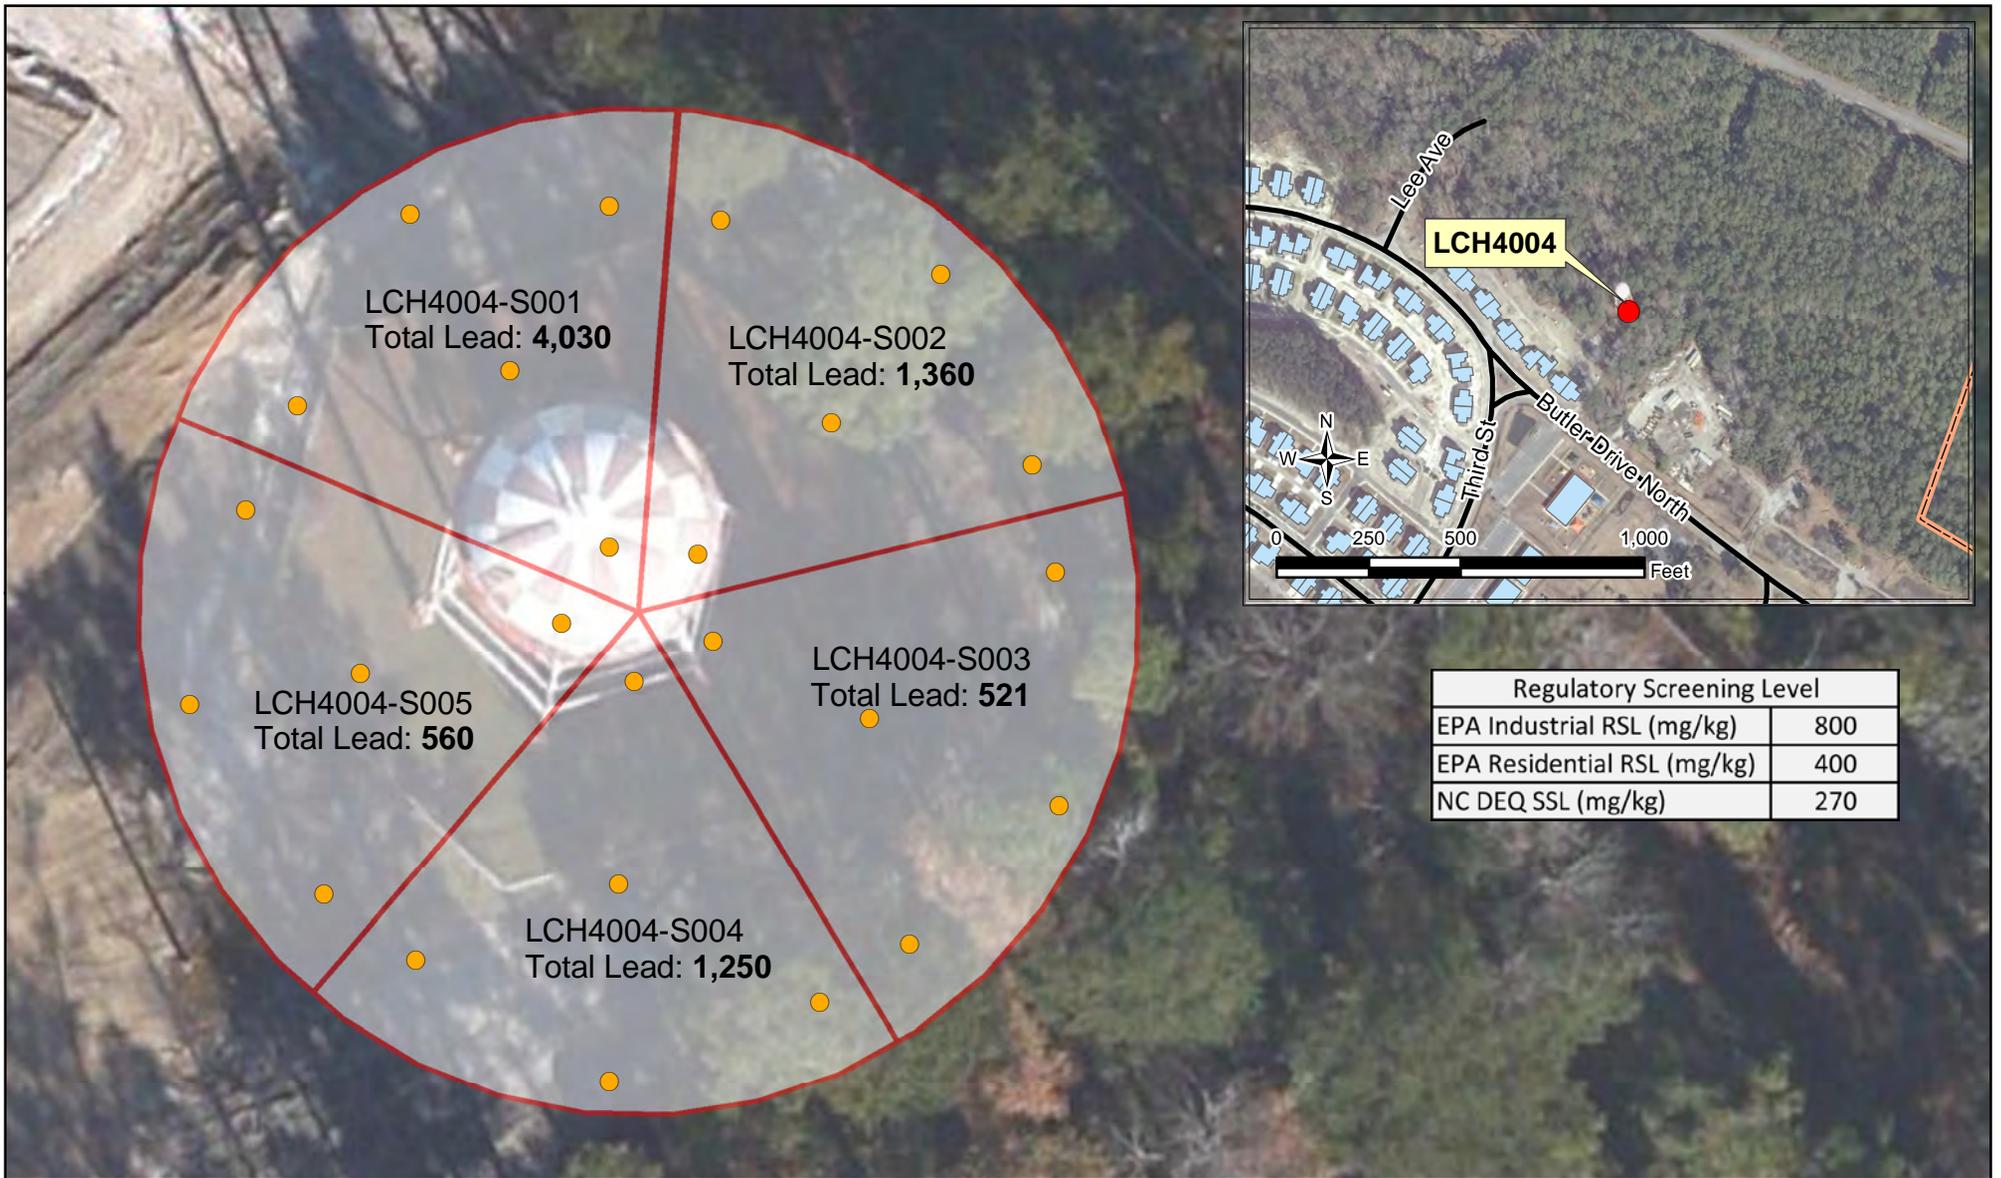
Figure 5
 LCH4004 Composite Sample Location Map
 MCBCAMLEJ
 North Carolina

LCH-4004 WATER TOWER - COMPOSITE SOIL SAMPLE RESULTS – TOTAL LEAD							
EPA Industrial RSL (mg/kg)	800						
EPA Residential RSL (mg/kg)	400						
NC DEQ SSL (mg/kg)	270						
Sample ID	LCH400 4-S001	LCH400 4-S002	LCH400 4-003	LCH400 4-S004	LCH400 4-S005	LCH400 4-BG01	LCH400 4-BG02
Analytical Result (mg/kg)	4,030	1,360	521	1,250	560	10.4	15.6

All five composite samples collected from the former LCH-4004 Water Tower site indicated concentrations of lead in excess of regulatory screening levels. Samples S003 and S005 indicated concentrations in excess of the NC DEQ SSL and the Residential RSL. Samples S001, S002 and S004 indicated concentrations in excess of the NC DEQ SSL, as well as both Residential and Industrial RSLs. Figure 5 illustrates the composite sample locations. As tabulated above, background samples were substantially below all regulatory screening levels for lead.

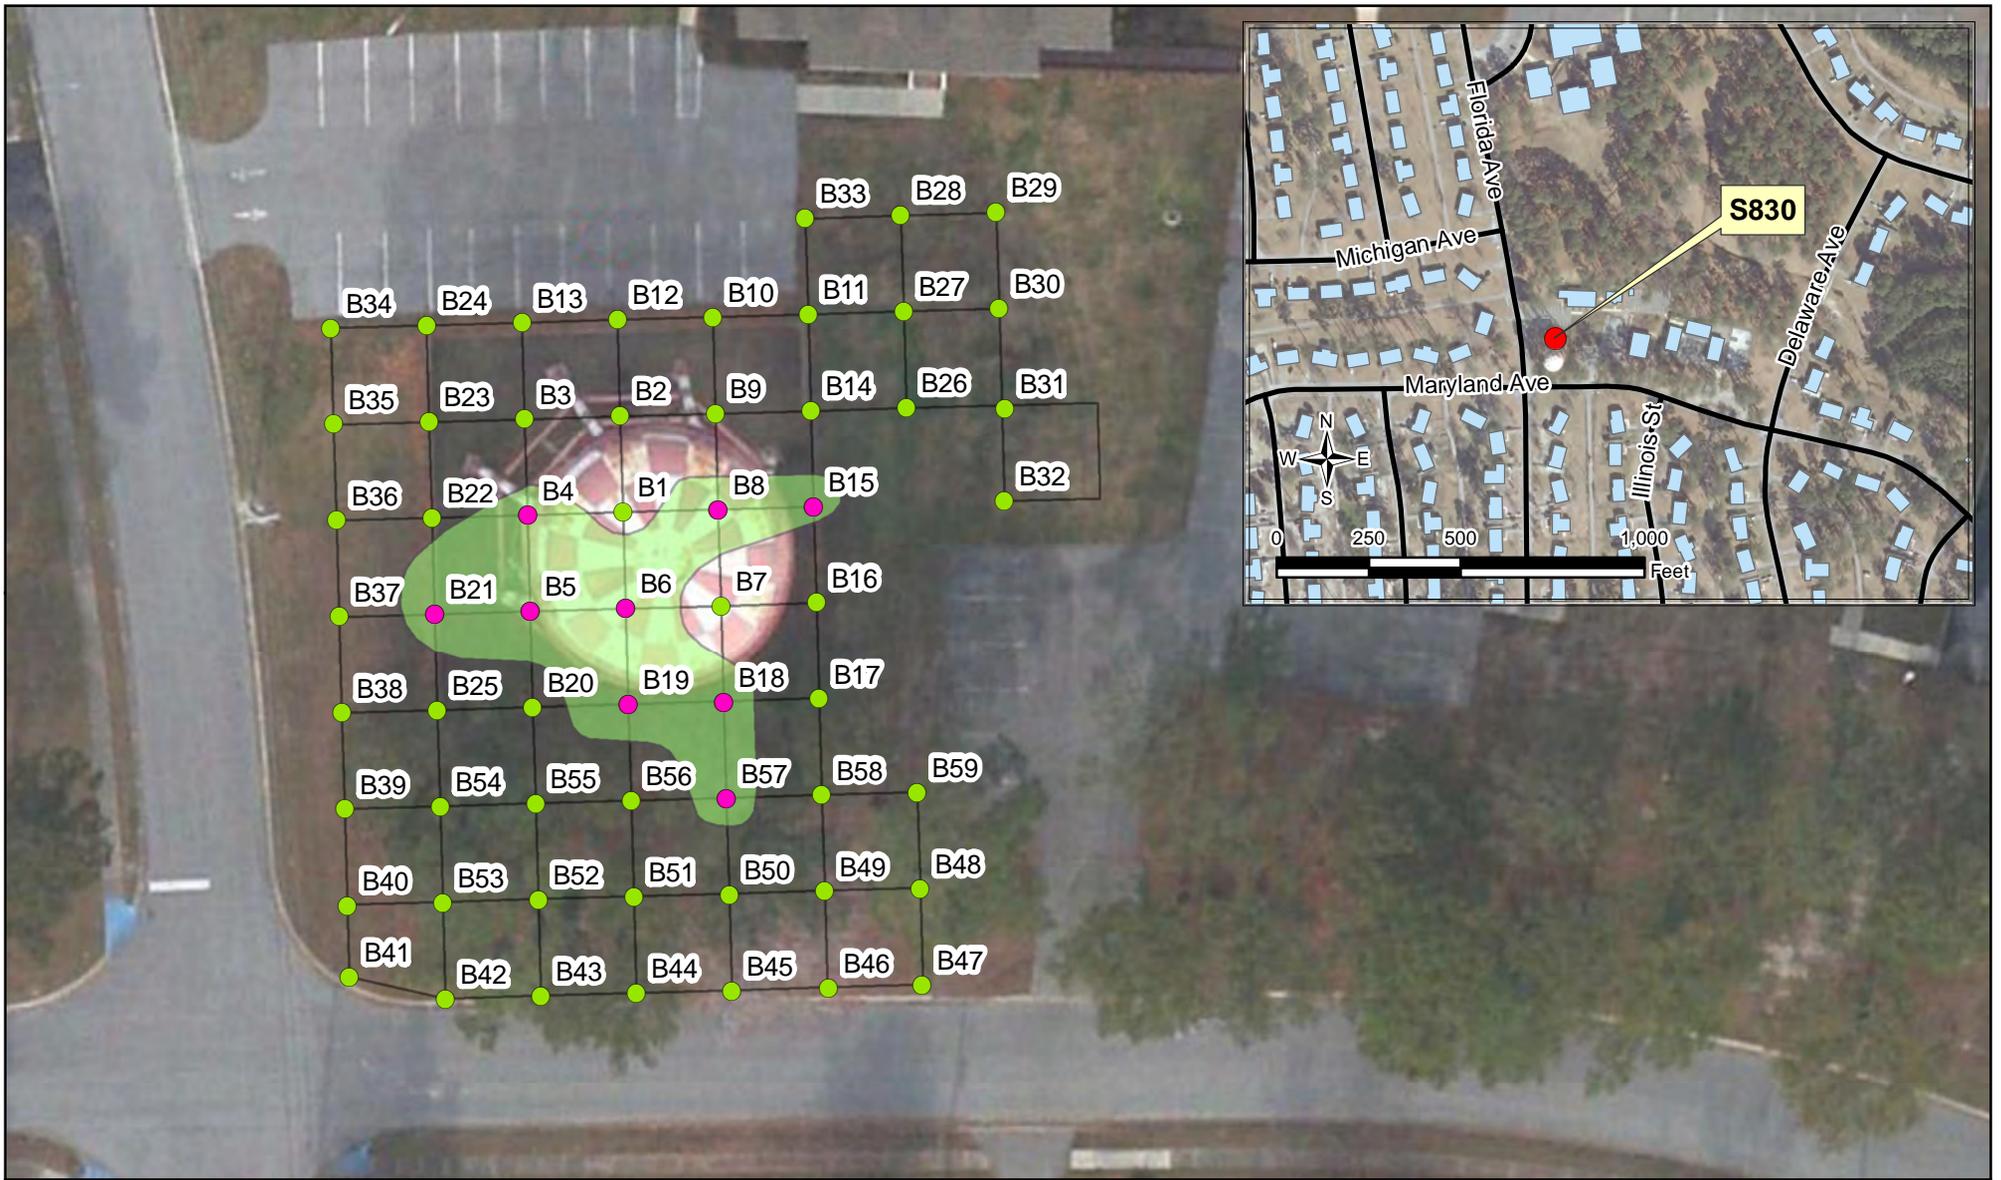
Figure 6
 S830 XRF Investigation
 MCBCAMLEJ
 North Carolina

Due to the residential land use in the vicinity of the former S-830 and LCH-4004 Water Towers, interim measures were conducted to preliminarily delineate lead impacts and mitigate potential exposures at the sites. In December 2015, Osage mobilized to the two sites to conduct a delineation of lead impacted soils via X-ray fluorescence (XRF) spectrometer. Osage established a 20-foot sample grid and conducted shallow soil borings at the each grid node. The grid was expanded outward from the center of the composite sampling investigation areas until XRF data indicated no lead impacts. Data collected by the XRF spectrometer is considered quasi-quantitative; however, screening data were within the same order of magnitude as detected in the November 2015 analytical composite samples. The XRF instrument used is reportedly accurate to within 20 parts per million (ppm). As a protective measure, safety fencing with was erected at each site along the boundary of soils with lead concentrations detected in excess of 250 mg/kg. The boundary concentration of 250 mg/kg was implemented to account for soils within 20 ppm of the most restrictive regulatory screening level (NC DEQ SSL = 270 mg/kg). Red ribbon labeled “Danger” was placed along the top of the protective boundary fencing. The XRF sampling grids, highlighted areas with detections greater than 250 mg/kg, and XRF screening data are illustrated on Figures 6 and 7.

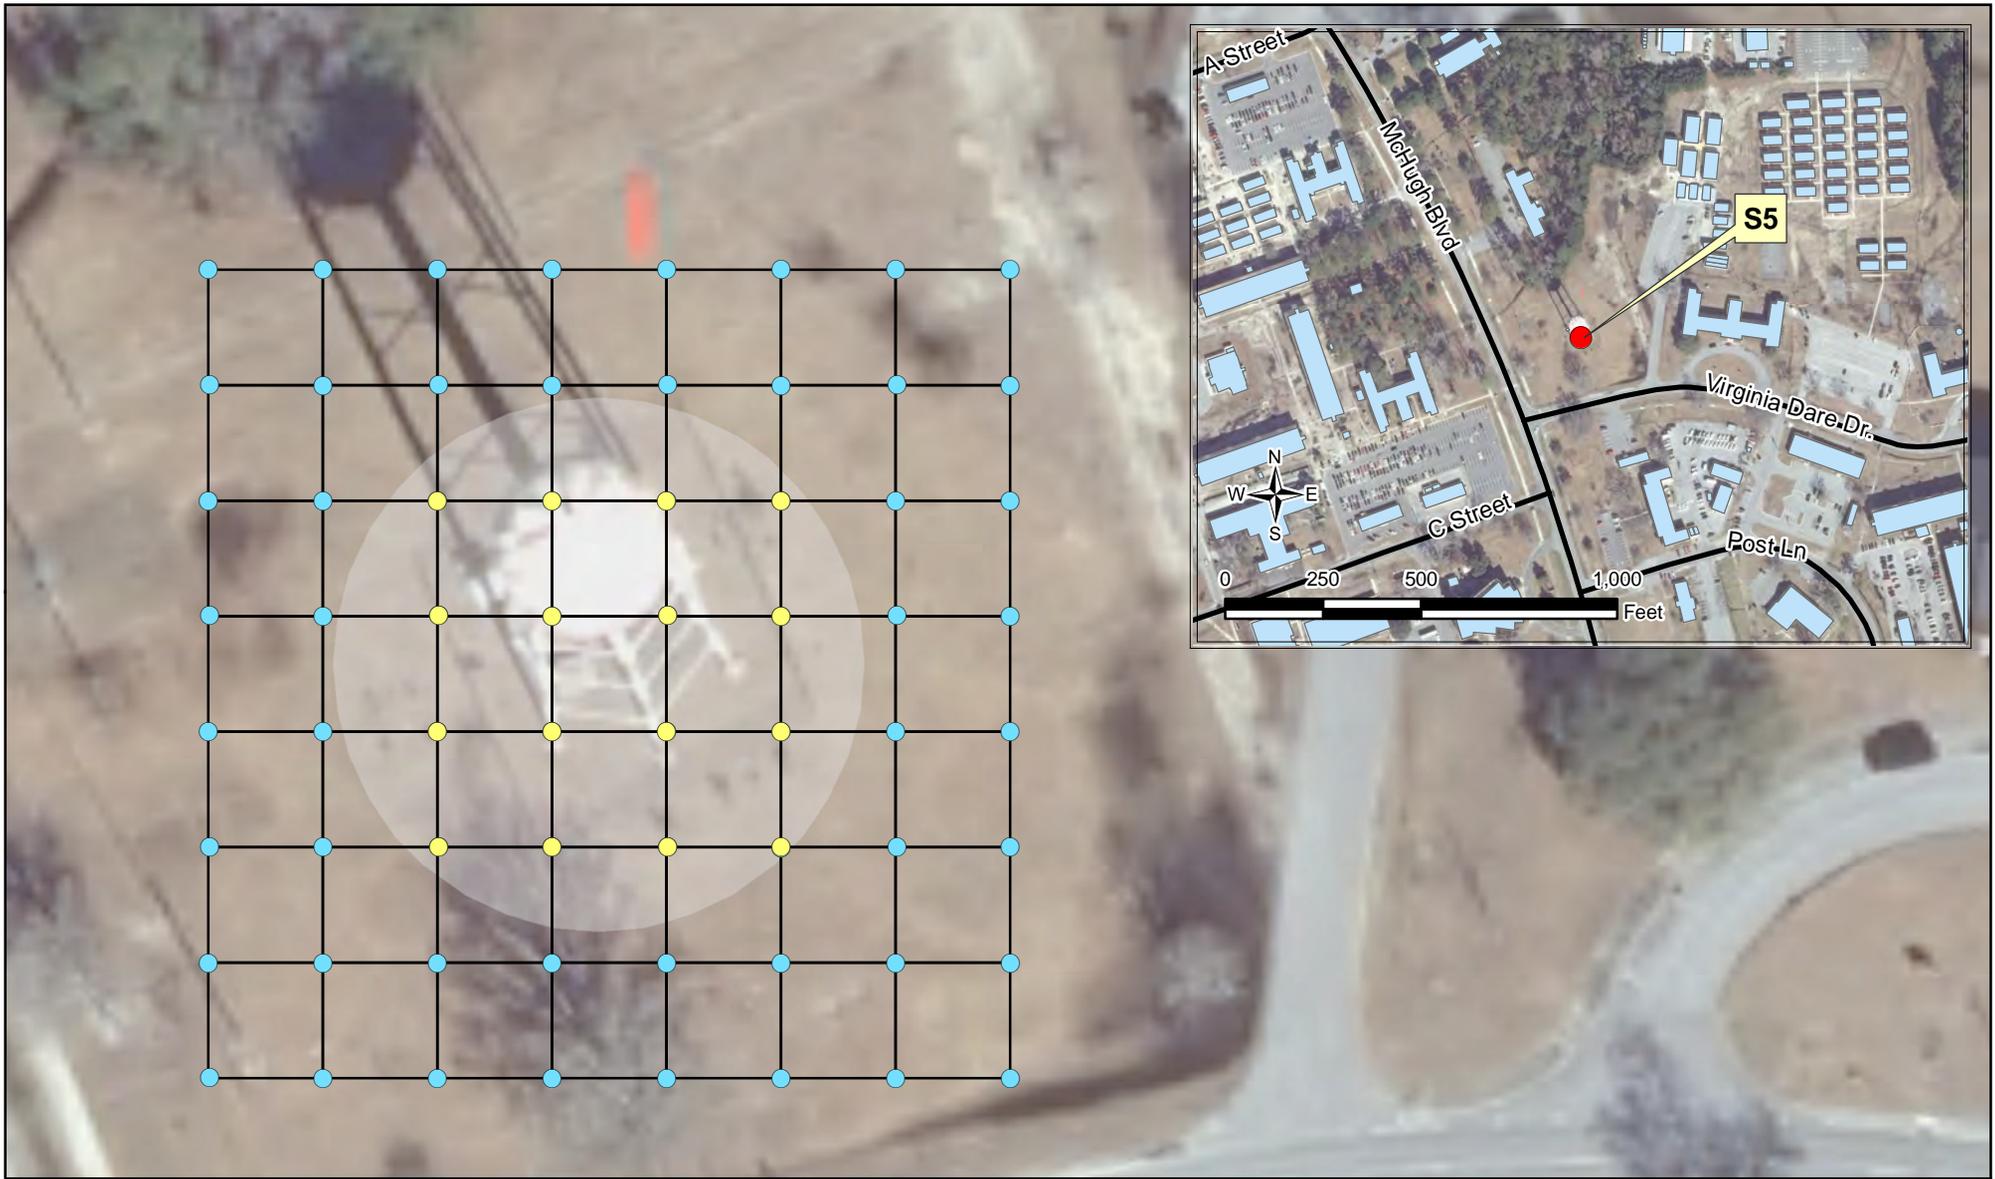
Figure 8
 S5 Proposed Delineation Sample Location Map
 MCBCAMLEJ
 North Carolina

Osage will conduct soil sampling at each site sequentially with a direct push technology (DPT) drilling machine. Borings will be conducted across a 20-ft grid at former water tower sites S-830 and LCH-4004. Due to the lack of XRF delineation data at former water tower sites S-5 and SBA-108, sampling grid nodes will be spaced farther apart to encompass a greater area and help ensure complete delineations. Sampling grids will include two grid nodes in every direction beyond former composite sampling areas or areas determined to be noncompliant via XRF screening (S-830 & LCH-4004). The proposed DPT sample grid for each site is illustrated on Figures 8 through 11.

- Initial grab sample location - analysis to immediately follow lab submittal
- Step-out grab sample location - analysis on hold pending results of initial or preceding interior step-out sample
- 30ft x 30ft Sample Grid
- 2015 Composite Sample Area

In order to achieve complete lateral and vertical delineation, and to minimize unnecessary lab costs, samples collected from step-out borings (illustrated as blue on figures 8 through 11), as well as from depths of 2.5 to 4.5-feet will be initially placed on hold by the laboratory. If initially-analyzed samples indicate non-compliant lead concentrations, then hold samples from corresponding step-out borings will be analyzed. Similarly, if overlying samples indicate noncompliant lead concentrations, deeper samples collected from the same boring will be analyzed sequentially until compliant lead concentrations are detected vertically.

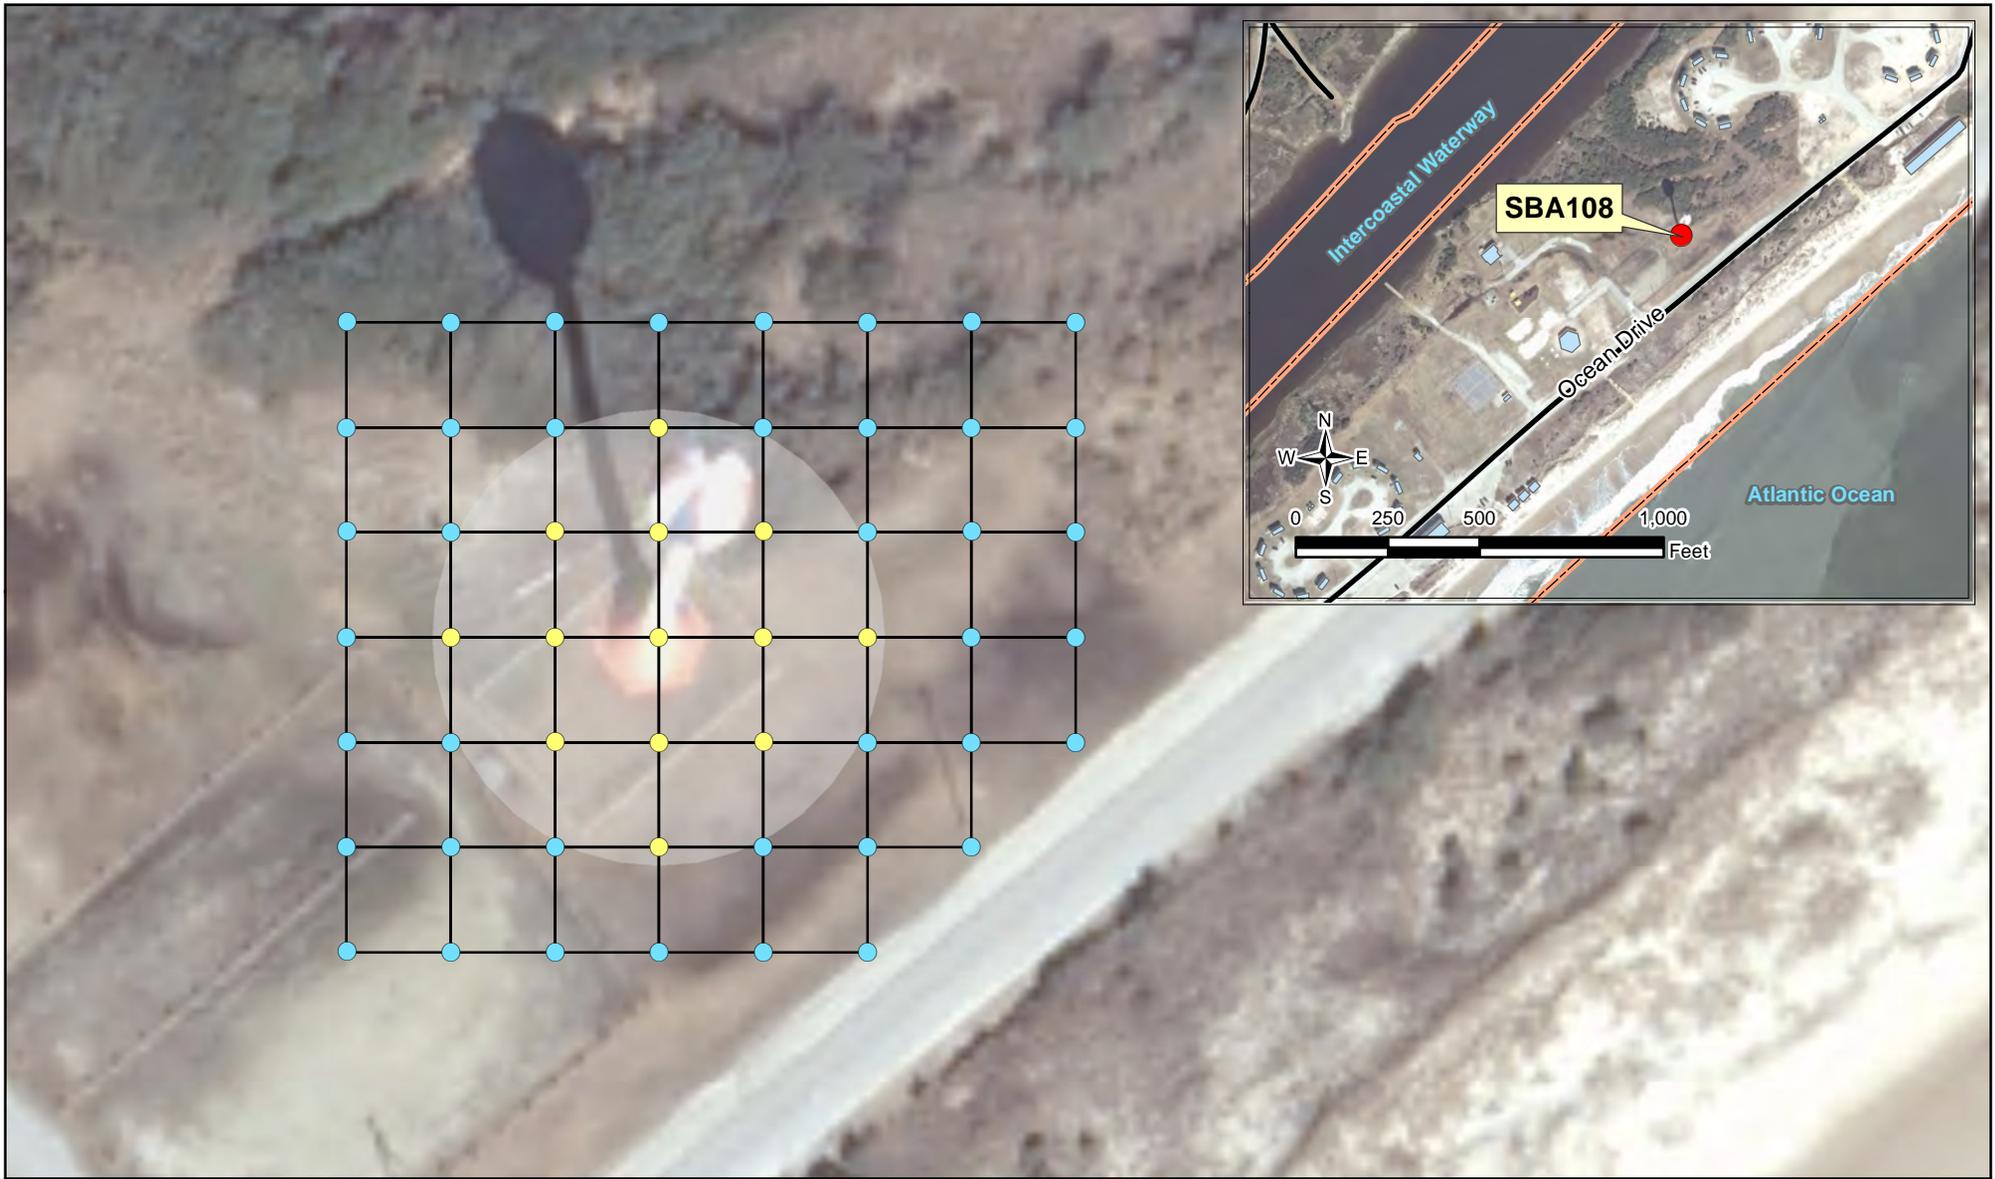
Figure 9
SBA108 Proposed Delineation Sample Location Map
 MCBCAMLEJ
 North Carolina

- 30ft x 30ft Sample Grid
- 2015 Composite Sampling Area
- Former Water Tower Location
- Camp Lejeune Base Boundary
- Initial grab sample location - analysis to immediately follow lab submittal
- Step-out grab sample location - analysis on hold pending results of initial or preceding interior step-out sample
- Road
- Existing Structure

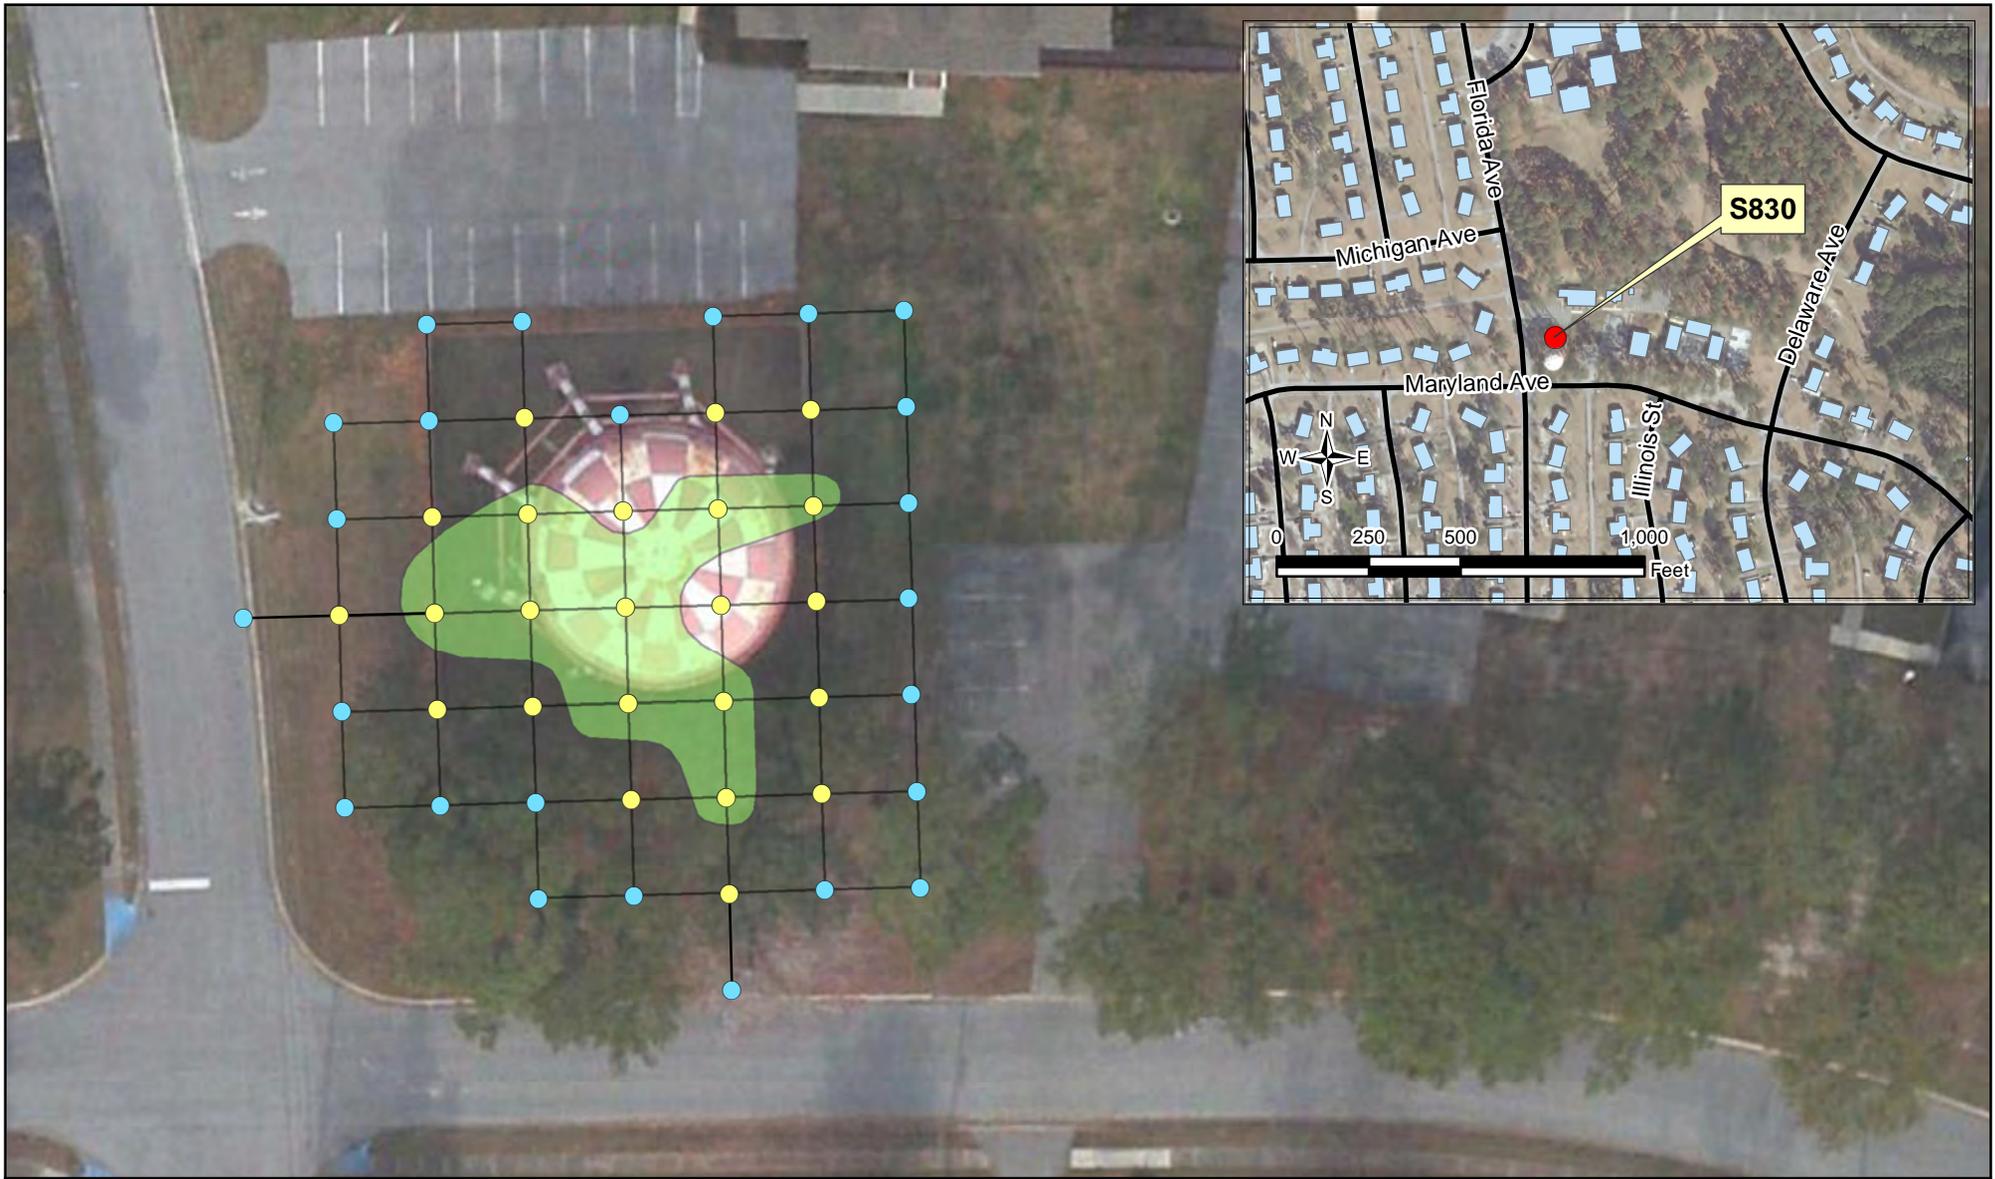
Figure 10
S830 Proposed Delineation Sample Location Map

Initial grab sample location - analysis to immediately follow lab submittal

Step-out grab sample location - analysis on hold pending results of initial or preceding interior step-out sample

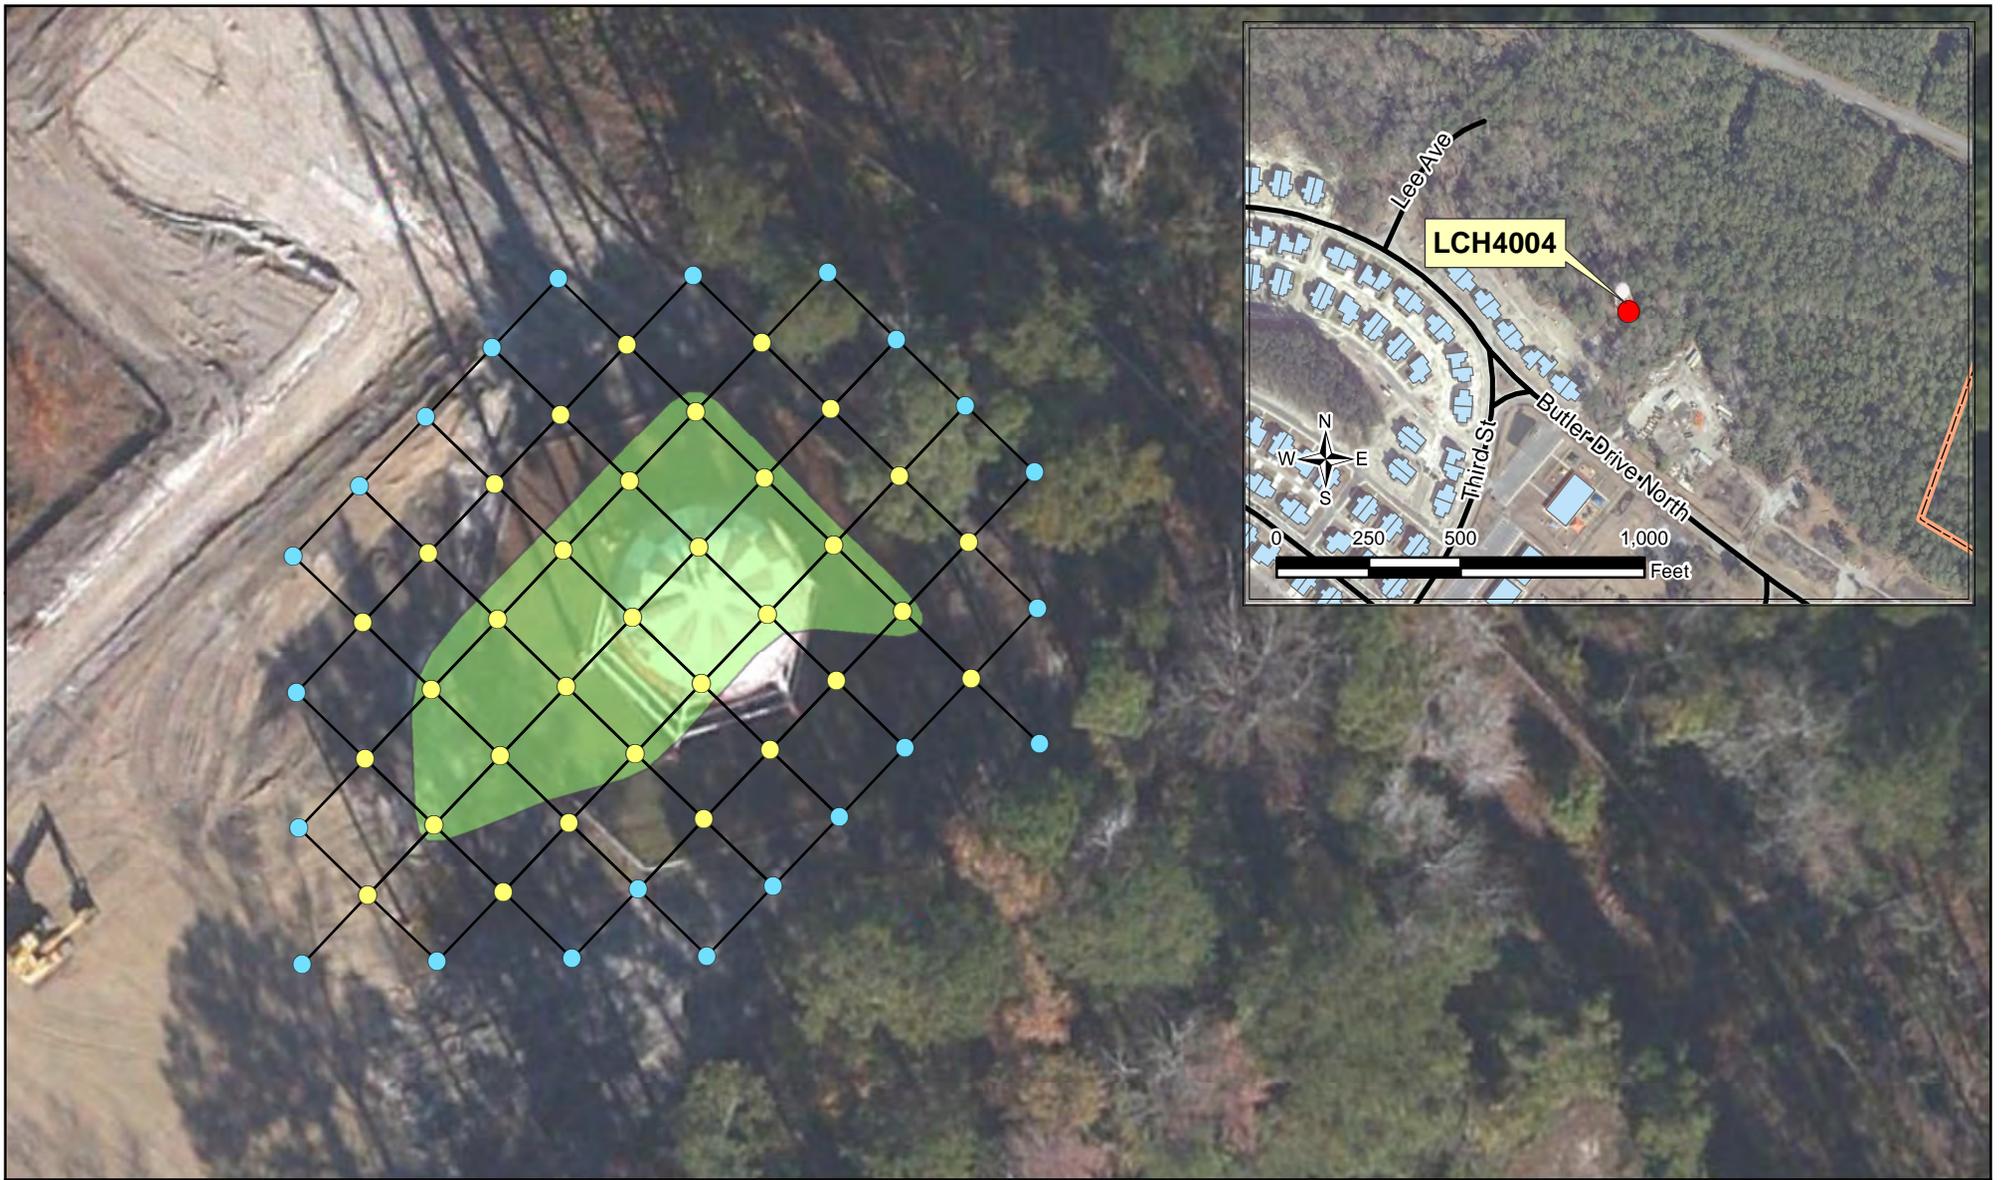
Figure 11
 LCH4004 Proposed Delineation Sample Location Map
 MCBCAMLEJ
 North Carolina

Initial grab sample location - analysis to immediately follow lab submittal
-

Step-out grab sample location - analysis on hold pending results of initial or preceding interior step-out sample
-
