**Re: Off-Site Soil Gas Sampling Report  
Easy Wash Dry Cleaners  
Fayetteville, Cumberland County  
DSCA ID # DC260002  
H&H Job No. DS0-15Q**

**1.0 Introduction**

TITLE		<b>SITE LOCATION MAP</b>	
PROJECT		<b>EASY WASH DRY CLEANERS</b> <b>DSCA ID # DC260002</b> 5308 BRAGG BOULEVARD FAYETTEVILLE, CUMBERLAND COUNTY

<b>TITLE</b> SOIL GAS CONTAMINANT CONCENTRATION MAP	
<b>PROJECT</b> EASY WASH DRY CLEANERS DSCA ID: DC260002 5308 BRAGG BLVD. FAYETTEVILLE, CUMBERLAND COUNTY	
2923 South Tryon Street-Suite 100 Charlotte, North Carolina 28203 704-586-0007(p) 704-586-0373(f) License # C-1269 / #C-245 Geology <b>SMARTER ENVIRONMENTAL SOLUTIONS</b>	
DATE: 10-12-16	REVISION NO. 0
JOB NO: DSO-15	FIGURE NO: 2

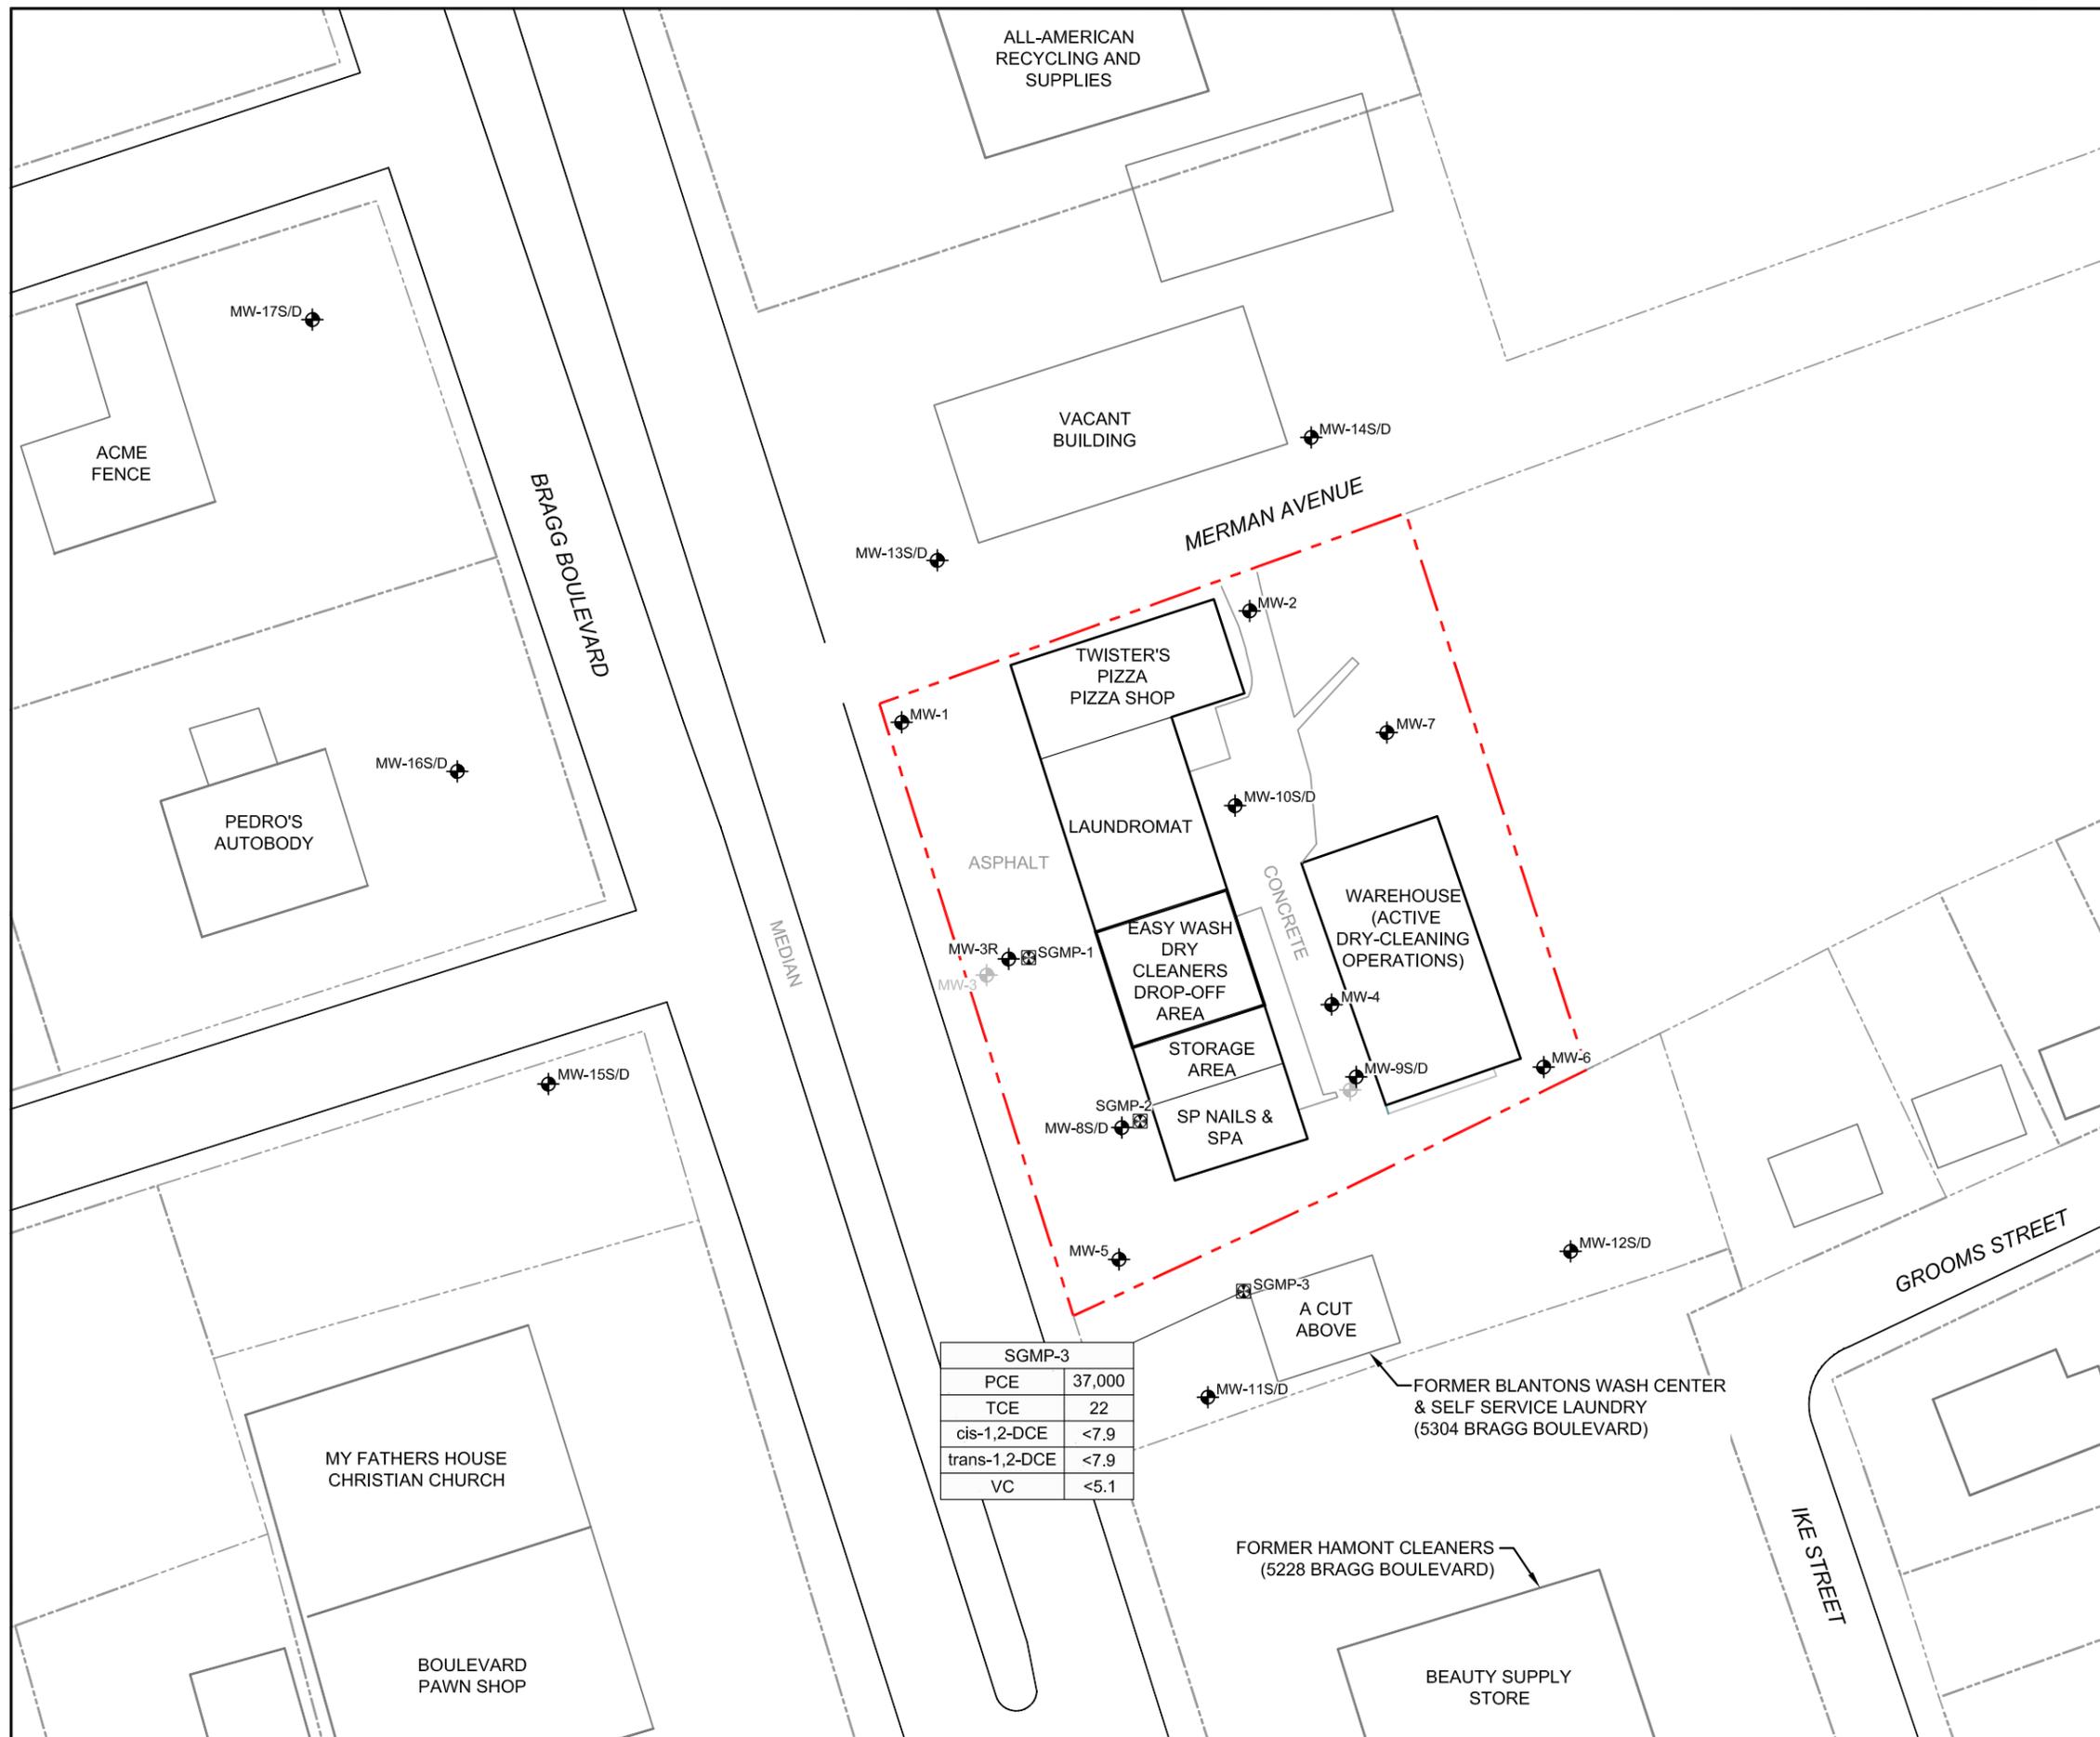
In February 2016, H&H contracted Geologic Exploration to install a permanent subsurface soil gas monitoring point (SGMP-3) adjacent to the off-site building located at 5304 Bragg Boulevard. Based on historical groundwater elevation data, the soil gas monitoring point was installed with a stainless steel hand auger to a depth of approximately 7 ft bgs. The soil gas monitoring point was completed with a 6-inch flush-mount protective manhole cover set inside a concrete pad. Upon completion, the end of the Teflon® sample tubing assembly was secured inside the manhole with a plastic cap. The sample location is depicted on Figure 2.

PCE and its degradation product TCE were detected in soil gas sample SGMP-3 at concentrations of 37,000  $\mu\text{g}/\text{m}^3$  and 22  $\mu\text{g}/\text{m}^3$ , respectively. No other constituents were detected in the soil gas sample. As previously noted, the soil gas impacts are believed to be associated with the Hamont Dry Cleaning site located cross-gradient to the Easy Wash Dry Cleaners source property. The soil gas results are summarized in Table 4 and shown on Figure 2.

SGMP-3	CONCENTRATION (µg/m <sup>3</sup> )
PCE	37,000
TCE	22
cis-1,2-DCE	<7.9
trans-1,2-DCE	<7.9
VC	<5.1

- NOTES:**
- SOIL GAS SAMPLE SGMP-3 COLLECTED ON 9/12/16.
  - PCE = TETRACHLOROETHYLENE  
TCE = TRICHLOROETHYLENE  
cis-1,2-DCE = cis-1,2-DICHLOROETHYLENE  
trans-1,2-DCE = trans-1,2-DICHLOROETHYLENE  
VC = VINYL CHLORIDE

Concentrations of PCE ( $37,000 \mu\text{g}/\text{m}^3$ ) and TCE ( $22 \mu\text{g}/\text{m}^3$ ) were detected in soil gas collected near the northwestern corner of the commercial building at 5304 Bragg Boulevard. H&H calculated the potential vapor intrusion risk associated with the detected soil gas concentrations, and the non-carcinogenic risk exceeds acceptable levels under the current non-residential use scenario and both the carcinogenic and non-carcinogenic risks exceed acceptable levels under the residential use scenario. Indoor air sampling is recommended to further evaluate vapor intrusion risk at the 5304 Bragg Boulevard property.

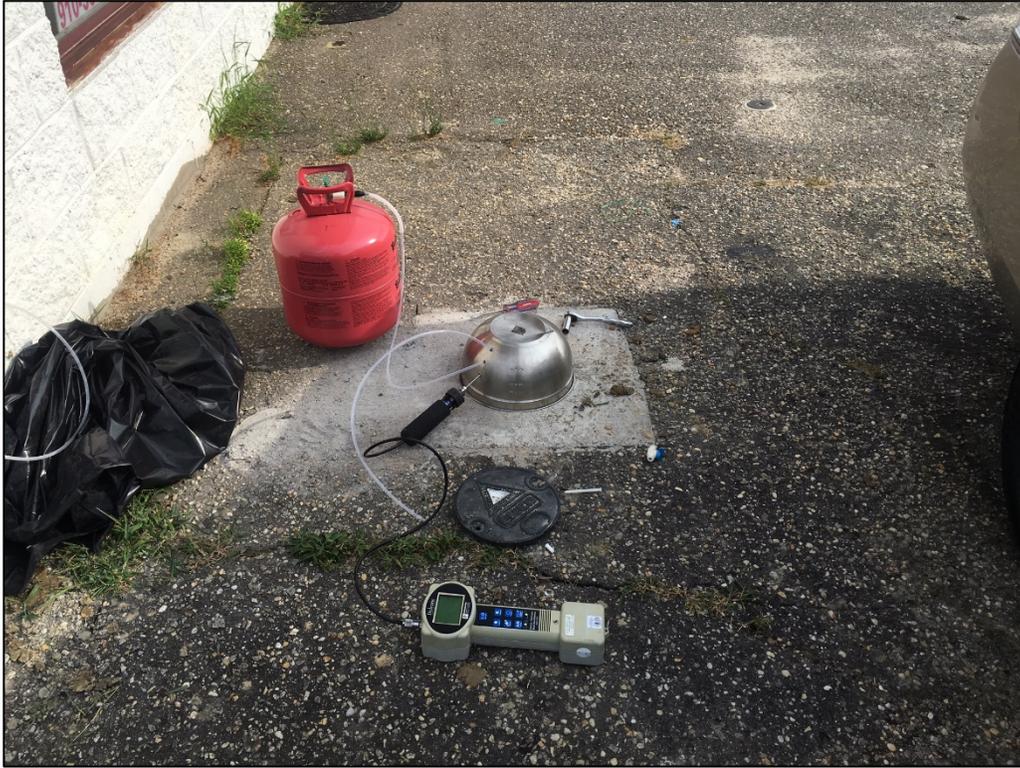
Following reinstallation, H&H collected a soil gas sample from SGMP-3. Prior to sampling, the soil gas monitoring point was purged using a syringe and Tedlar® bag to evacuate a minimum of three volumes of air from the sampling system. A leak check was performed by placing a shroud around the sampling point and saturating the air within the shroud with helium gas. A helium gas detector was used to determine the concentration of helium in the shroud. The sampling point was then purged into a Tedlar® bag, and the collected vapor was analyzed by the helium gas detector to confirm that the Tedlar® bag did not contain a helium concentration greater than 5% of the helium concentrations detected in the shroud. The soil gas monitoring point passed the helium leak check criteria.

Photograph 1: Helium leak check performed at SGMP-3.

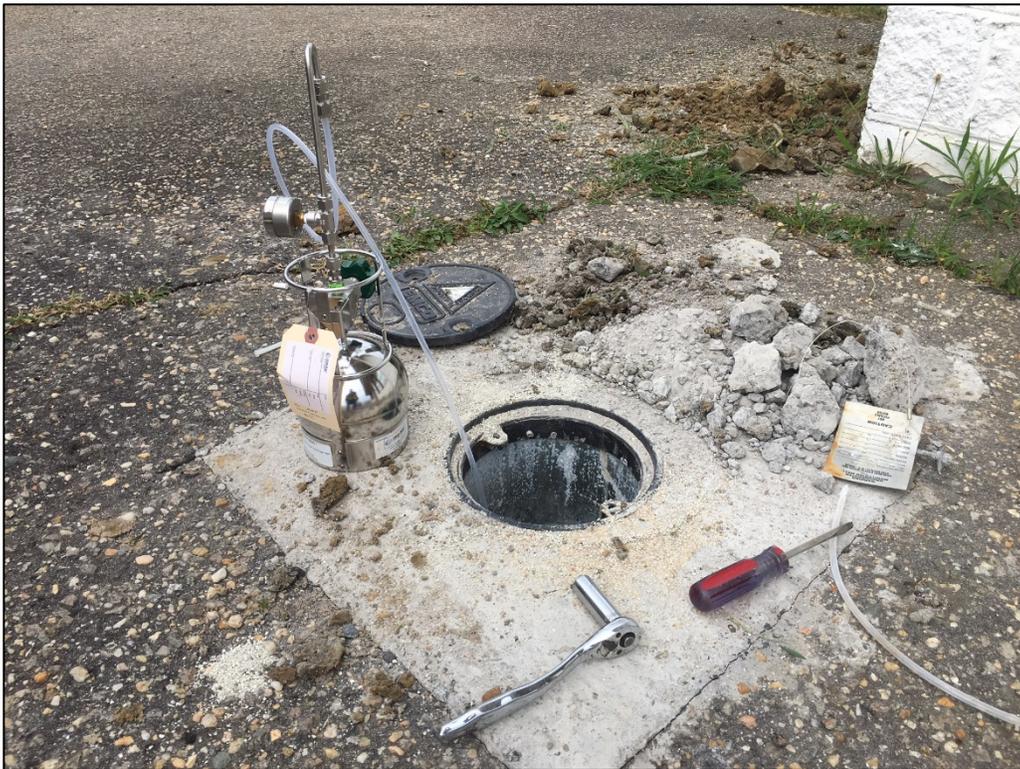
Following purging and a successful leak check, a laboratory-supplied 1-Liter Summa canister with flow regulator was connected to the tubing using a Swagelok® compression fitting to form an air-tight seal. Subsequently, the canister's intake valve was opened to collect the subsurface soil gas sample. The flow regulator was set by the laboratory to collect the samples over a period of approximately 5 minutes (i.e., flow rate of 200 mL/min). Vacuum readings on the Summa canister were recorded prior to and following the 5-minute sampling period to confirm adequate sample volume was collected. Photographs of the leak check, summa canister, and sample location are provided in Appendix A.

Photograph 2: Sample collection at SGMP-3.
