Re: Aerial Photographic Site Analysis  
Koch Sulfur Products Company - Wilmington Plant

# Aerial Photographic Site Analysis Koch Sulfur Products Company Wilmington, North Carolina

*Draft Report*

*January 5, 2001*

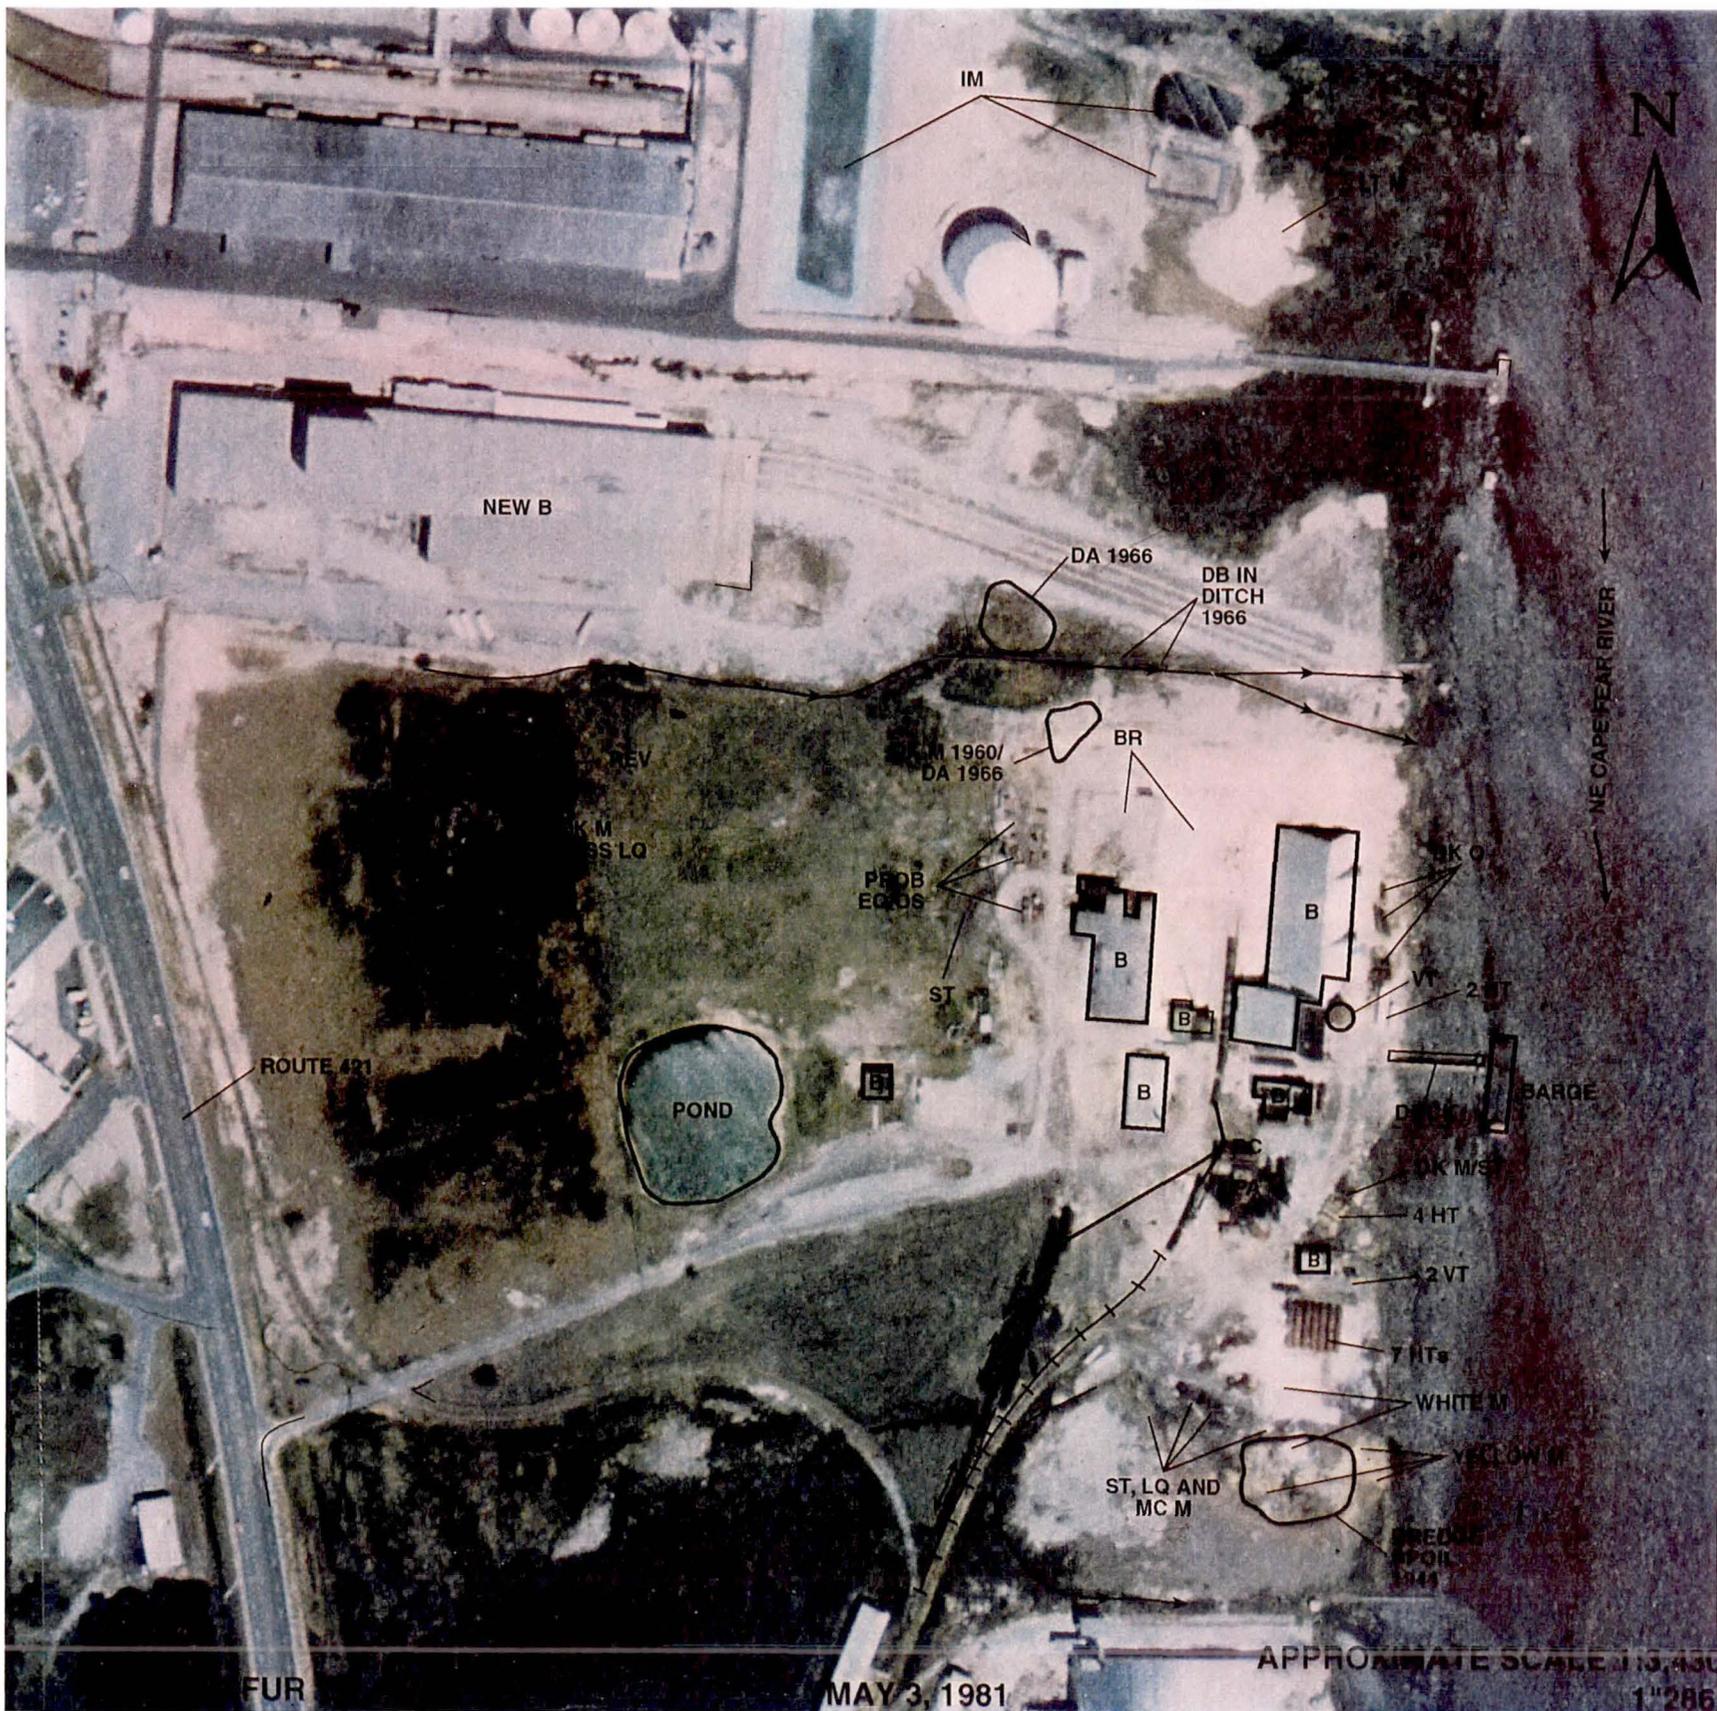
**Koch Industries**  
**Wilmington, North Carolina**  
**Date Flown: April 8, 1969**  
**Frame No.: 83**  
**Source: USGS**  
**Approx. Scale: 1 inch = 263' feet**

The disposal area within the northern end of the site remains. The majority of this disposal area is revegetated by 1970. Only a small amount of debris possibly containing drums remains within the disposal area by 1972. Debris is also visible within the ditch to the east. A section of the ditch further east contains fill material. Light-toned material was noted within this portion of the ditch in 1968. A significant amount of liquid and staining was visible surrounding a cylindrical object just southeast of the disposal area in March 1969. The excavation to the west remains. A new probable well feature has been constructed west of the excavation since 1966. Excavation activity expanded to the south in 1972. Light-toned material remains in the northeastern portion of the site. A large smoke plume (SP) is visible west of the light-toned material. Liquid and staining are noted near the process area. A dark-toned drainage channel was noted leading from the process area to the west in 1968. Pools of liquid are located south of an oval-shaped access road in the south end of the site. Multi-colored (MC) and gray mounds of material were located east of the access road in 1968.
