Site Name (Subject):	STARLING DAVID PROPERTY				
Site ID (Document ID):	NCD003185311				
Document Name (DocType):	Preliminary Assessment/Site Inspection (PA/SI)				
Report Segment:					
Description:	Screening Site Investigation Report				
Date of Document:	12/14/1989				
Date Received:					
Box: Enter SF and # with no spaces	SF10,625				
Access Level:	PUBLIC				
Division:	WASTE MANAGEMENT				
Section:	SUPERFUND				
Section.	SUPERFOND				
Program (Document Group):	SERB (SERB)				
Document Category:	FACILITY				
Print Report for Go to New	Go to New Record - Delete Record				
Record Blank Record	(default to last record values)

SUBJECT: Screening Site Investigation Report

David Starling Disposal Site NCD 003185311 Route 2, Box 246 U.S. Highway 258 Farmville, Pitt County, NC 27828

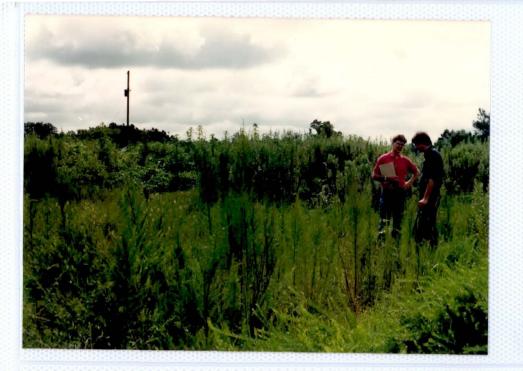
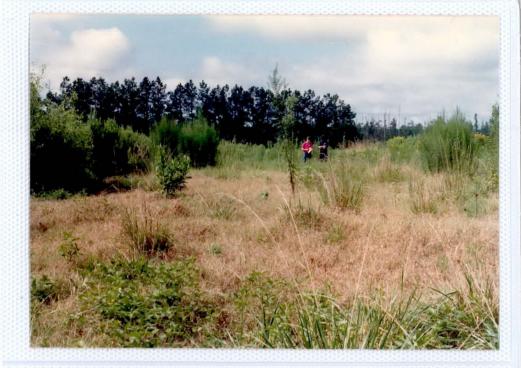
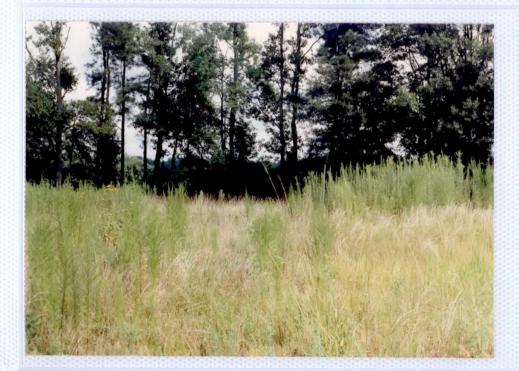
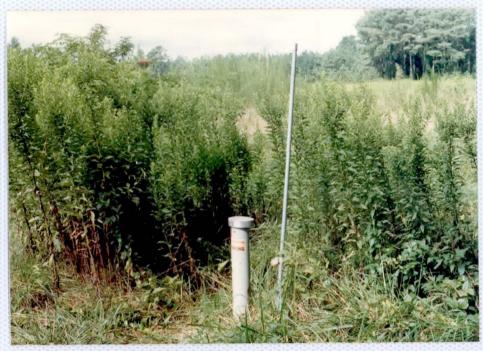
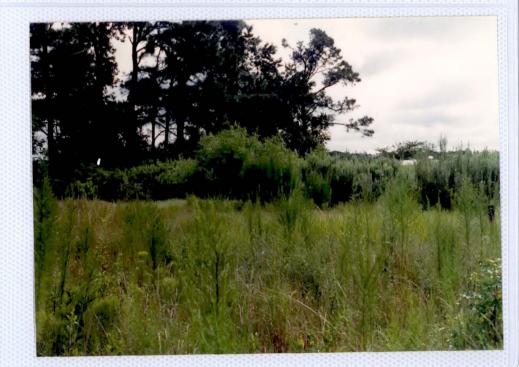
VARIOUS VIEWS OF THE DAVID STARLING PROPERTY DISPOSAL AREA, 8/16/89.
