Site Name (Subject): SWAIN COUNTY LANDFILL

Description: Site Re-Assessment Report

Subject: Site Re-Assessment Report
Swain County Landfill
EPA ID: NC3120000002
Bryson City, Swain County, North Carolina

DRAFT
SITE INSPECTION REPORT
GRAHAM COUNTY LANDFILL and
SWAIN COUNTY LANDFILL

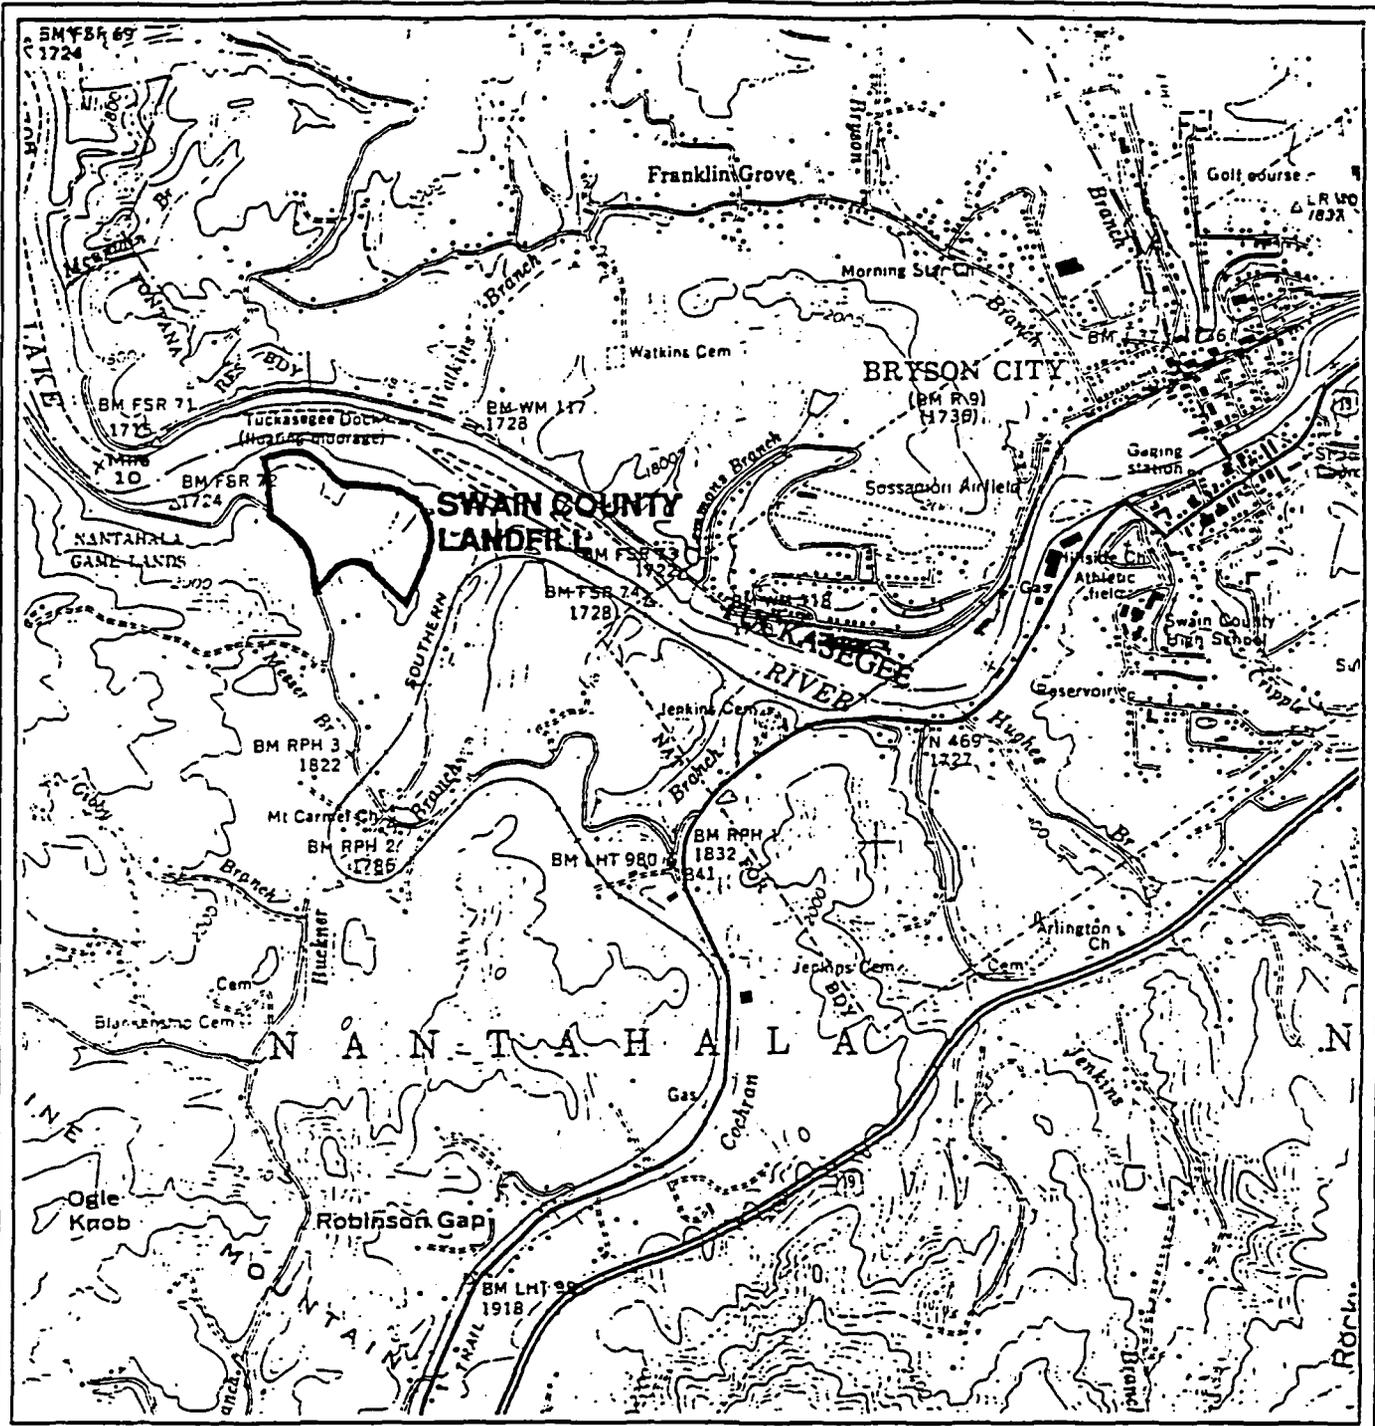
FIGURE 4.1

SITE LOCATION MAP
SWAIN COUNTY LANDFILL
NANTAHALA NATIONAL FOREST
 SOURCE: BRYSON CITY, N.C. QUADRANGLE
 7.5 MINUTE SERIES, 1962 (PHOTO REVISED 1978)

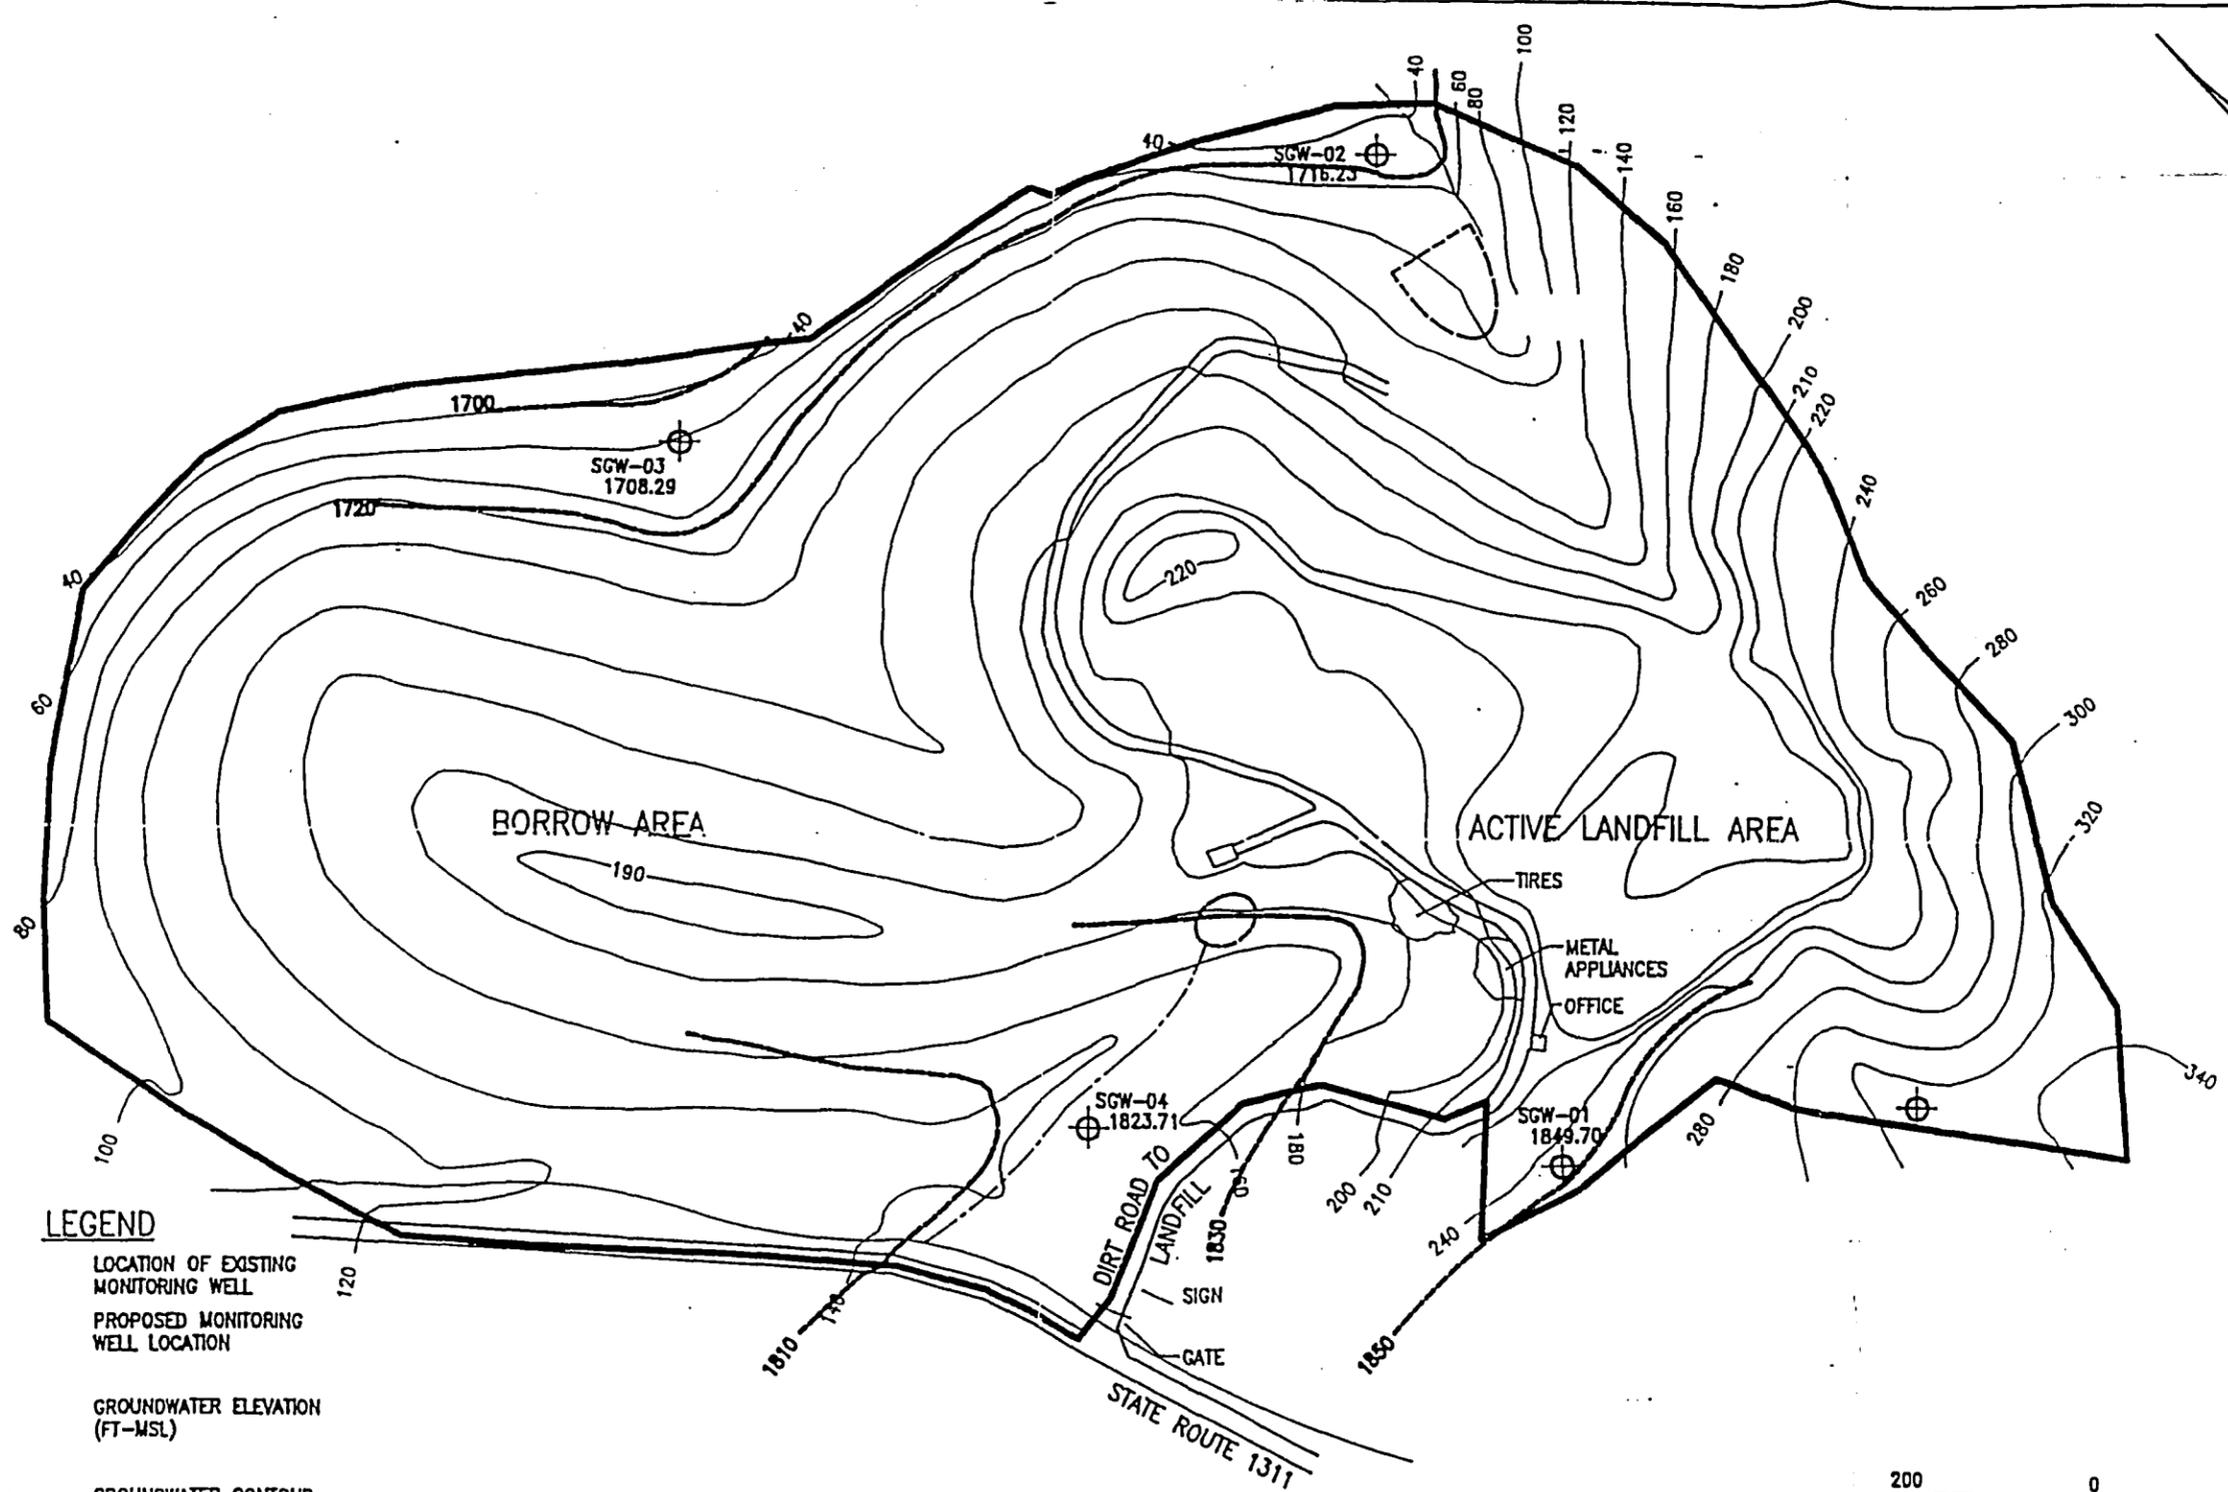
Water levels from the four monitoring wells were measured by M&E personnel during the January 1993 sampling event. Water levels ranged from 8.8 to 86.1 feet below the top of the well casing and the water table elevations ranged from 1708.3 to 1849.7 ft-msl. Thus, the water table elevation change is about 141 feet. As discussed in Section 4.4.1 the topography does not correlate with the surveyed well elevations or groundwater elevations. Figure 4.3 shows the interpreted groundwater contours at the site. Groundwater flow is generally to the north towards the Tuckasegee River although some northwestern flow occurs

- LOCATION OF EXISTING MONITORING WELL
- PROPOSED MONITORING WELL LOCATION
- 1849.70 GROUNDWATER ELEVATION (FT-MSL)
- GROUNDWATER CONTOUR
- CONTOUR INTERVAL 20 FEET
- SEDIMENTATION BASIN
- WET WEATHER DRAINAGE FEATURE

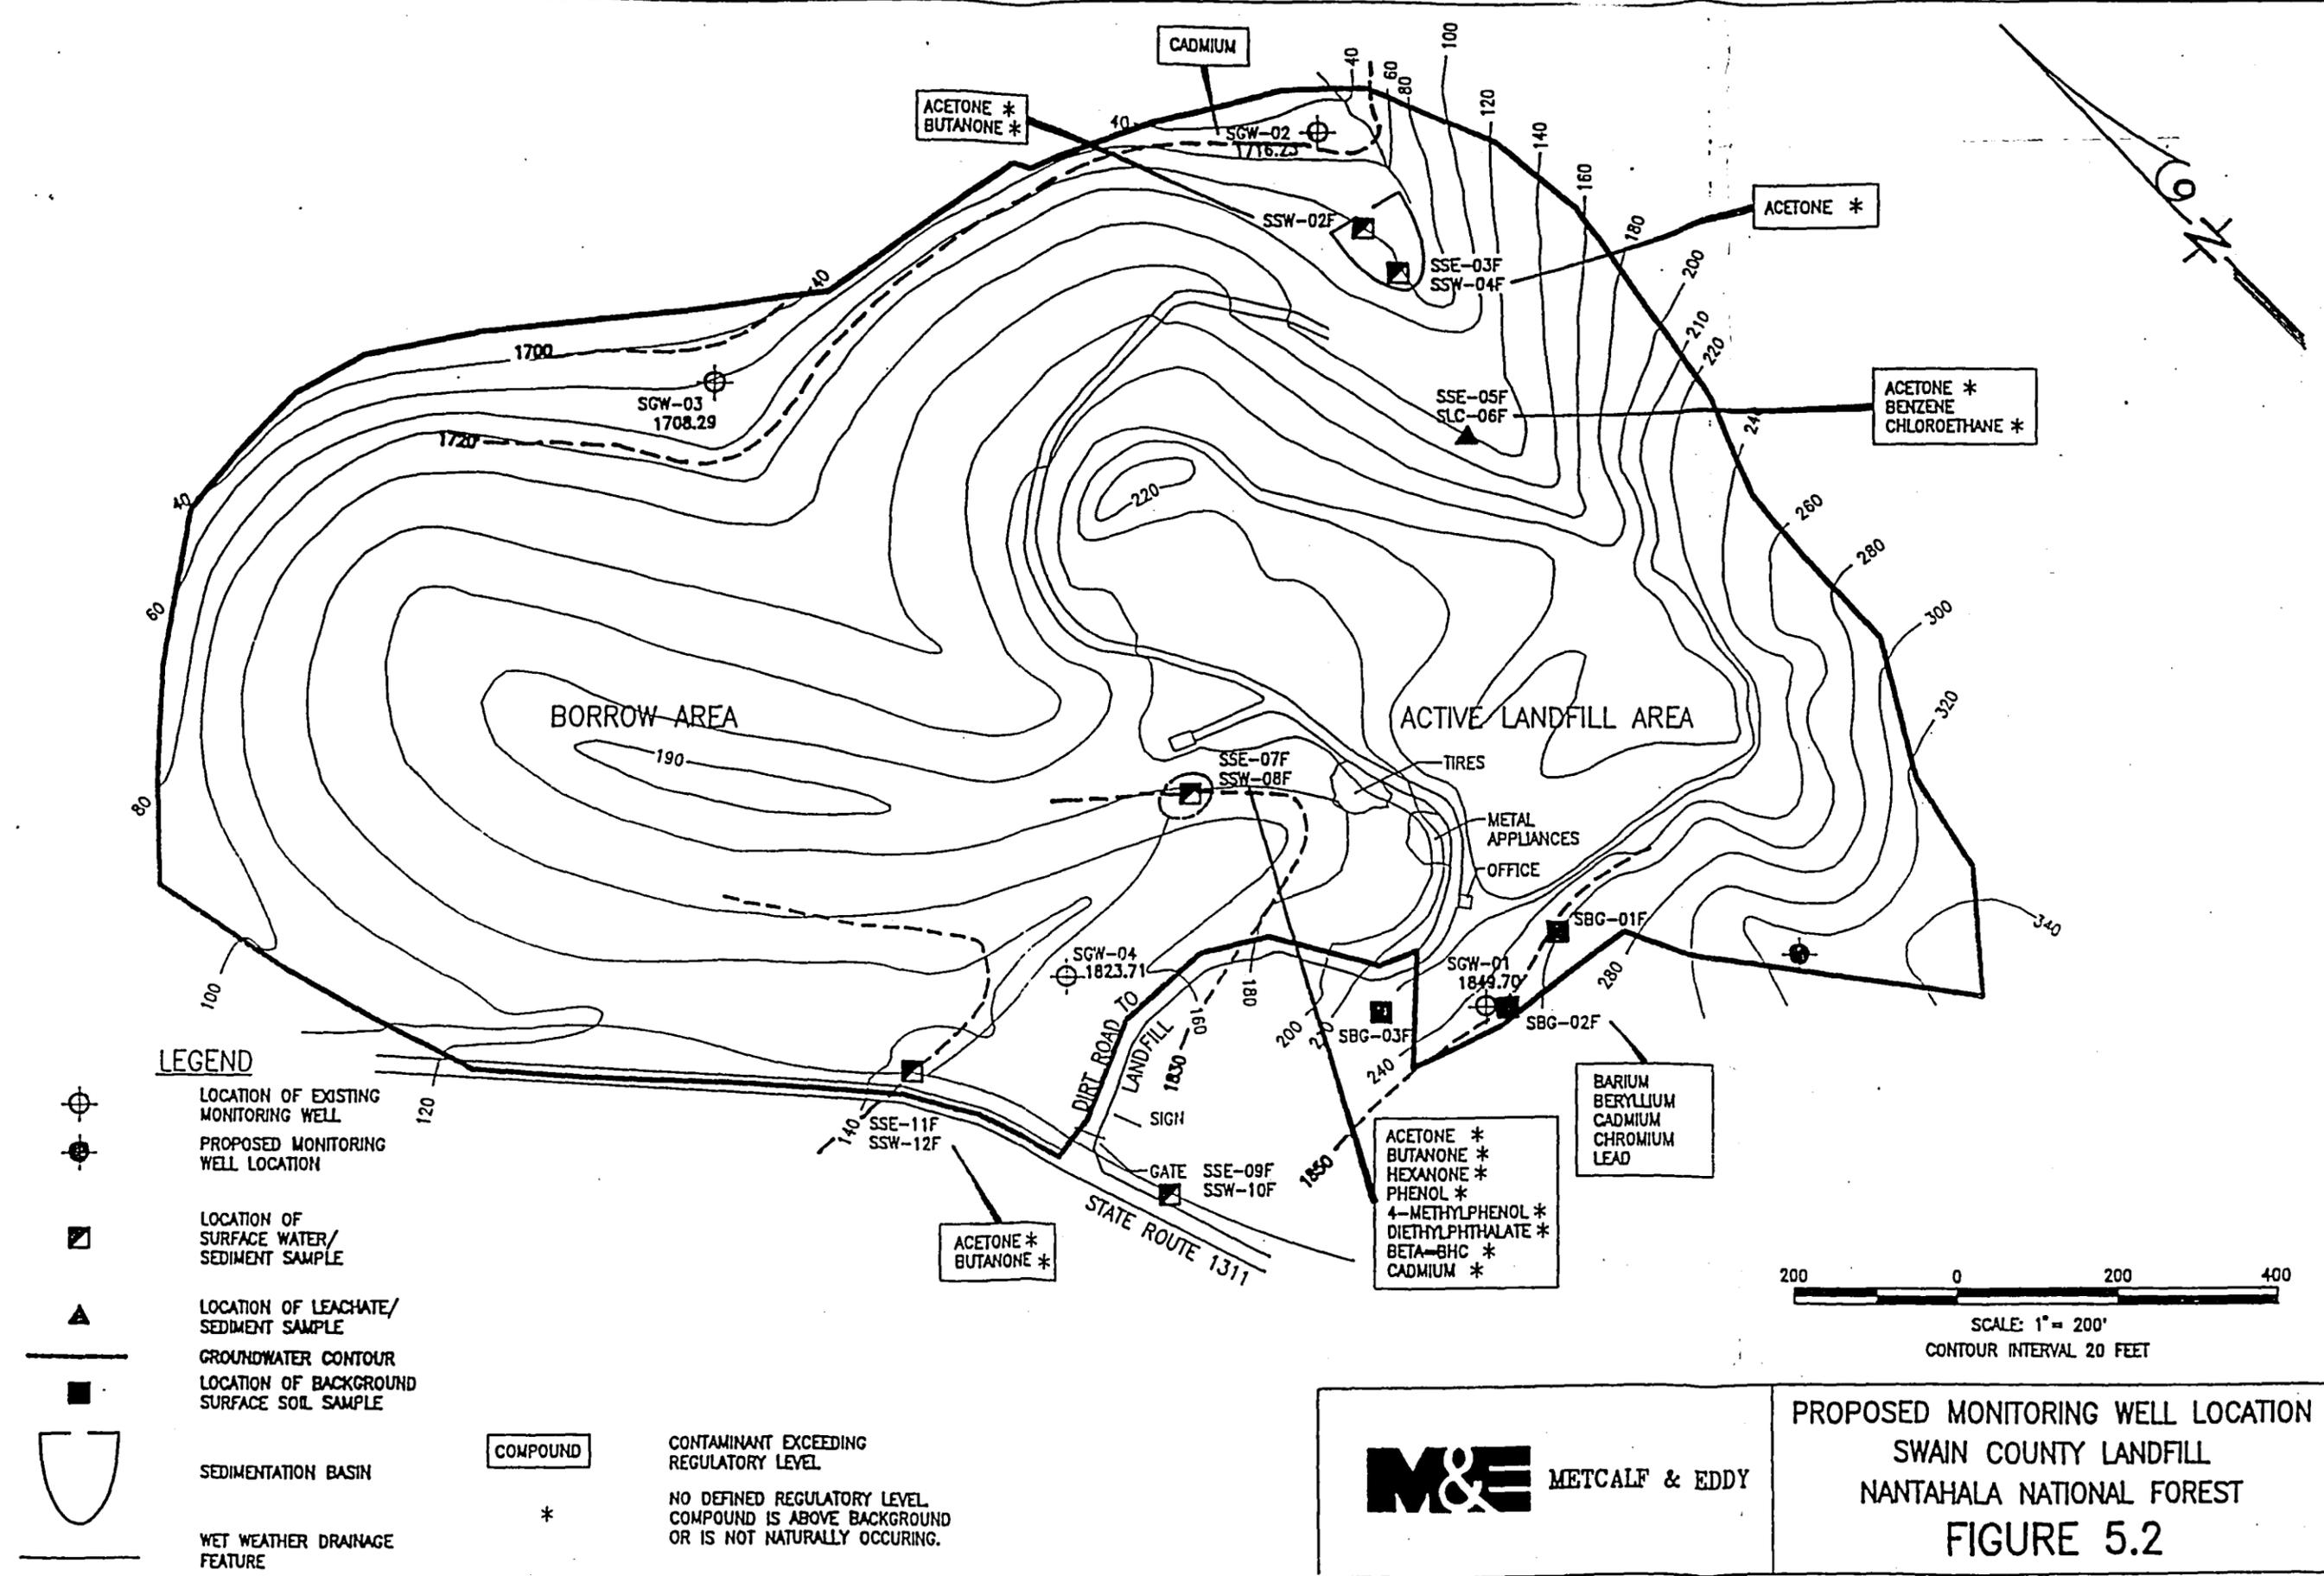
Contaminants such as acetone, butanone and hexanone found in the sedimentation pond are also found at the point where the surface drainage meets the unnamed creek at much higher concentrations. These organic contaminants are also present at much lower concentrations downstream. Phenolic compounds, diethylphthalate, and cadmium were detected in the sedimentation pond and increase in concentration upon entering the stream. With the exception of cadmium, these compounds do not have assigned MCLs; however, they are not naturally occurring in the environment and are above background concentrations. The sediment samples collected at the same locations as the surface waters apparently have not been impacted by the surface migration.

- LOCATION OF EXISTING MONITORING WELL
- PROPOSED MONITORING WELL LOCATION
- LOCATION OF SURFACE WATER/ SEDIMENT SAMPLE
- LOCATION OF LEACHATE/ SEDIMENT SAMPLE
- GROUNDWATER CONTOUR
- LOCATION OF BACKGROUND SURFACE SOIL SAMPLE
- SEDIMENTATION BASIN
- WET WEATHER DRAINAGE FEATURE

The presence of the inorganic analytes above ARARs in the background well and low levels of chlorinated organics in three other wells indicates the need for further groundwater monitoring. These low levels of contaminants should decrease when the landfill is closed and capped and surface water is prevented from infiltrating the landfill. Groundwater monitoring after closure should determine if any additional monitoring wells are necessary. Monitoring the groundwater along with an additional well (background) would confirm the presence or absence of these contaminants.

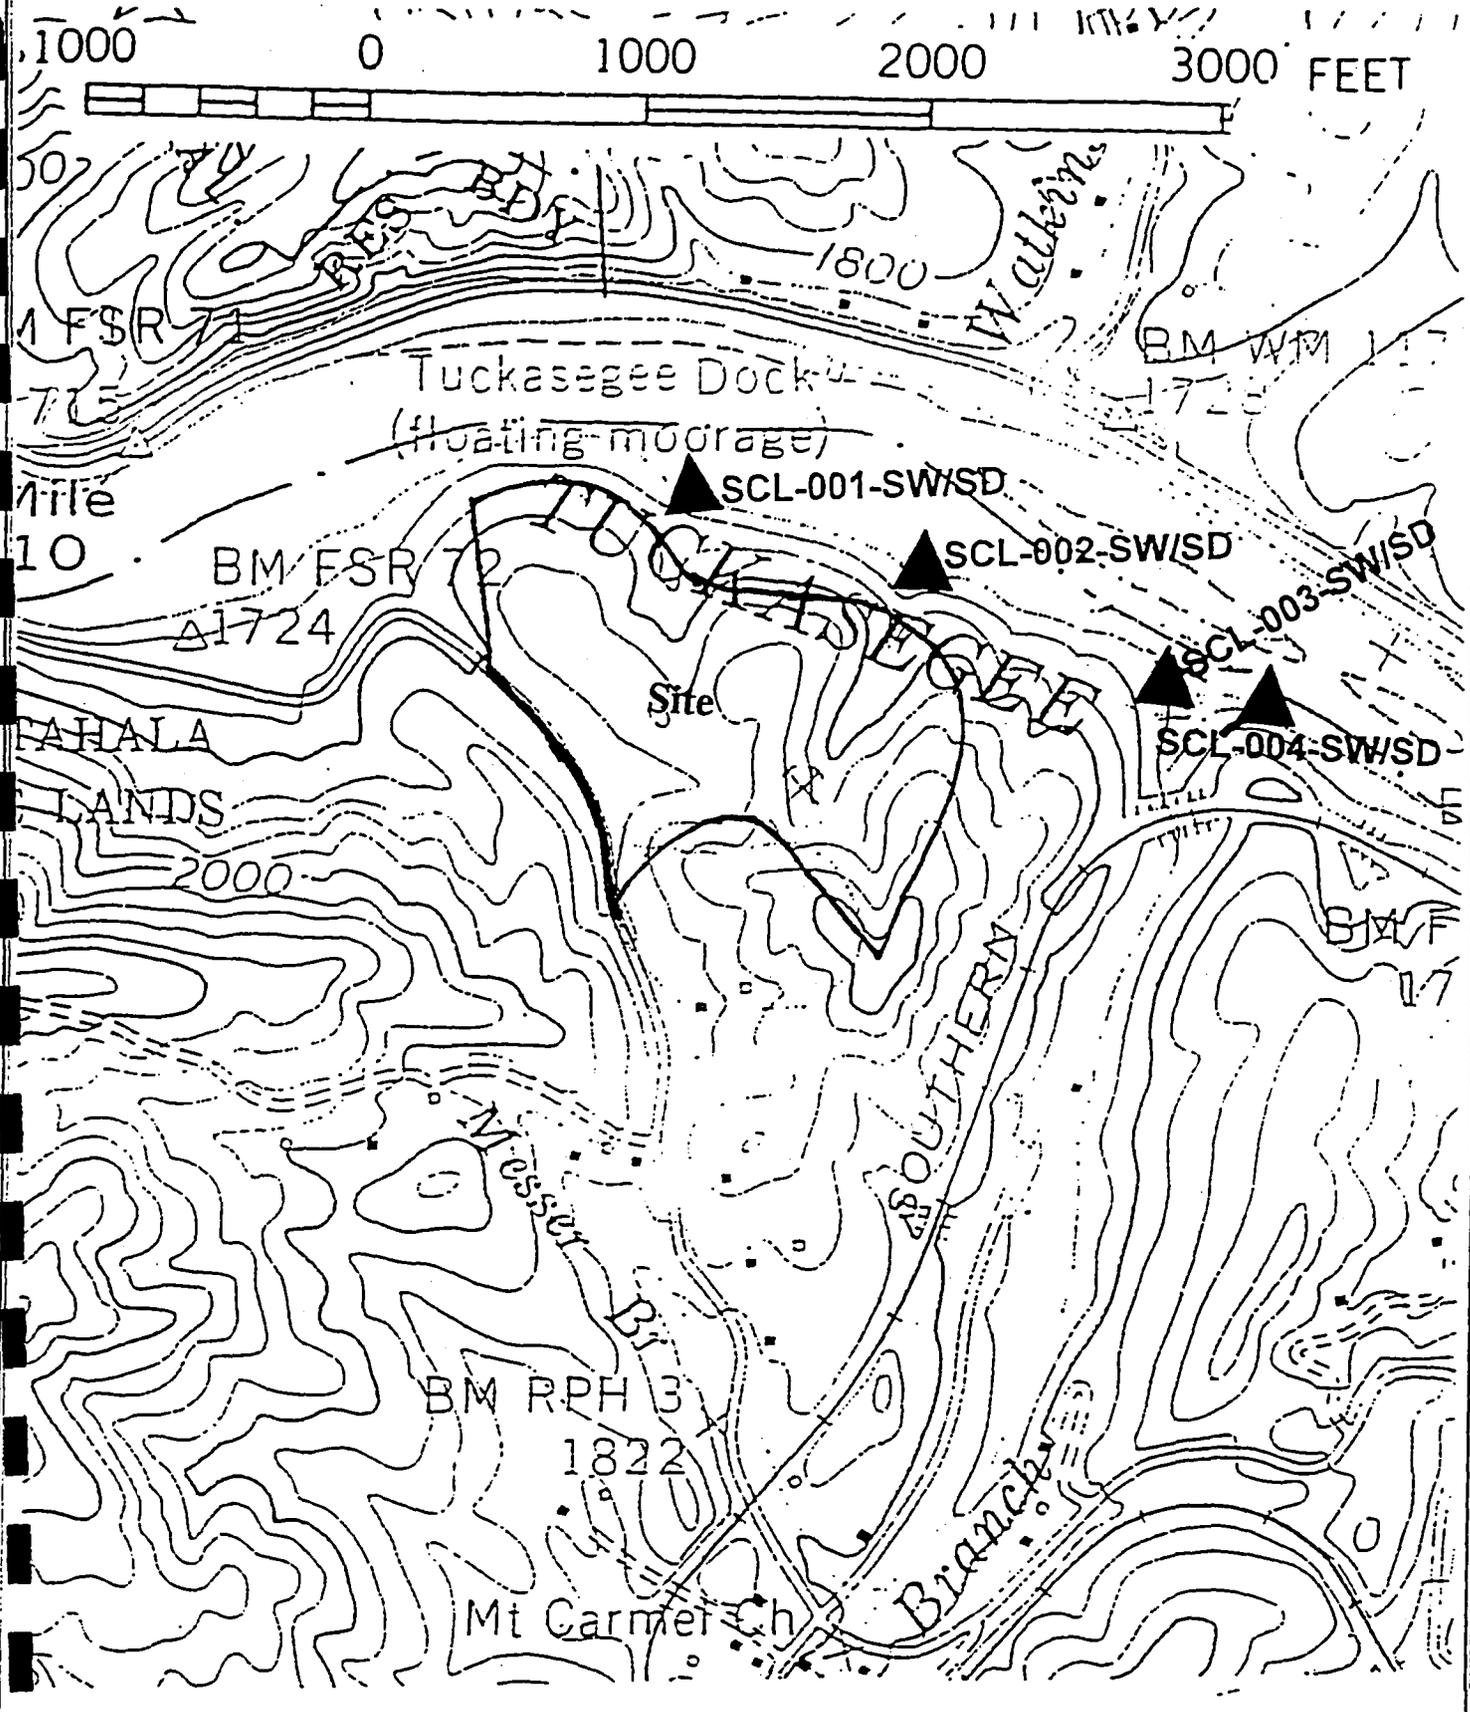
Sample Plan Map 1
 Date: 02/21/02
 Drawn By: MDB

Sample ID	Location and Rational	Analyses
SCL-001-SW/SD	Surface water and sediment sample collected from first probable point of entry (PPE1) in Tuckasegee River. Document release to fishery.	V,S,I
SCL-002-SW/SD	Surface water and sediment sample collected from second probable point of entry (PPE2) in Tuckasegee River. Document release to fishery.	V,S,I
SCL-003-SW/SD	Surface water and sediment sample collected in Tuckasegee River at intersection with Buckner Branch. Document release to fishery.	V,S,I
SCL-004-SW/SD	Surface water and sediment sample collected in Tuckasegee River upstream of intersection with Buckner Branch. Background sample.	V,S,I

Site: Swain County Landfill
 US EPA ID #: NC3120000002
 Bryson City, Swain County
 Approximate Scale: See Above
