**Swiss Bear, Inc.  
NCD 075550517**

**Phase I  
Screening Site Inspection**

**April 1991**

PHASE I  
SCREEN SITE INVESTIGATION  
FOR THE  
SWISS BEAR, INC. SITE  
NEW BERN, NORTH CAROLINA

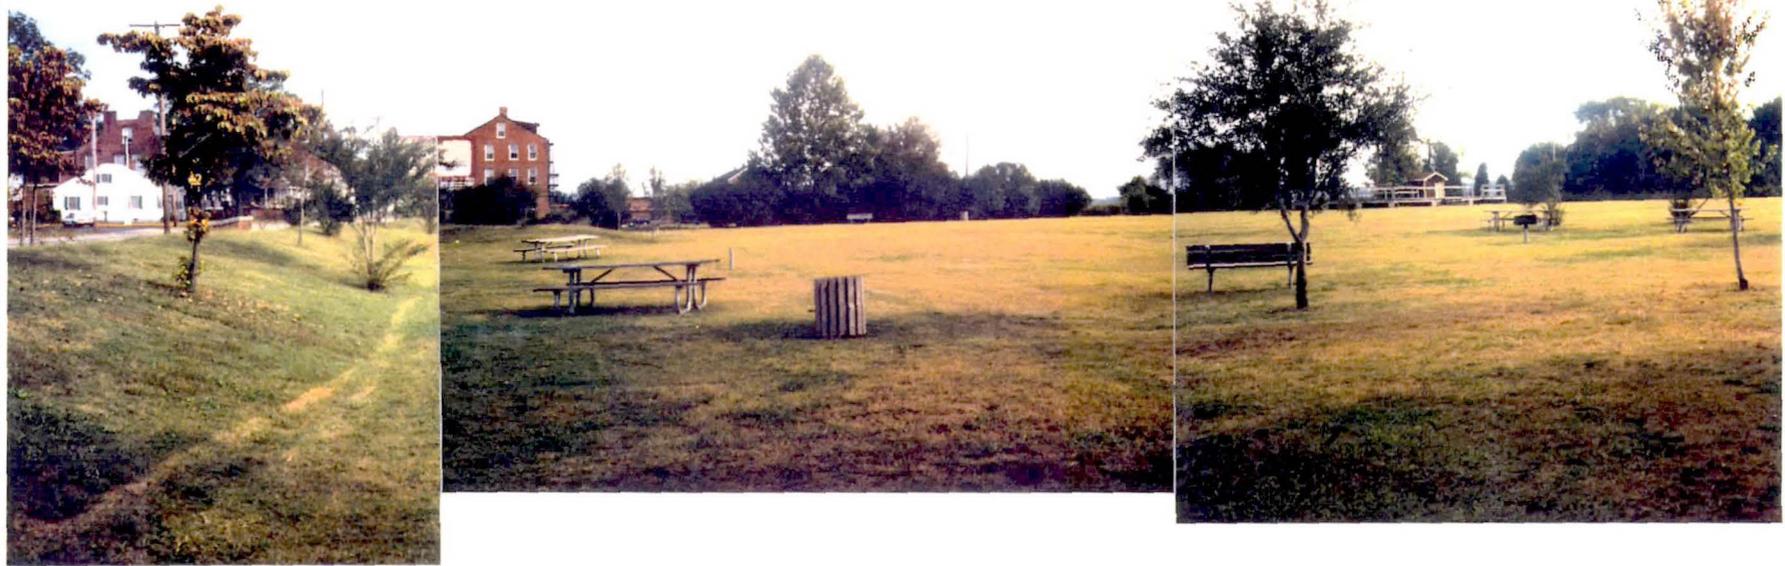
The site visit verified that the site has been graded, grassed, and is currently used as a park for passive recreation. In addition, there was no evidence of sludge disposal such as stained soils, stressed vegetation, seepage, unusual or unexplainable depressions, or "mucky" conditions.

PHOTO 1 – Panoramic view of Duffy Park (Swiss Bear, Inc.) looking northeast.

In conclusion, Greenhorne & O'Mara, Inc. is recommending that the site be designated as "no further remedial action planned (NFRAP)" due to the fact that there is no evidence that sludge was buried onsite and the site is not a threat to human health or the environment.
