Site Name (Subject): TUNGSTEN QUEEN MINE/ATLAS MINE

Description: Immediate Removal, 1994 - 1998

SUBJ: Tungsten Queen Mine Site
Tungsten, Vance Co., North Carolina

Subject: Immediate Removal Re-evaluation Request
Tungsten Queen Mine, NCD 082 362 989
Tungsten, Vance County, NC

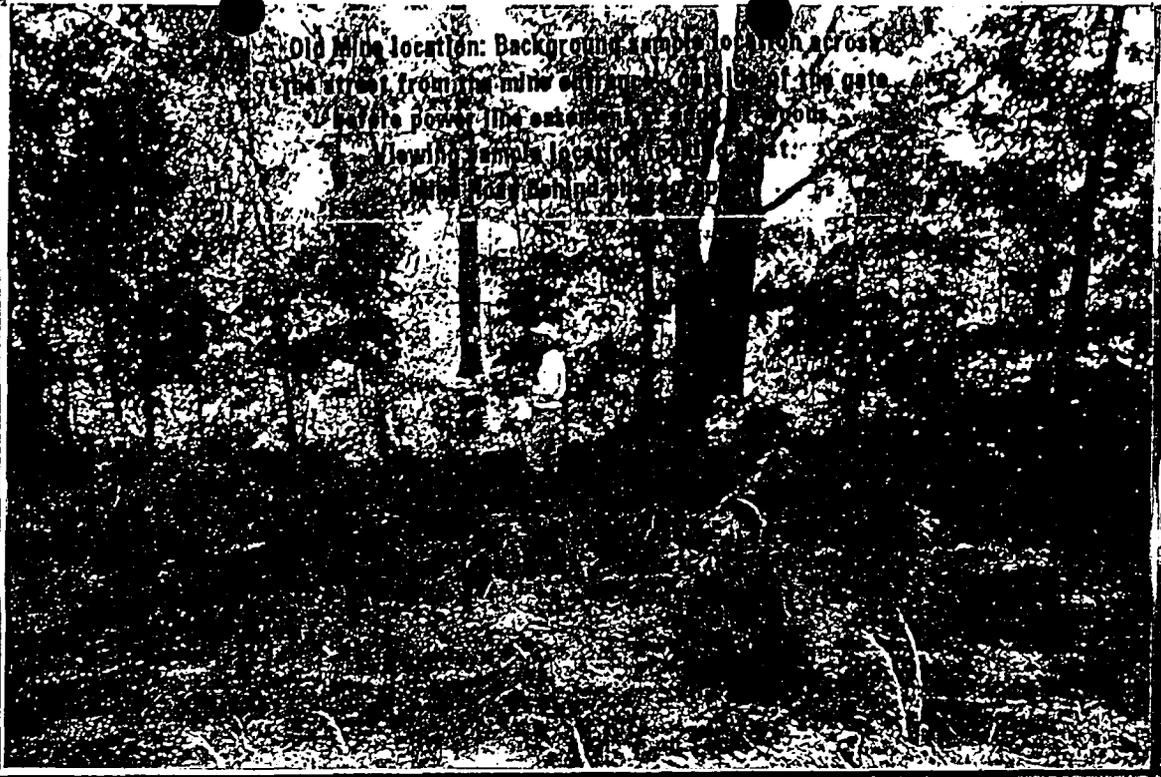
Old Mine location: Background sample
location from the mine entrance
to the power line entrance.

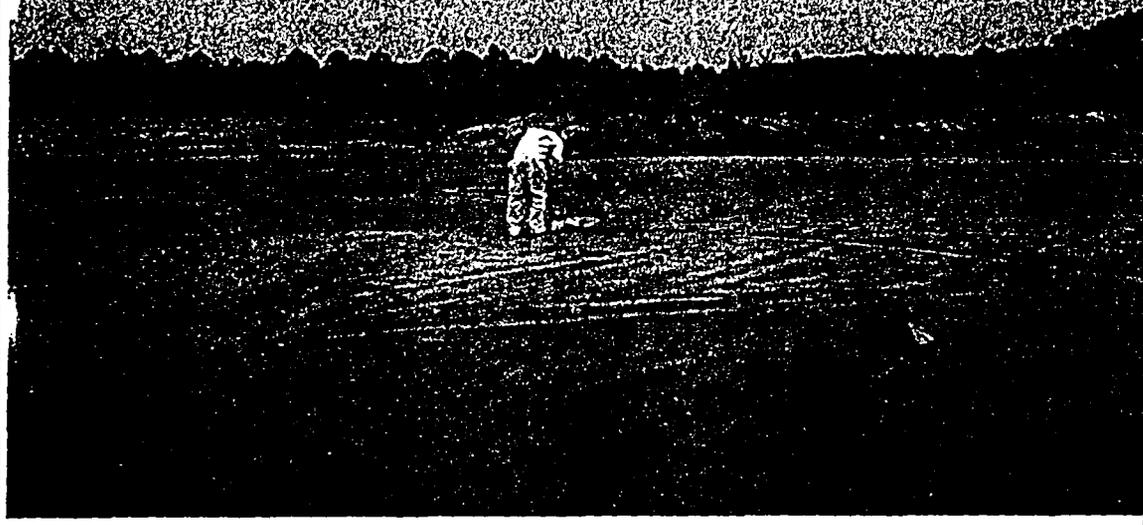
Old Mine location. Tailings pond adjacent to Island Creek
View of asphalt-like sludge fallings in pond near
Island Creek.

Old Mine location:
North edge of tailings pond closest to Island Creek.
Viewing NE.

Old Mine location: Photographed from pond closest to
gravity separation - white sands. Island Creek.
Viewing NE

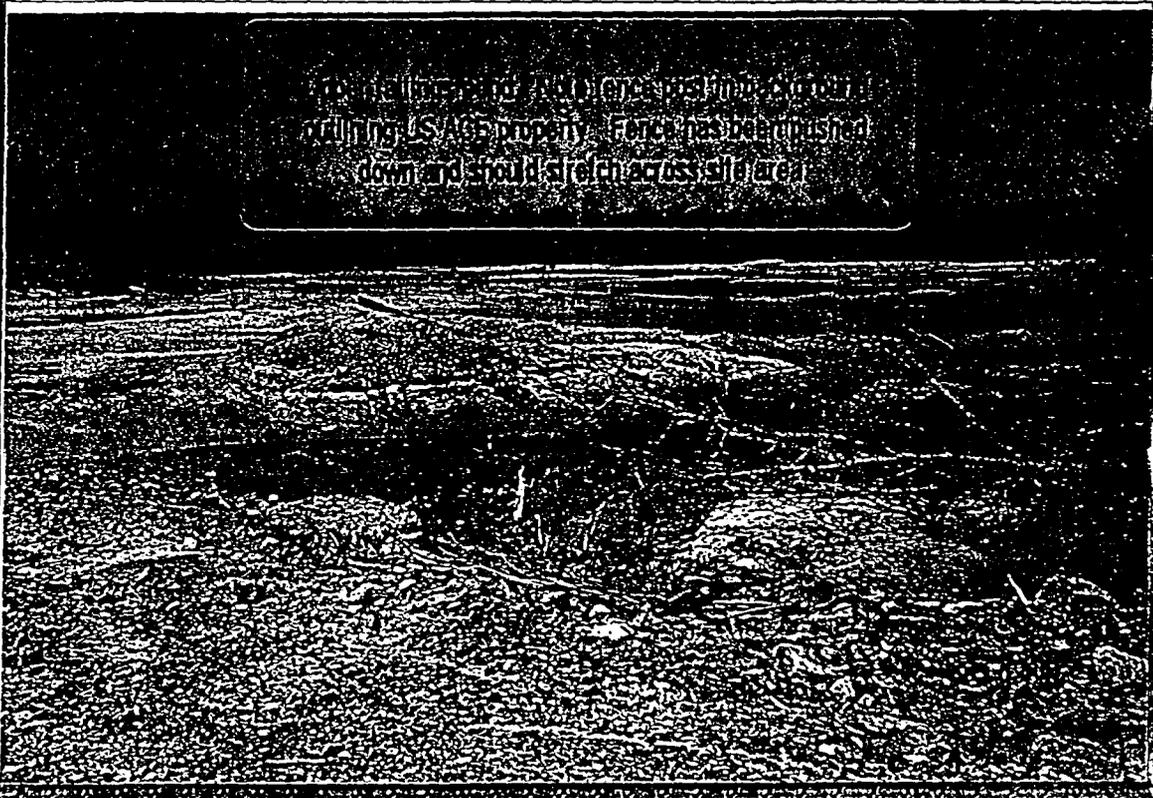
Remnants of a fence post and a
ruined USAF property. Fence has been pushed
downward and is in a state of disrepair.

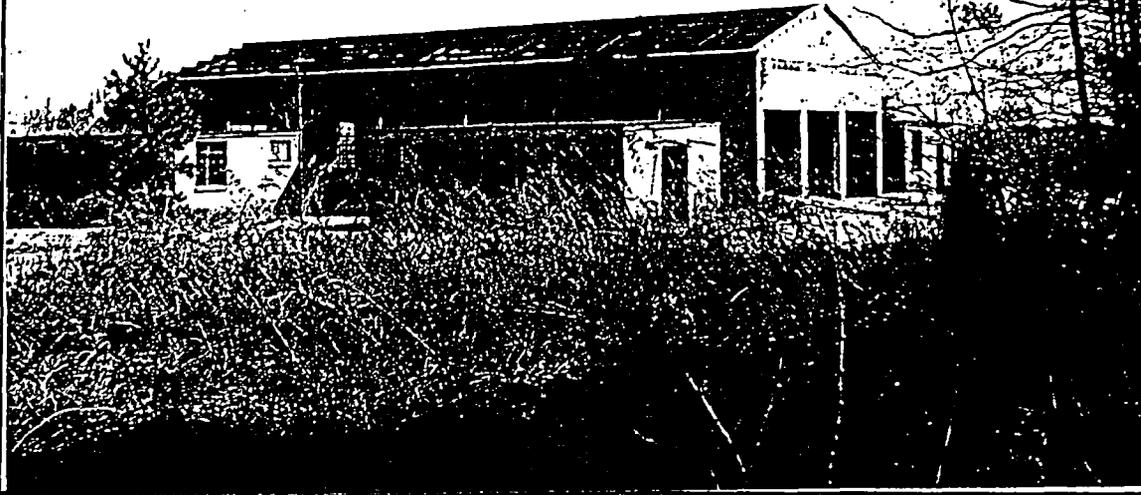
Warehouse roof removed

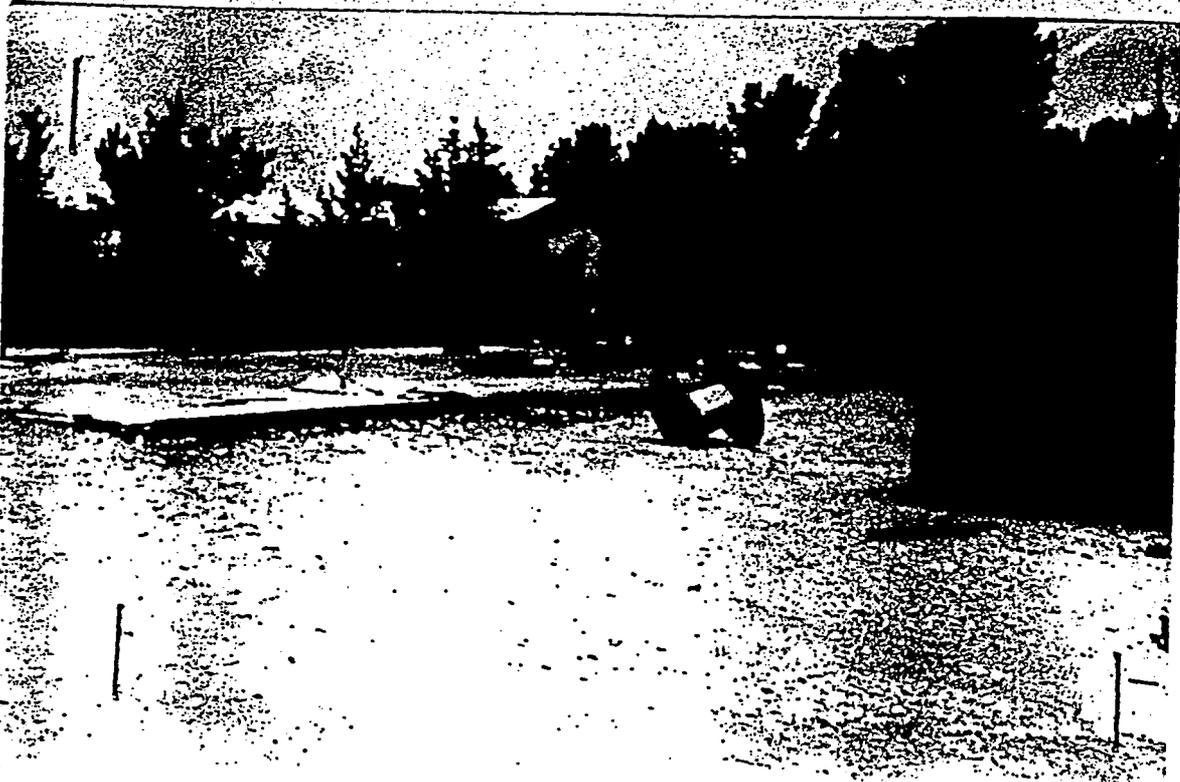
②

Pad Behind Bld #2 Tungsten Mine

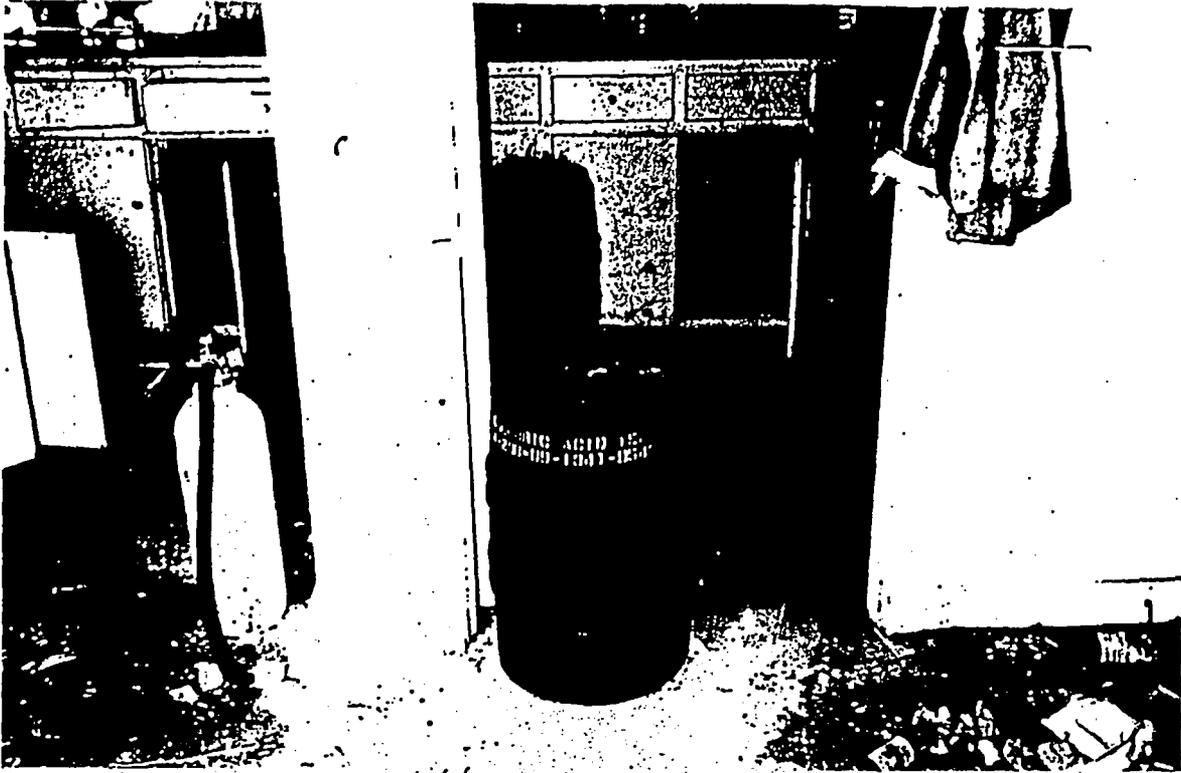
7

Building #1 (photos 7, 8, 9, 10, 11, 12) was a LAB. Inside there are several containers of chemicals, some of the chemicals are; (photo 7) mini drums of sulfuric acid; (photo 8) Table top numerous containers (note empty container of perchloric acid); Bench bottom shelf (photo 9) numerous containers (note broken bottles); Bench top (photo 10) several containers, one of which is Arsenic trioxide.

2-1-77 Lab #1 246 Thompson Mine - sulfuric acid

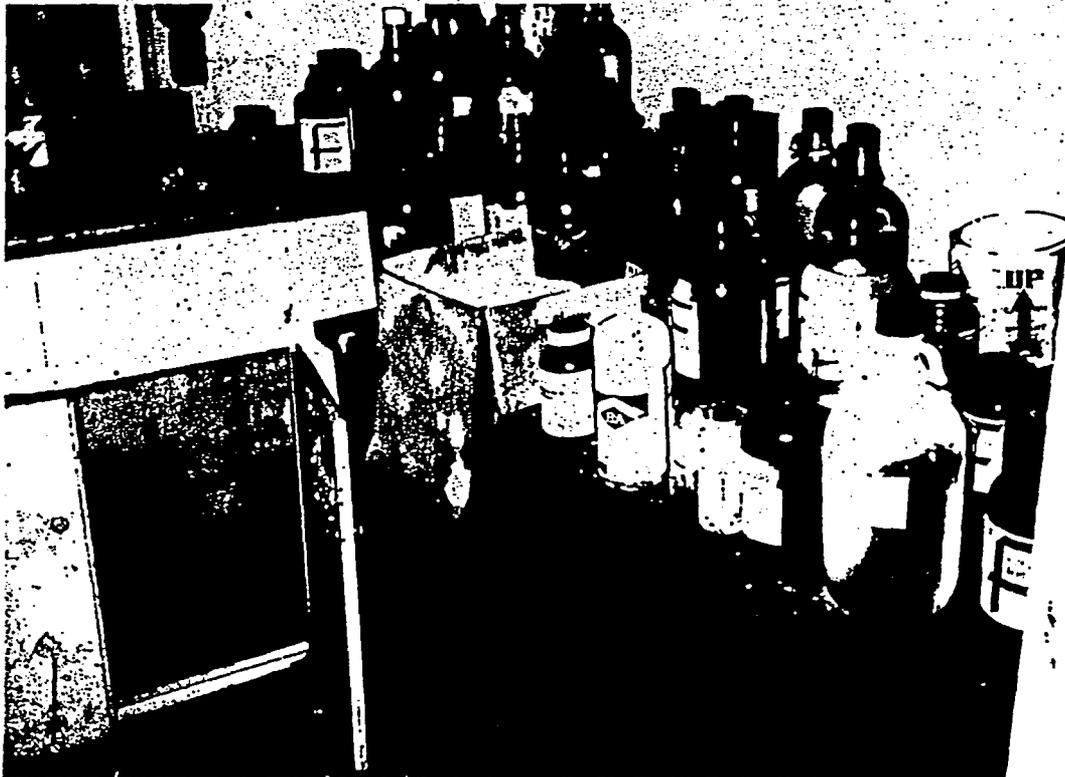
8

2-1-77 Lab #1 246 Thompson Mine - empty cust. of sulfuric acid

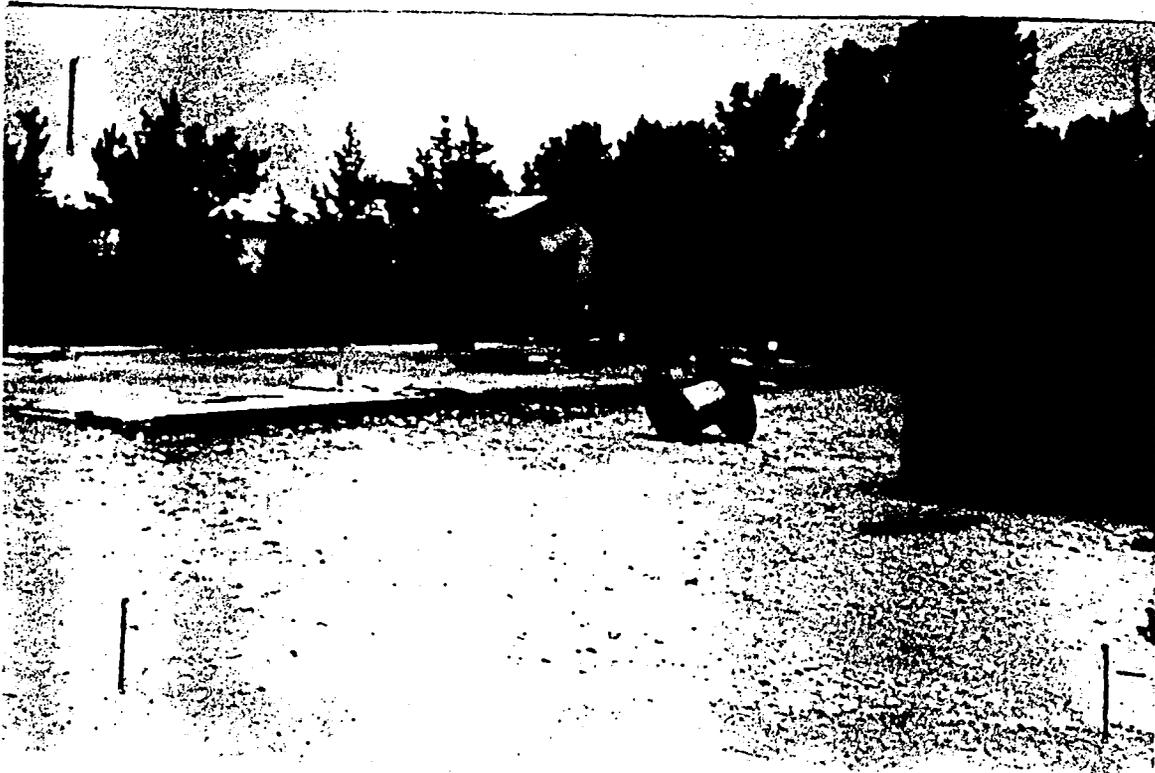
②

Concrete Pad (was a building) (photo #2) held a few drums, most empty. (There was a heavy sulfur smell at that location.)

Pad Behind Bld #2 Tungsten Mine

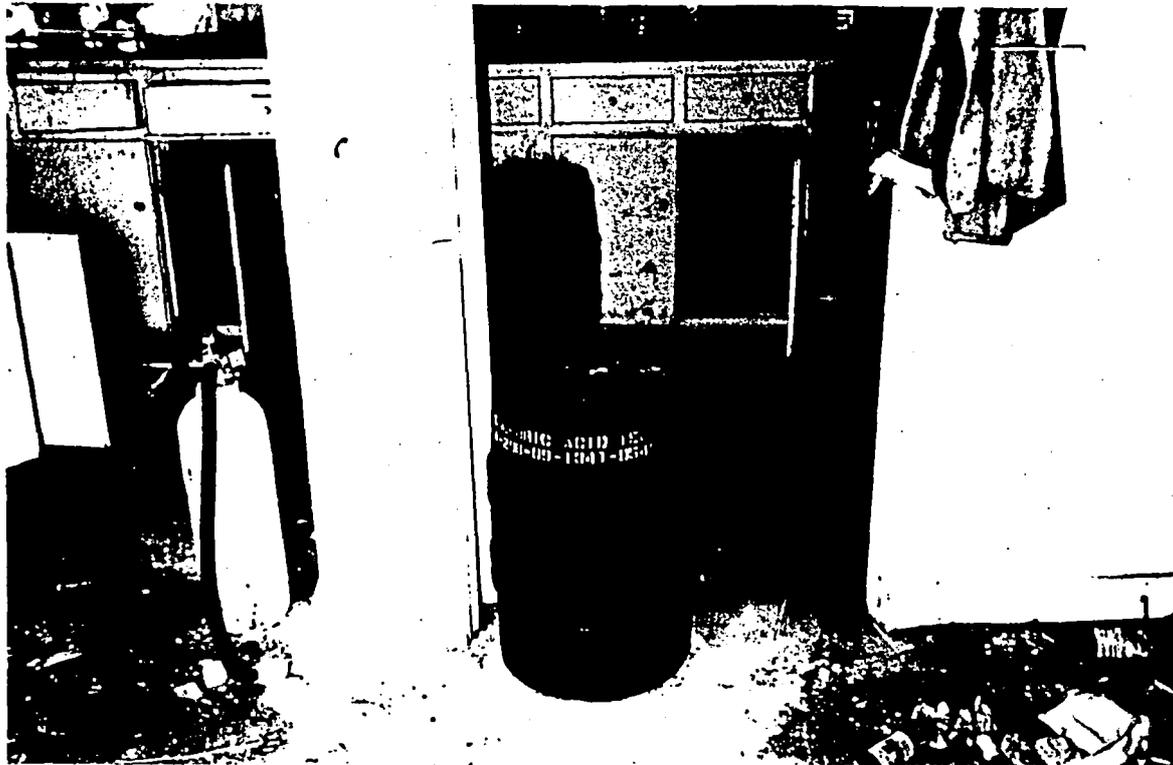
7

mini drums of sulfuric acid; (photo 8) Table top numerous containers (note empty container of perchloric acid); Bench bottom shelf (photo 9) numerous containers (note broken bottles); Bench top (photo 10) several containers, one of which is Arsenic trioxide.

2-1-77 Lab #1 Milk Thompson Mine - sulfuric acid

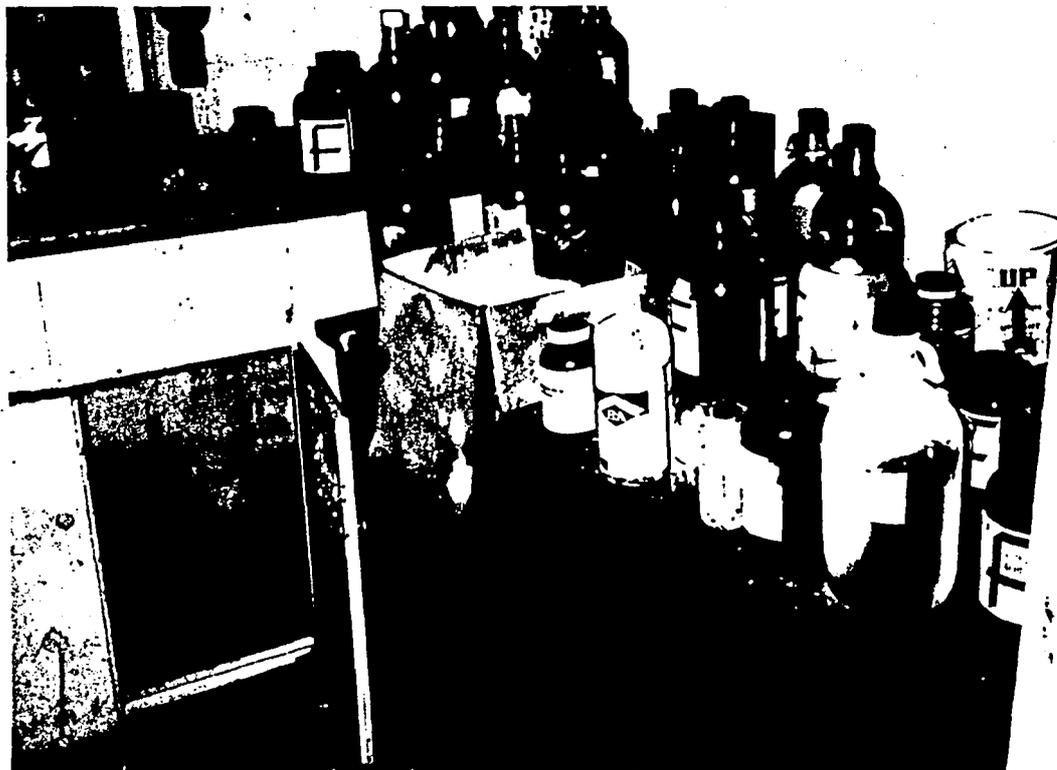
8

2-1-77 Lab #1 Milk Thompson Mine - empty cont. of phosphoric acid
