Site Name (Subject): SOUTHSIDE INVESTMENTS LLC

Document Name (DocType): Pre-CERCLIS Screening (PSA)

Subject: Pre-CERCLIS Site Screening (SS)  
Southside Investments  
Charlotte, Mecklenburg County, NC  
NON CD0 001 076

Re: Potential Receptor Survey  
Former Lida Facility  
2222 South Boulevard  
Charlotte, North Carolina  
H&H Job No. PPA-04

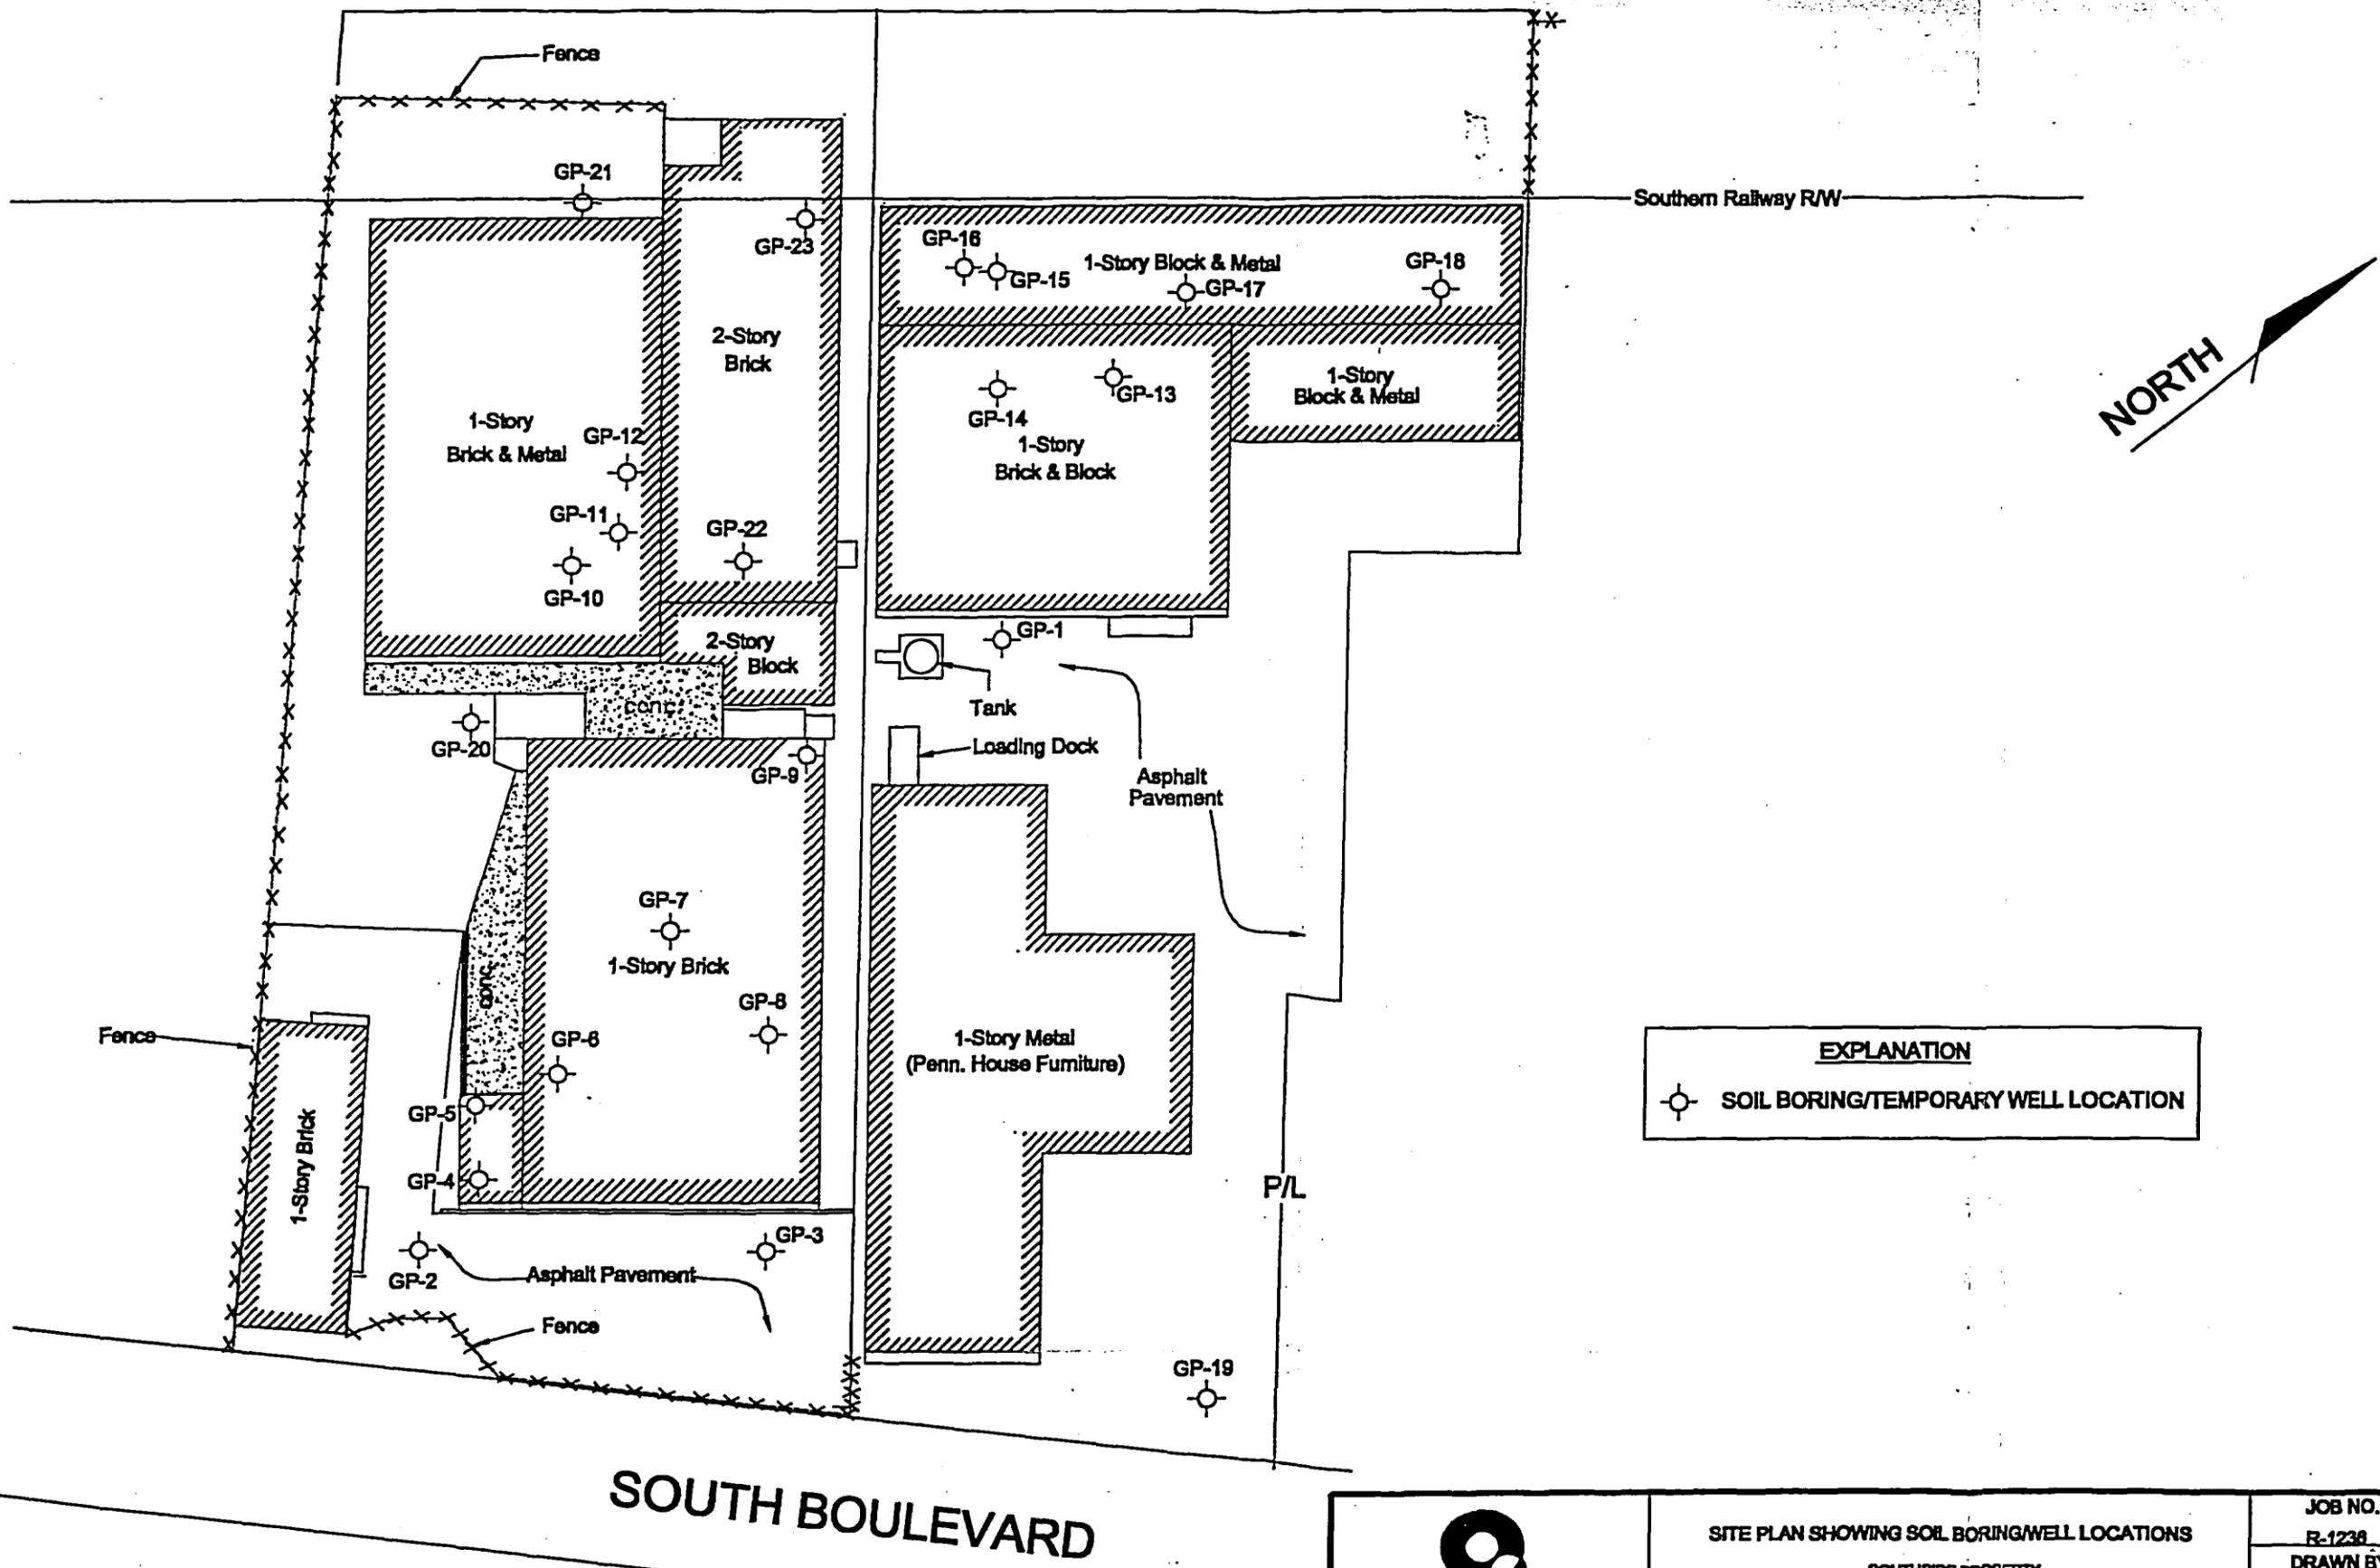
- GP-4 through GP-18, GP-22 and GP-23 were completed inside the existing buildings at select locations adjacent to floor drains and apparent underground distribution piping. GP-4, GP-5, and GP-23 were also completed in close proximity to previously identified drums located inside the buildings. In addition, GP-9, which was completed as close as possible to the previously identified oil-stained piping, was located inside of the 2222 South Boulevard building next to an apparent underground distribution pipe;

Review of the boring data indicates that the soil boring depths ranged from 4 feet to 8 feet below land surface (BLS). Boring refusal was encountered at GP-22 approximately 8 inches BLS, just beneath the floor slab, at 10 different locations. A petroleum odor was noted on the probe point during one of the boring attempts; however, no soil sample could be collected for laboratory analysis due to probe refusal. Based on the laboratory results for the soil samples collected from the other soil borings, concentrations of mercury, barium, chromium, lead, fluoranthene, phenanthrene, pyrene, chrysene, benzo (a) anthracene, benzo (b) fluoranthene, and benzo (a) pyrene were detected. Mercury, chromium, and benzo (a) anthracene were detected at concentrations that exceed the Soil Screening Levels provided by the Hazardous Waste Section of the NCDENR. The soil laboratory data is summarized on Table 1. Copies of the laboratory results are provided in the Appendix.

**EXPLANATION**  
 ⦿ SOIL BORING/TEMPORARY WELL LOCATION
