Re: Review of Initial Abatement Action Report  
Stancil Builders  
540 Richlands, Highway, Jacksonville  
Onslow County  
Incident Number: 94140  
Risk Classification: Low

Re.: Chromium Background Soil Sampling Results  
Stancil Property  
540 Richlands Highways  
Jacksonville, North Carolina  
Onslow County

**TABLE 1 (page 1 of 2)**  
**SOIL SAMPLE RESULTS SUMMARY**  
**STANCIL PROPERTY**  
**540 RICHLANDS HIGHWAY, JACKSONVILLE, NORTH CAROLINA**  
**SAMPLED ON 5/24/12 & 8/2-3/12**

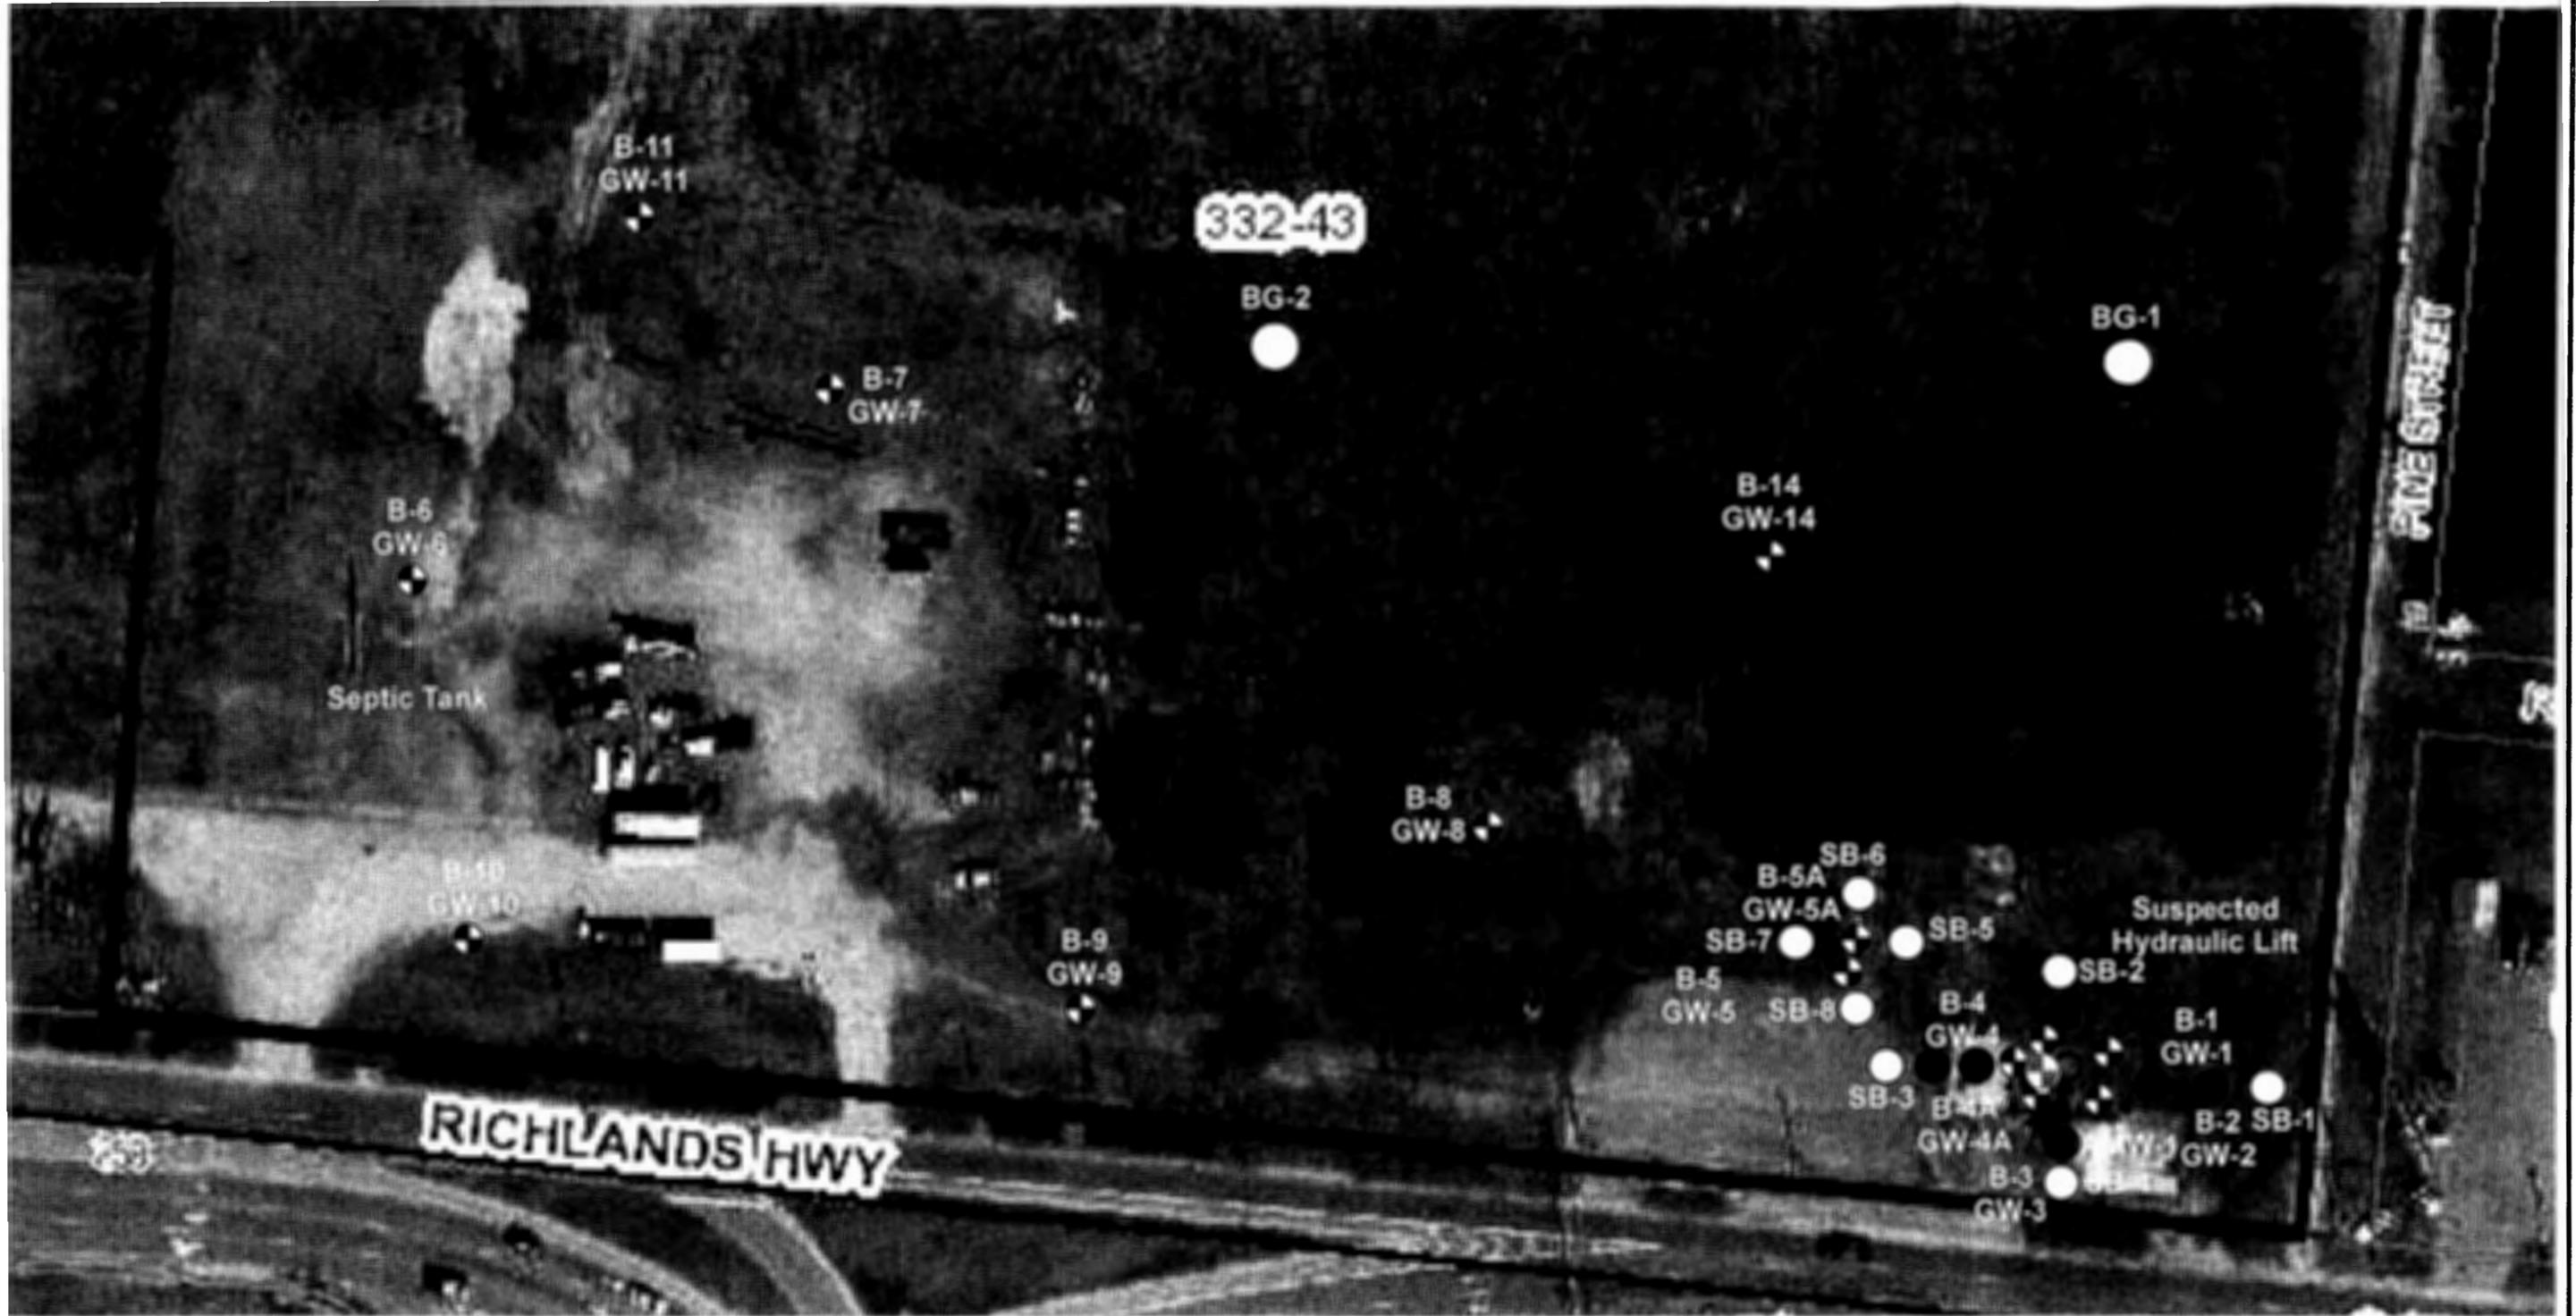
FIGURE:  
**2**

Previous Geologic Soil and Groundwater Sample Locations
  -

Type II Monitoring Well (AMW-1) Installed By ARM
  -

Delineation Soil Boring/Sample Location
  -

Delineation Soil Boring With Strong Hydrocarbon Odor
  -

Background Soil Boring/Sample Location
- Note: Adapted from the Onslow County On-line GIS.

TITLE: AERIAL PHOTO WITH SOIL AND GROUNDWATER SAMPLING LOCATIONS			
JOB: 12098	SCALE: Approx: 1" = 70'	DATE: 9/19/2012	DRAWN BY: KLC/JLZ
