FACILITY COMPLIANCE INSPECTION REPORT
Division of Waste Management
Solid Waste Section

Date of Inspection: 15 April 2016

Coastal Dragline Services LCID Landfill
175 Brown Farm Road
Vanceboro, NC 28586

Comprehensive Facility Compliance Inspection

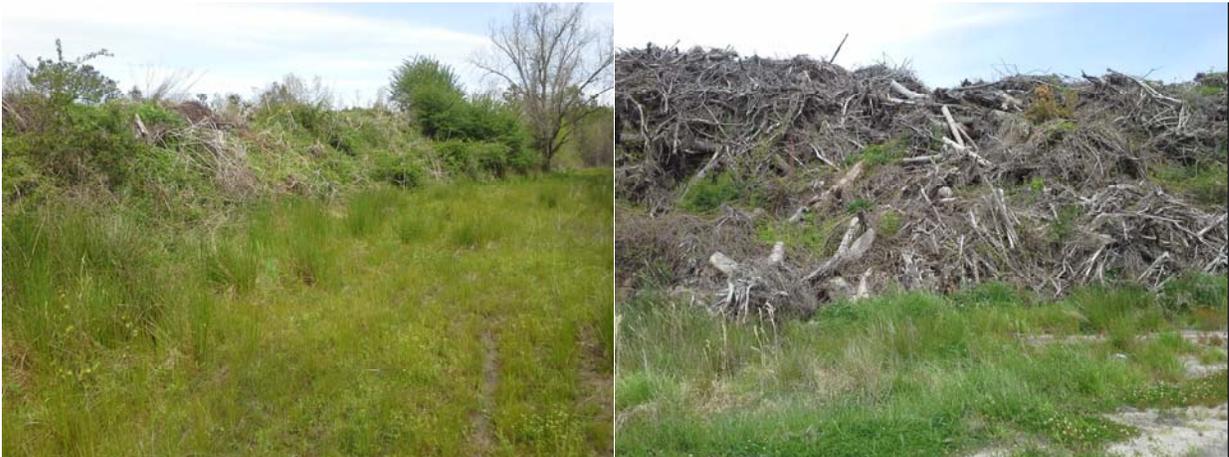
- 13) The outside slopes have not been compacted and covered as required. \*Please ensure that all outside slopes are covered and graded at a slope not greater than 3:1, and are seeded and mulched to establish a groundcover suitable to prevent erosion of the landfill cap system.

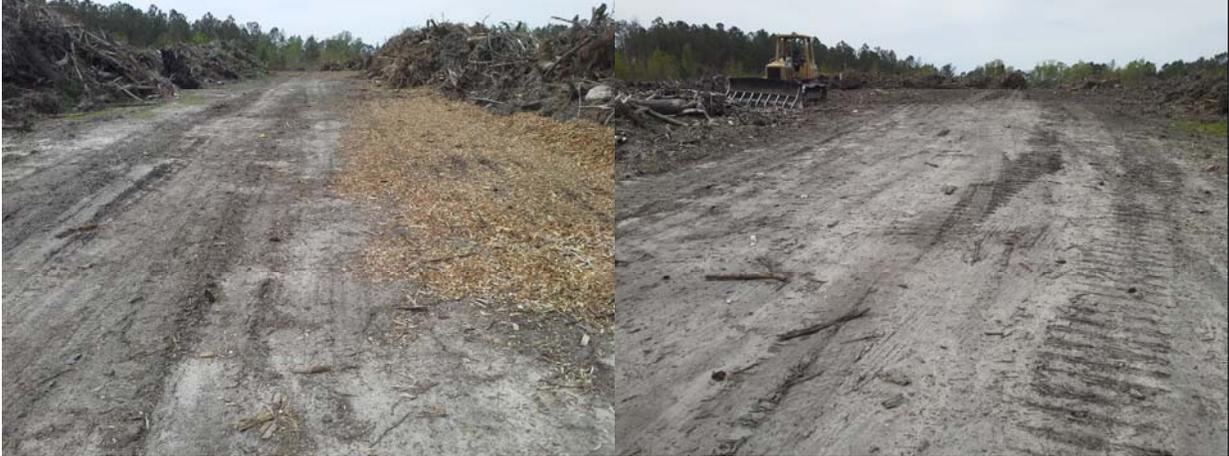
- 14) The landfill working face appears to be approaching one acre in size. \*Plans need to be underway to compact and cover the active working area. Please ensure that only one working area is maintained at a time and that all waste is compacted, covered and graded monthly or when the active working area reaches one acre in size, whichever occurs first.

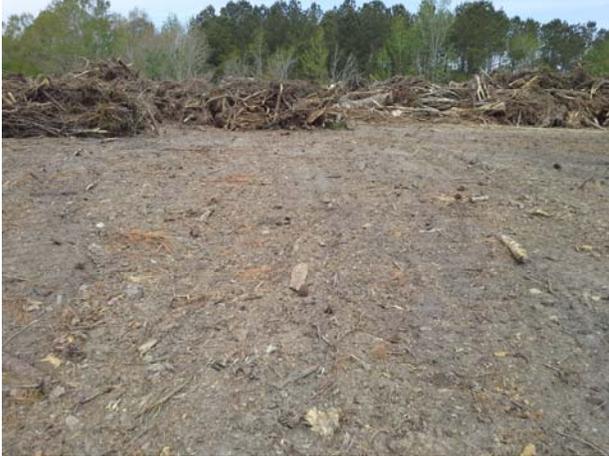
15) The waste type was reviewed. The waste being disposed is LCID waste and no unpermitted waste types were observed during this Facility Compliance Inspection.
