**Reference: 2013 Annual Site Monitoring Report
Former Hancock Country Hams
3484 NC Highway 22 North
Franklinville, North Carolina
Environmental Alliance, Inc. Project # 2719A**

**2013 ANNUAL SITE MONITORING REPORT
FORMER HANCOCK COUNTRY HAMS
3484 NC HIGHWAY 22 NORTH
FRANKLINVILLE, NORTH CAROLINA**

**HANCOCK COUNTRY HAMS
SITE MONITORING REPORT**

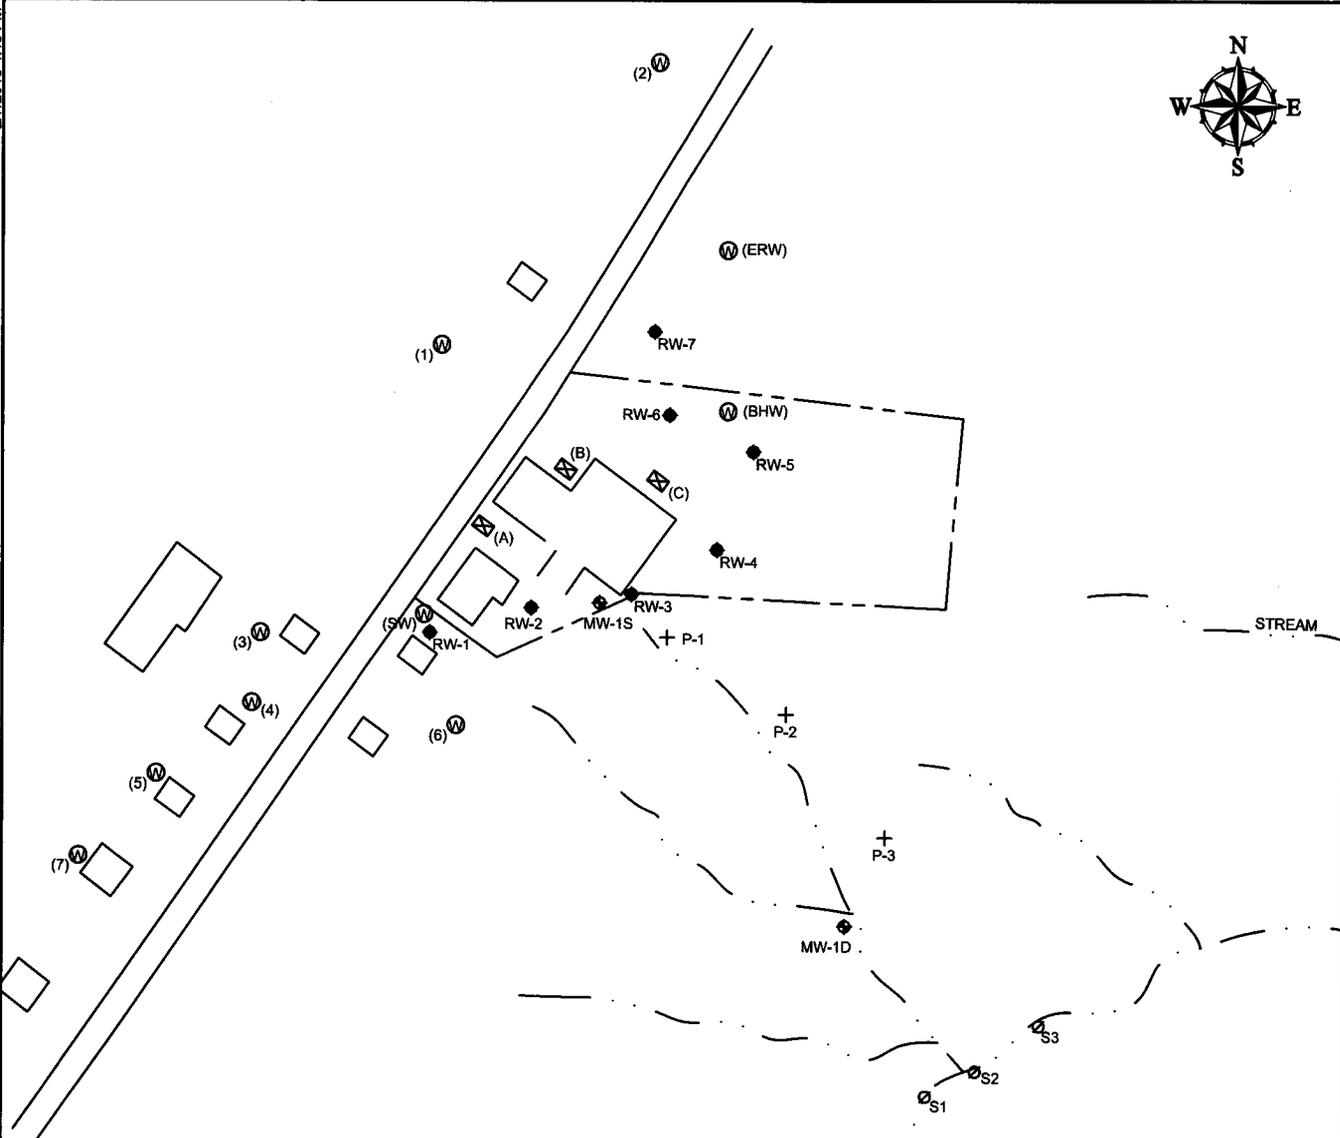
Monitoring well MW-1S and monitoring well MW-1D were sampled on January 24, 2013. The locations of the monitoring wells are shown on Figure 2. The samples were sent to REIC Laboratories in Beaver, West Virginia and analyzed for chloride using EPA Method 300.0.

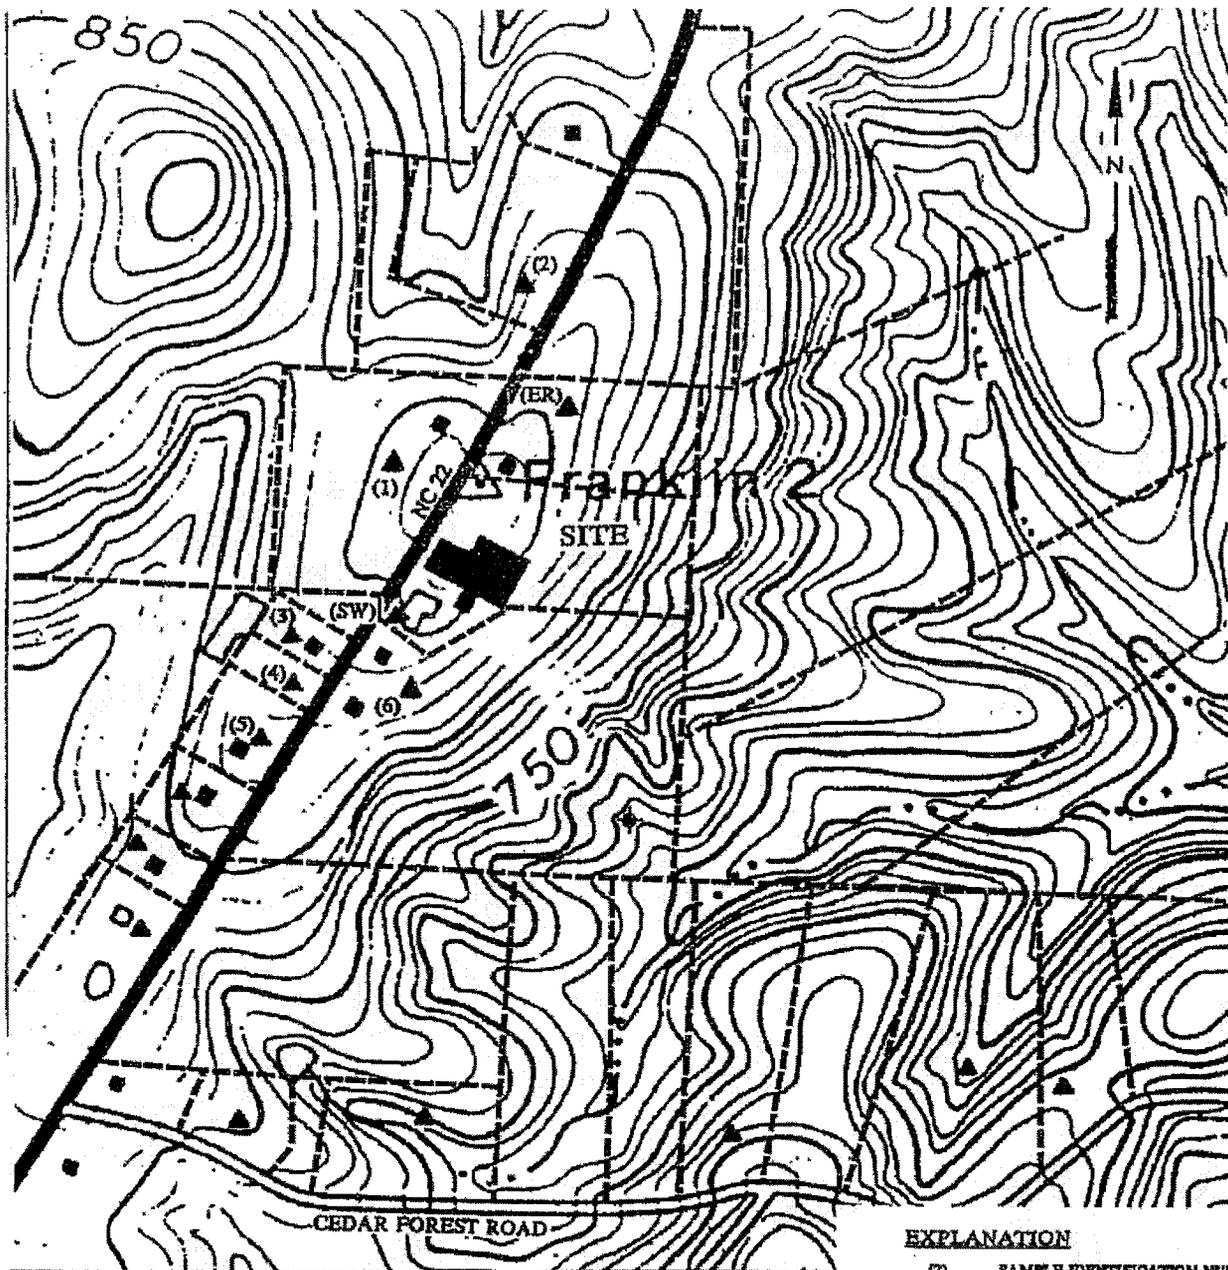
FIGURE
4

Topographic Relationship of Water Wells to the Site

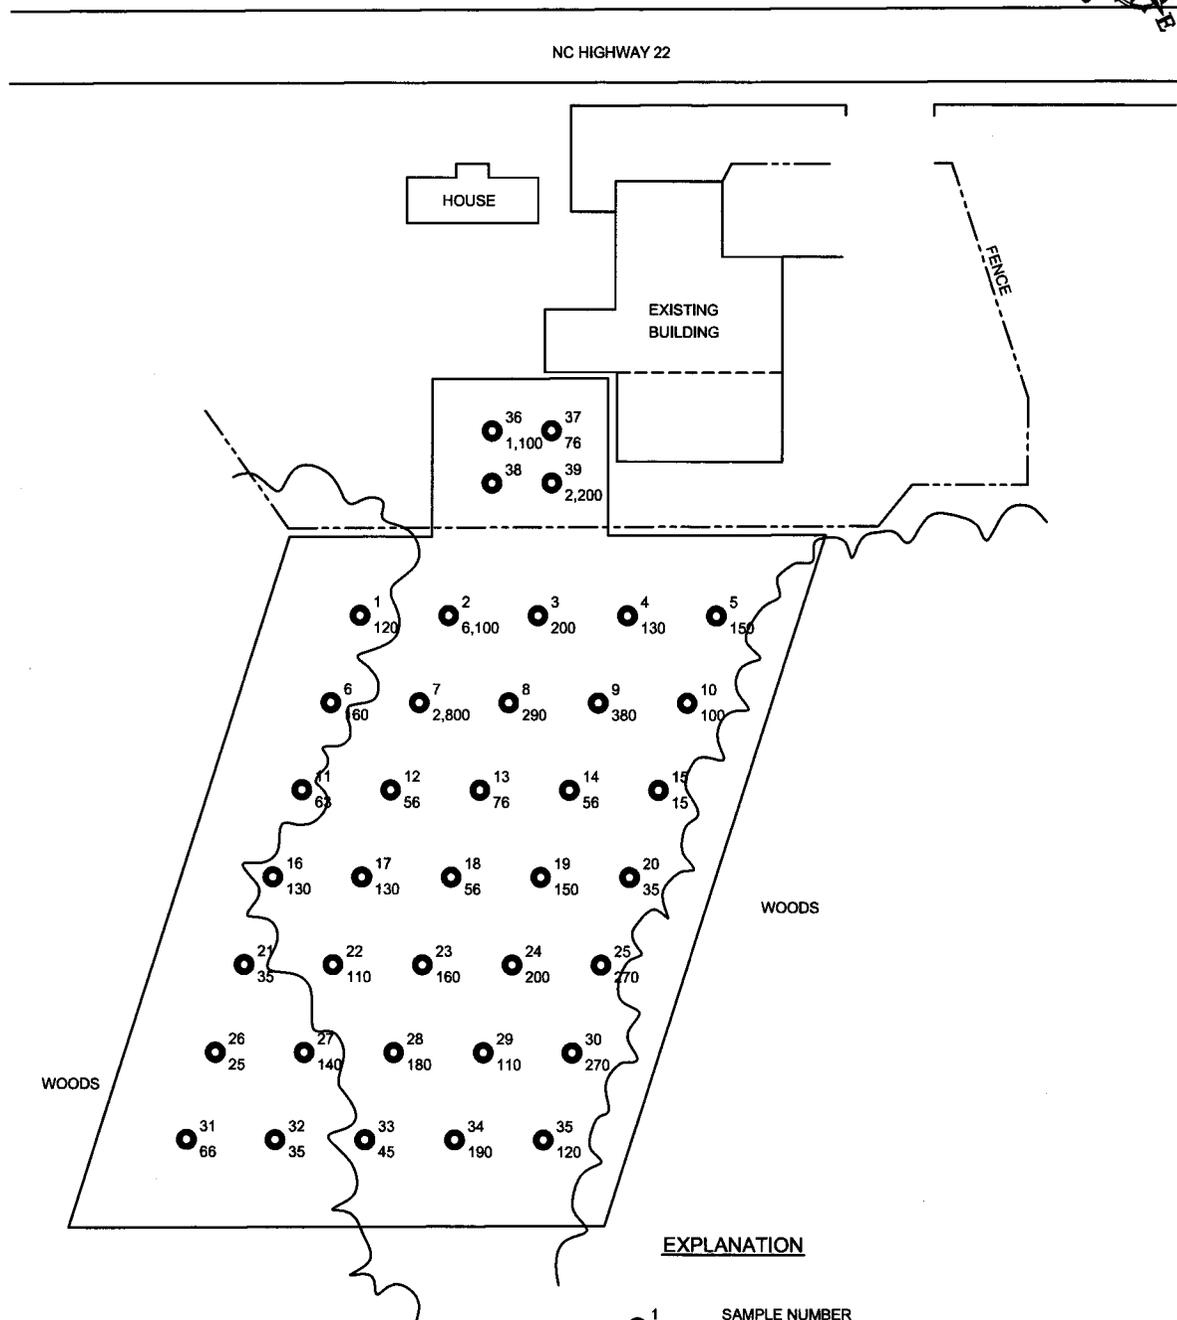
DESIGNED BY: —	DRAWN BY: AGG	UPDATED BY: —	FIGURE NO: 5
APPROVED BY: JSE	PROJECT NO: 2719	DATE: 2/7/2013

**SOIL CHLORIDE
 CONCENTRATION - 1990**

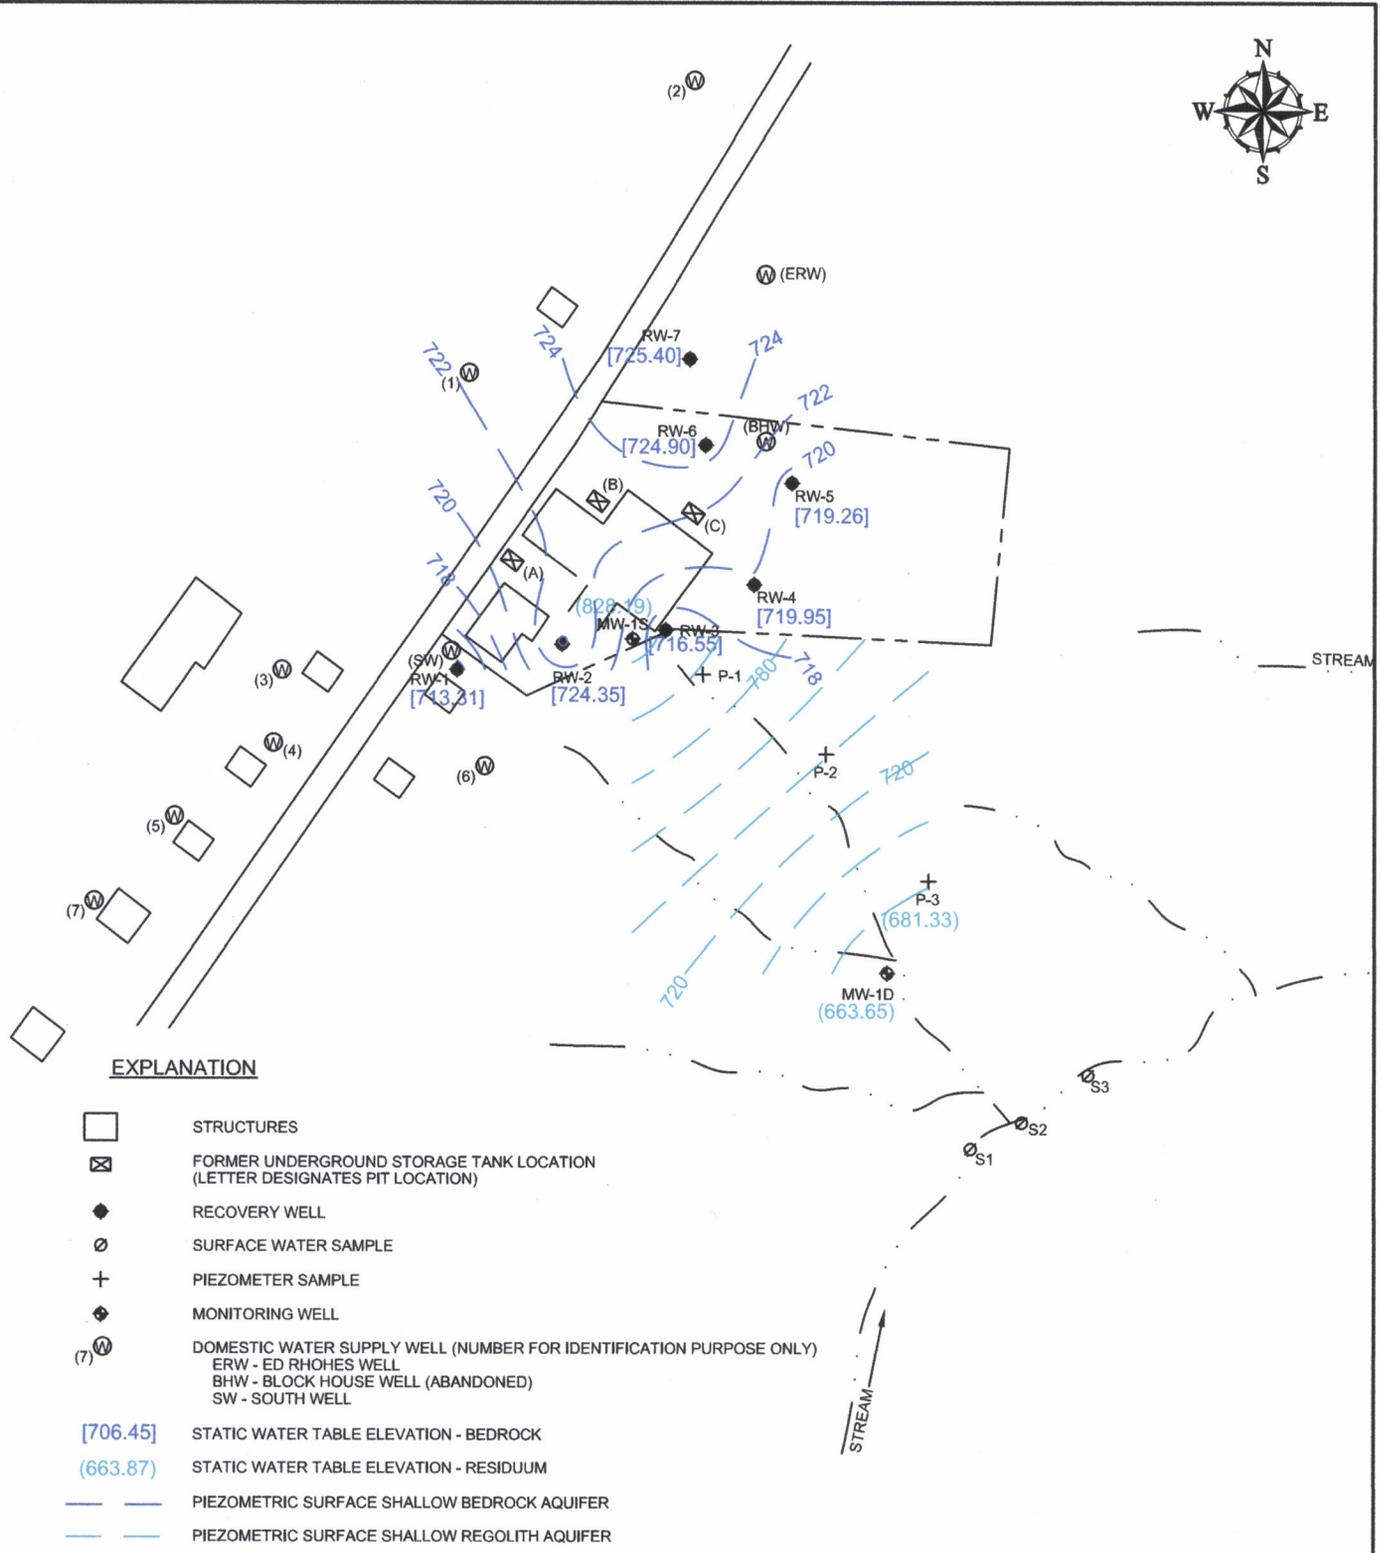
DESIGNED BY: JSE	DRAWN BY: SKJ	UPDATED BY: —	FIGURE NO.:
APPROVED BY: JSE	PROJECT NO. 2719	DATE: 2/6/2013	7

The groundwater measurements collected on January 23, 2013 were used to prepare a groundwater surface contour map (Figure 8). The data shows groundwater in both the residuum and bedrock are moving generally to the southeast toward the stream. The water level data are summarized in Table 6.

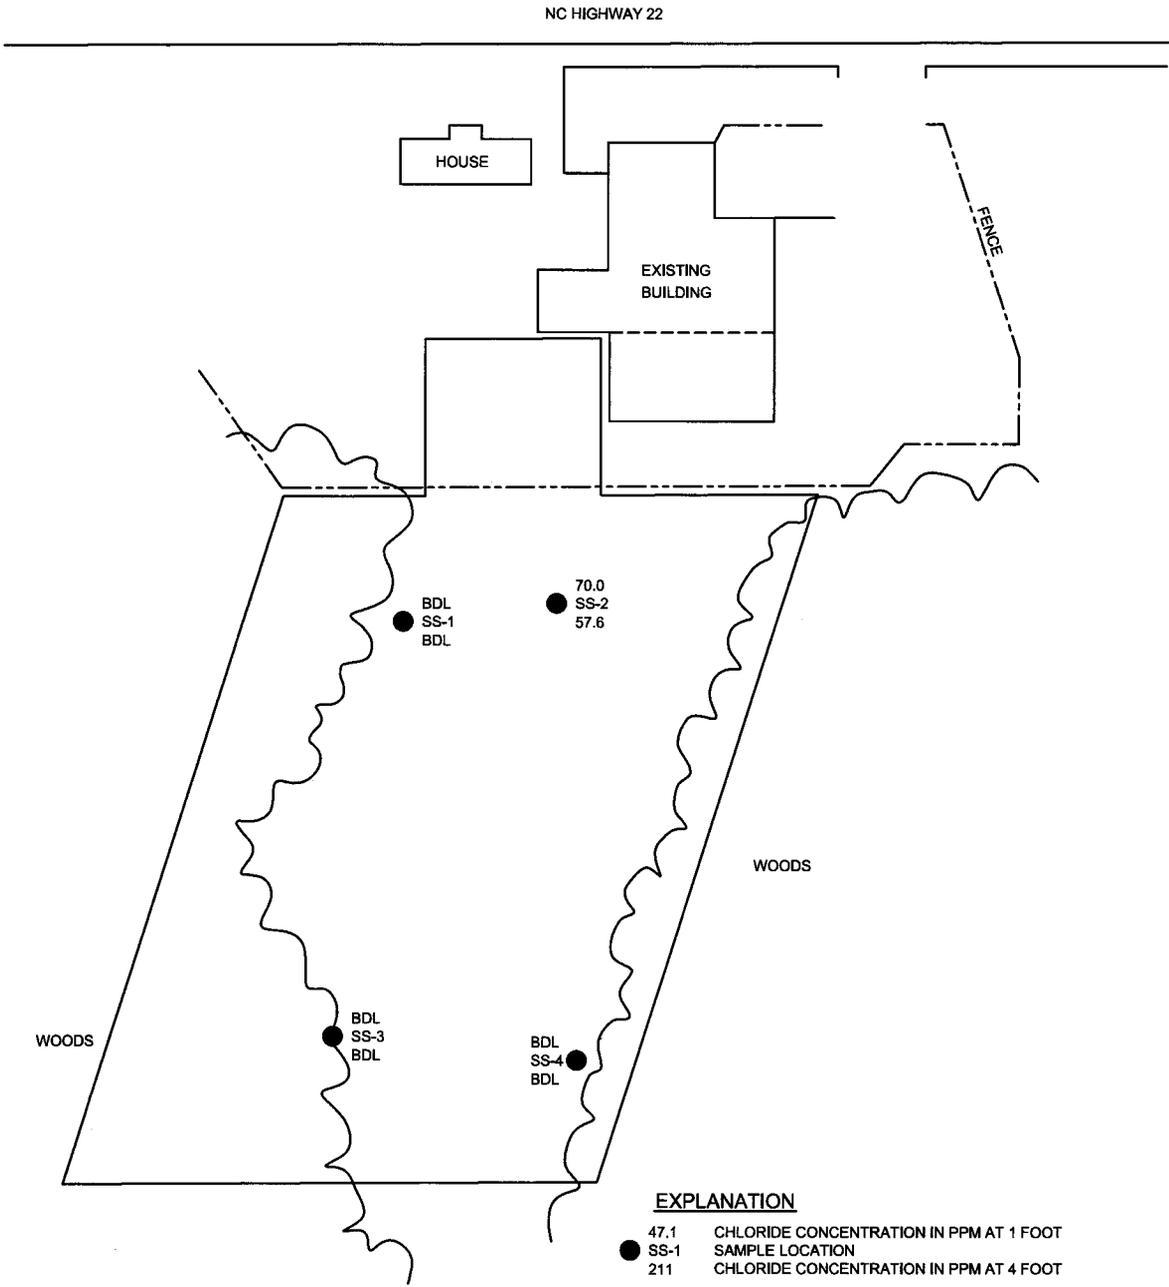
DESIGNED BY: JSE	DRAWN BY: SKJ	UPDATED BY: —	FIGURE NO: 6
APPROVED BY: JSE	PROJECT NO. 2719	DATE: 2/19/2013

Concentrations of chloride in the soil samples collected on January 25, 2013 were below detection limits (BDL) in the 1-foot samples from SS-1, SS-3, and SS-4. The 1-foot soil sample collected from SS-2 indicated a chloride concentration of 70.0 mg/kg. Chloride concentrations at SS-2 in the 4-foot samples were detected at 57.6 mg/kg. The SS-1, SS-3, and SS-4 4-foot samples were reported as BDL. The soil sampling analytical data is summarized on Table 4, and the accompanying laboratory analyses and chain-of-custody can be found in Appendix A.

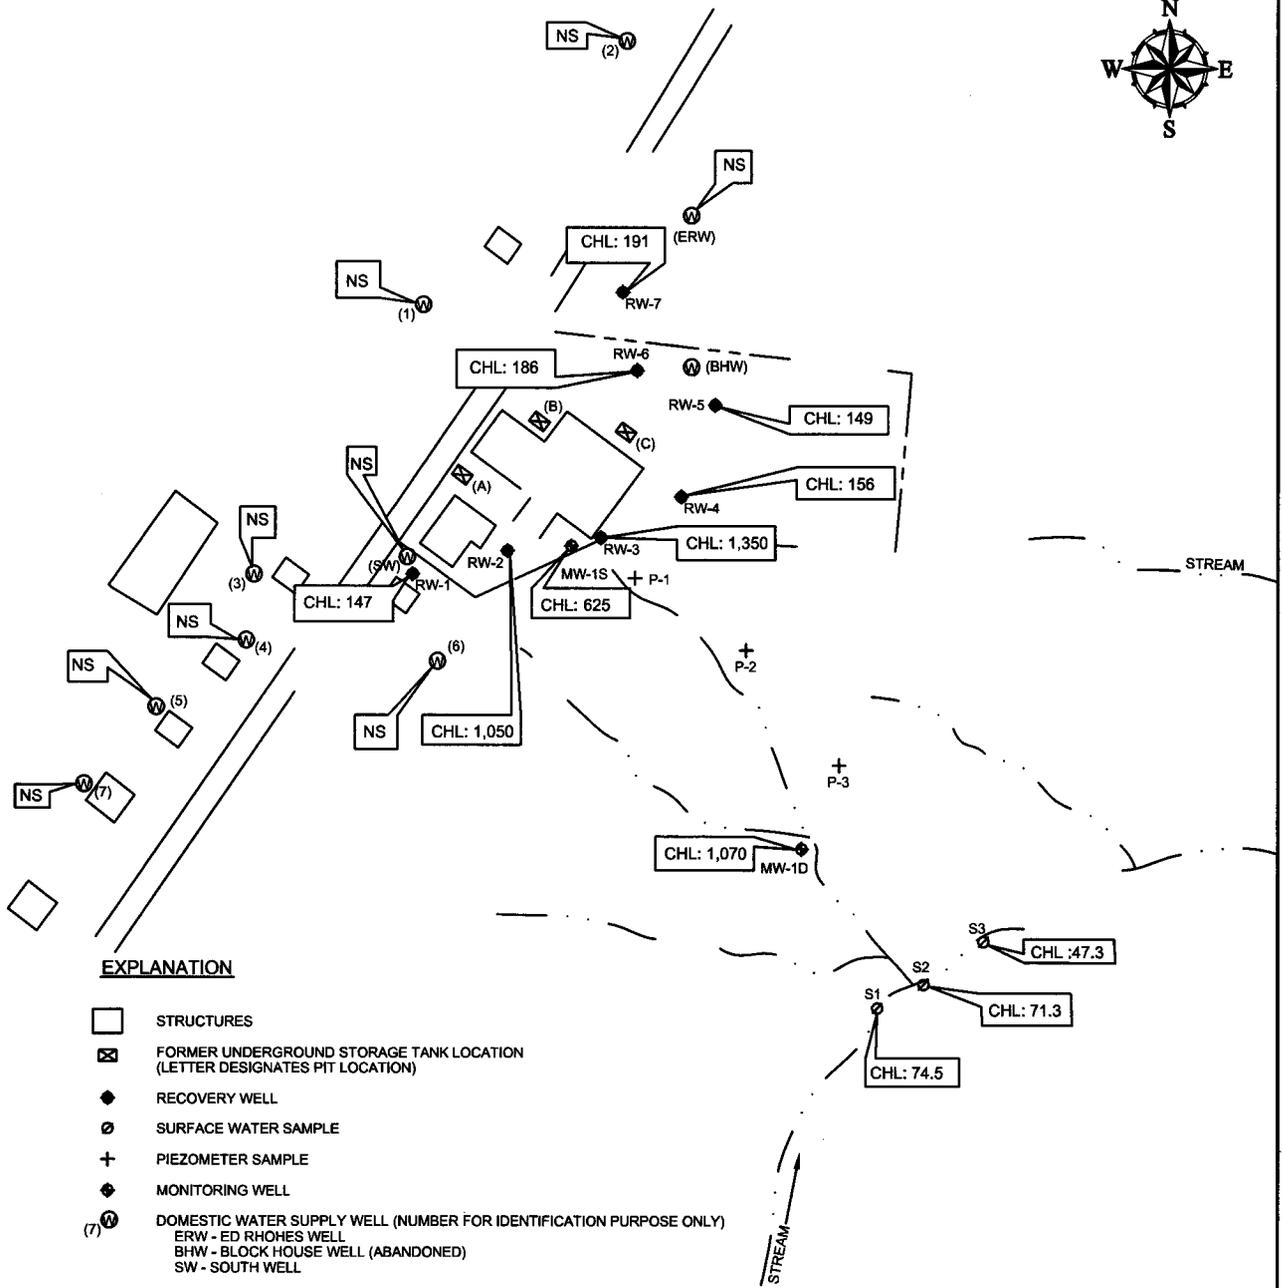
Based on the data collected during the January 2013 sampling event, chloride is concentrated in the area immediately behind (east-southeast of) the plant (MW-1S, RW-2, and RW-3) and along a line extending to the southeast toward the stream (MW-1D). A diffuse plume of chloride extends to the north, southwest, and west of the plant. Groundwater chloride results from the January 2013 sampling event are plotted on Figure 8.

Because the groundwater chloride concentrations are currently above the 2L standard of 250 mg/L, Alliance recommends continued annual monitoring of the site.

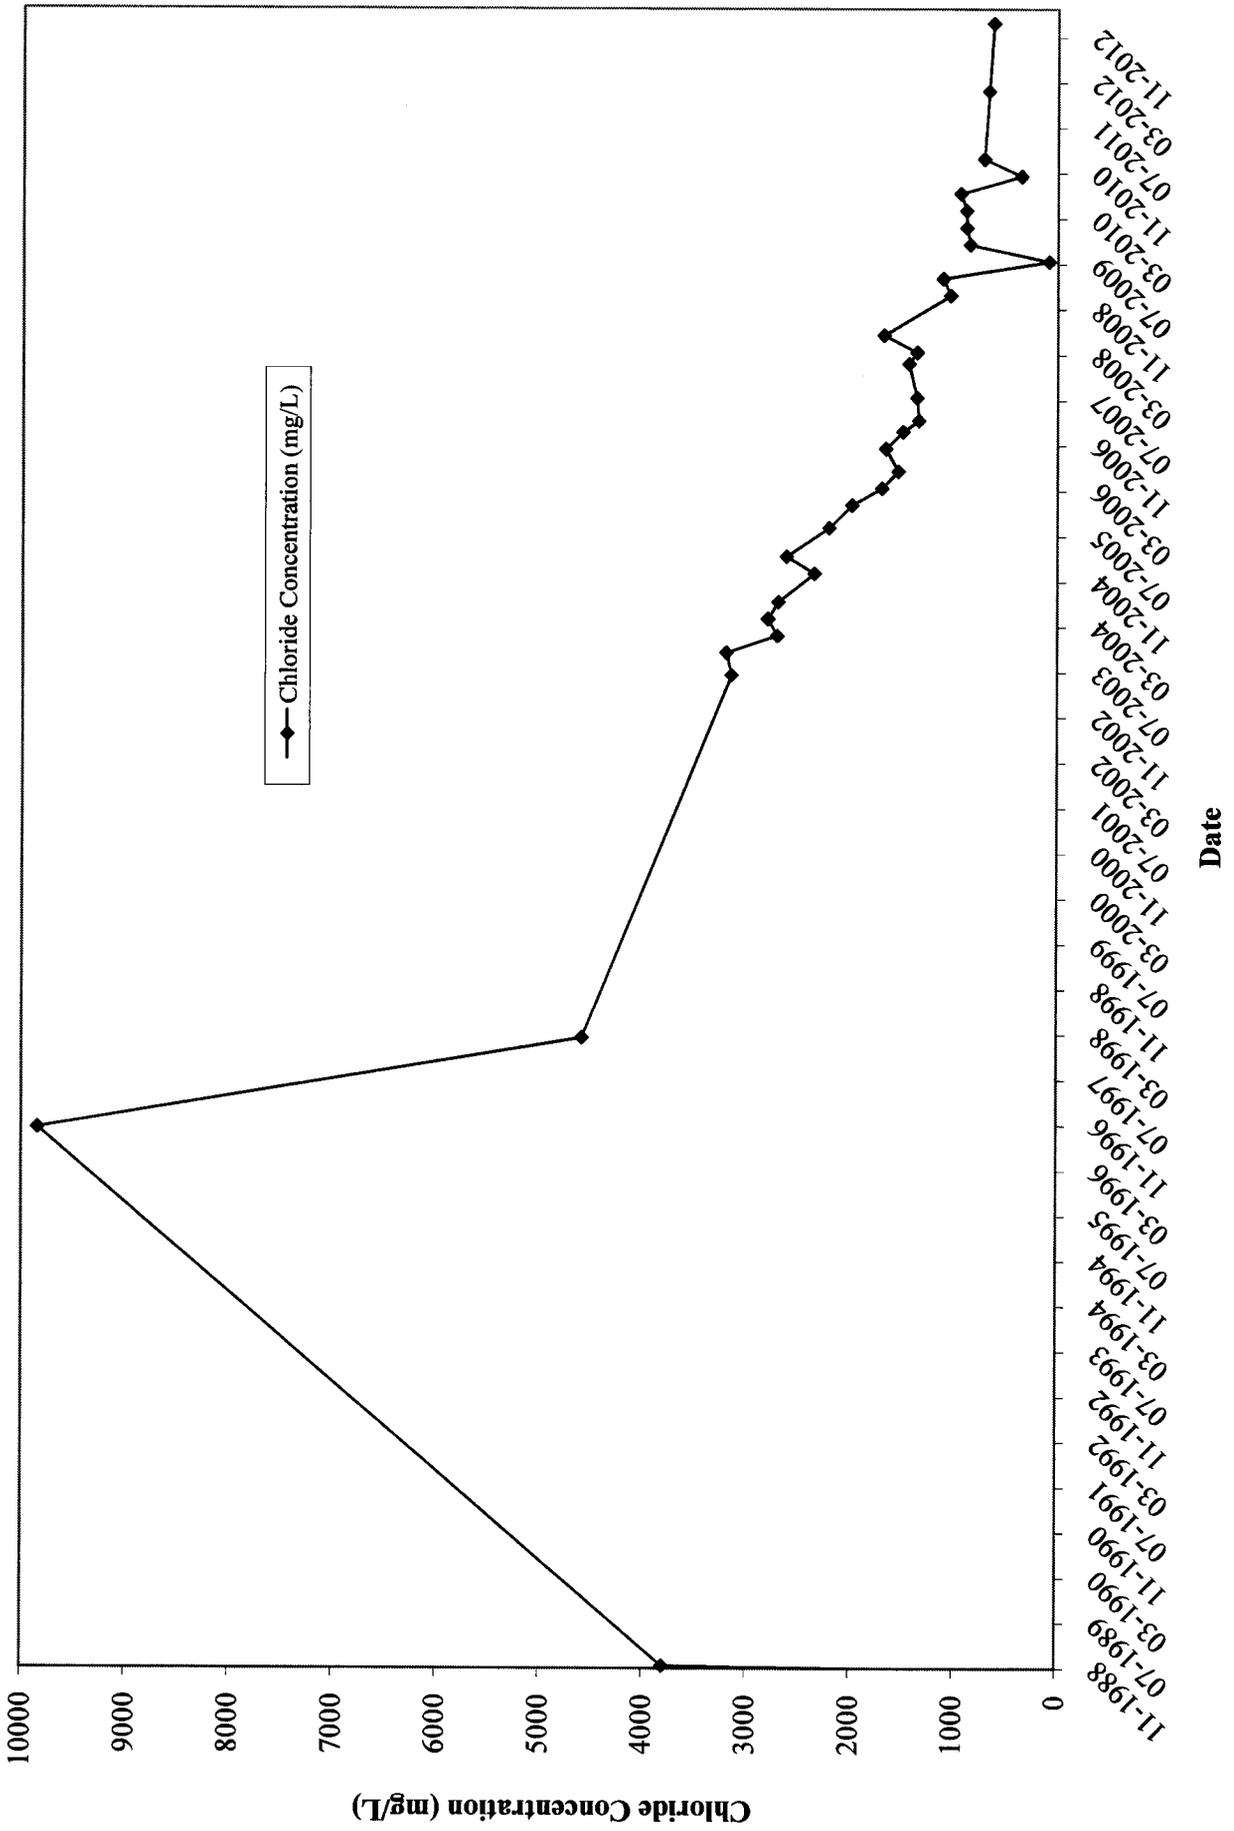
MW-1S Chloride Concentration Over Time

Chloride was detected in wells MW-1S (625 mg/L) and MW-1D (1,070 mg/L) above the State's 2L .0202 Standard of 250 mg/L. The laboratory results are summarized in Table 3 and the complete laboratory reports are included as Appendix A.

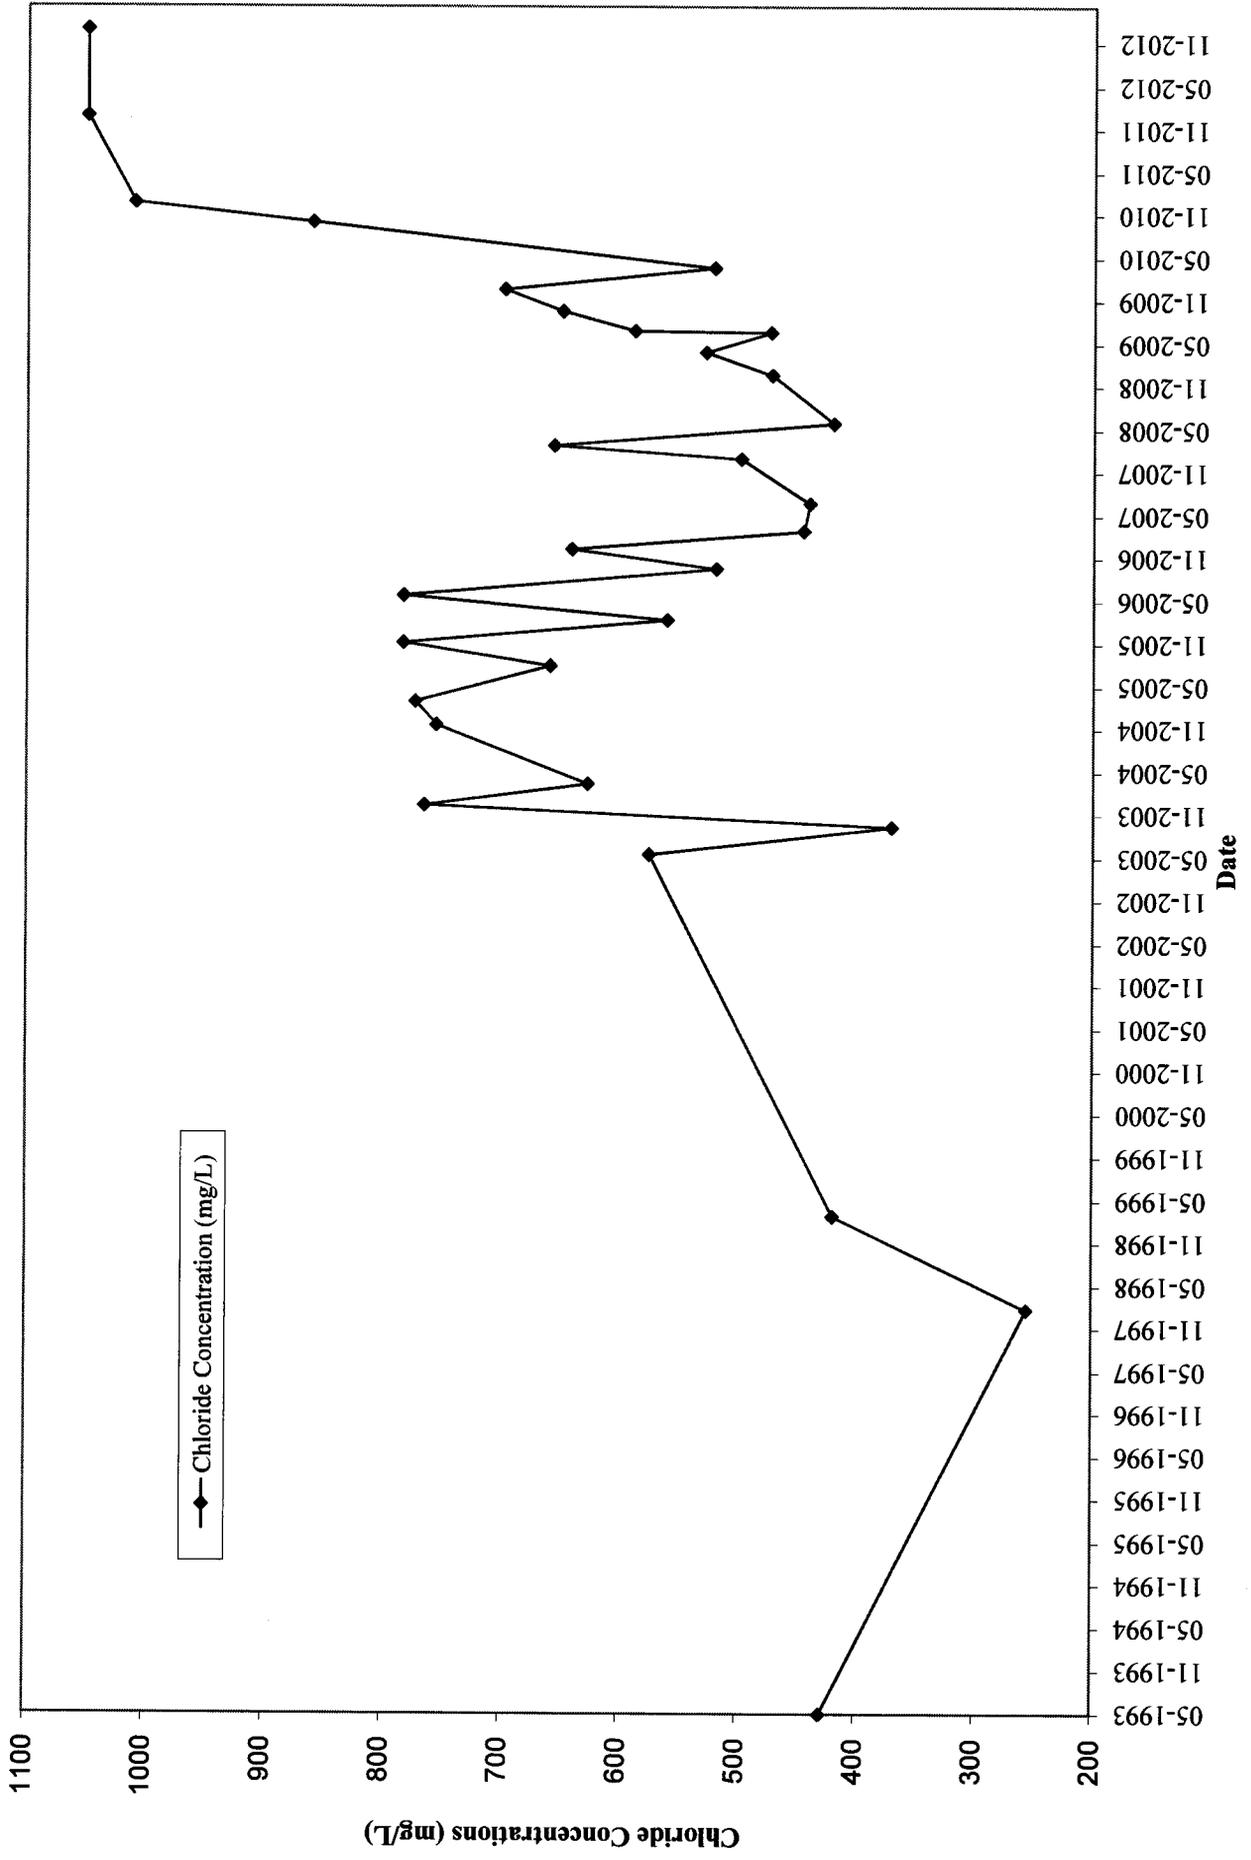
RW-2 Chloride Concentrations Over Time

Chloride was detected in recovery wells RW-2 (1,050 mg/L) and RW-3 (1,350 mg/L) above the State's 2L .0202 Standard of 250 mg/L. The laboratory results are summarized in Table 3 and the complete laboratory reports are included as Appendix A.
