Subject: Pre-CERCLIS Screening Assessment Report
Asheville Industries, Inc
20 Glenn Bridge Road, Arden, Buncombe County, NC 28704

The NC Superfund Section has completed a Pre-CERCLIS Screening Assessment of the above site. Based on findings of this assessment, the NC Superfund Section does not recommend listing this site on CERCLIS for further federal investigation.

TAX MAP
 Phase I Environmental Site Assessment
 ASHEVILLE INDUSTRIES, INC.

TEST PIT BORING LOCATION DIAGRAM

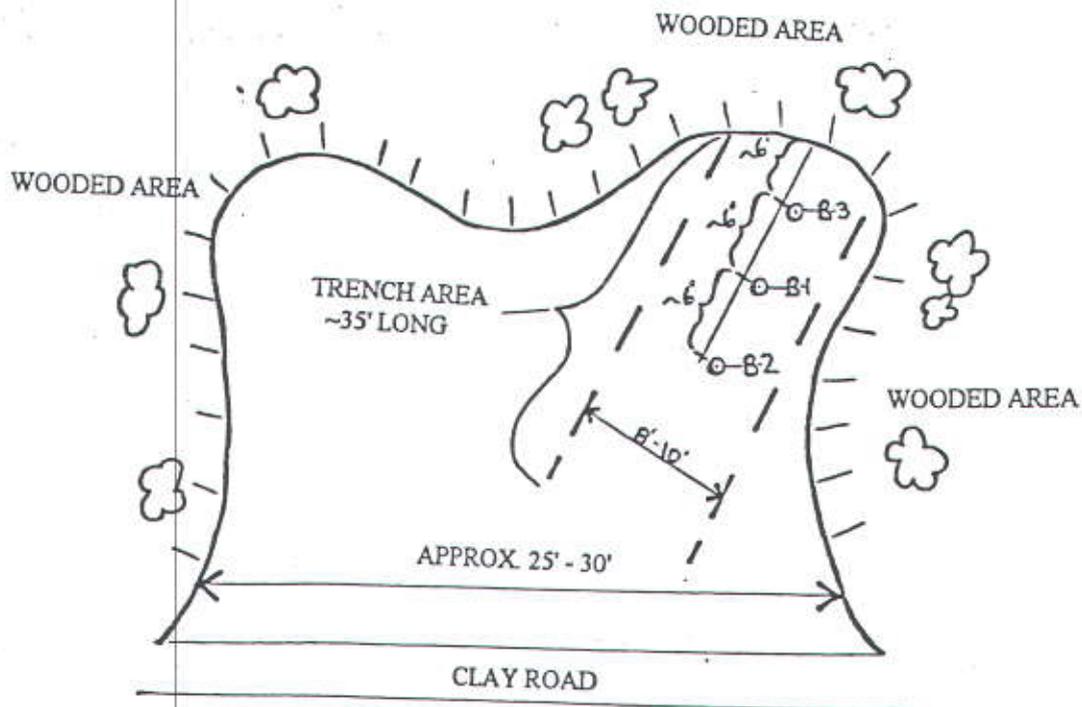
SCHEMATIC OF TRENCH CROSS SECTION

SITE MAP OF AII LANDFILL CLOSURE

BORING SITES MARKED 1-3 CORRELATE WITH SAMPLE IDENTIFICATION CODES FOUND ON THE FOLLOWING PAGES e.g., 1S05 INDICATES THIS SAMPLE WAS TAKEN FROM BORING 1 AT THE 5 FOOT LEVEL; 02S17 INDICATES THIS SAMPLE WAS TAKEN FROM BORING 2 AT THE 17 FOOT LEVEL; 1SC10 INDICATES THIS SAMPLE IS A COMPOSITE SAMPLE OF ALL 3 BORING SITES AT THE 10 FOOT LEVEL etc...

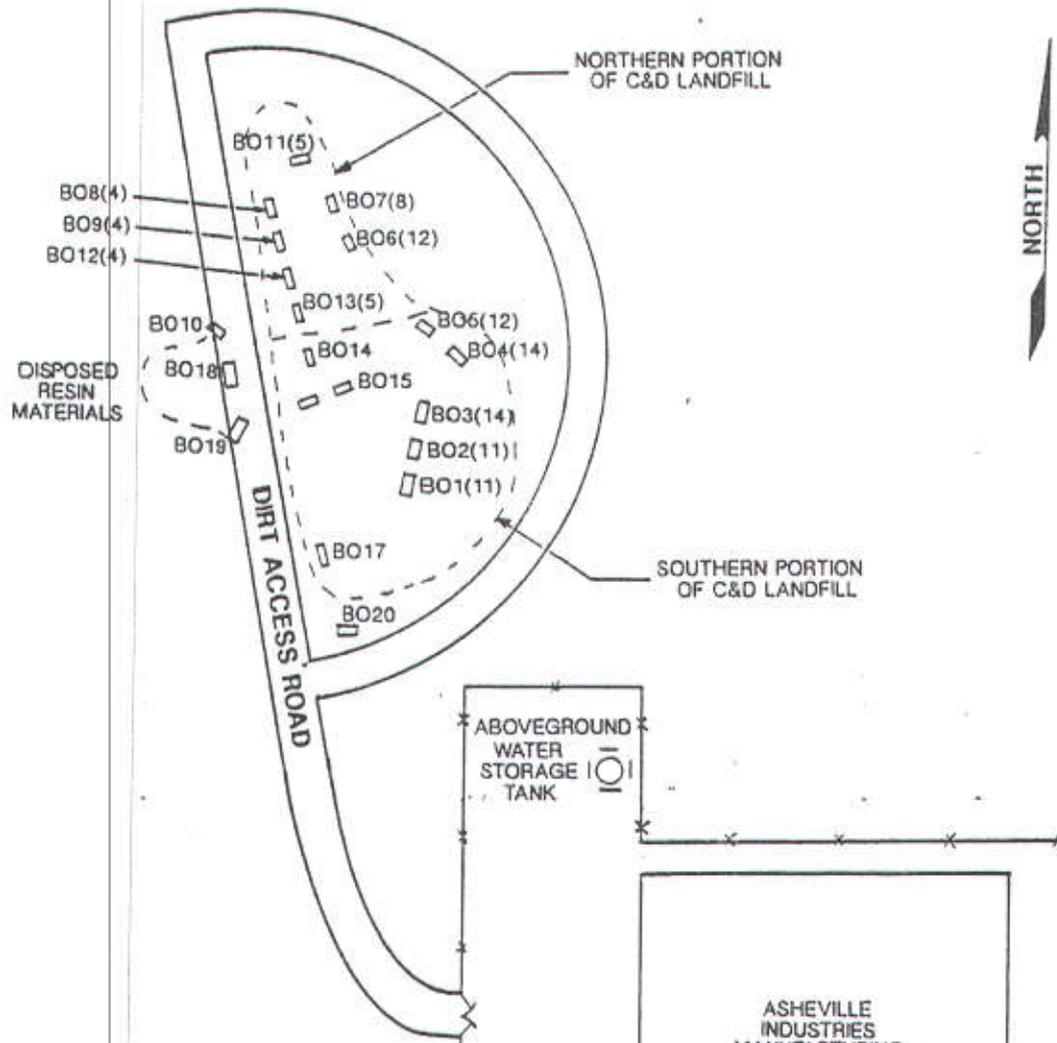
DRAWING NUMBER
254043-2

- - TEST PIT BORING
- - DISPOSAL AREA LIMITS
- BO1(11) BORING NO. (DEPTH TO RESIDUUM)
- BO10 BORING NO.

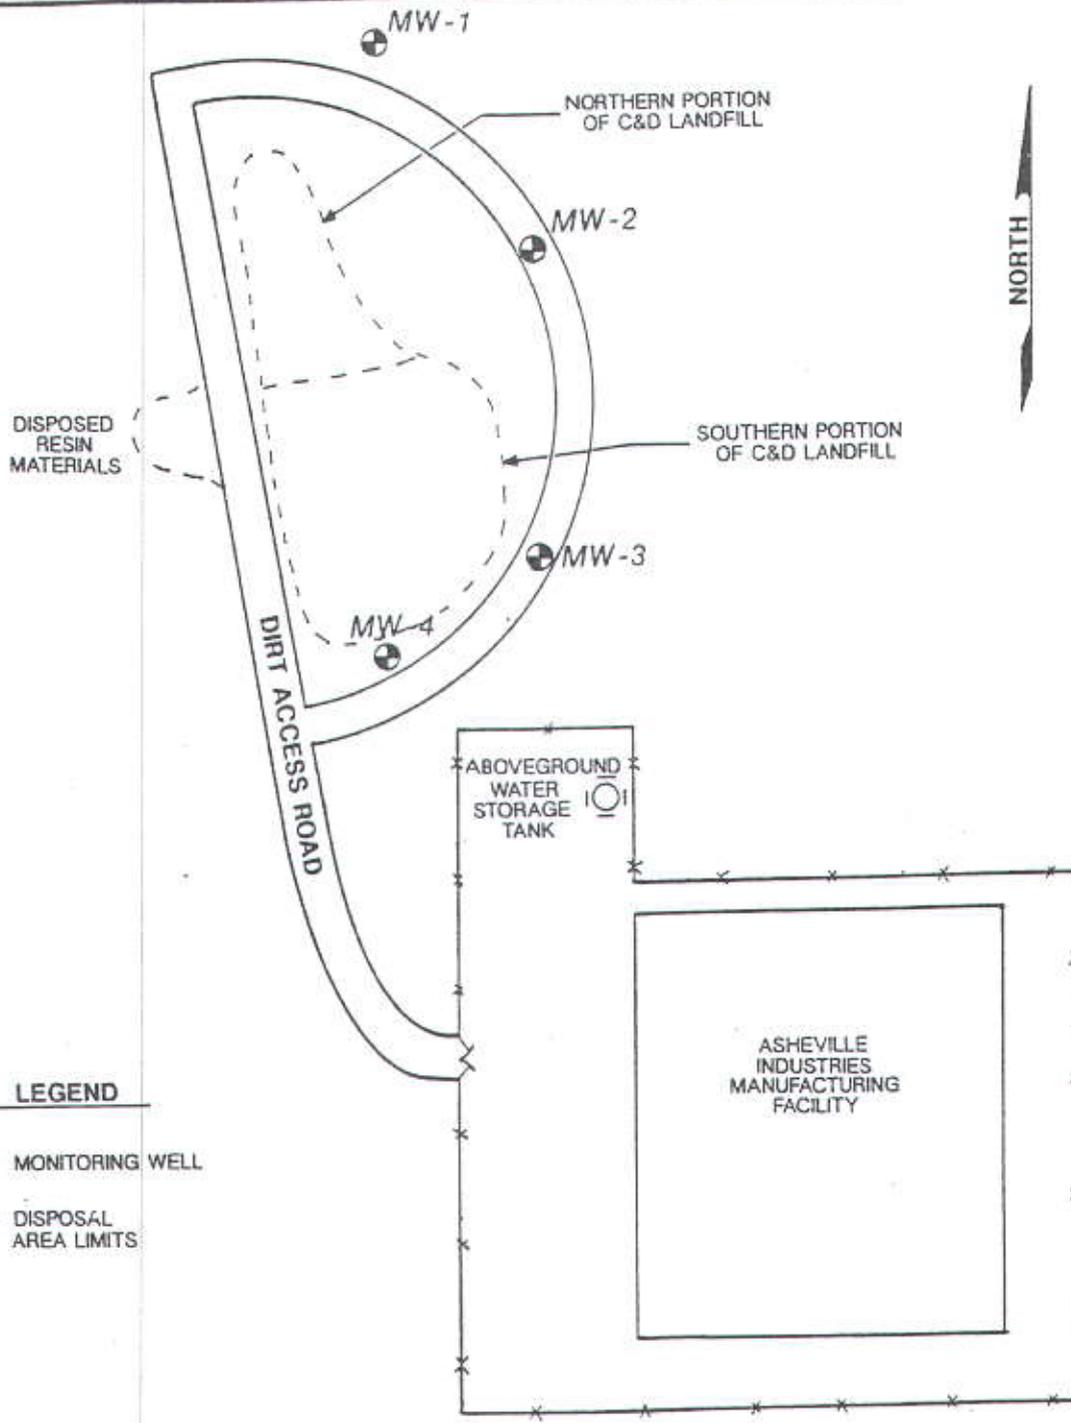
DRAWING NUMBER
254043-3

- ⊕ - MONITORING WELL
- DISPOSAL AREA LIMITS

Based on results of the laboratory analyses, impact of groundwater was suspected in the vicinity of monitoring well MW-1. The compounds 1,1,1-trichloroethane (TCA) and 1,1-dichloroethane (DCA) were reported in the groundwater sample obtained from this well; however, their concentrations did not exceed the North Carolina groundwater standards of 200 parts per billion (ppb) and 700 ppb, respectively. A subsequent resampling and analysis of the four monitoring wells failed to detect either 1,1,1-TCA or 1,1-DCA in MW-1; however, 40 ppb of 1,1,1-trichloroethane was reported in MW-3.

TCA and DCA concentrations of less than 100 parts per billion in groundwater are substantially less than the North Carolina 2L Standards. In addition, concentrations of less than 100 parts per billion approach the lower detection limits of 1 part per billion for both TCA and DCA for their test methodology. Reported concentrations within one order of magnitude of their detection limit cannot be established as significant without additional sampling data. Based upon North Carolina's groundwater standards, no further action is recommended with regard to the groundwater investigation.

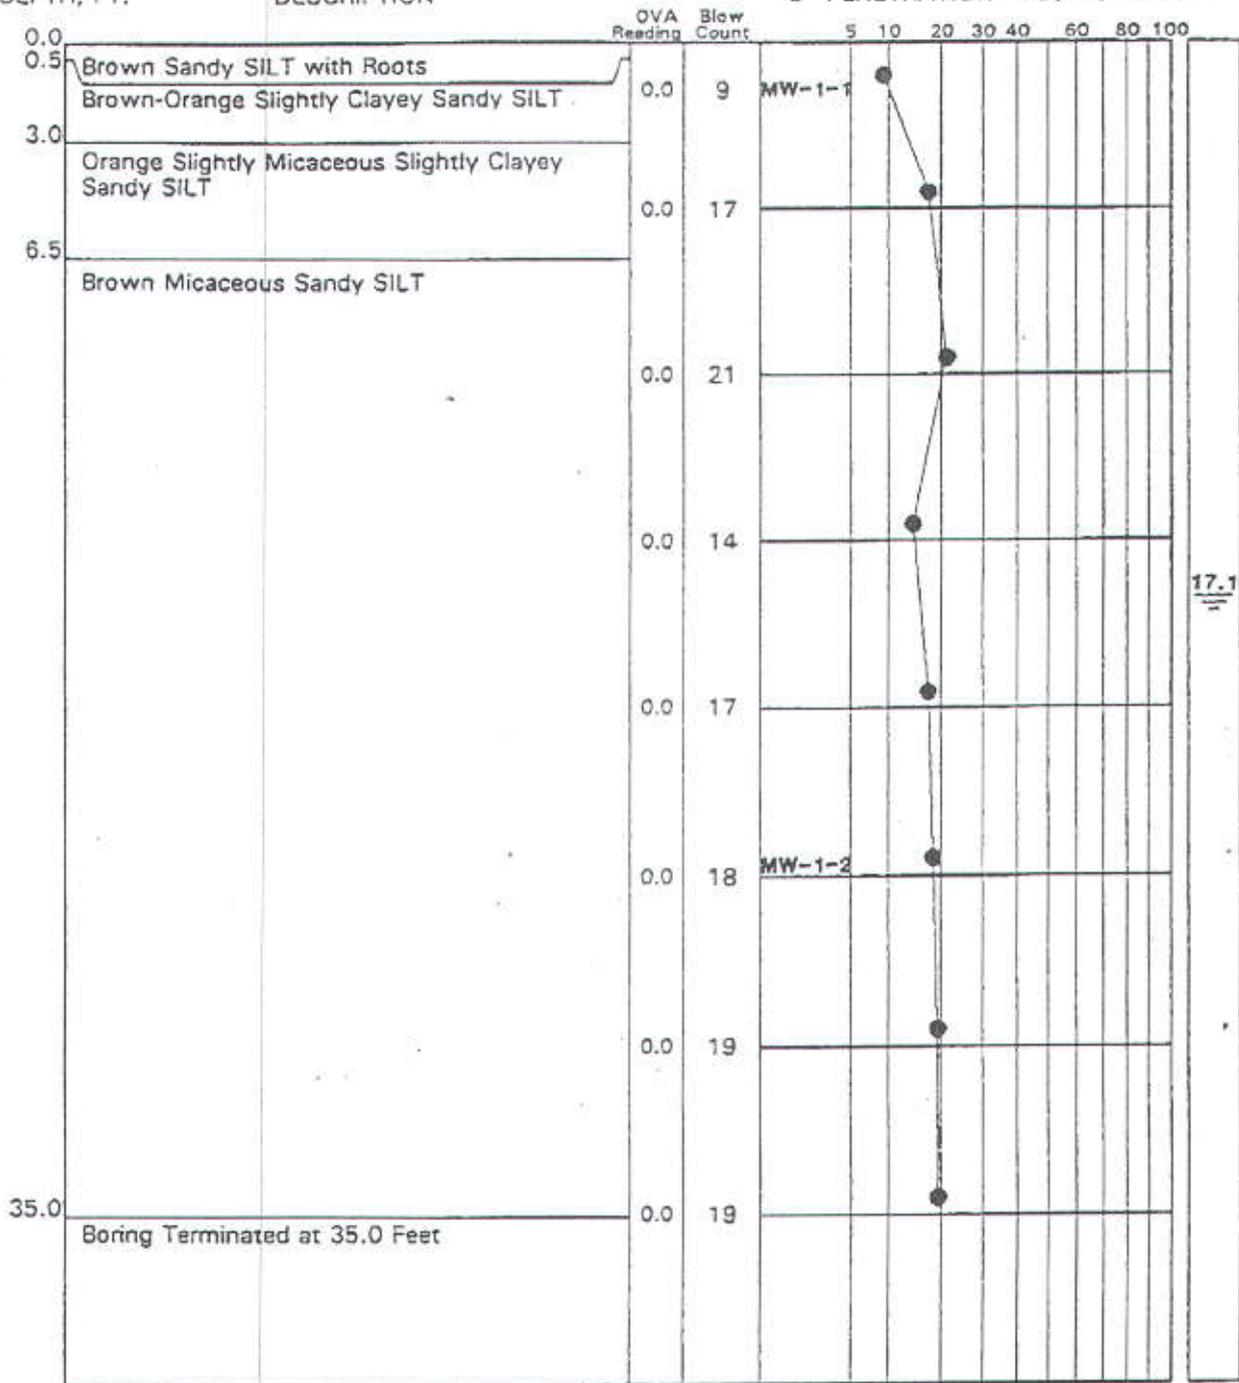
BORING NO. MW-1
 DATE DRILLED 05/17/94
 JOB NO. 025-94-043
 PAGE 1 of 1

TEST BORING RECORD

BORING AND SAMPLING MEETS ASTM D-1586
 CORE DRILLING MEETS ASTM D-2113

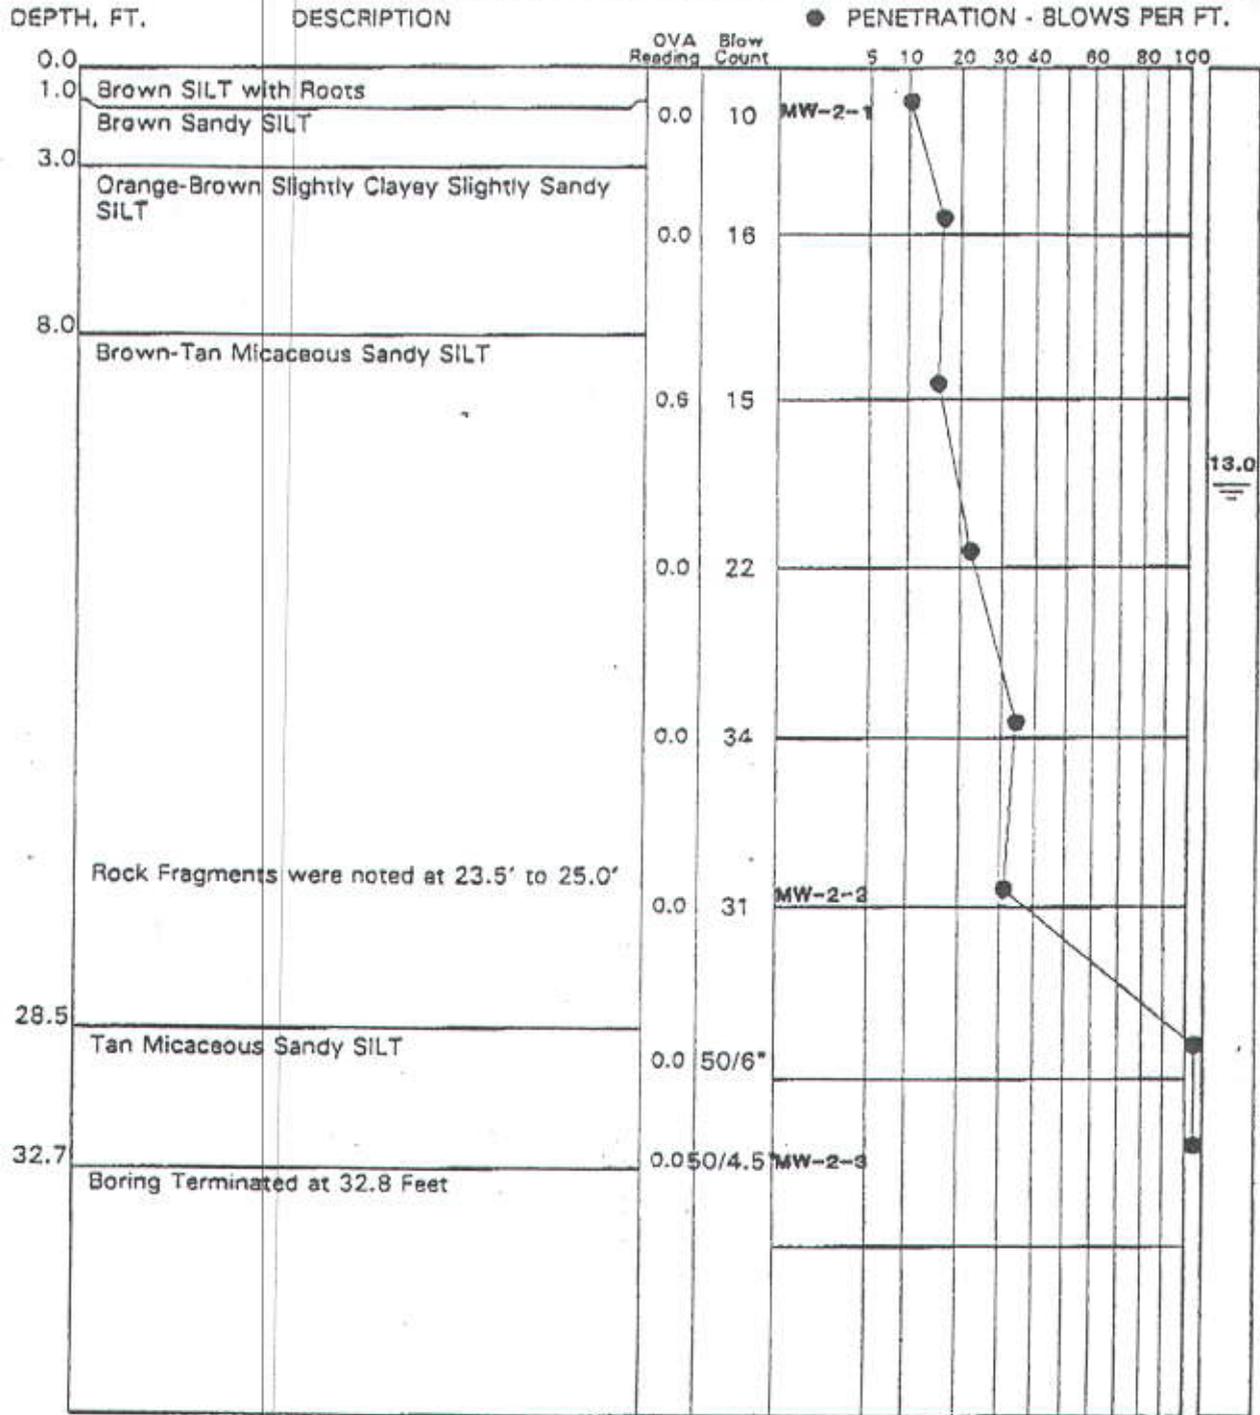
BORING NO. MW-2
 DATE DRILLED 05/18/94
 JOB NO. 025-94-043
 PAGE 1 of 1

TEST BORING RECORD

BORING AND SAMPLING MEETS ASTM D-1586
 CORE DRILLING MEETS ASTM D-2113

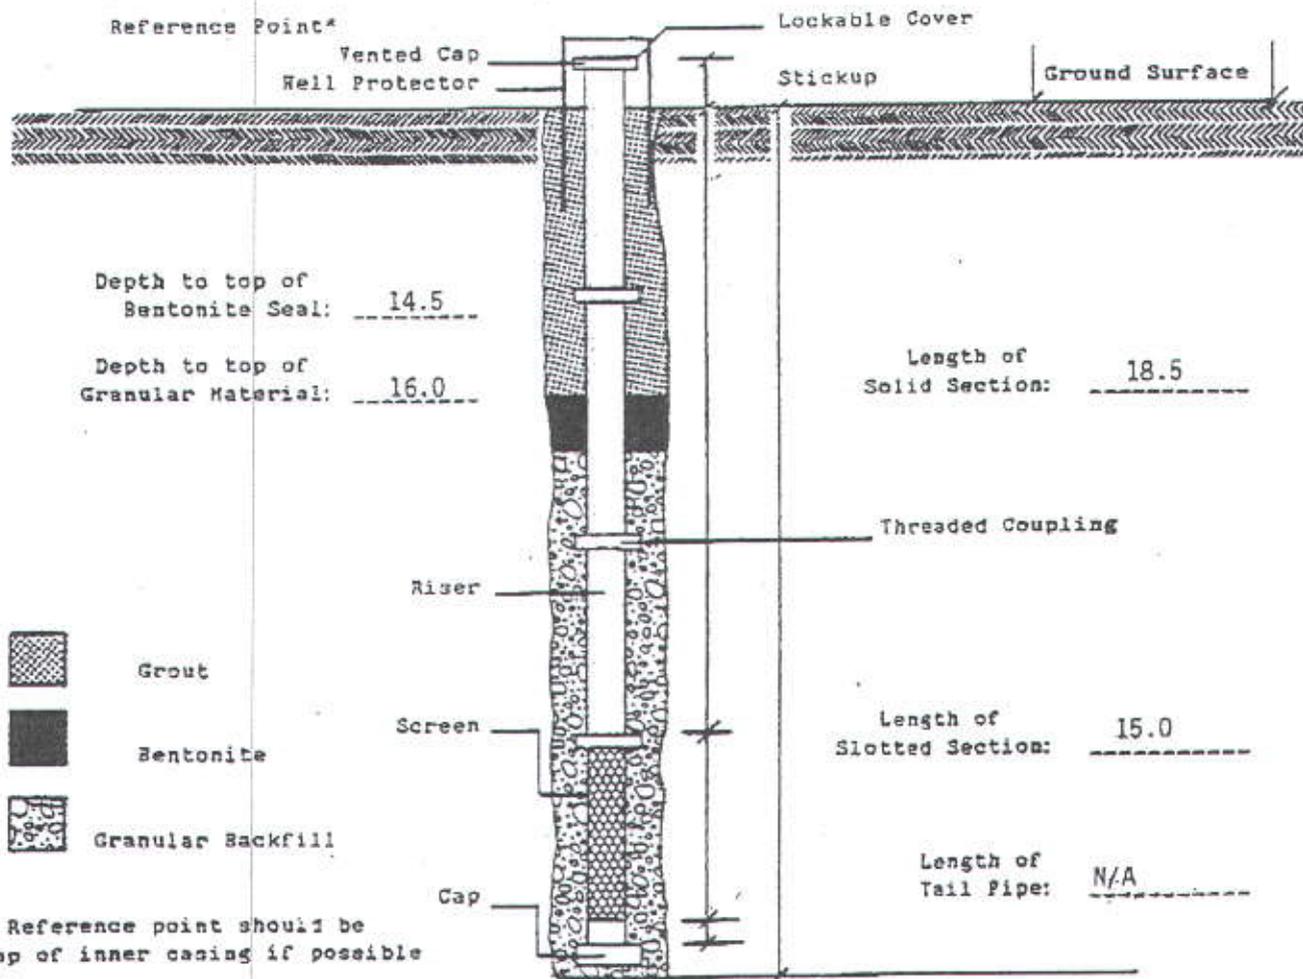
Ground Surface Elevation: ---- Well Number: MW-1
 Total Depth of Well: 31.5 Date Installed: 5-17-94
 Granular Backfill Material: Fine Filter Sand Slot Size: 0.01"
 Screen Material: PVC Screen Diameter: 2"
 Riser Material: PVC Riser Diameter: 2"
 Drilling Technique: HSA Driller: Brian King
 Borehole Diameter: 5 1/4" Lock Data: Master
 Key Code/Combination: 3297
 Stabilized Water Level: 17.1 feet below ground surface. Measured on: 5-19-94

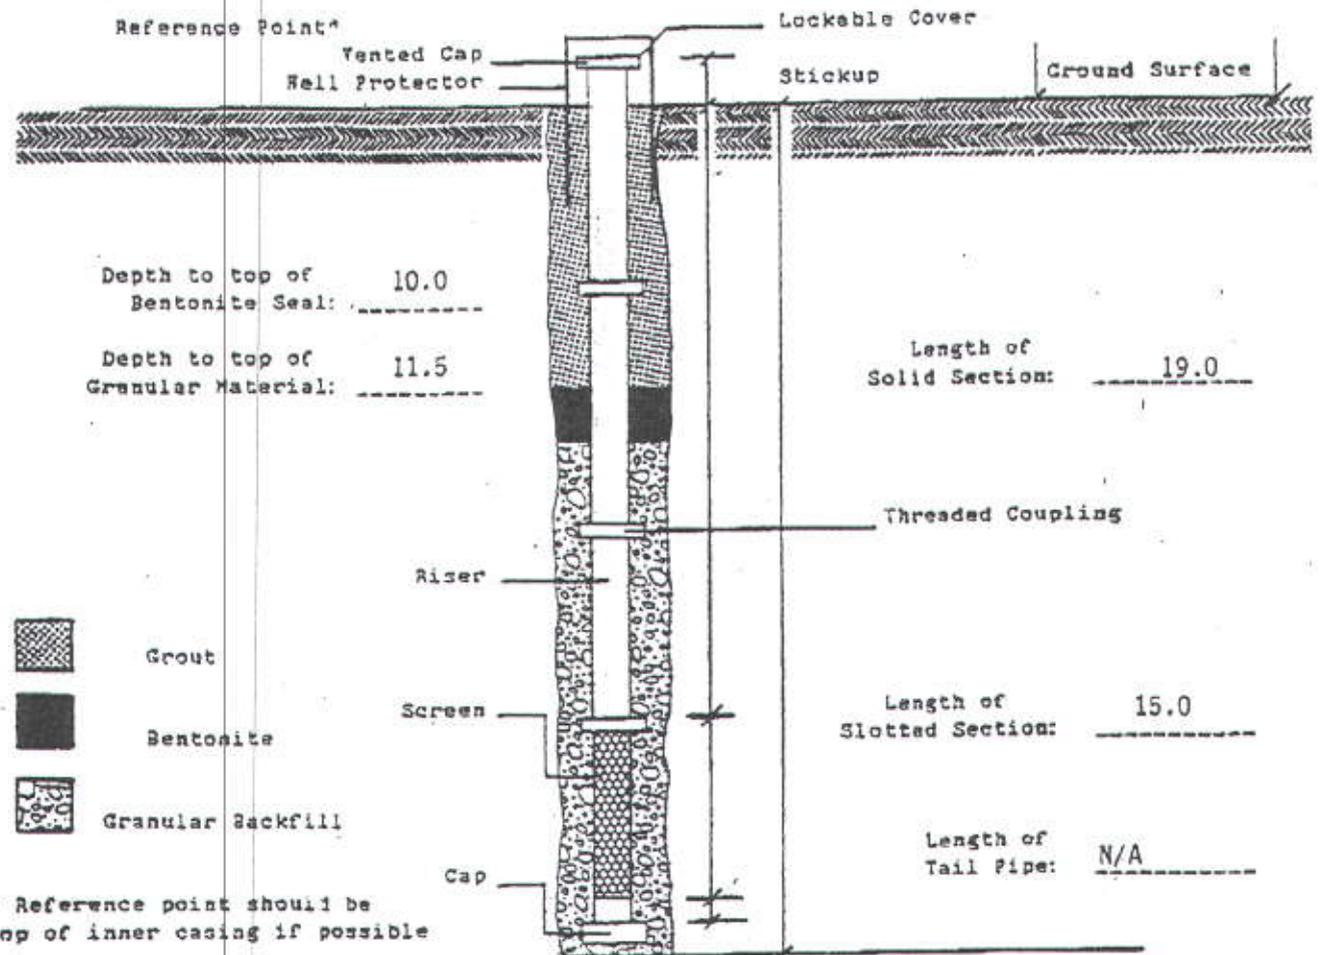
Ground Surface Elevation: ----
 Total Depth of Well: 32.0
 Granular Backfill Material: Fine Filter Sand
 Screen Material: PVC
 Riser Material: PVC
 Drilling Technique: HSA
 Borehole Diameter: 6 1/4"
 Key Code/Combination: 3247
 Stabilized Water Level: 13.0 feet below ground surface. Measured on: 5-19-94

Well Number: MW-2
 Date Installed: 5-18-94
 Slot Size: 0.01"
 Screen Diameter: 2"
 Riser Diameter: 2"
 Driller: Brian King
 Lock Data: Master

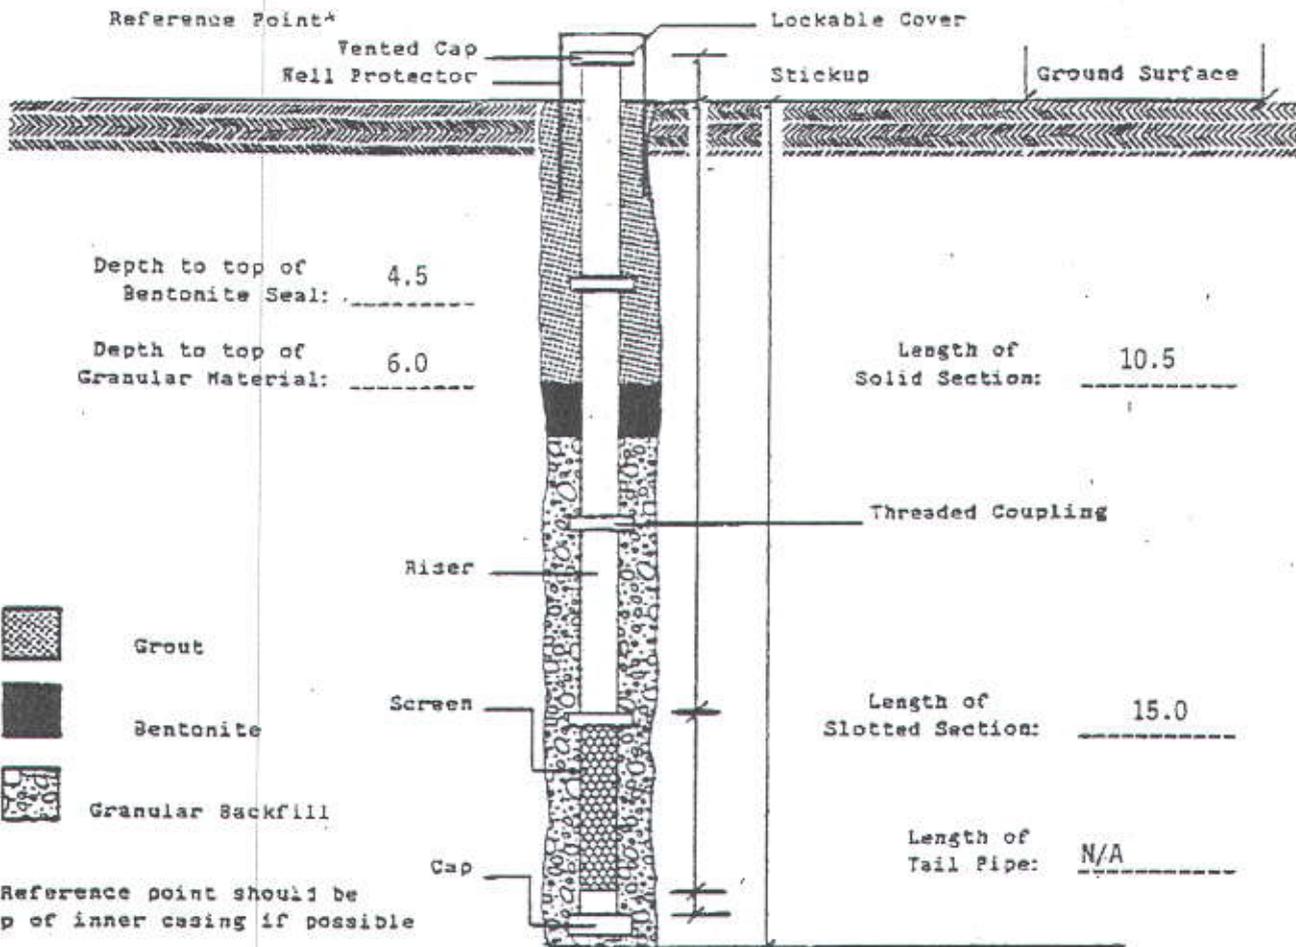
Ground Surface Elevation: -----
 Total Depth of Well: 23.8
 Granular Backfill Material: Fine Filter Sand
 Screen Material: PVC
 Riser Material: PVC
 Drilling Technique: HSA
 Borehole Diameter: 6 1/4"
 Key Code/Combination: 3247
 Stabilized Water Level: 10.5 feet below ground surface. Measured on: 5-19-94

Well Number: MW-3
 Date Installed: 5-18-94
 Slot Size: 0.01"
 Screen Diameter: 2"
 Riser Diameter: 2"
 Driller: Brian King
 Lock Data: Master

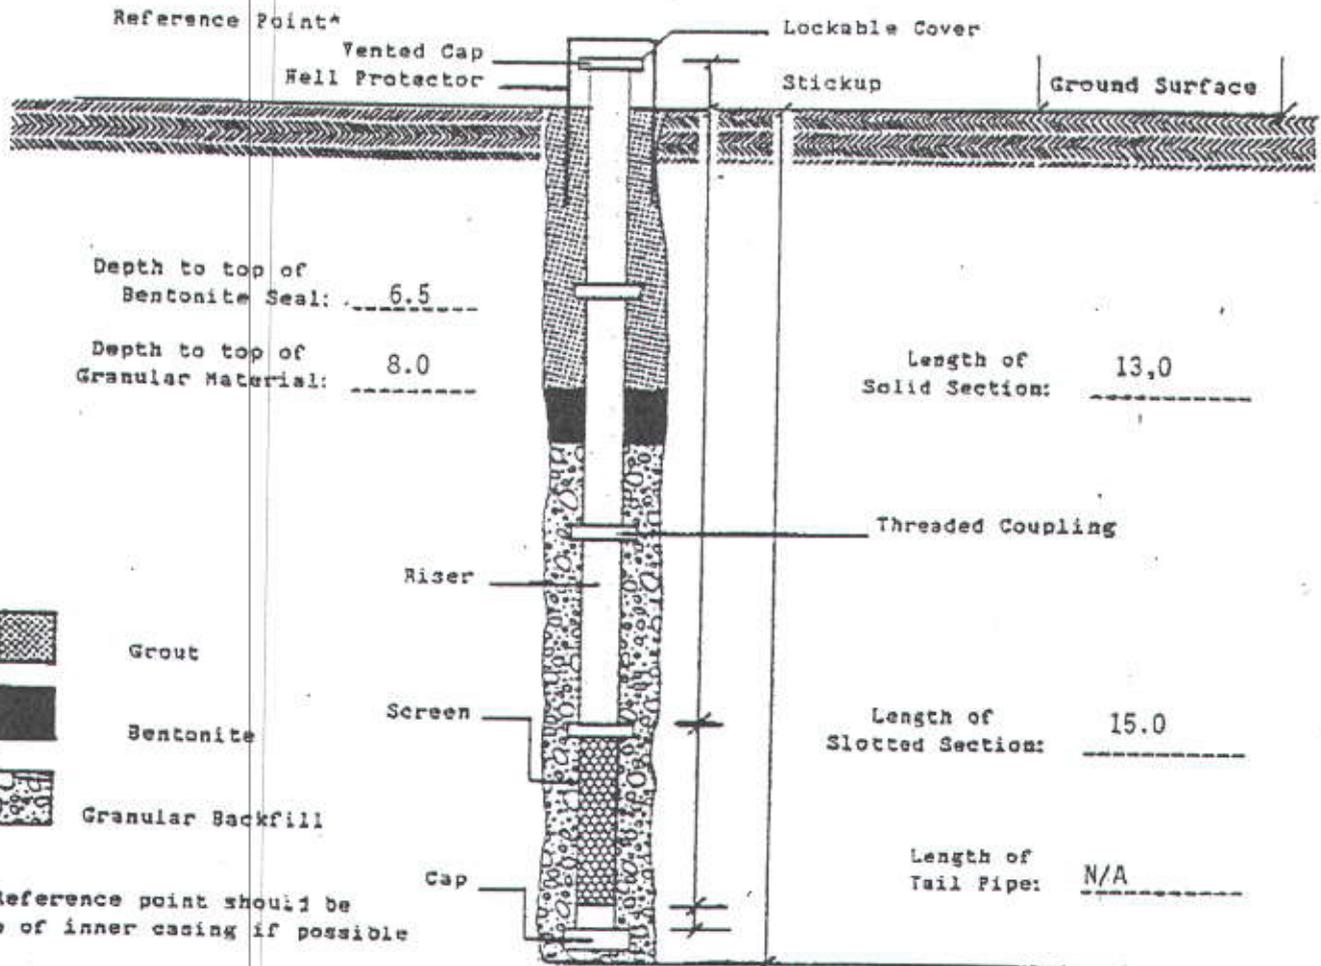
Ground Surface Elevation: -----
 Total Depth of Well: 25.5
 Granular Backfill Material: Fine Filter Sand
 Screen Material: PVC
 Riser Material: PVC
 Drilling Technique: HSA
 Borehole Diameter: 6 1/4"
 Key Code/Combination: 3247
 Stabilized Water Level: 18.5 feet below ground surface. Measured on: 5-18-94

Well Number: MW-4
 Date Installed: 5-18-94
 Slot Size: 0.01"
 Screen Diameter: 2"
 Riser Diameter: 2"
 Driller: Brian King
 Lock Data: Master
