North Carolina Department of Environment and Natural Resources
Division of Waste Management

Subject: Expanded Pre-CERCLIS Screening Assessment (EPSA)
Sheet Metal Restoration
Asheville, Buncombe County, NC

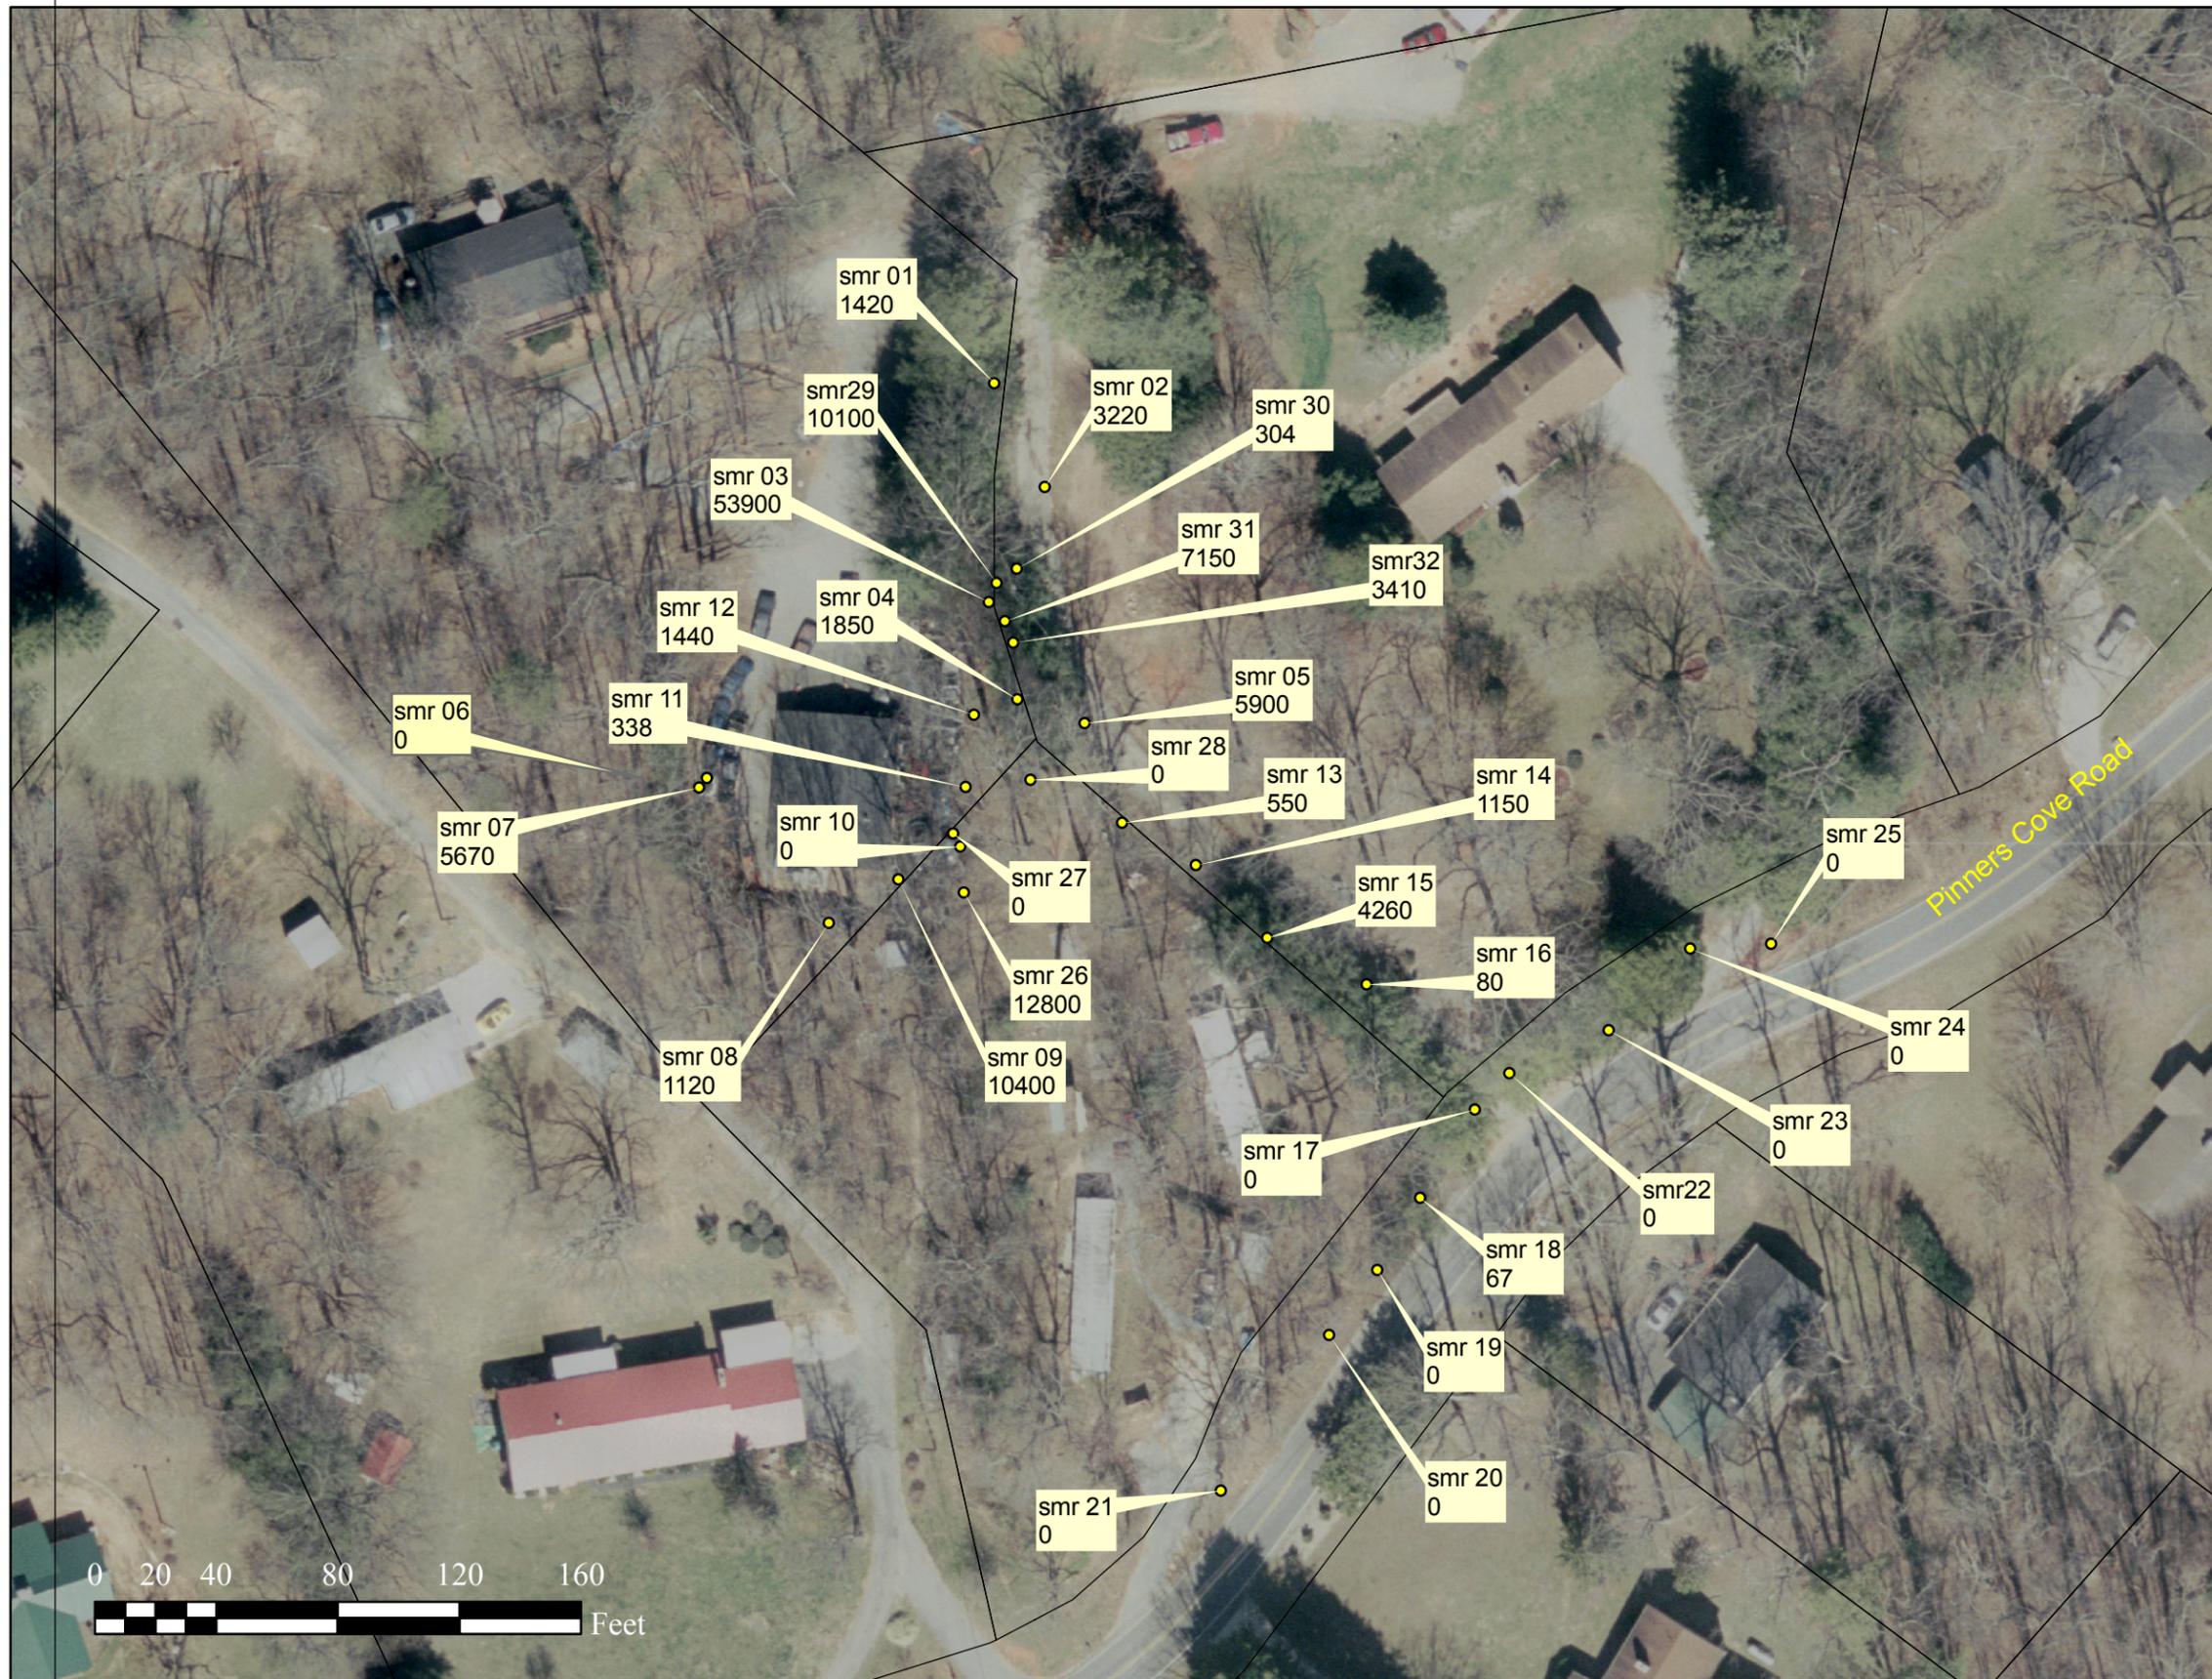
During the week of November 8, 2010, Harry Zinn and Kay Dechant of NC DENR collected soil vapor readings from 32 locations around the SMR property. Soil vapor screening locations are shown on Figure 1. Nine readings (SMR 01-05 and SMR 13-16) were placed along the driveway between 60 and 68 Pinner's Cove Road. Seven readings (SMR 06-12) were located around the SMR buildings themselves. Nine readings (SMR 17-25) were along Pinner's Cove Road and seven readings (SMR 26-32) were at special points of interest. A 5/8 inch diameter shaft with a dedicated point was driven by a Bosch hammer drill to a depth of 9 feet or to refusal. Holes were 6 feet or deeper, except those near the west side of the main building on the SMR property and those immediately downhill, which were 4 feet or less. Sample depths are noted in Table 1.

Vapor Screening values are shown in Figure 1 and in Table 1. Low level readings taken in the vicinity of the SMR facilities could be explained by the presence of petroleum hydrocarbons related to the number of vehicles parked in this area and the amount of auto parts found all around the area. SMR 07 had a slightly higher reading but is located in close proximity to the diesel storage tank. The low levels found along the driveway may be attributable to vehicle traffic on the driveway since these locations were within the drainage pathway along the driveway. The locations along Pinners Cove Road were uphill and across the road from the drainage pathway parallel to that road, and this may be a reason these readings were consistently lower than elsewhere.

Locations are approximated on Figure 1. Locations were approximated on Arcmap and the coordinates were referenced from the digital aerial photos supplied by NC OneMap for Buncombe County. No field gps data is available for these locations

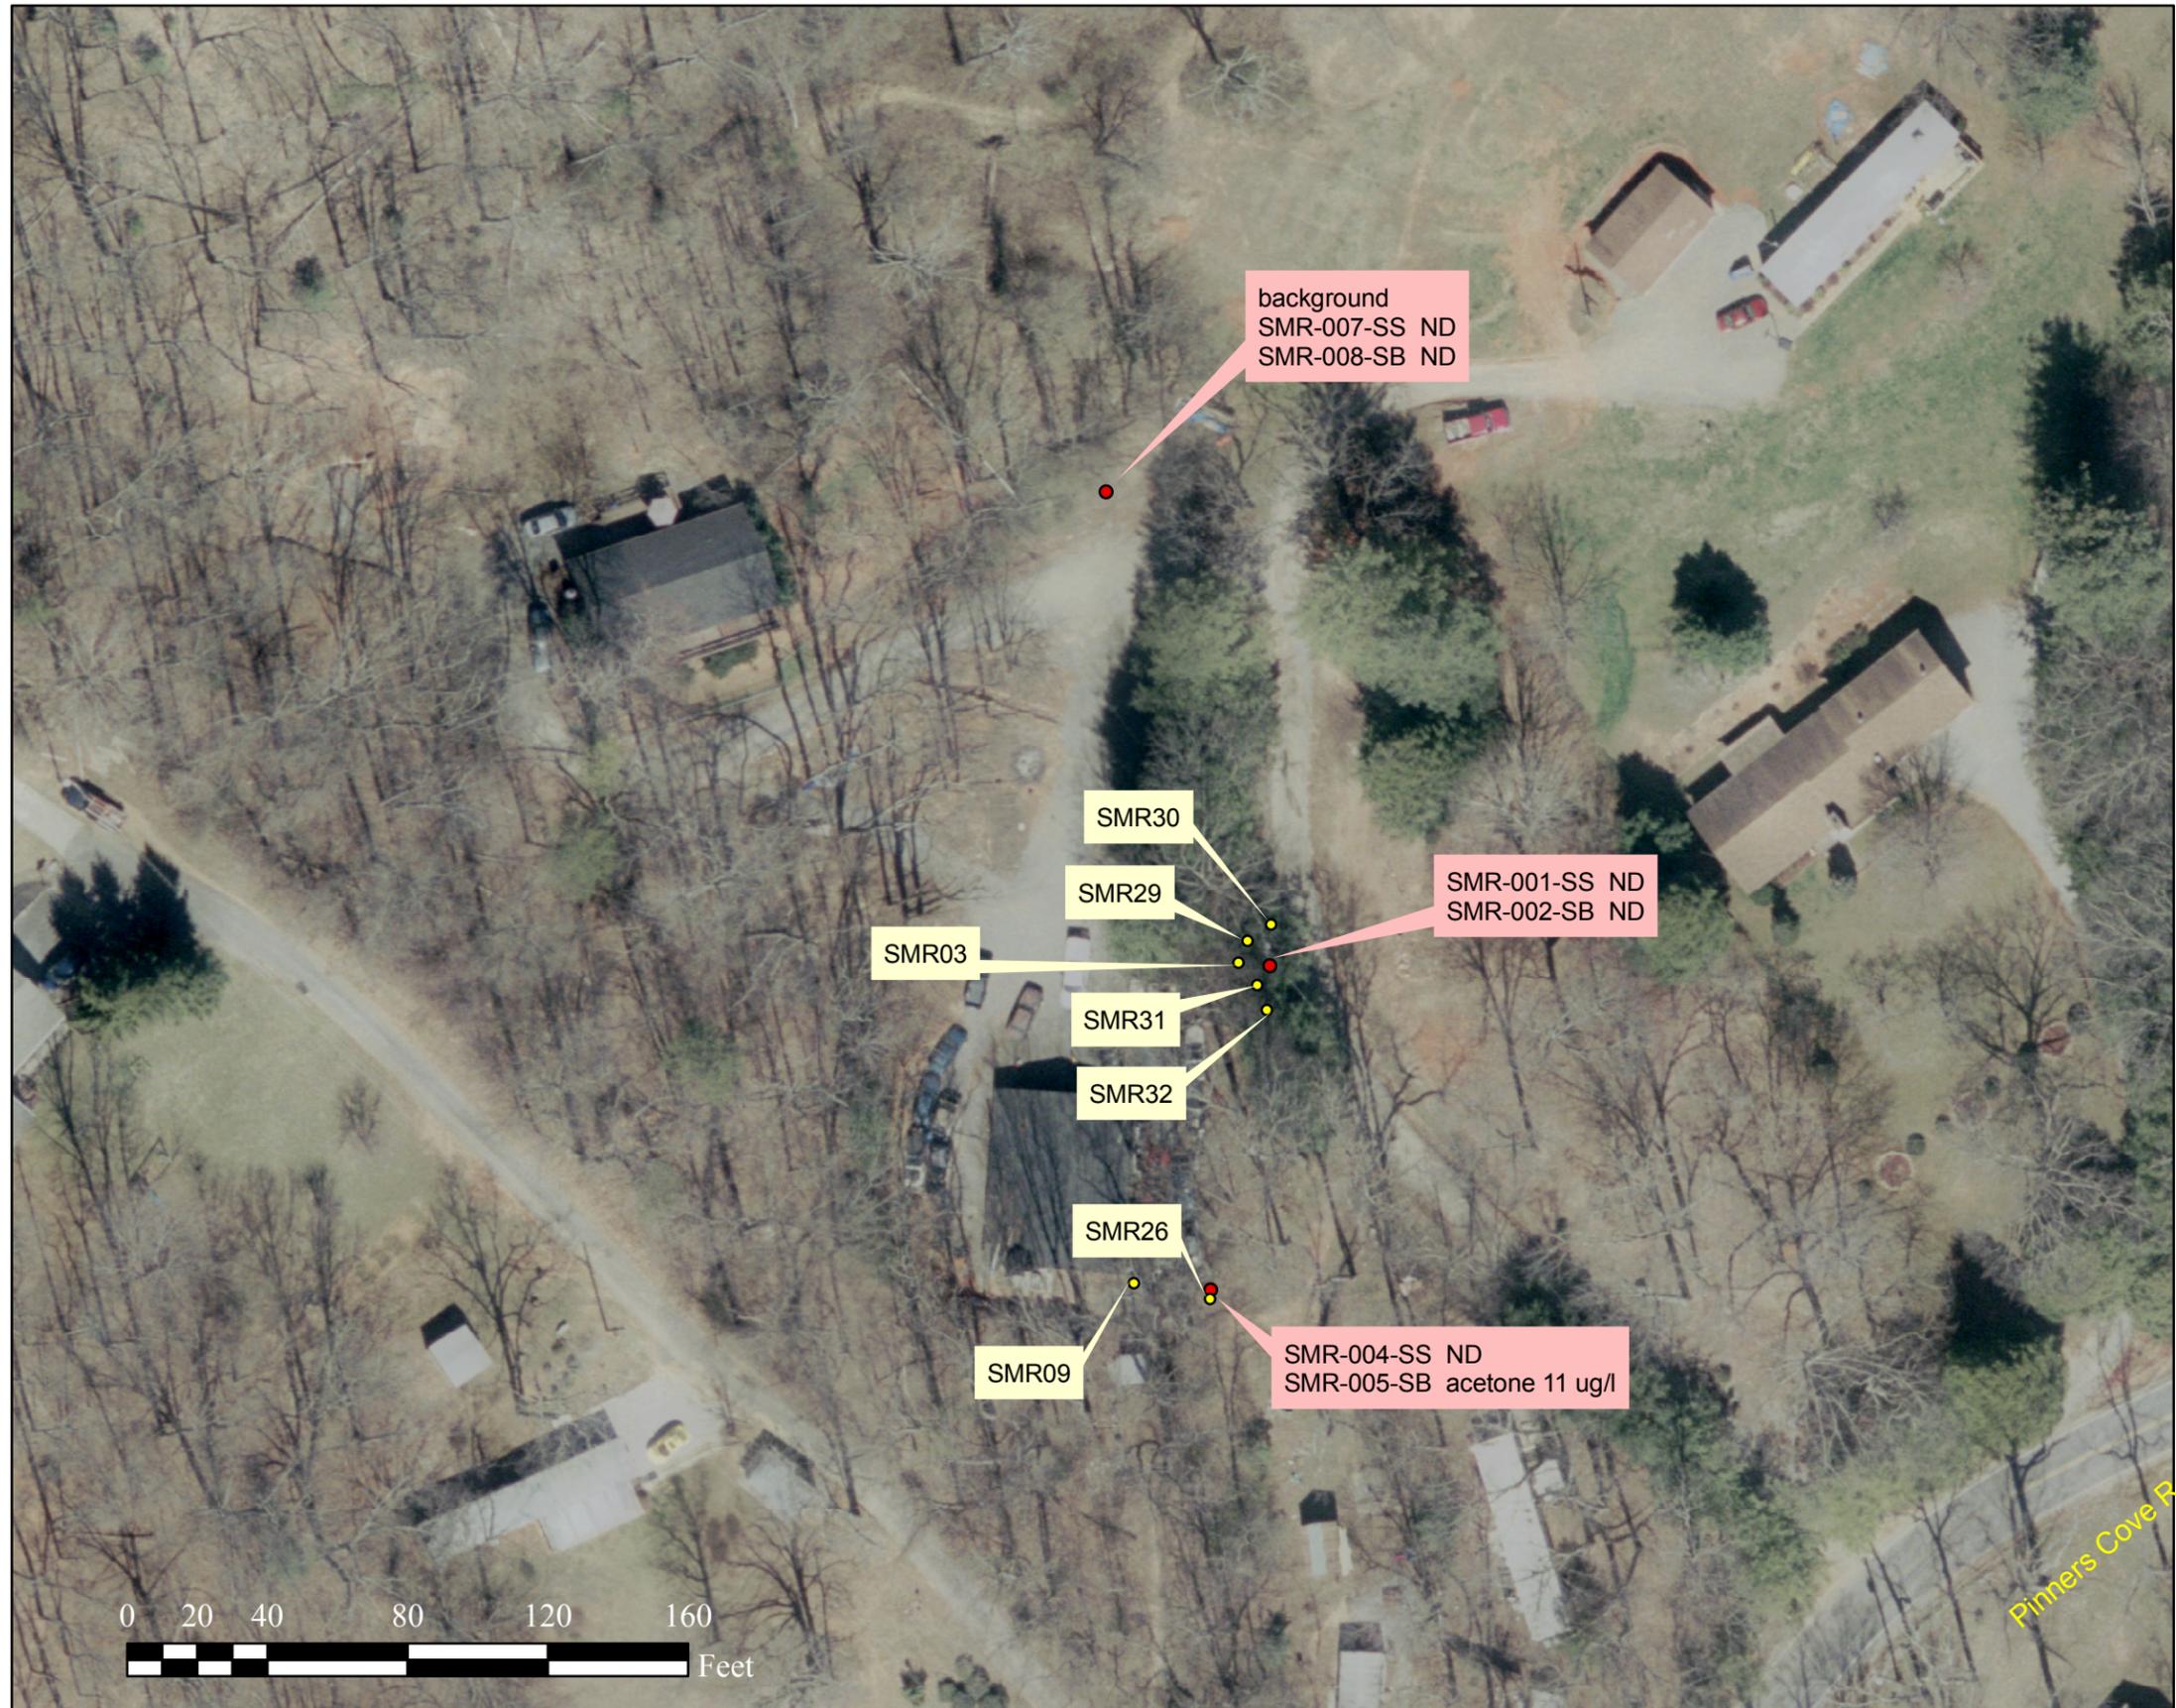
**Soil Sample Locations
Phase 2**

After the auger was changed, the hole was continued to 4 foot depth with no PID detections. SMR-002 SB was collected from 3.5 to 4 foot depth. After the auger was changed the hole was continued to 7.5 foot depth where auger refusal was encountered. Since no PID detections were found SMR-003 SB was collected from 7 to 7.5 foot depth.

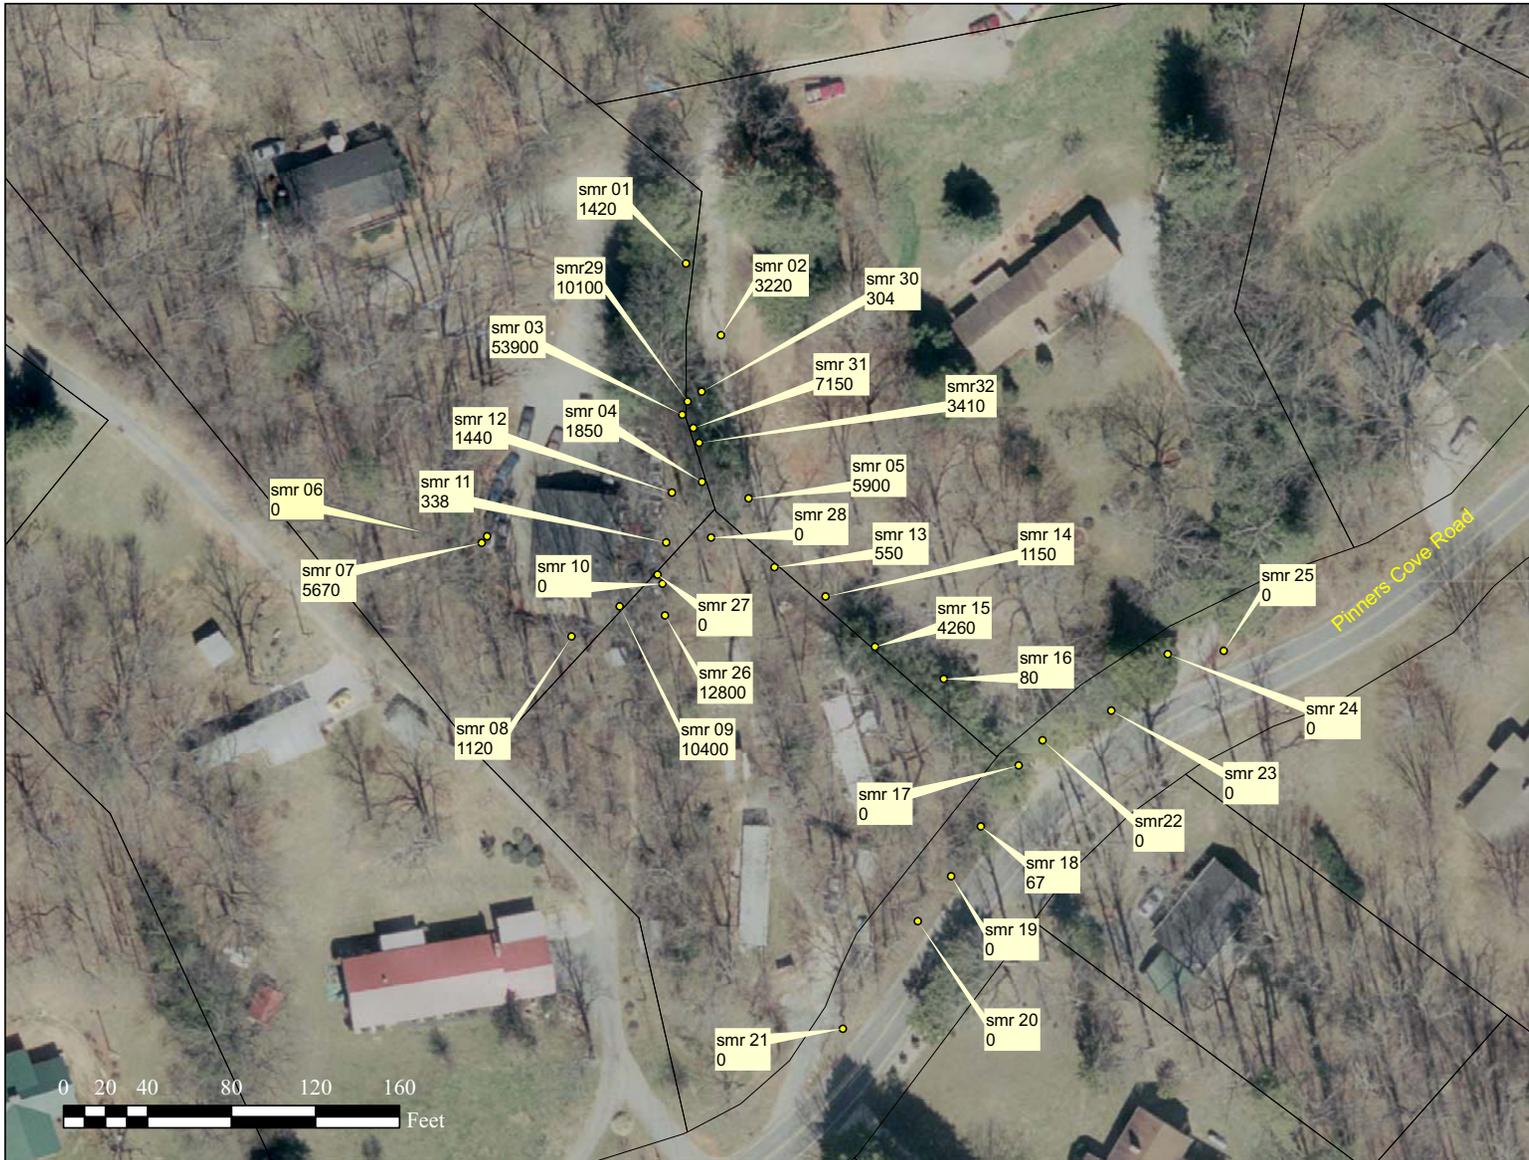
Sheet Metal Restoration
Soil Vapor Sampling 11/2010

Low level readings taken in the vicinity of the SMR facilities could be explained by the presence of petroleum hydrocarbons related to the number of vehicles parked in this area and the amount of auto parts found all around the area. Smr 07 had a slightly higher reading but is located in close proximity to the diesel storage tank. The low levels found along the driveway may be attributable to vehicle traffic on the driveway since these locations were within the drainage pathway along the driveway. The locations along Pinnars Cove Road were uphill from the drainage pathway along Pinnars Cove Road and may be the reason these readings were consistently lower than elsewhere.

There are two areas that may require further investigation. The surface drainage pathway from the southeast corner of the main building on the SMR facility is one. Both smr 09 inside the fence and smr 26 outside the fence had elevated readings at 10.4 ppm and 12.8ppm. Also, smr 03 with the highest reading at 53.9 ppm warrants further investigation. While smr 29-32 bracket this location and demonstrate that this is a discrete area, the cause for this elevated reading has not been definitively identified.

Locations plotted on Figure 1 no gps available

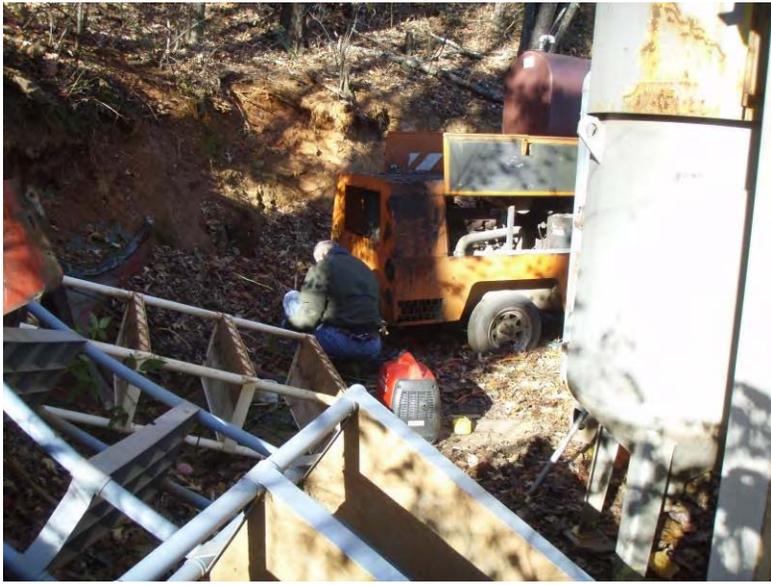
smr 07

Most of the readings collected around the SMR facility were in the 1 to 4 ppm range. SMR 07, located close to the diesel storage tank behind the main SMR building had a reading of 5.67 ppm. This area had been cut out of the bank in order to construct the main building and refusal was encountered at 4 feet. SMR 03, located approximately 140 feet downhill from the sharp bend in the SMR driveway, had a reading of 53.9 ppm. When the hole was resampled the next day it had a reading of 0.7 ppm. A new hole was installed approximately 3 feet north, SMR 29, and it had a reading of 10.1 ppm. SMR 30 was installed 15 feet north of SMR 03 and had a reading of 0.3 ppm. SMR 31 was installed 3 feet south of SMR 03 and had a reading of 7.15 ppm. SMR 32 was installed 15 feet south of SMR 03 and had a reading of 3.41 ppm. Mr. Hermann inquired if any high readings were encountered and when he was told of the approximate locations of the higher readings in this area, he said that there was possibly an old inactive septic drain field in the general vicinity due west of SMR 03. During the property visit, no floor drains inside any of the buildings were noted and no restroom facilities were identified in any of the buildings that may have been connected to this septic system suggesting that if an old septic tank and drainfield existed, it would have been associated with a house. A review of the Aerial Photographic Analysis of Mills Gap Road Groundwater Contamination Site, by Lockheed Martin for US EPA Region 4 in January 2010, revealed a house was located in the area of the inactive septic system in 1951. The house was replaced by a larger structure, possibly a chicken coop, in 1963. The chicken coop was reduced to the present shop size in 1982 (Ref. 8).

Set up at SMR 07 beside diesel generator
R 1009B
Refusal at 4'-0" R 1009C
After 5 min purge 5.67 stable

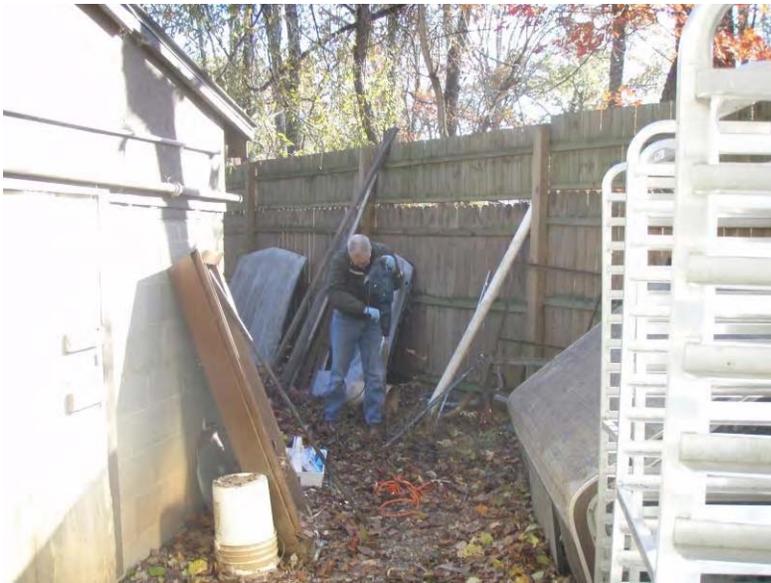
smr 09

Two areas were identified that required further investigation. The surface drainage pathway from the southeast corner of the main building on the SMR facility was one. Both SMR 09 inside the fence and SMR 26 outside the fence had elevated readings at 10.4 ppm and 12.8ppm. Also, SMR 03 with the highest reading at 53.9 ppm warranted further investigation. While SMR 29-32 bracketed this location and demonstrated that this is a discrete area, the cause for this elevated reading has not been definitively identified.

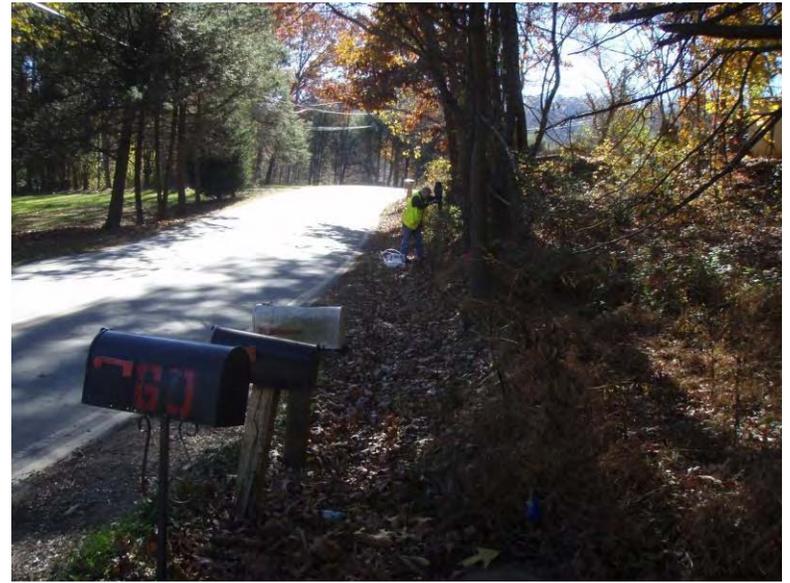
smr 18

Holes SMR 17 through 25 were all located along Pinners Cove Road and all had readings of 0.00 ppb, except SMR 18 which had a reading of 0.067 ppm (Ref. 3). This location is immediately downgradient from the vehicle parking area for 54 Pinners Cove Road and the level detected is less than those found along the driveway leading to 60 Pinners Cove Road.

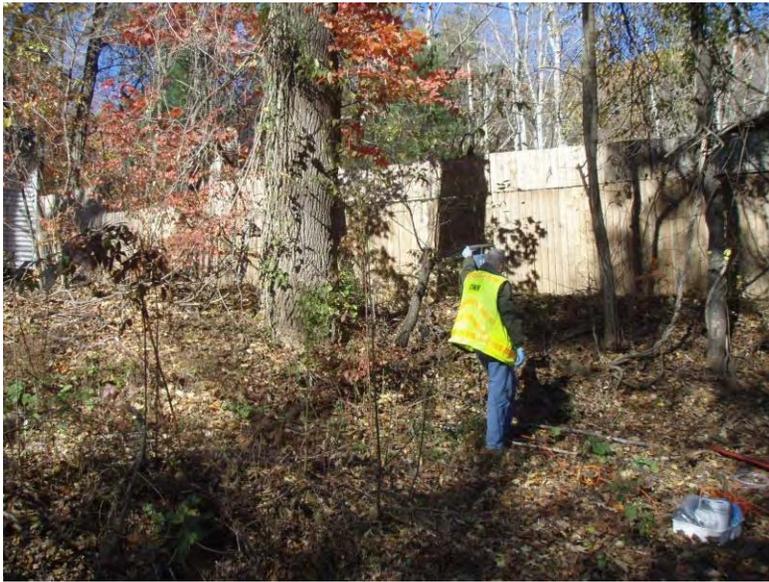
smr 26

Three additional holes were installed outside the fence at the back of the SMR facilities in areas that did not appear to have been disturbed. SMR 26 is located 20 feet outside the fence in the surface drainage pathway from the southeast corner of the main SMR building. SMR 26 had a reading of 12.8 ppm. SMR 27 is located 15 feet outside the fence at the fence corner located by the southeast corner of the medium sized shed on the SMR facility. SMR 27 had a reading of 0.00 ppb. SMR 28 is located approximately 15 feet outside the fence downhill from SMR 11 and had a reading of 0.00 ppb.

SMR 26 Located 20' outside of fence behind corner of Shop, on the surface water runoff path. R 11/10/09
 Depth of hole 3'-0" refusal
 Reading after 5 min 12.8 ppm

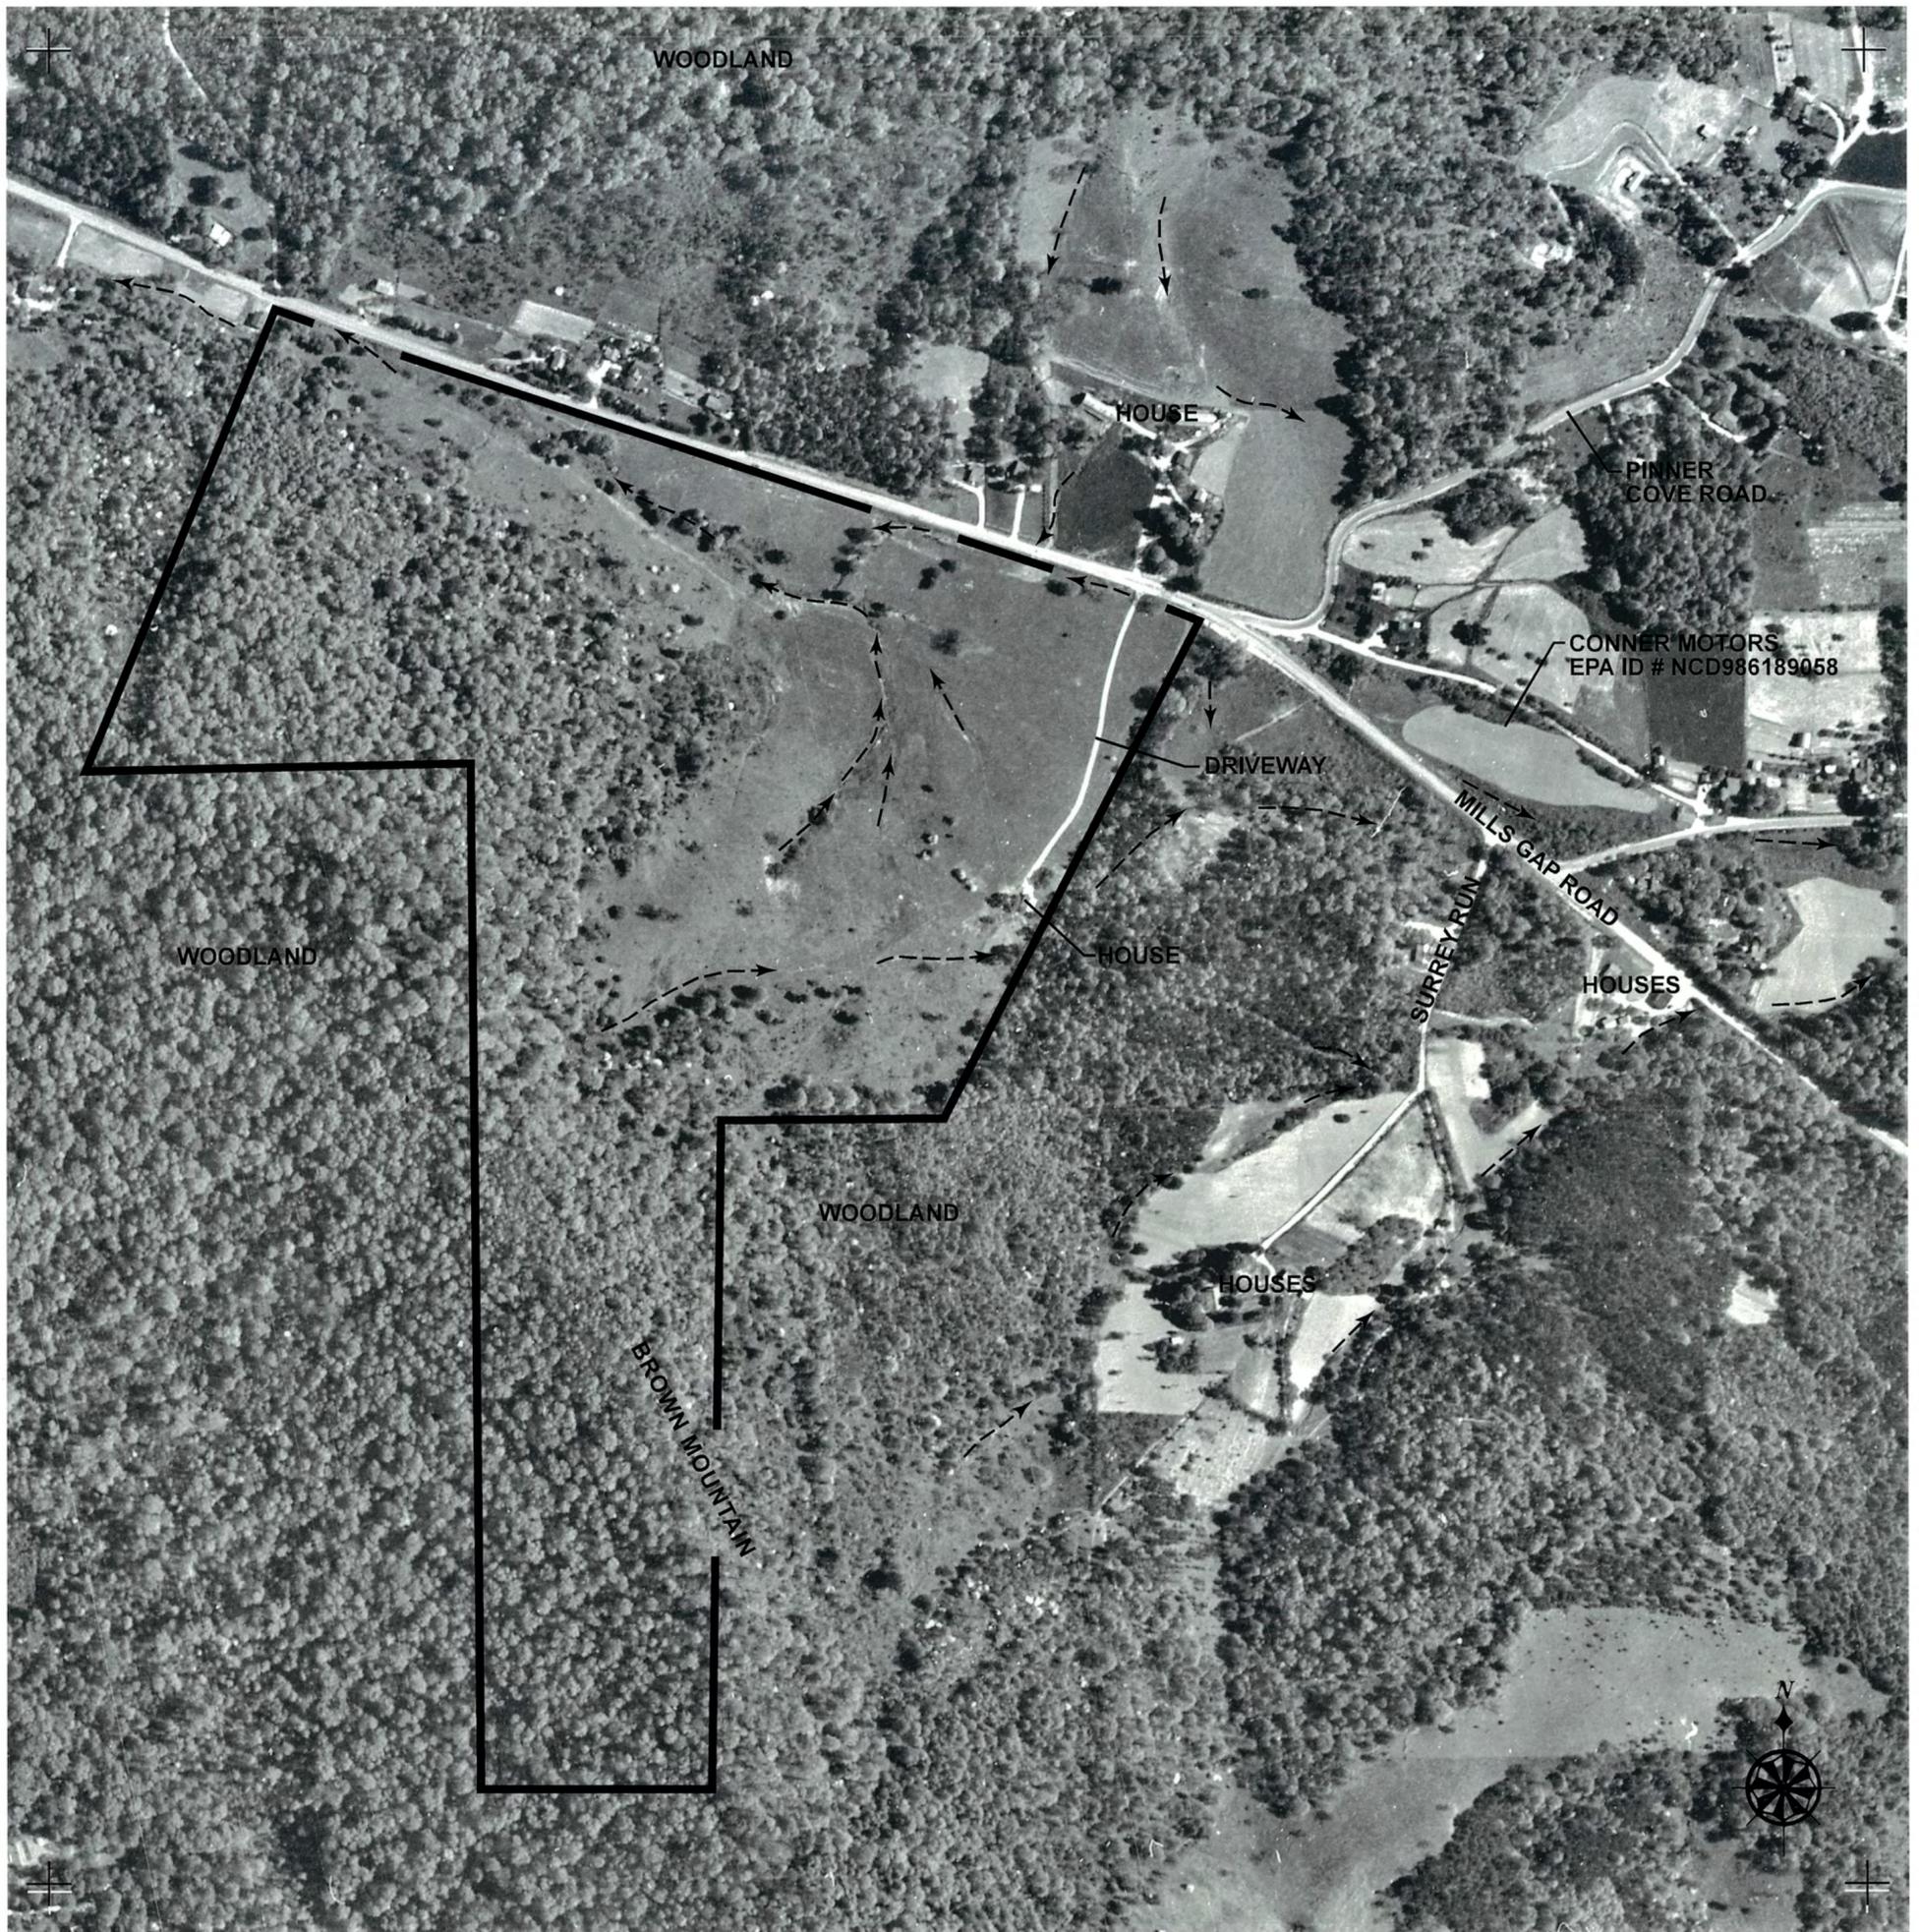
FIGURE 3. MILLS GAP ROAD GROUNDWATER CONTAMINATION SITE, MAY 9, 1951. APPROXIMATE SCALE 1:3,290.

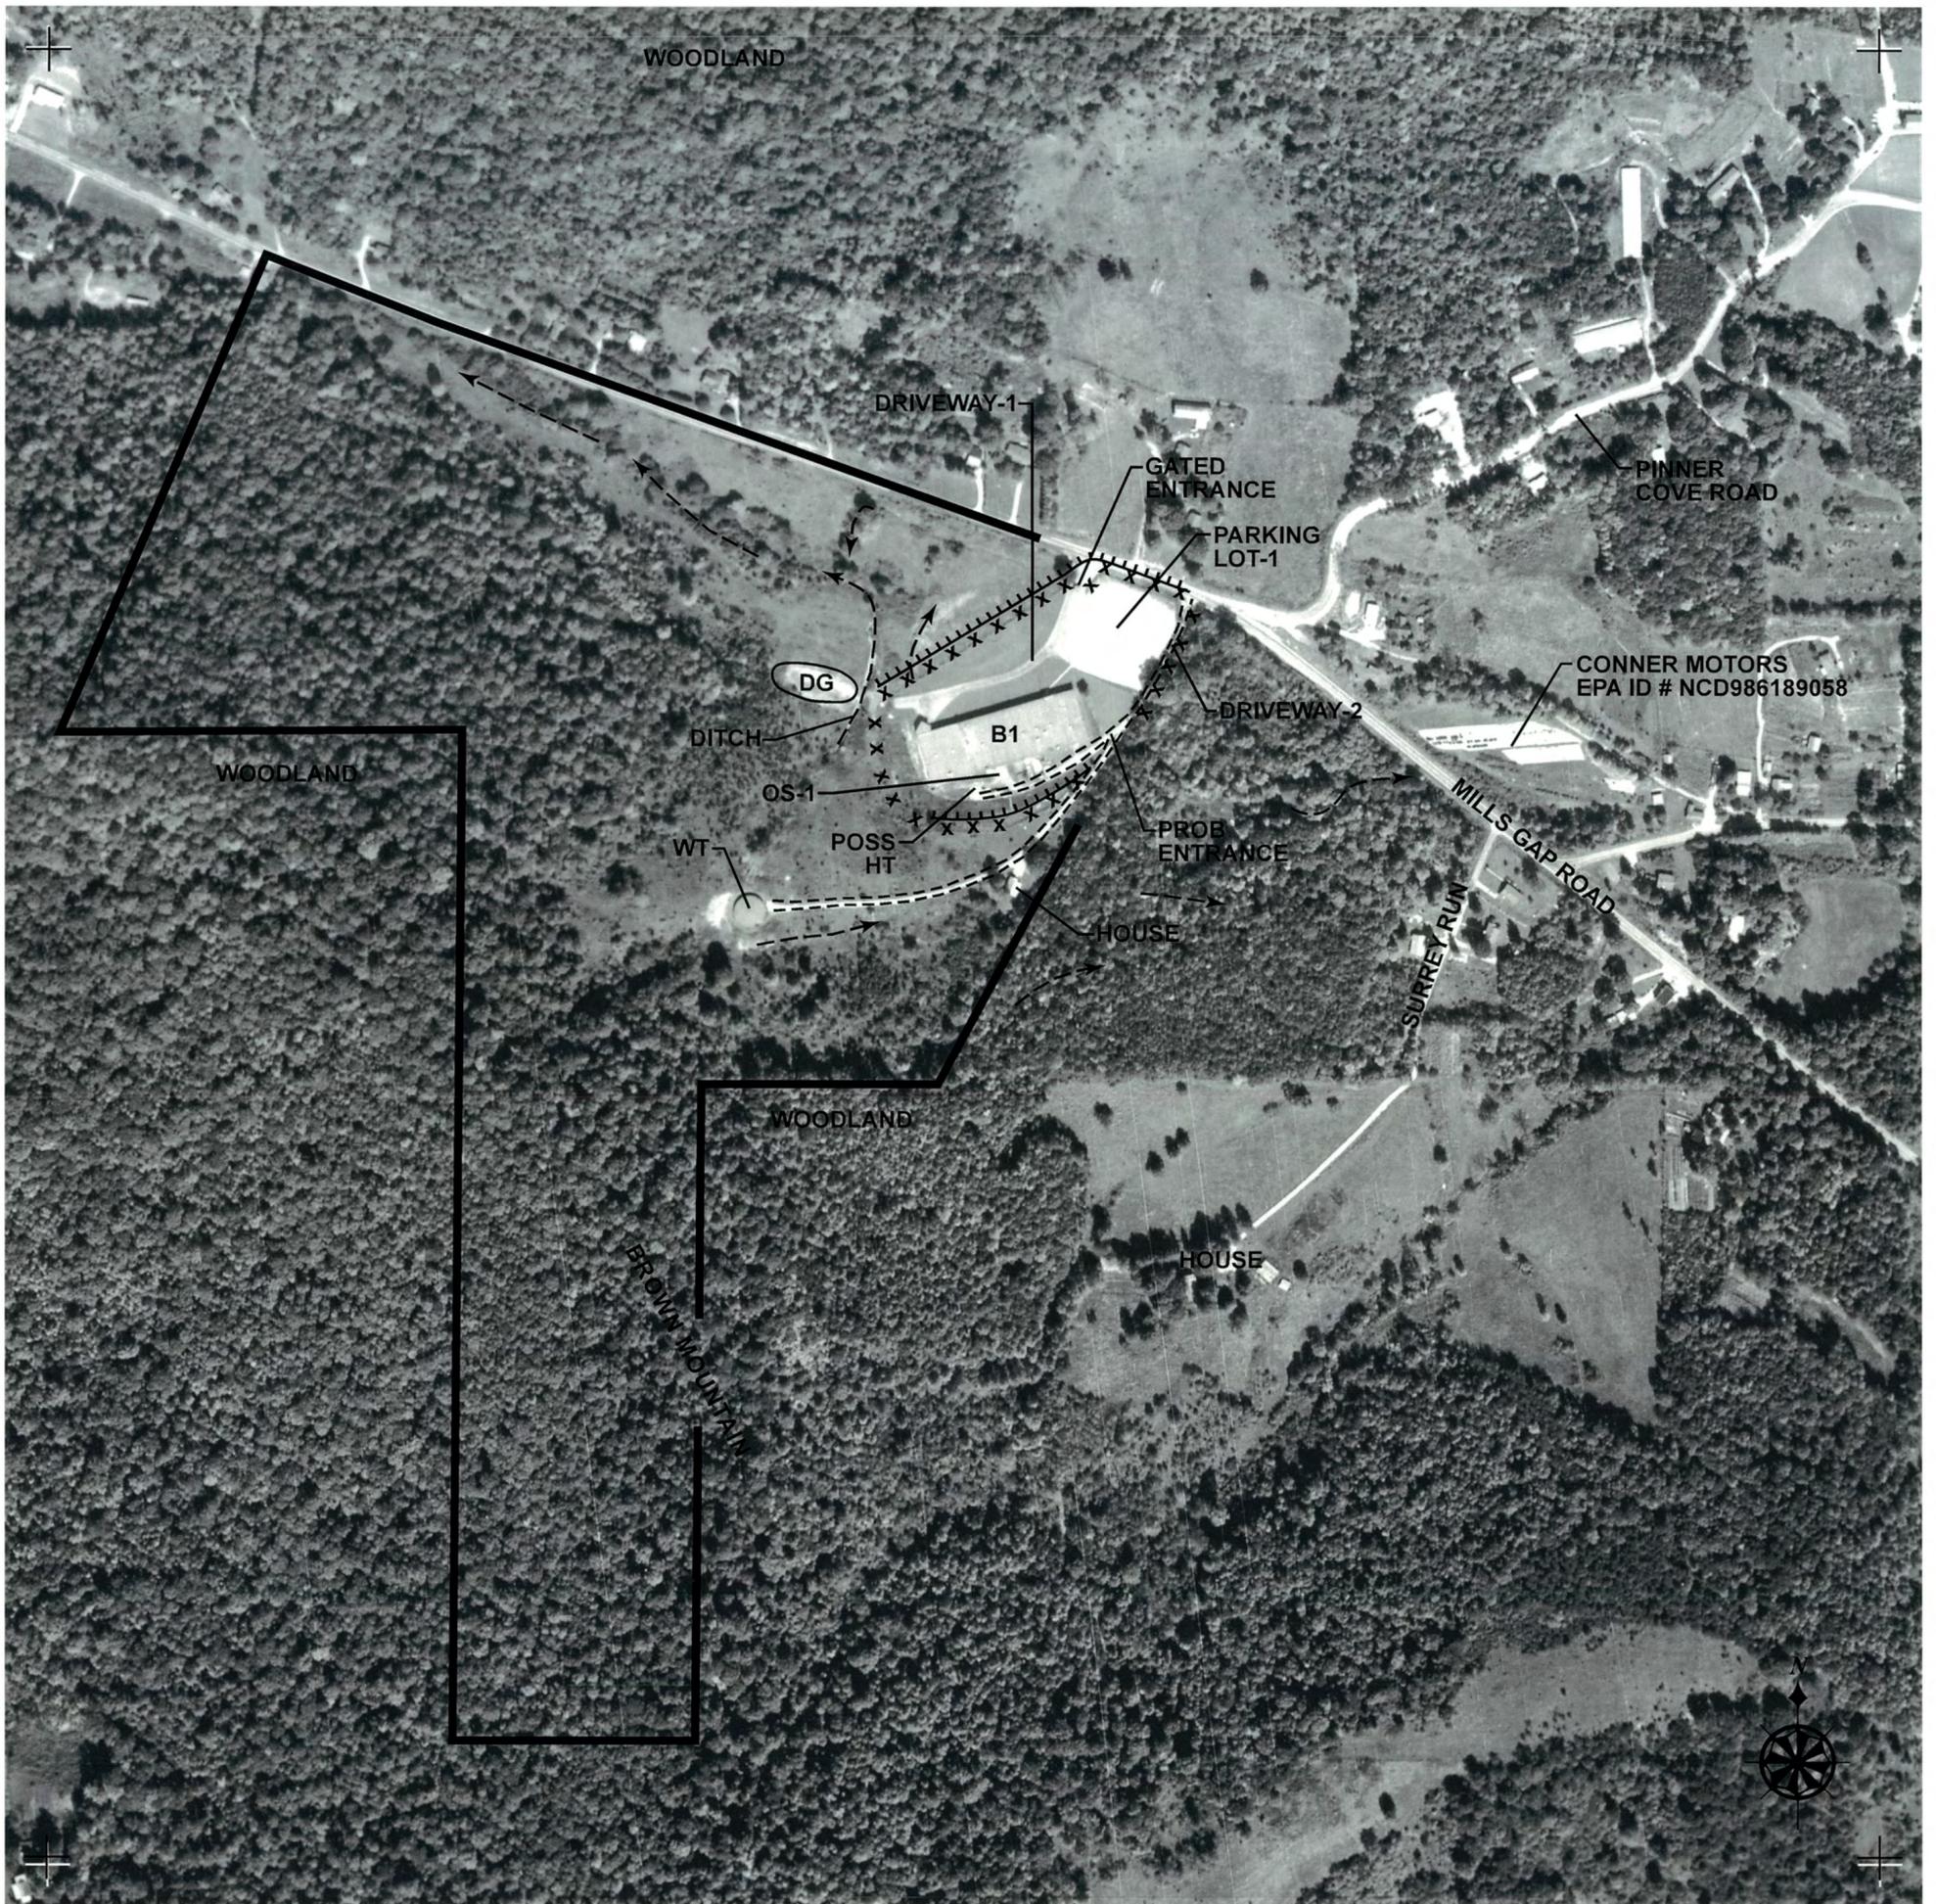
FIGURE 4. MILLS GAP ROAD GROUNDWATER CONTAMINATION SITE, OCTOBER 6, 1963. APPROXIMATE SCALE 1:3,290.
