January 30, 2015

Reference: **GPR/Supply Well Sampling/Water Line Inquiries Letter Report**
LWY Groometown Eckerd
3611 Groometown Road
Greensboro, Guilford County, North Carolina
Groundwater Incident #30687
W&R Project Number: 02140214.81

ATTACHMENT A
PHOTOGRAPHIC DOCUMENTATION

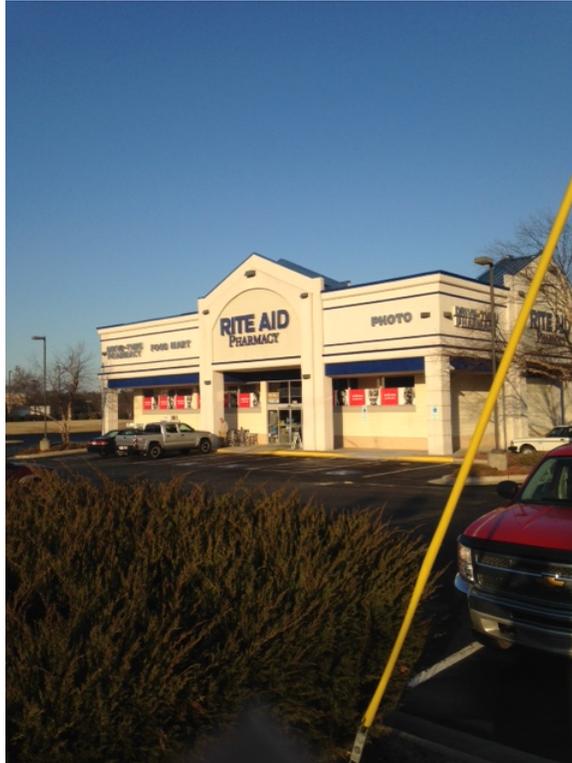
Photograph 1

View of Site Structure from Groometown Rd. & Vandalia Rd. Intersection

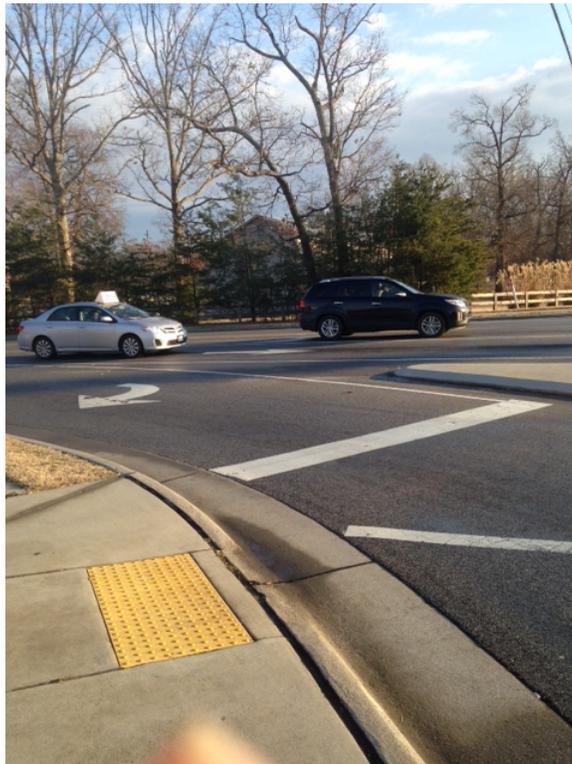
Photograph 2

Suspected Anomaly Area
(View from Southwest to Northeast, Vandalia Rd. at Left)

Data obtained in the performance of a GPR survey at the site did not indicate the presence of specific anomalies indicative of buried metallic tanks or USTs. Several underground utilities including traffic signal lines and fiber optic phone line(s) are present in the area. Based on a February 1993 aerial photograph of the property, it is likely that any tanks located on the property prior to its development as a drug store in the late 1990's and subsequent roadway expansion were situated in what are now the travel lanes of Groometown Road and W. Vandalia Road.

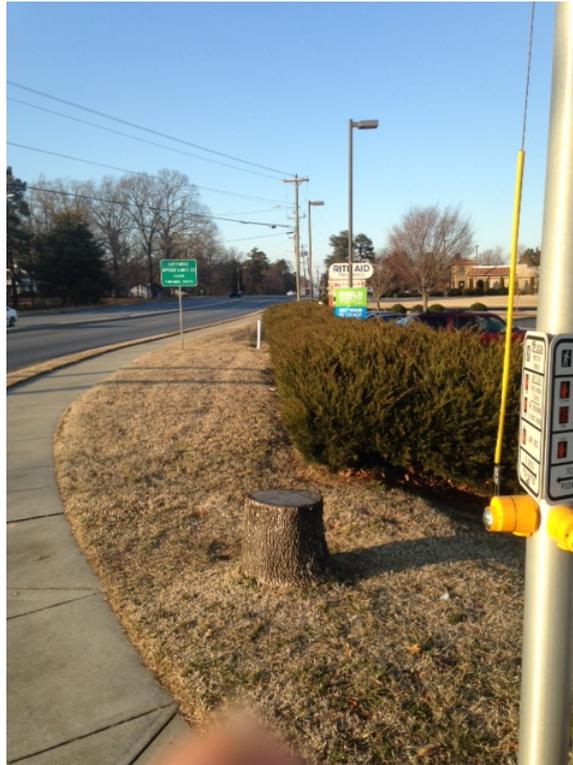
Photograph 3
Suspected Anomaly Area
(View from Northeast to Southwest, Groometown Rd. in Background)

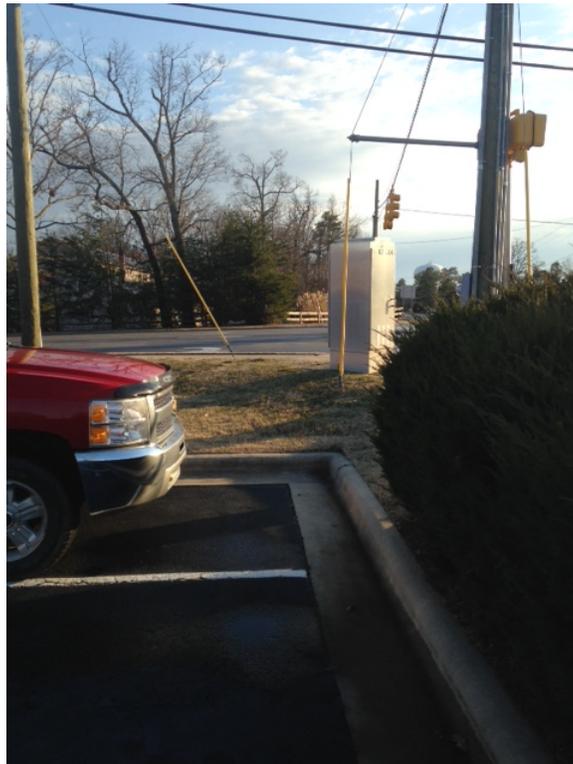
Photograph 4
Suspected Anomaly Area & Traffic Control Box
(View from West to East, Vandalia Rd. in Background)

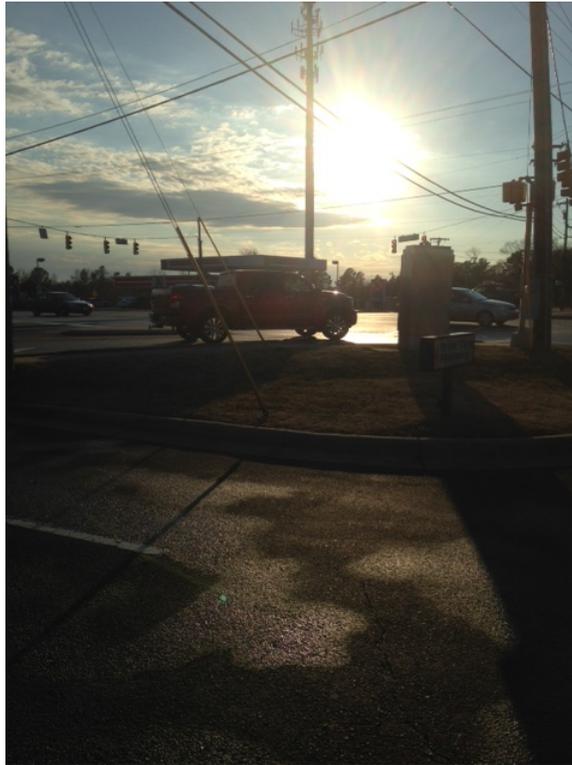
Photograph 5

Suspected Anomaly Area & Traffic Control Box
(View from North to South, Groometown Rd. / Vandalia Rd. Intersection in Background)

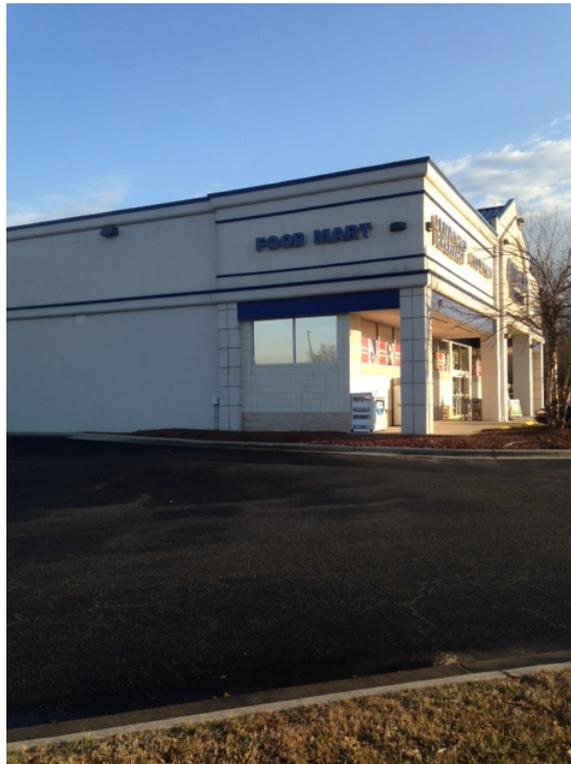
Photograph 6

Site Structure Viewed from Southwest to Northeast

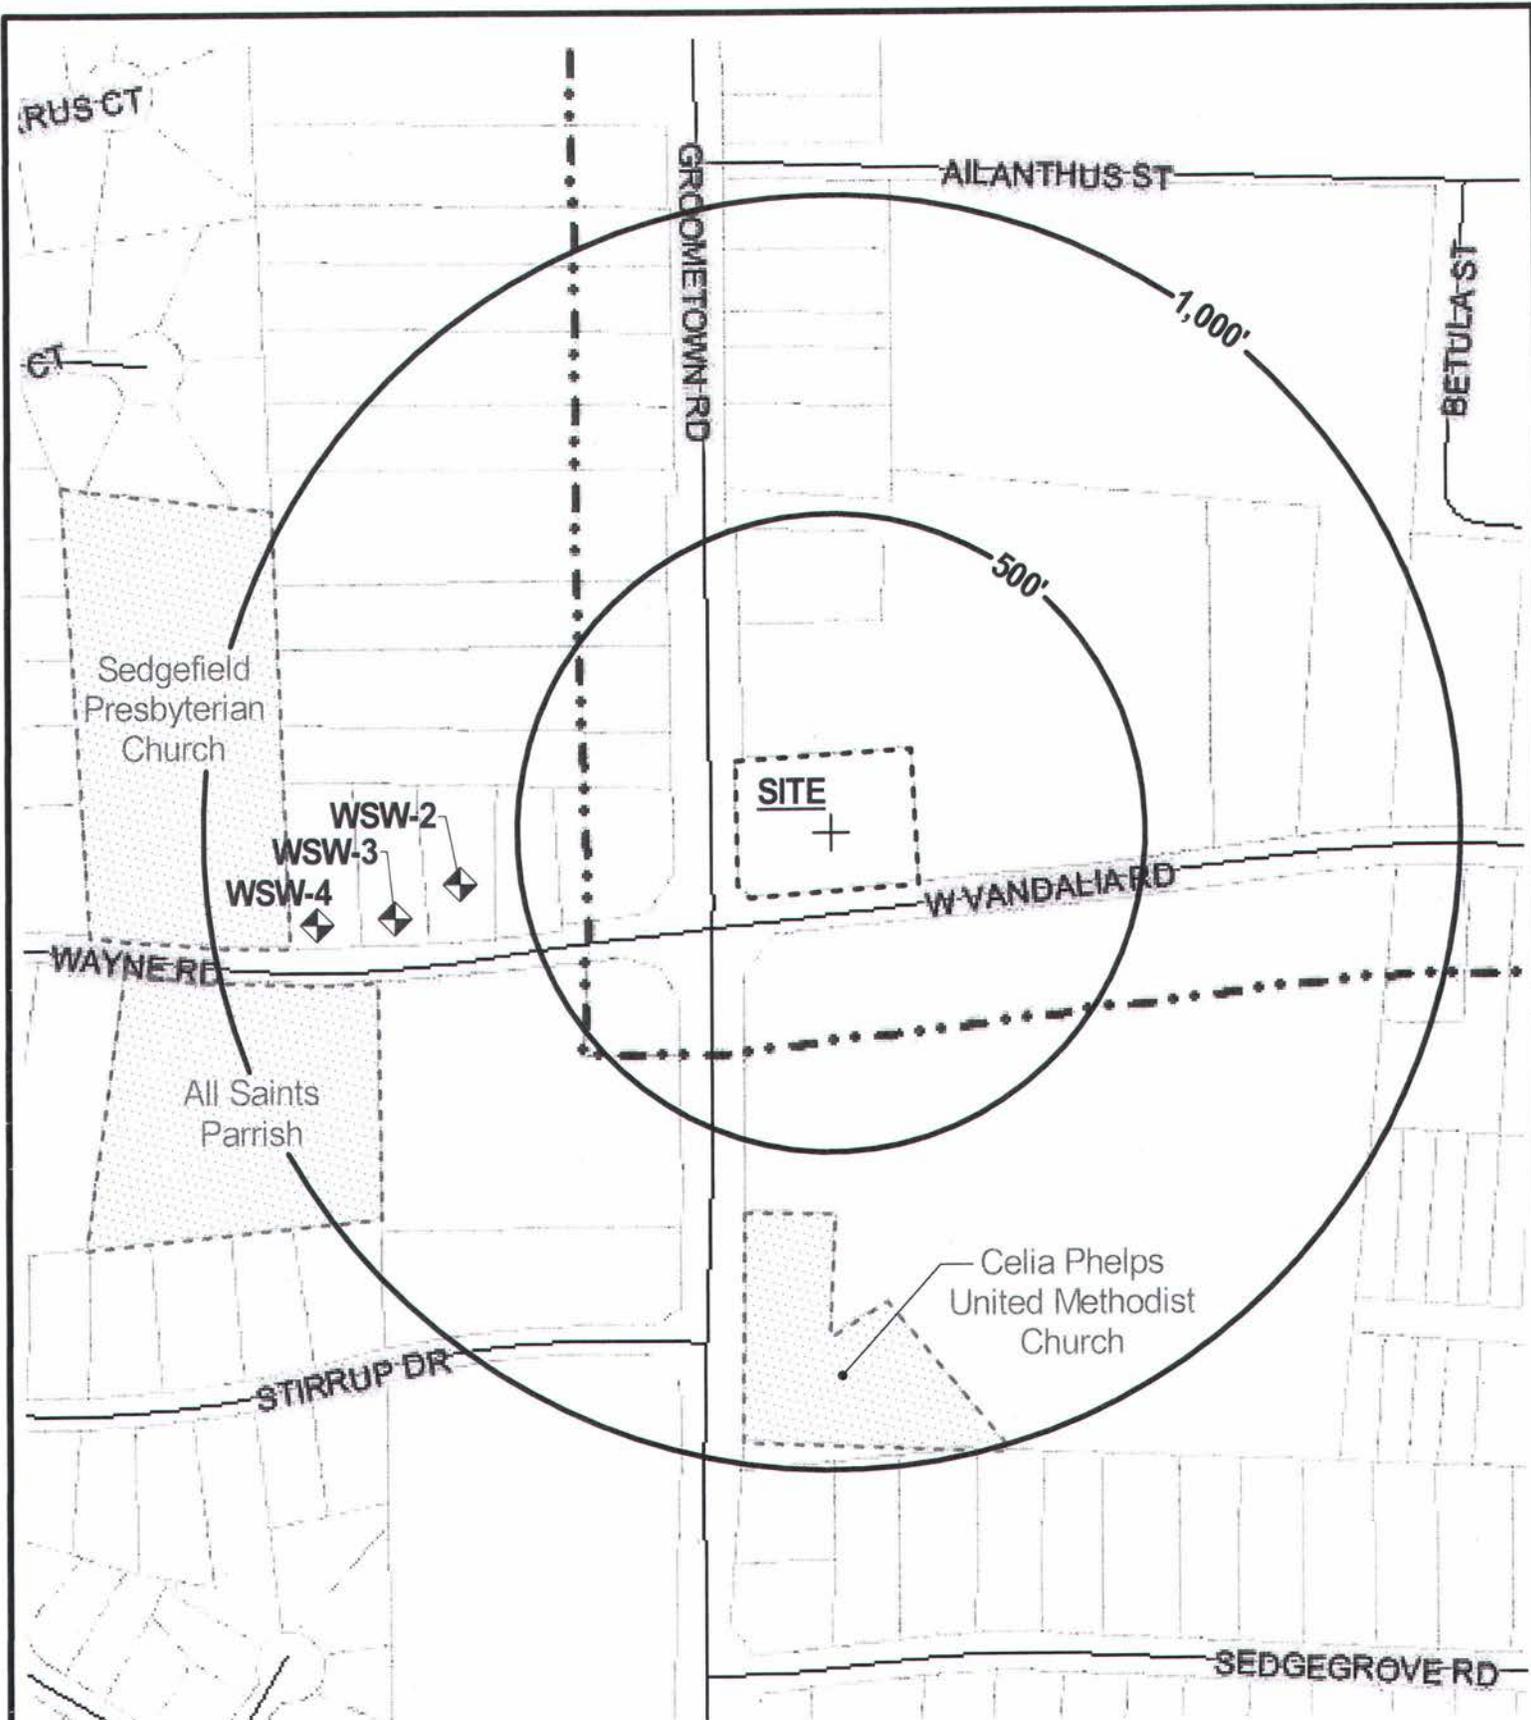
Figure 2

Receptor Locations Map
LWY Groometown Eckerd
 3611 Groometown Road
 Greensboro, Guilford County, North Carolina

Crawford Environmental Services, Inc. (CES) performed a receptor survey and obtained samples from supply wells on April 11, 2013. In performing the receptor survey, CES confirmed the presence of three active, potable supply wells, WSW-2, WSW-3 and WSW-4, located within 1,000 feet of the site. Analytical data for samples from these wells did not indicate the presence of targeted compounds at levels above the method detection limit (MDL) for SM 6200B. CES also confirmed that potable water was available through the City of Greensboro municipal supply system to the entire area, and that the site was not located within a wellhead protection area or the Coastal Plain Physiographic Province of the State. W&R has not performed an updated receptor survey in association with the site, but has confirmed property ownership information for the supply wells. This information is included in **Table B-5**.

Based on a receptor survey conducted by CES during April 2013, supply wells WSW-2, WSW-3 and WSW-4 remain active potable wells. Also based on CES' findings from April 2013, the site is not located within a wellhead protection area or in the Coastal Plain Physiographic Province. Municipal water is available to the site and surrounding properties. W&R was unable to sample water supply wells WSW-2, WSW-3 or WSW-4 as W&R personnel could not obtain permission to conduct the sampling of the wells. In subsequent contact with the owners of the supply wells, W&R was informed that two of the three owners are open to the connection of their properties to municipal water service, and the remaining owners (WSW-4) may be open to connection of their property.

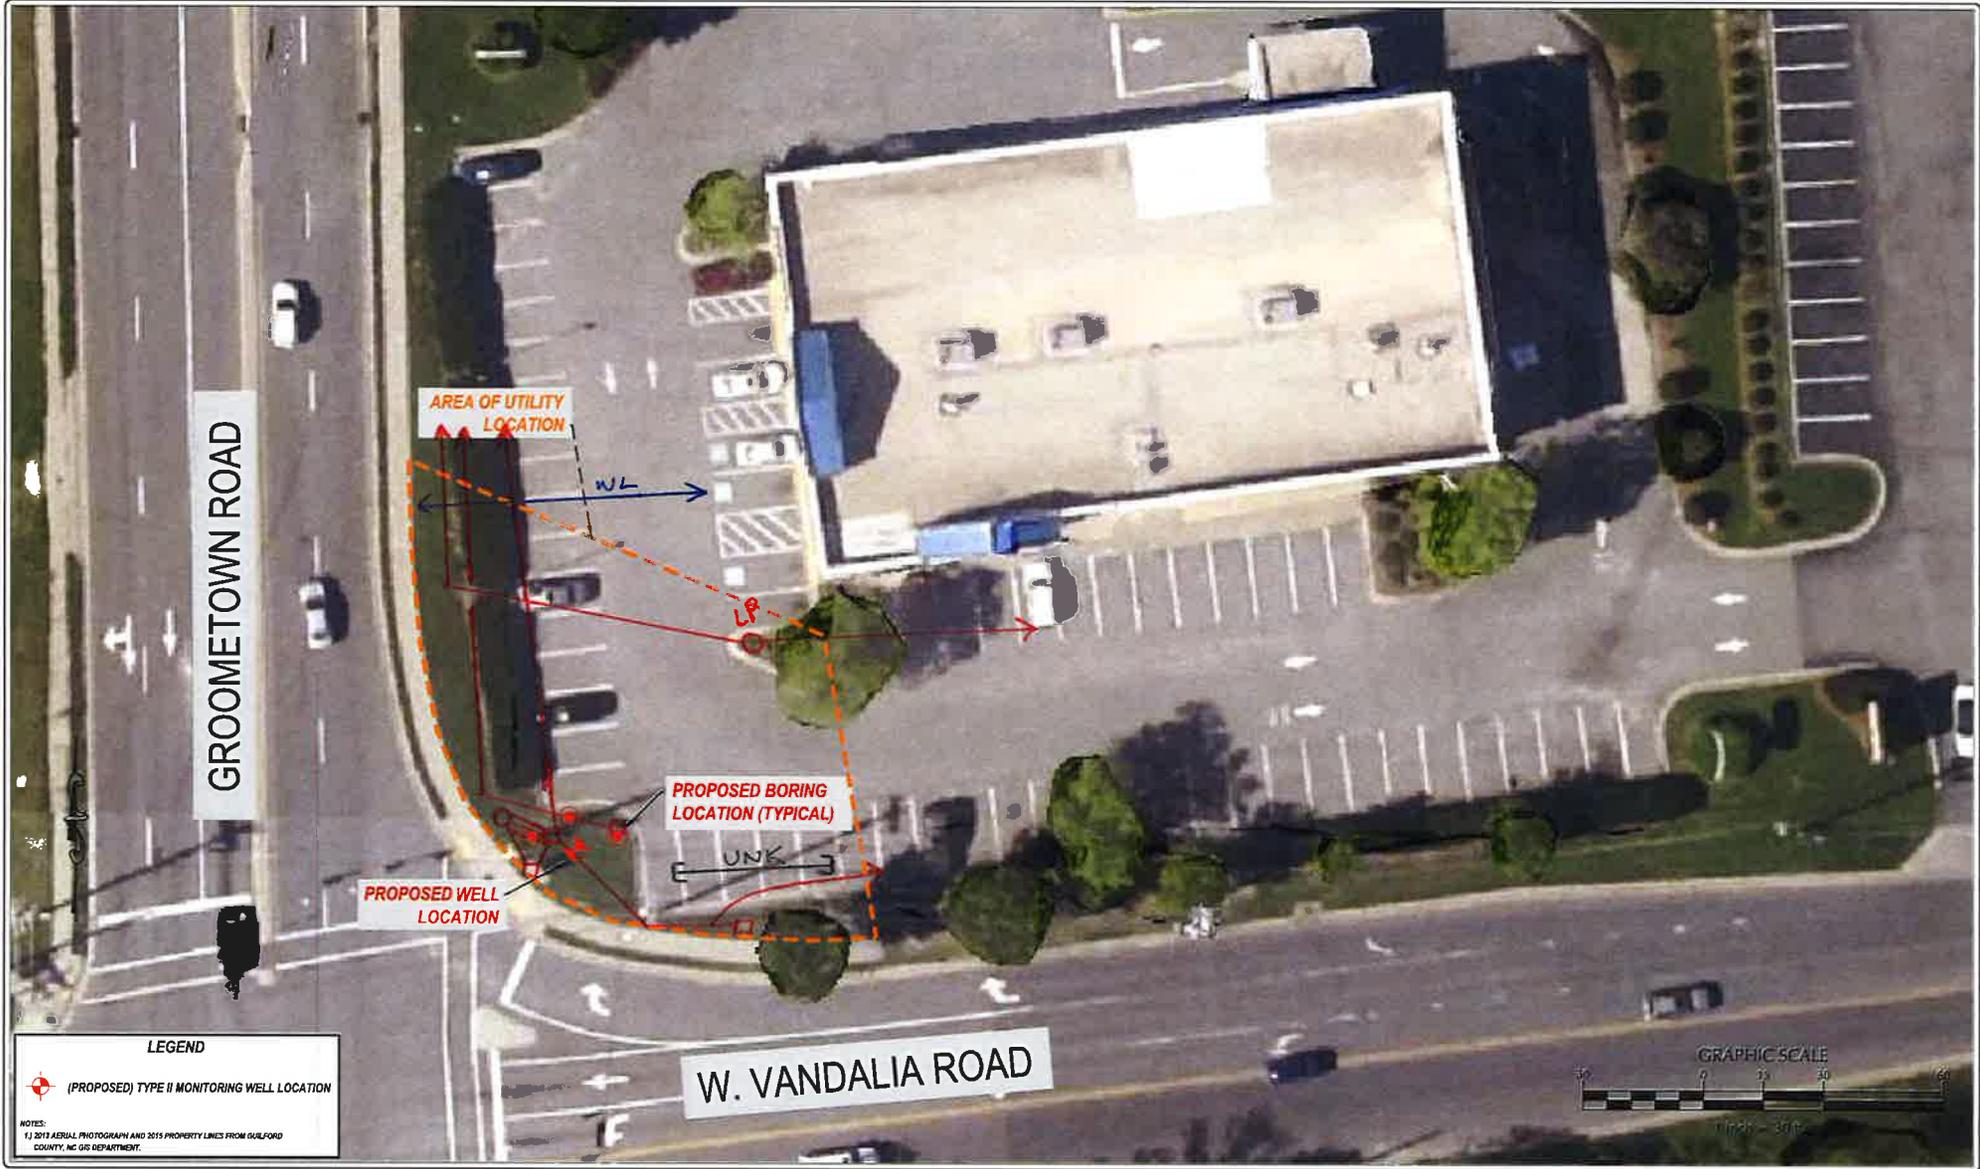
SITE MAP

The site sketch and along with the utilities found are shown on page two as an attachment.

AREA OF UTILITY LOCATION

PROPOSED BORING LOCATION (TYPICAL)

PROPOSED WELL LOCATION

- Installation and sampling of a Type II monitoring well near the southwestern corner of the property to verify contaminant levels in the groundwater of the site,
- Review of the Incident file for the Circle K # 7930,
- Obtain signed agreements with owners of supply wells WSW-2, WSW-3 and WSW-4 for the abandonment of their wells and installation of water taps/lines to connect to the municipal water supply system, followed by the performance of these tasks,
- Based on abandonment of WSW-2, WSW-3, and WSW-4, connection of these properties to the municipal water service and findings of appropriate risk-based soil and groundwater data, reduction of the site risk to allow for the preparation of a Notice of Residual Petroleum (NORP) for the site.
