FACILITY COMPLIANCE INSPECTION REPORT

Date of Site Inspection: 4/28/2016

Clay County Solid Waste Transfer Facility
1160 Hinton Center Road
Hayesville, N. C. 28904

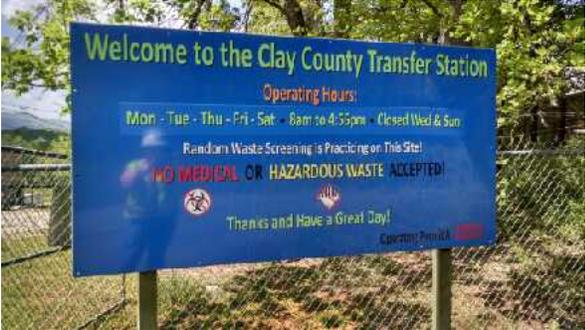
Location	Photo 1
<p data-bbox="164 632 233 655">NOTES</p>

<p data-bbox="800 632 992 655">NOTES Facility Sign</p>
Photo 2	Photo 3

- All photos were taken by Lee Hill on April 28, 2016
- The facility is owned, managed and operated by Clay County.
- Waste is transported by CEI from the facility to the Pine Bluff MSW Landfill Facility (Permit 028-039D[SL]) in Ball Ground, Georgia for disposal.
- The service area for the facility is Clay County.
- The facility hours are Monday, Tuesday, Thursday, Friday, and Saturday 8:00 am to 4:55 pm. The facility is closed on Wednesday and Sunday.
- The permit number is incorrect on the facility sign and reads 22021. Please update the sign to reflect the proper permit number 2202T.

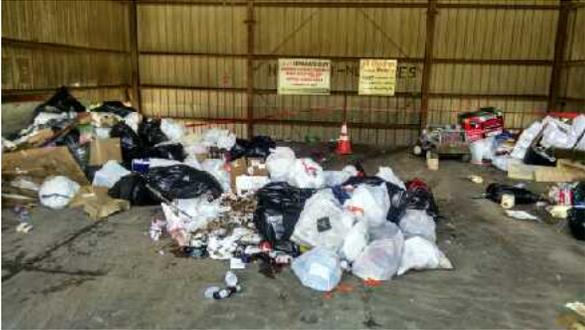
<p data-bbox="164 1188 370 1211">NOTES Tipping Floor</p>

- The transfer station consists of a pre engineered building with a single loading bay.
- Residential and commercial customers dump their waste directly on the tipping floor.
- The tipping floor was observed and appeared to be in good condition.
- The facility does not have trench drains at the entrance to the tipping floor but it appears that the floor slopes toward the rear of the facility. Please note that any water that comes into contact with waste is considered leachate and must be managed accordingly. ** The drains on the outside of the

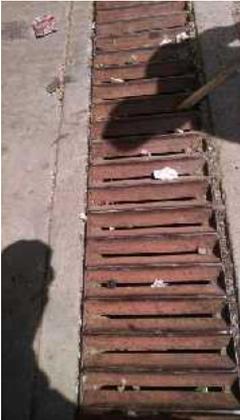
<p data-bbox="800 1188 1175 1211">NOTES Trench Drains in Recieving Bay</p>
Photo 4	Photo 5

- The facility washes down the walls of the facility approximately one time per year.
- No unacceptable waste was observed on the tipping floor at the time of inspection.
- Minimal waste was observed in the receiving bay of the facility. Trench drains in the receiving bay were clear and appeared to be working properly.
- Facility staff cleans windblown litter on a daily basis. Minimal windblown material was observed during the inspection.

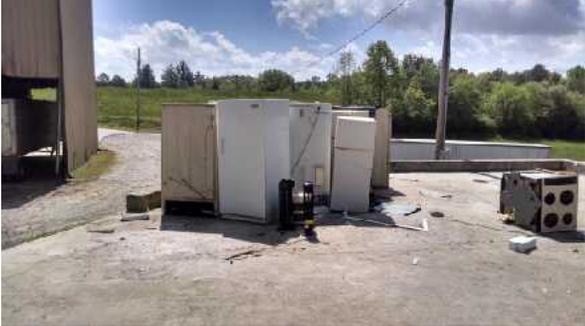
<p data-bbox="164 1734 423 1757">NOTES White Goods Area</p>

- Refrigerants are removed by and independent contractor, Rob Mease. The contractor gives a log which includes the serial number of all units that have been evacuated to the facility. Units are store upright until refrigerant extraction occurs. The last refrigerant extraction occurred on 2/27/2016.
- Scrap tires are stored in van trailers and are sent to Northeast Georgia Tire Recycling for disposal.
- White goods, aluminum and steel cans are sent to Desoto Trail in Franklin for recycling.
- The facility collects, processes and bales cardboard, office paper, plastic bottles and sends it to American Recycling in Candler.
- Electronic waste is collected, placed on pallets or in Gaylord boxes and is sent to Synergy Recycling in Madison for recycling.
- These areas appeared to be well managed.

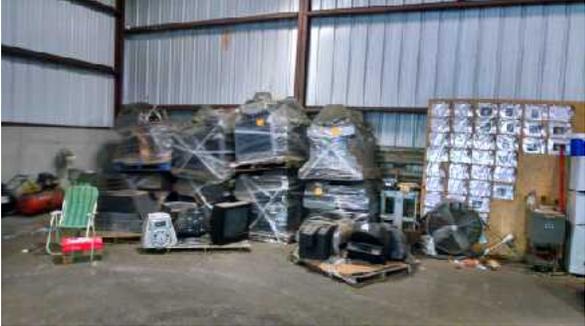
<p data-bbox="800 1734 1032 1757">NOTES Electronics Area</p>
