COMMERCIAL FACILITY REPORT
Resident Inspector Program
Waste Management Division
Department of Environmental Quality

RESIDENT INSPECTOR REPORT

Ecoflo
2750 Patterson Street
Greensboro, NC

**EcoFlo Photographs
NCD980842132**

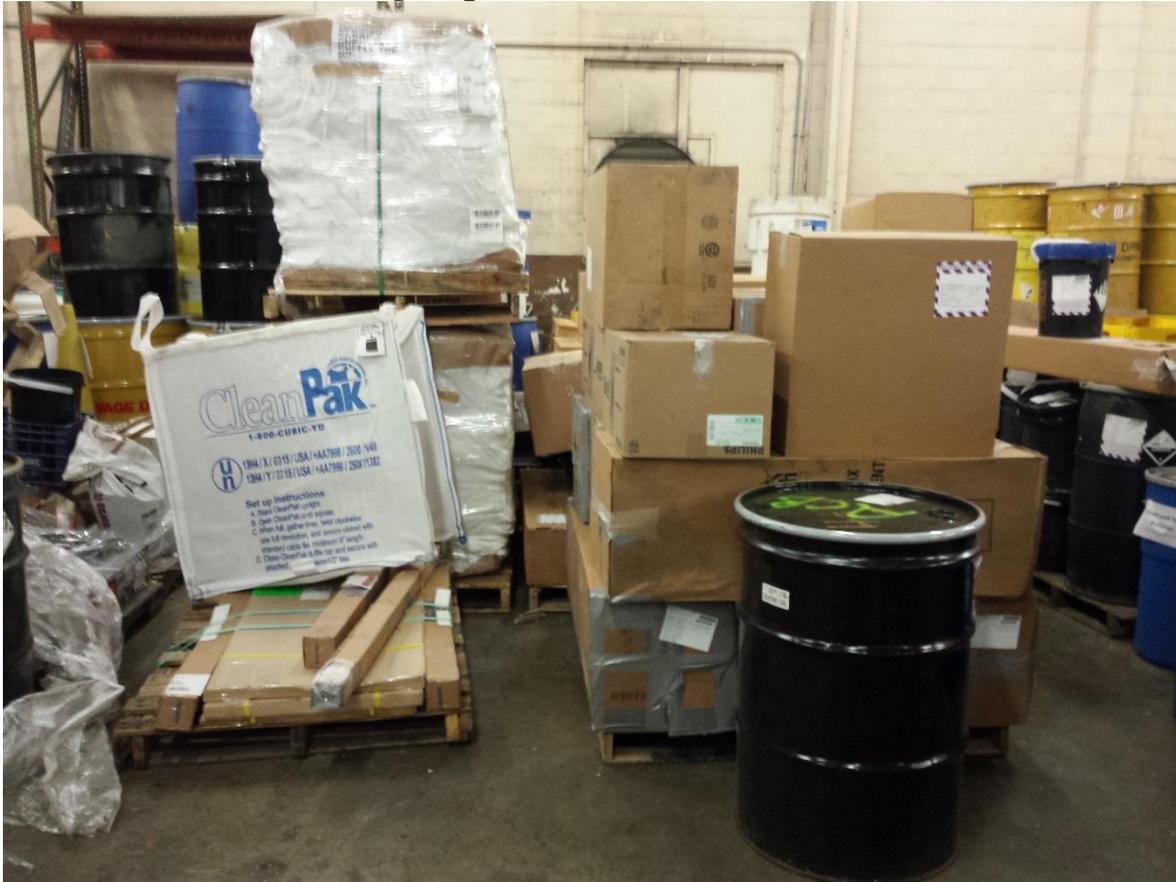
Figure 1: The photograph above depicts the Universal Waste Storage Area located in the rear portion of the West Staging Area. In this area two containers of improperly stored hazardous waste were found. Note the poor housekeeping in this area.

- The facility was observed to have poor housekeeping in multiple area. Areas were cluttered and difficult to access. It is recommended that the facility improve housekeeping throughout the facility. Especially in areas that pertain to access/egress to hazardous waste storage areas or emergency exits.
- A leaking cubic Yard bag of hazardous waste filter cake was observed in the Compatibles storage area. Black liquid was observed on the containers underneath it. It is recommended that the facility contain institute measures to stop the leak from occurring.

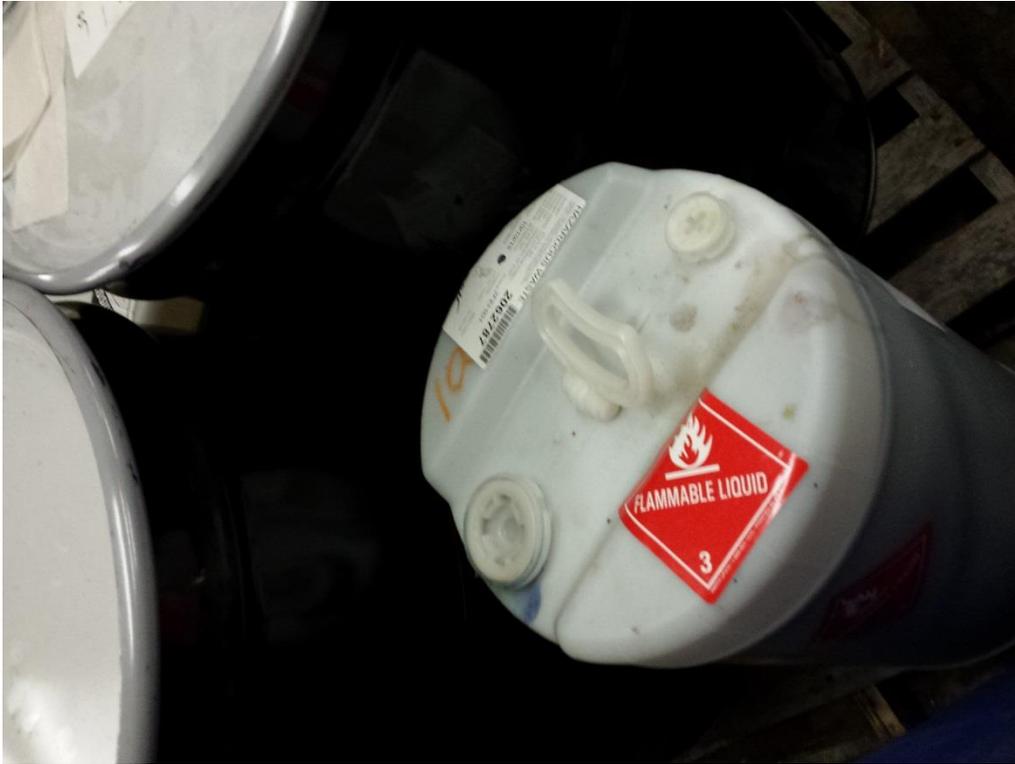
Figure 2: The photograph above depicts an improperly stored flammable hazardous waste container located with the universal waste in the West Staging Area. This area is within 50 feet of the property boundary.

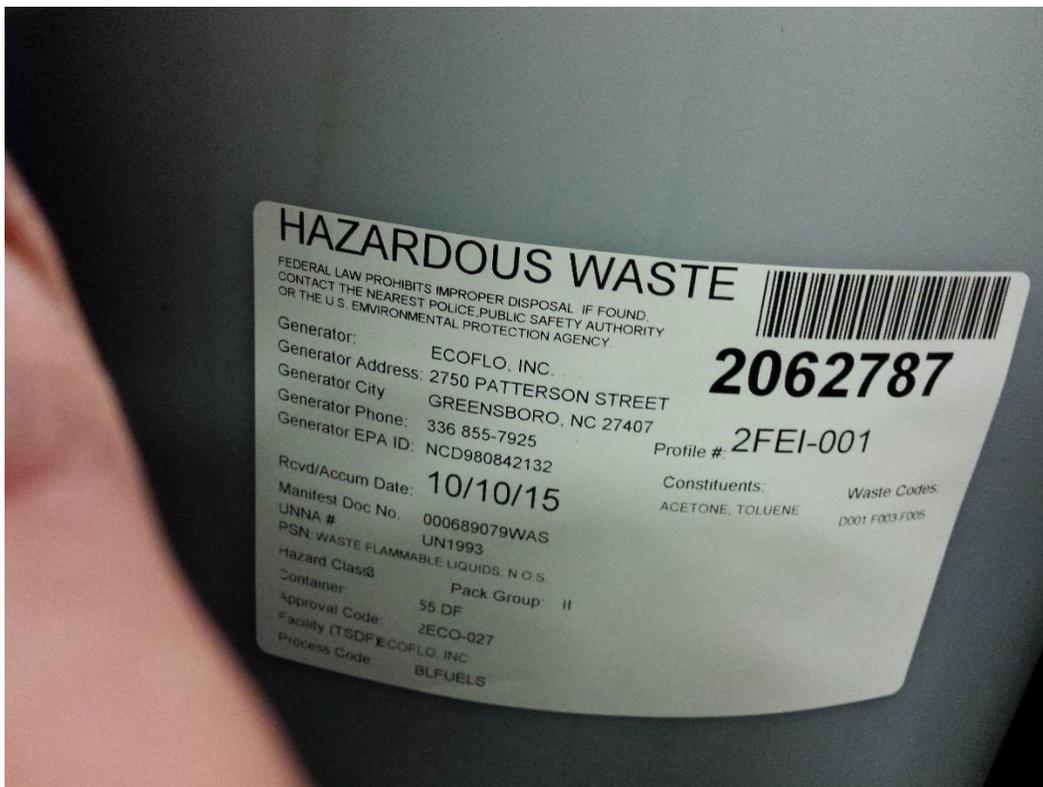
Ecoflo, Inc. is in violation of this Permit condition in that during the inspection, three hazardous waste containers were found being stored in areas of the facility that are not permitted for the storage of hazardous waste. Specifically, there was one container of flammable hazardous waste (approximately 15-gallons in size) and one container of corrosive hazardous waste (approximately 15-gallons in size) found staged along with universal waste containers in the rear portion of the West Staging Area.. The container of flammable waste was labeled with D001/F003/F005 EPA waste codes (Ecoflo Profile #2FEI-001) and the container of corrosive waste was labeled with D002/D007 EPA waste codes (Ecoflo Profile #2FEI-014). Labels on both of the containers listed the Hazardous Waste Manifest Tracking Number 000689079WAS and were marked with an accumulation start date of October 10, 2015. In addition, there was one 55-gallon container of flammable hazardous waste being stored on a concrete driveway, located outside of the facility in an area used to accumulate empty containers. The concrete driveway area is not equipped with a dike system or any other type of secondary containment. The container was labeled with D001/F003/F005 EPA waste codes (Ecoflo Profile #2FSG-002) and the Hazardous Waste Manifest Tracking Number 000688873WAS. The container was marked with an accumulation start date of October 27, 2015.

Figure 3: The photograph is a close up of the label for the improperly stored flammable hazardous waste container located with the universal waste in the West Staging Area. Note the container accumulation date.

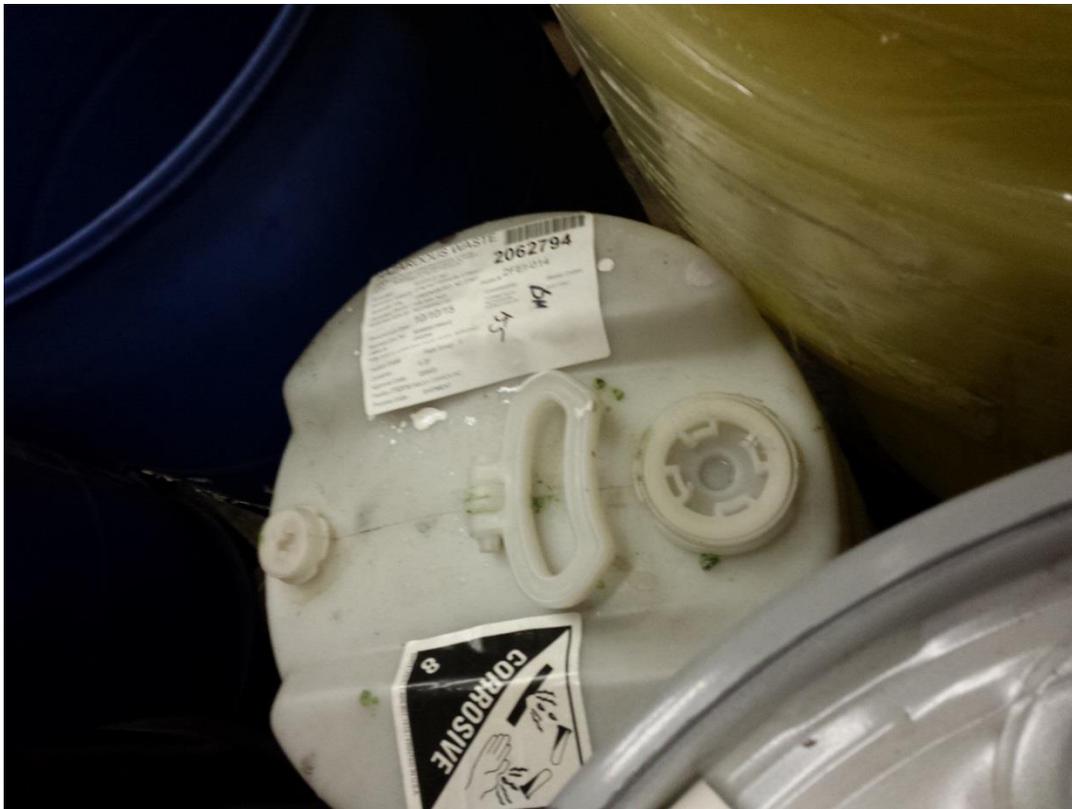
Figure 4: The photograph above depicts a improperly stored corrosive hazardous waste container located with the universal waste in the West Staging Area.

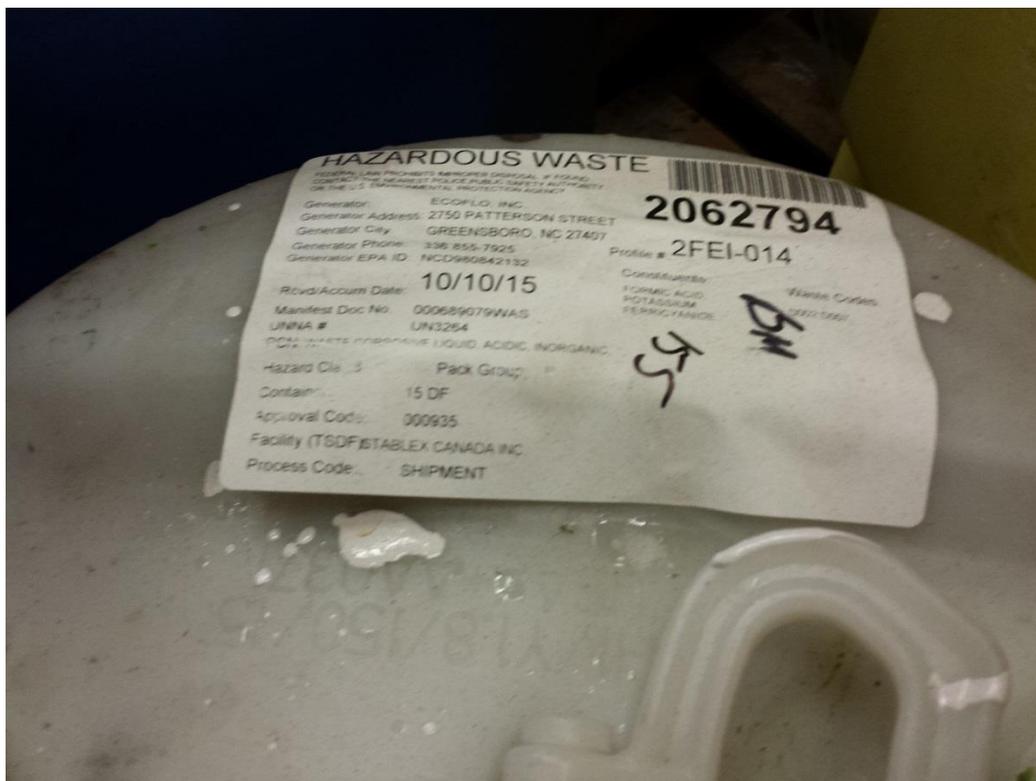
Figure 5: The photograph above is a close up of the label for the improperly stored corrosive hazardous waste container located with the universal waste in the West Staging Area. Note the container accumulation date.

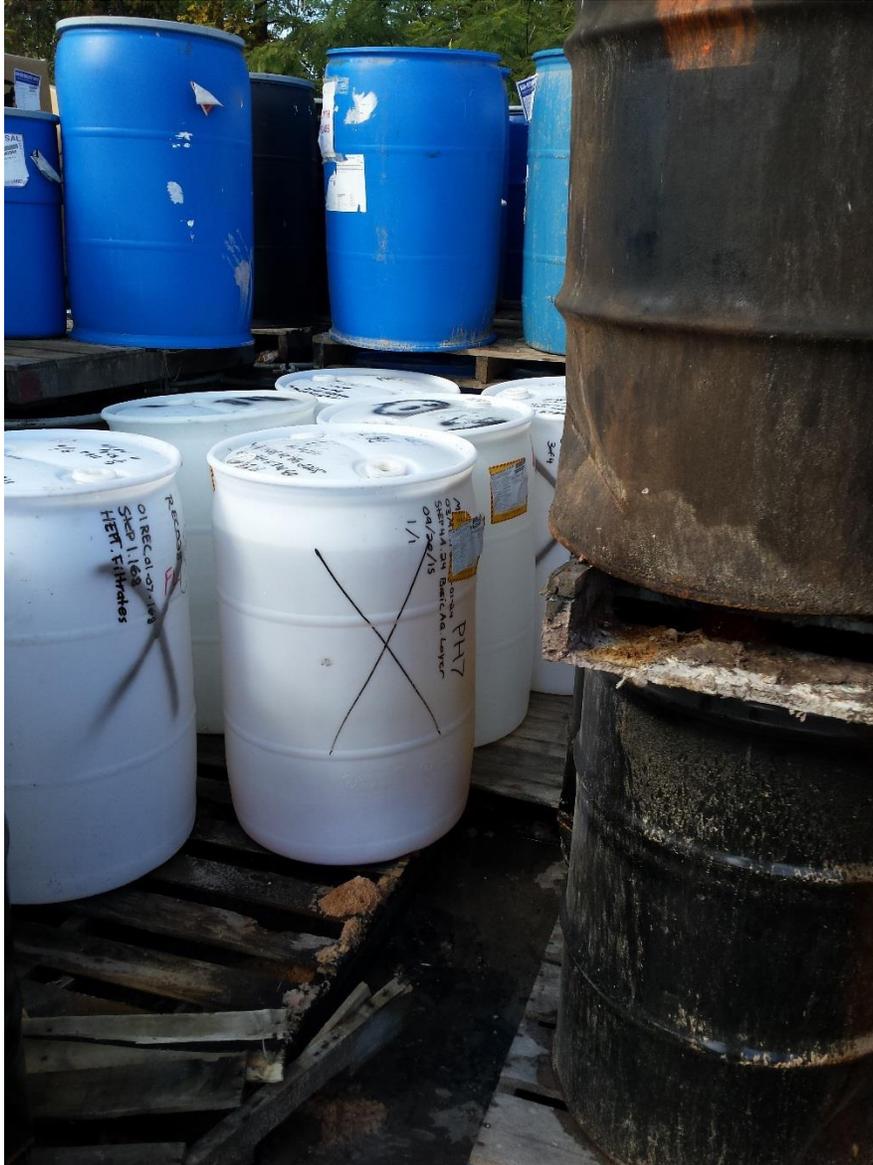
Ecoflo, Inc. is in violation of this permit condition in that at the time of the inspection there were two containers of flammable hazardous waste being stored in areas that are within 50-feet of the facility's property line. One of the containers (approximately 15-gallons in size) was labeled with D001/F003/F005 EPA waste codes (Profile #2FEI-001), and was staged with containers of universal waste near the rear wall of the West Staging Area. The second container (55-gallons in size) was labeled with D001/F003/F005 EPA waste codes (Ecoflo Profile #2FSG-002), and was staged outside of the facility; on a concrete pad within an area used to accumulate empty containers. Both of the hazardous waste containers were being stored in non-permitted areas that are within 50-feet of the facility's property line.

Figure 6: The photograph above depicts an improperly stored flammable hazardous waste container staged on the exterior concrete drive amongst empty containers. This area is within 50 feet of the property boundary. The amount of liquid within the container is clearly visible

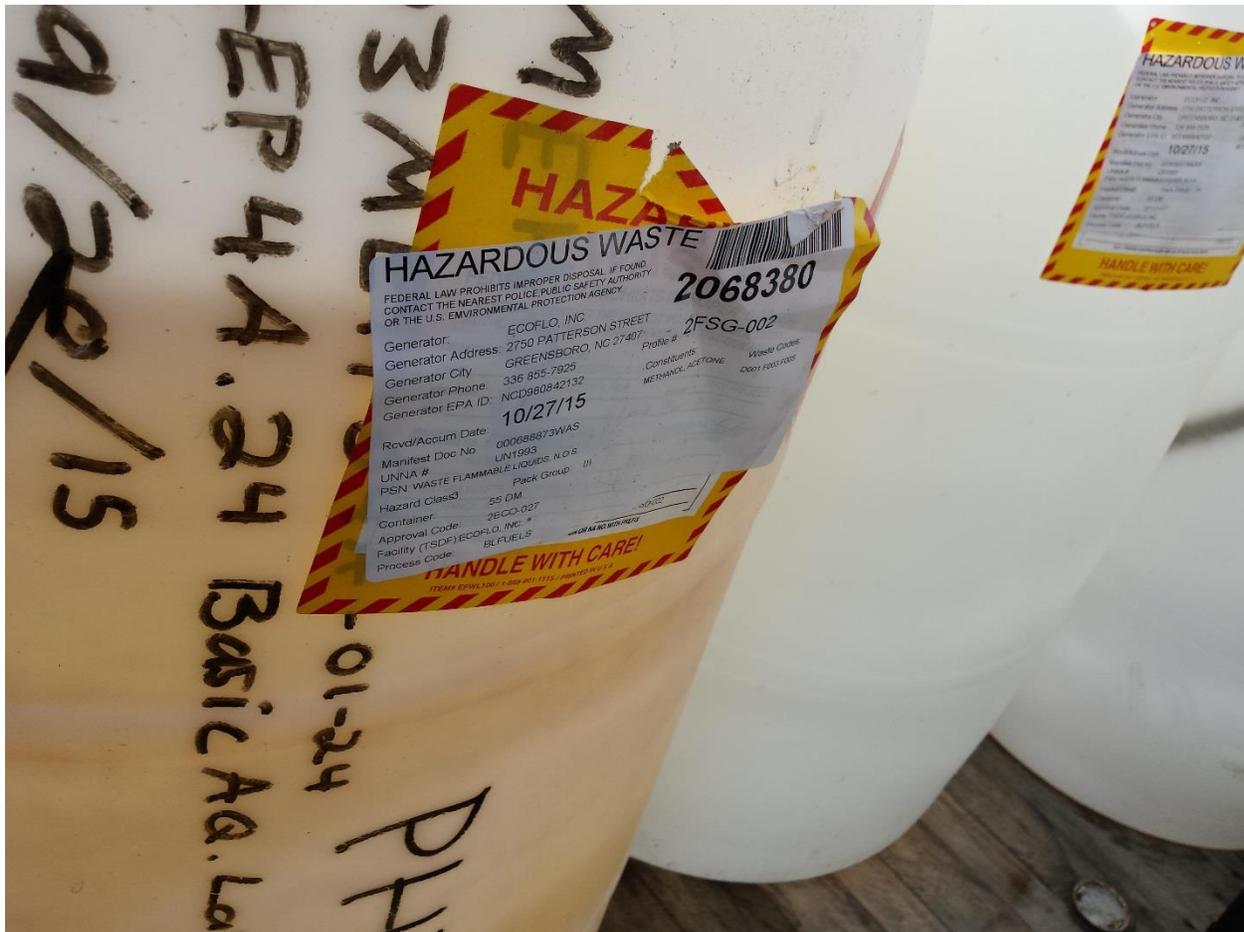
Figure 7: The photograph above is a close up of the label of the improperly stored flammable hazardous waste container staged on the exterior concrete drive amongst empty containers. Note the accumulation start date and liquid level.

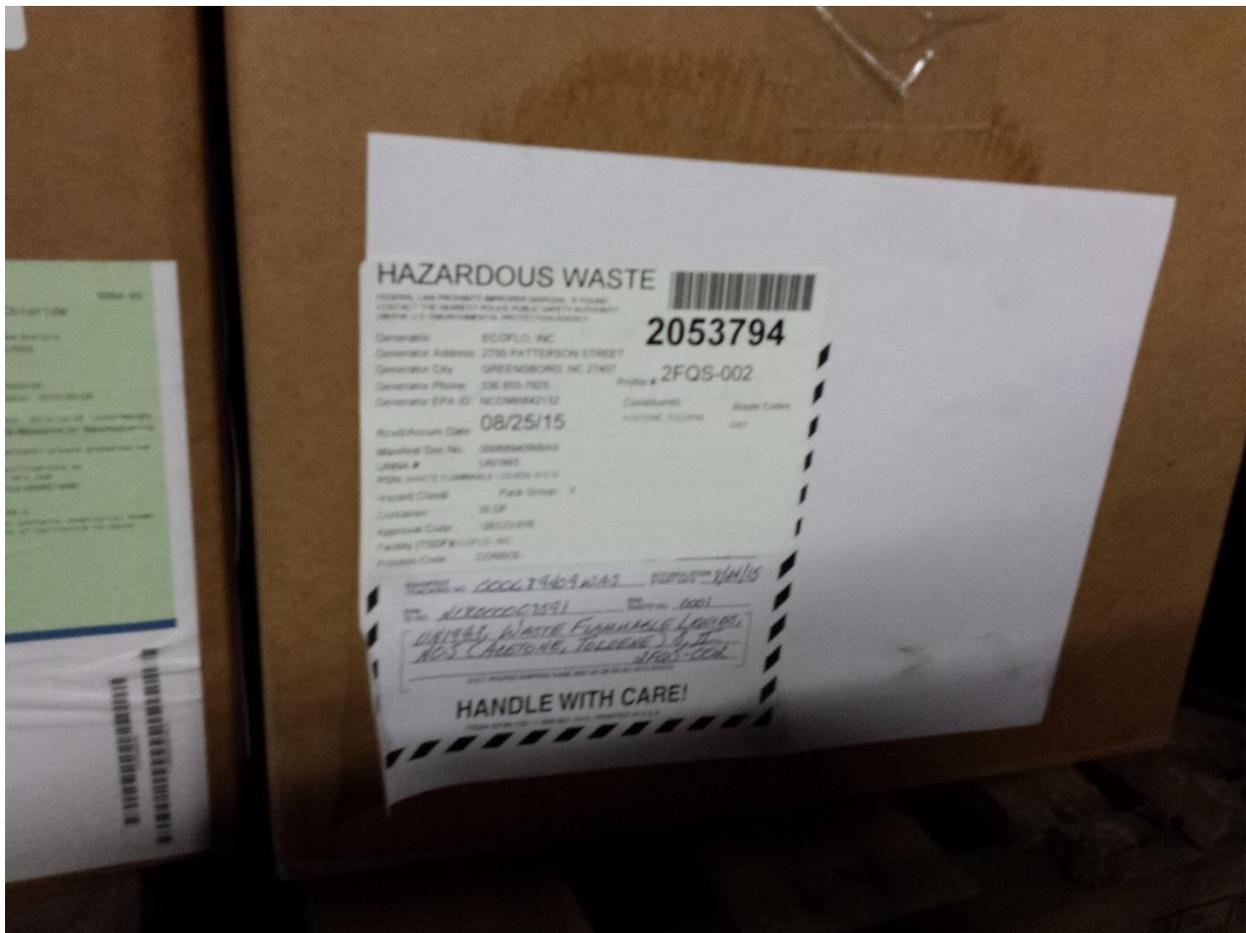
2. Ecoflo, Inc. is in violation of this permit condition in that at the time of the inspection there was one container of flammable hazardous waste being stored in the Compatibles Storage Area, which is not an area permitted for storage of such waste. The container was labeled with D001 EPA waste code (Ecoflo Profile #2FQS-002) and Manifest# 000079409WAS. The container was marked with an accumulation start date of August 25, 2015. Ecoflo, Inc. has failed to store this container of hazardous waste within the Flammable Materials Storage Area as specified within the facility's permit.

Figure 8: The photograph above depicts the label on the flammable hazardous waste container that was improperly stored in the compatibles storage area. Note the accumulation start date.

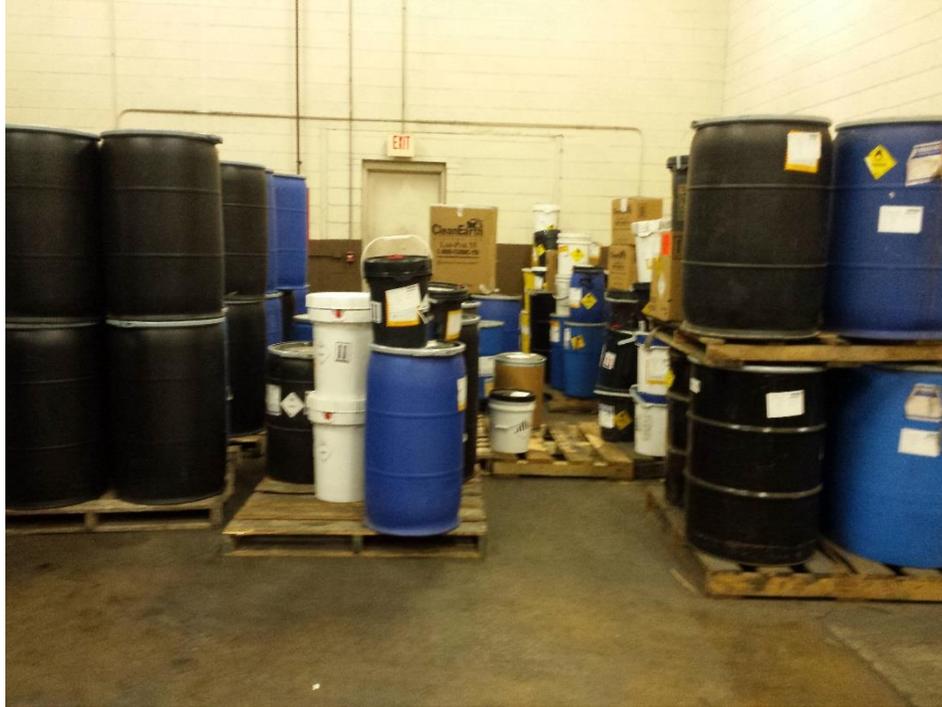
1. Ecoflo, Inc. is in violation of this permit condition in that pallets, supporting various sized hazardous waste containers, observed within the Toxic Material Storage Area were arranged in rows exceeding one pallet width and with an aisle spacing of less than 24 inches. Specifically, there were three rows of palletized hazardous waste containers and one row of palletized empty containers observed in a portion of the storage area, located next to the entrance ramp leading into the area, that were staged up against one another without any aisle spacing. The manner in which the pallets were staged within these rows prohibited easy access and inspection of several hazardous waste containers and restricted access to an emergency exit, located behind the rows. Although the facility's Permit allows for a pallet spacing variance for specific rows/portions within the Toxic Material Storage Area, the rows in question were not associated with the rows specified for a variance.

Figure 9: The photograph above depicts the improper aisle spacing within the Toxic Material Storage Area. Note the emergency exit located in the rear.

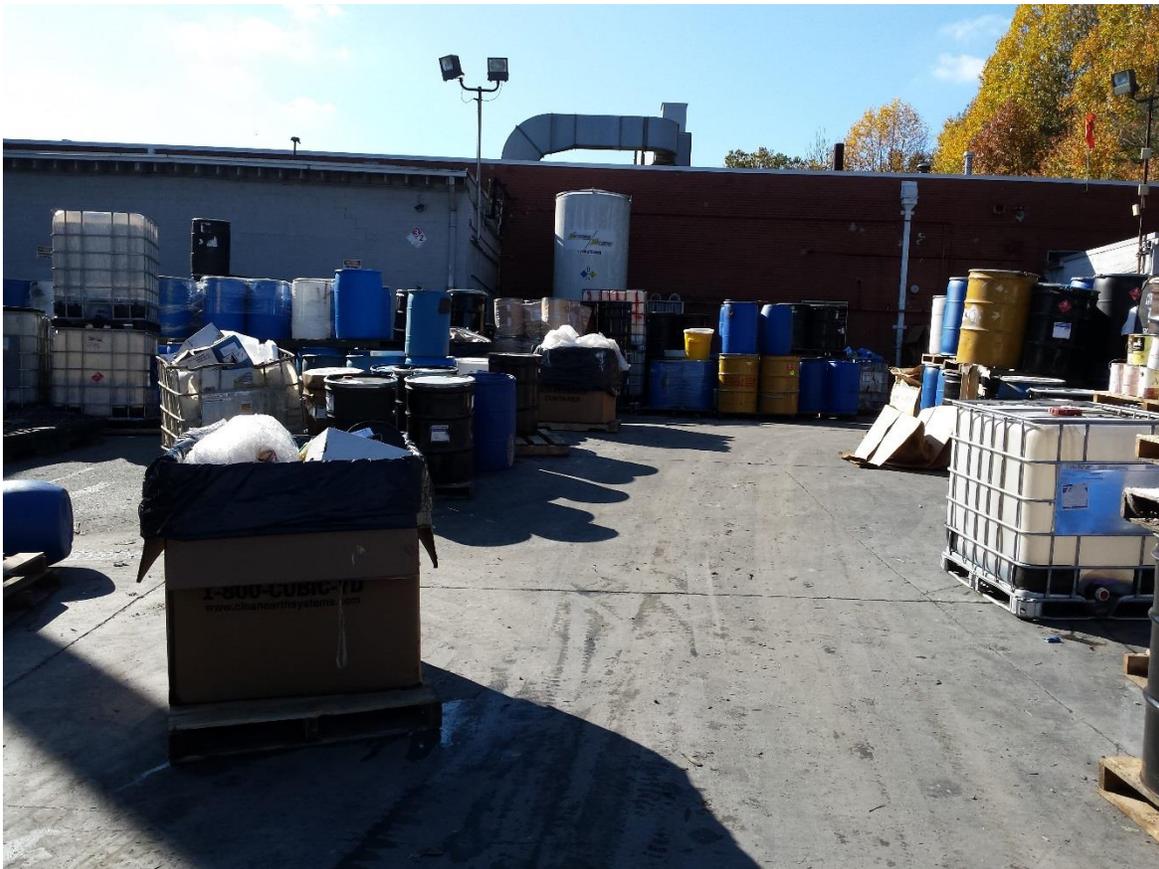
Ecoflo, Inc. is in violation of this regulation in that at the time of inspection the entrance way to the Alkaline Reactive Material Storage Area was obstructed by stacks of empty drums, containers of Household Hazardous Waste and other debris. Access to this area could only be achieved by stepping on and over pallets. Ecoflo, Inc. has failed to maintain adequate aisle space to allow the unobstructed movement of personnel, fire protection equipment, spill control equipment, and decontamination equipment to the Alkaline Reactive Material Storage Area in an emergency.

Figure 10: The photograph above depicts containers and debris obstructing the entrance way to the Alkaline Reactive Material Storage. The doorway the storage area is to the left of the liquid nitrogen tank below the light fixture.

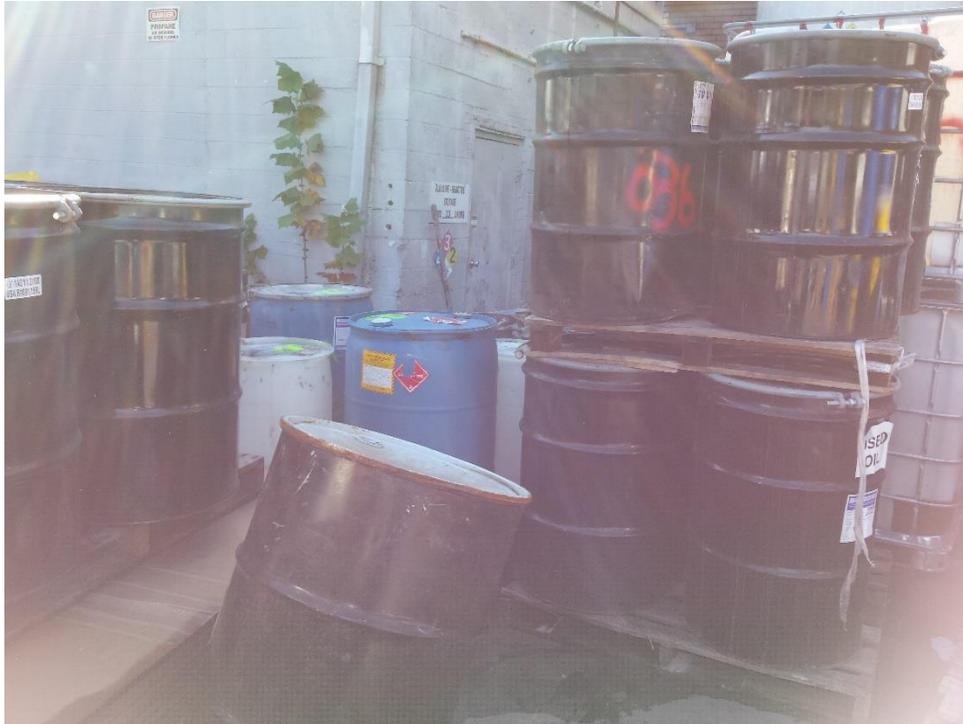
Figure 11: The photograph above depicts a closer view of the containers and debris obstructing the entrance way to the Alkaline Reactive Material Storage.

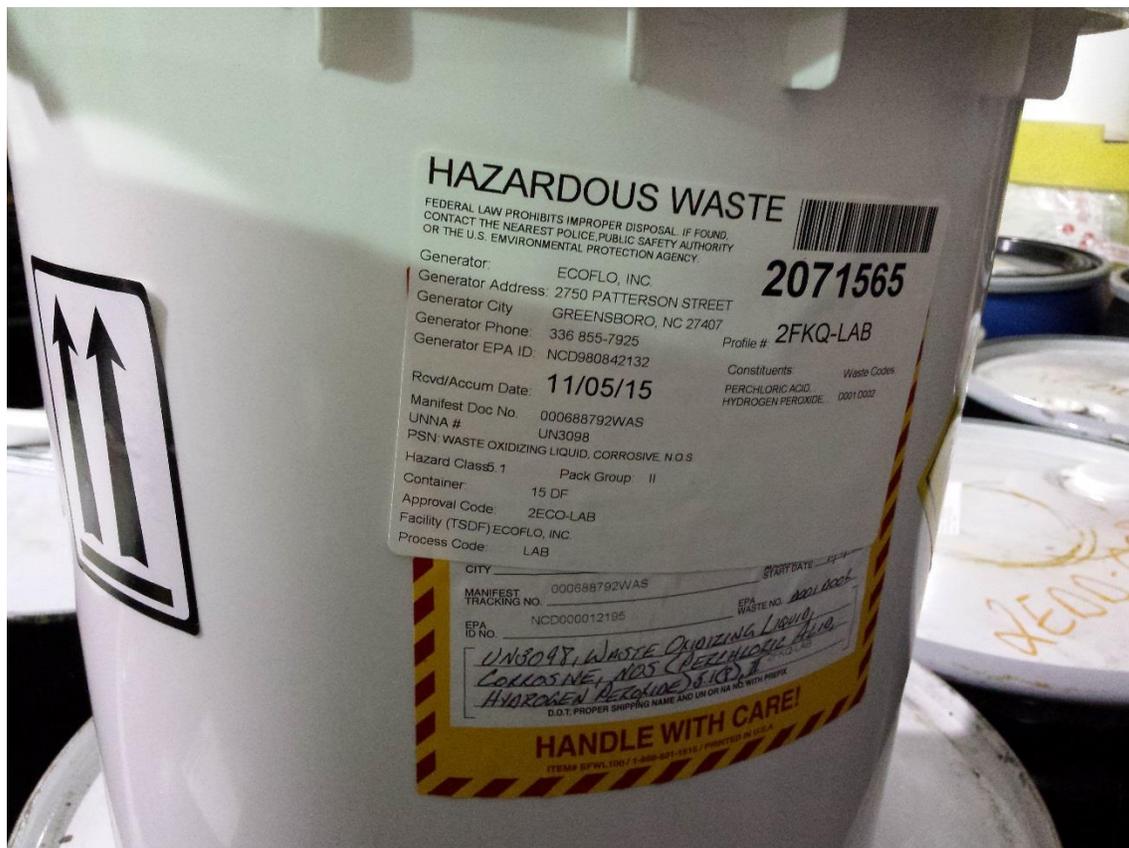
Ecoflo, inc. is in violation of this permit condition in that there were two containers of waste oxidizing materials discovered within the Flammable Materials Storage Area. The waste oxidizers are potentially incompatible with waste flammable liquids/materials that were also being stored within the Flammable Materials Storage Area. The labels observed on the containers of waste oxidizing materials described the waste as:

- One 5 gallon plastic bucket labeled Waste Oxidizing Liquid, Corrosive, N.O.S. (Perchloric Acid, Hydrogen Peroxide) 5.1(8) D001, D002. Container # 2071565, Ecoflo Profile #2FKQ-LAB. Manifest Document #00688792WAS
- One 5 gallon plastic bucket labeled Waste Corrosive Liquid (Nitric Acid, Silver Nitrate) 8 (5.1) D001, D002, D011. Container # 2071621, Profile # 2FKQ-LAB. Manifest Document #00688792WAS.

Figure 12: The photograph above depicts the label of the incompatible oxidizer hazardous waste container that was staged in the Flammable Materials Storage Area.

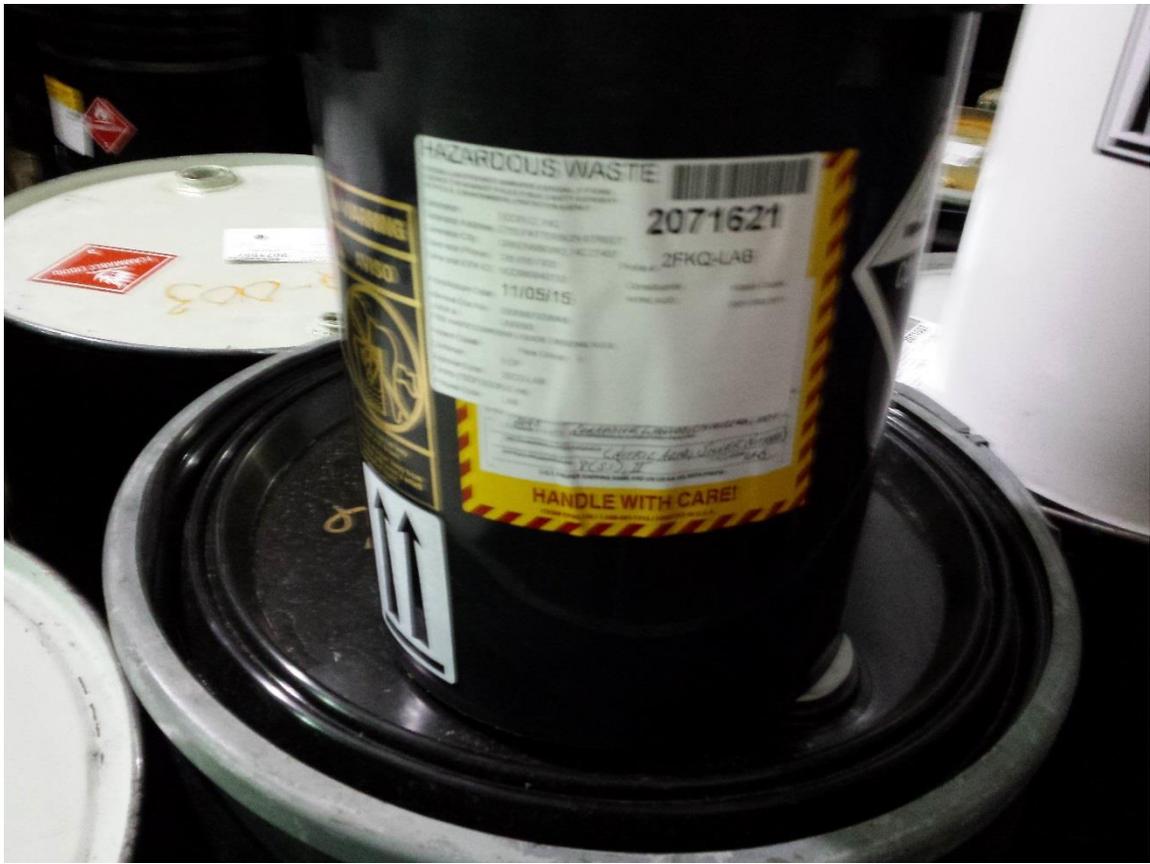
Figure 13: The photograph above depicts the label of the incompatible corrosive hazardous waste container that was staged in the Flammable Materials Storage Area. The container contained Nitric Acid and Silver Nitrate which are incompatible with flammable liquids. Note the flammable liquid placarding in the background.

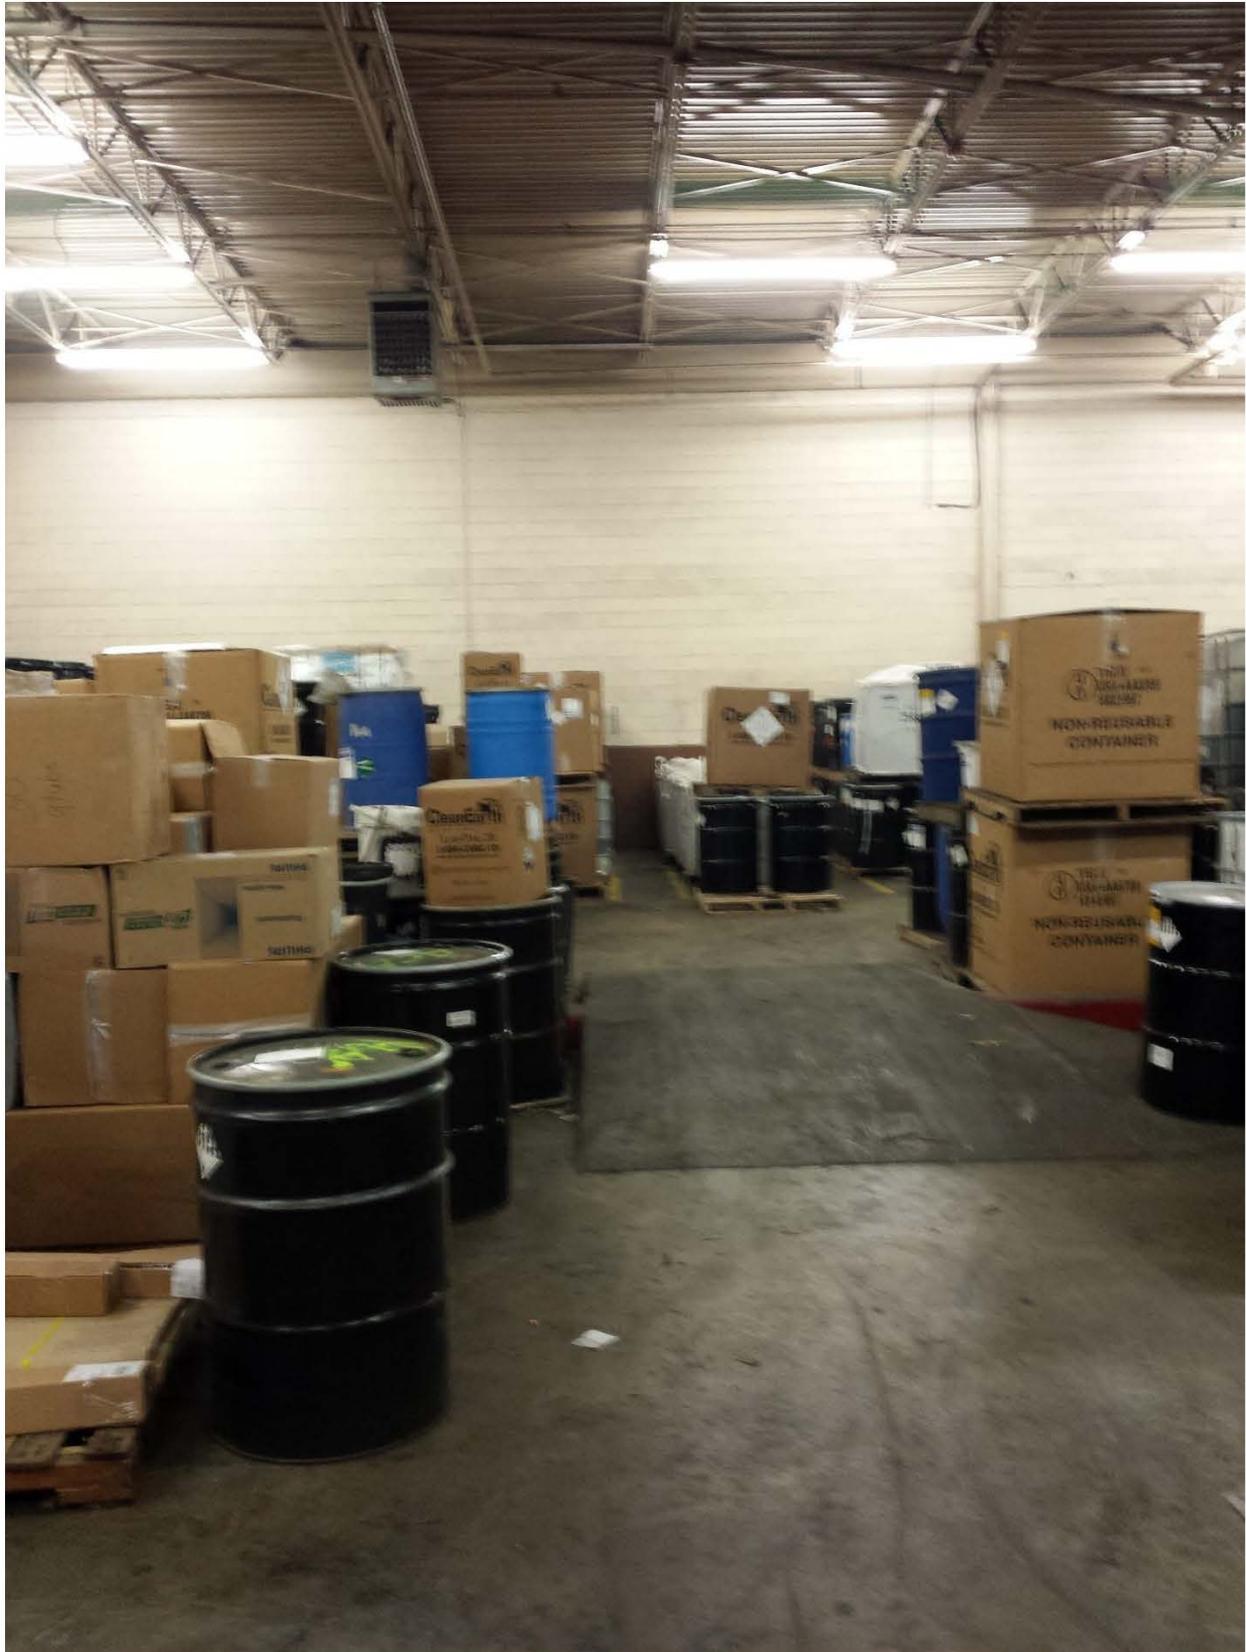
Figure 14: The photograph above depicts the marking used to indicate the 50 foot property line buffer. The marker is a small piece of grey duct tape located on the back wall that lines up with the left edge of the ramp. The picture was taken from the West Staging Area. Note that to the left is the universal waste storage area and is within the 50 foot buffer.
