Remedial Investigation - Subsurface Landfill Gas Survey

**CITY OF LUMBERTON LDFL
Lumberton, Robeson County, North Carolina**

**State Contract N11001S
Task Order No. 712DP-8
MM&A Project Number NCUL233P5**

July 11, 2014

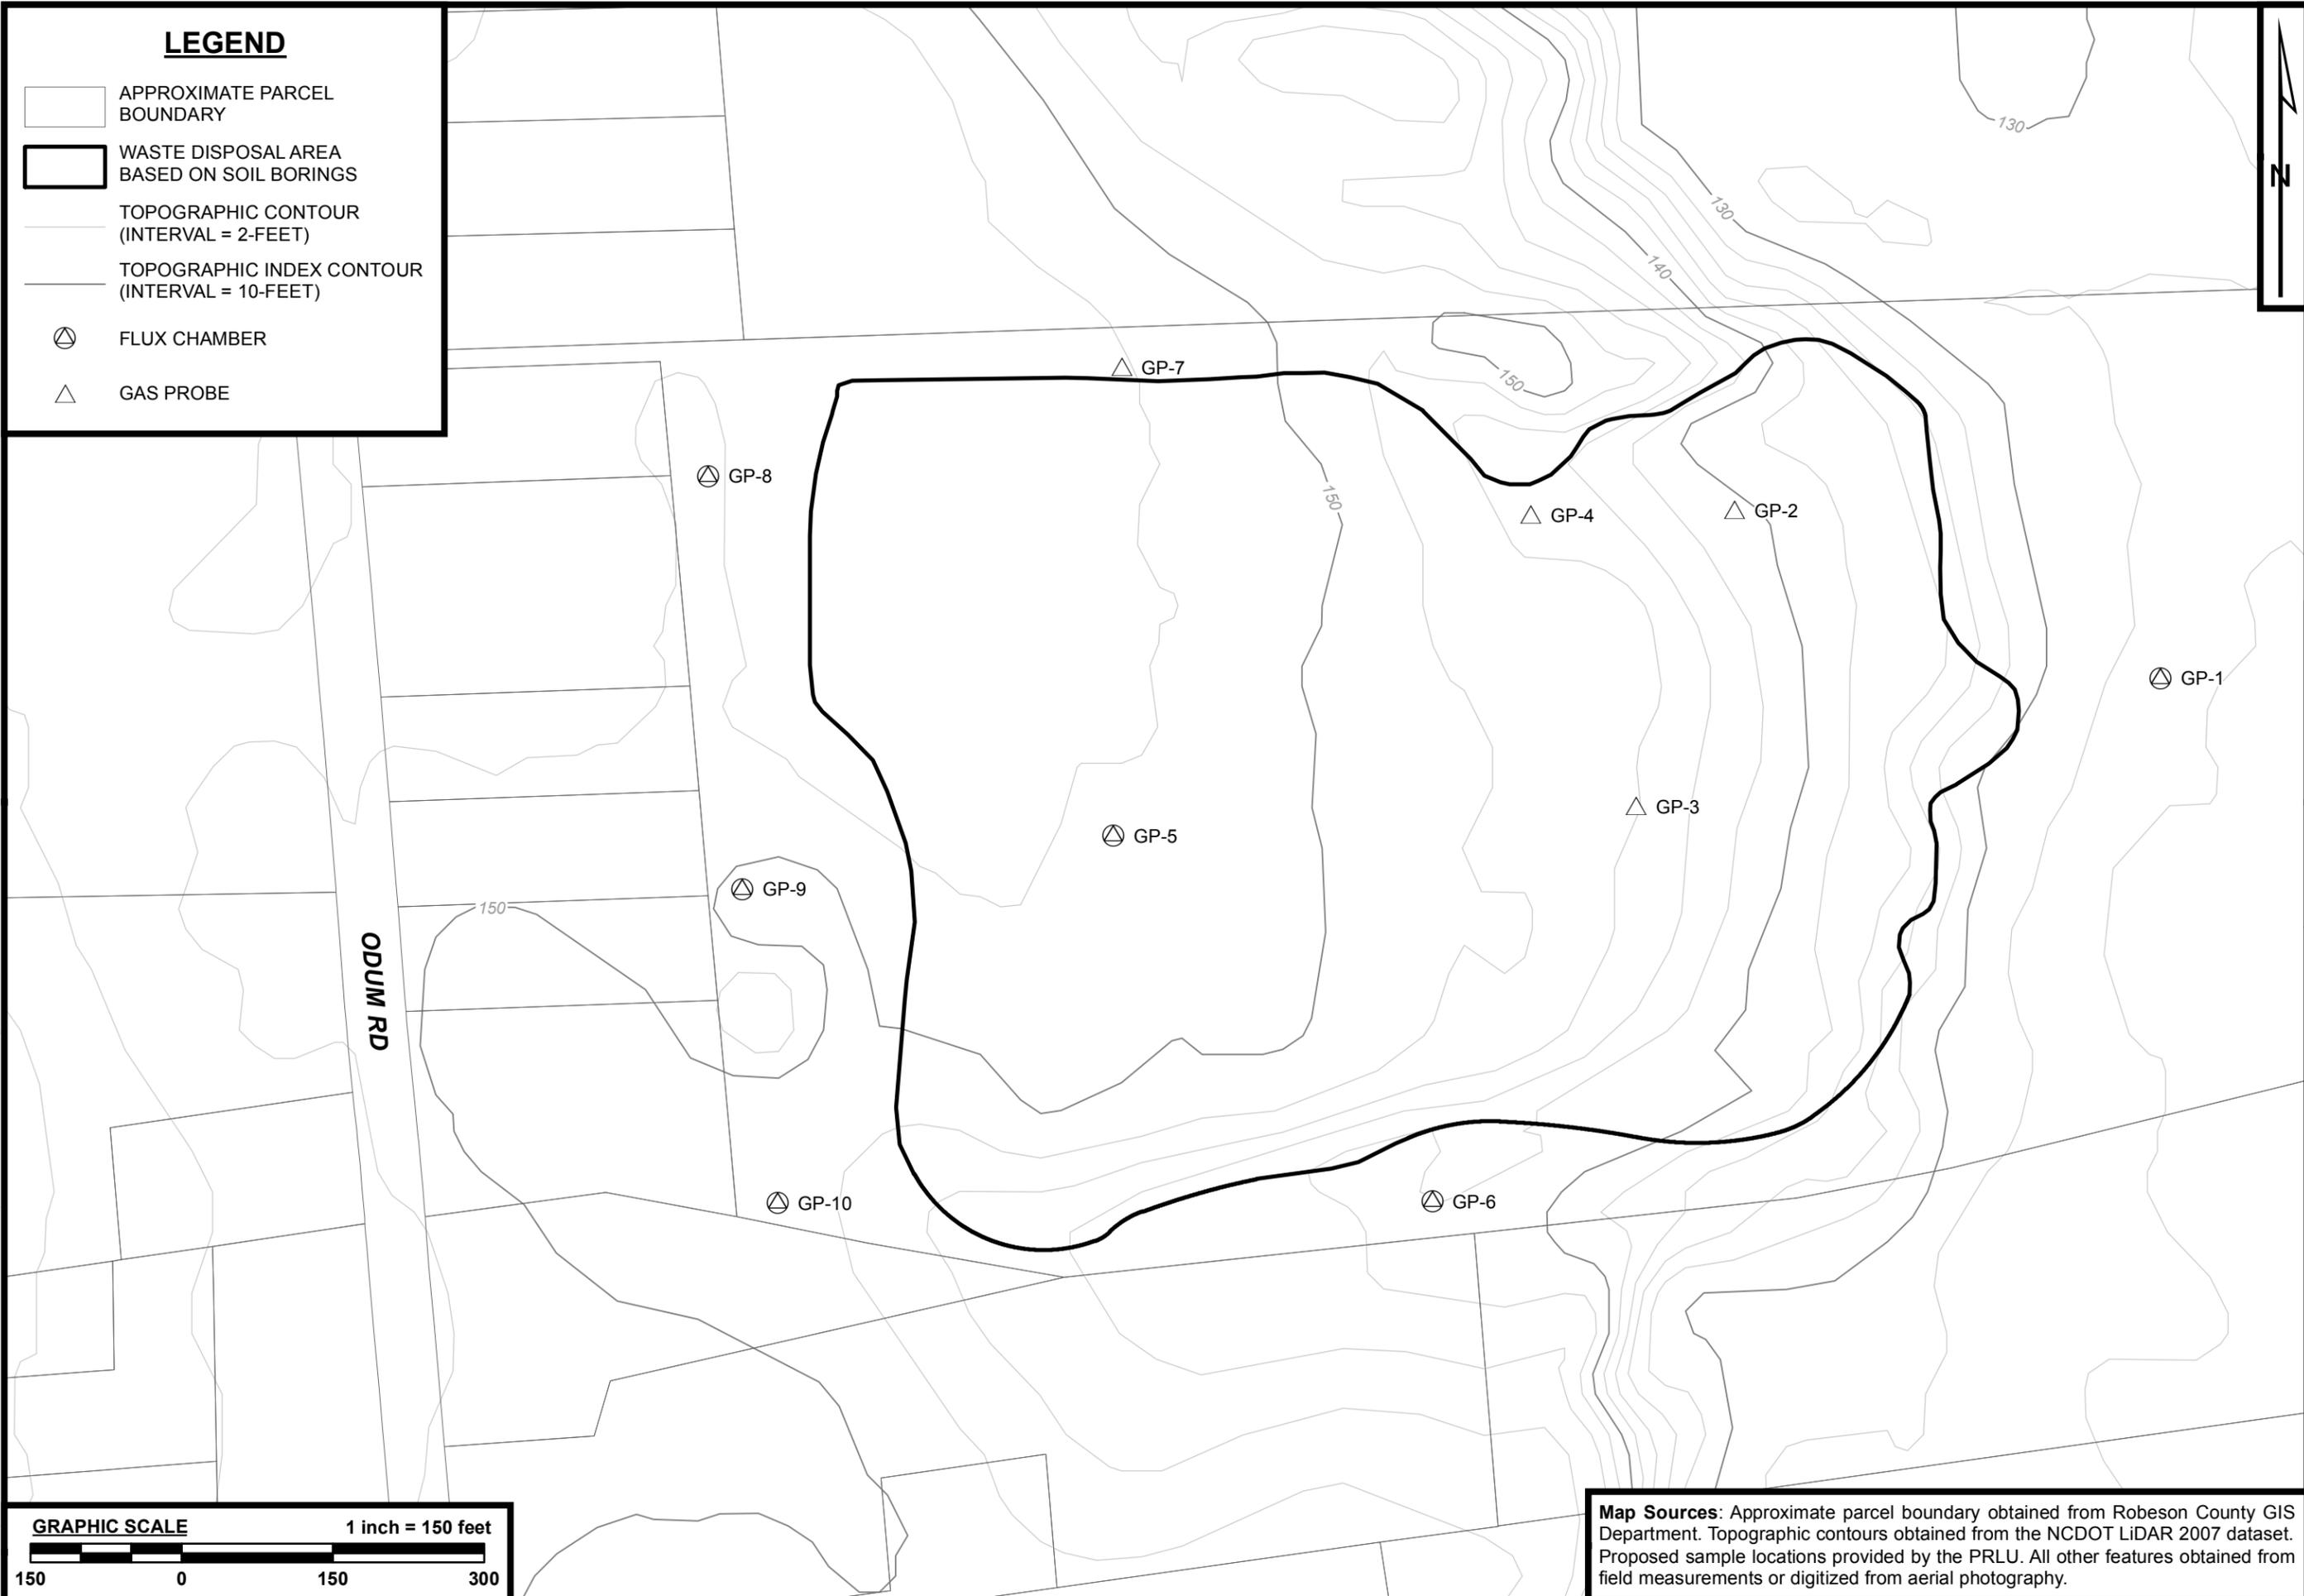
SITE MAP

Landfill gas probe construction records are included in *Table 1*, while boring logs are provided in **Appendix A**. Gas probe locations are shown on *Figure 1*. GPS coordinates of the gas probe locations are included in **Appendix B**.

Due to shallow groundwater, permanent landfill gas probes could not be installed at the GP-1, GP-5, GP-6, GP-8, GP-9, and GP-10 locations with the minimum five foot seal. Therefore, flux chambers were installed at each location (*Figure 1*).
