**N.C. DIVISION OF WASTE MANAGEMENT
HAZARDOUS WASTE SECTION – COMPLIANCE BRANCH**

**LARGE QUANTITY GENERATOR (LQG)
COMPLIANCE EVALUATION INSPECTION (CEI) REPORT**

Name: Horsehead Metal Products, Inc.
EPA ID NCR000159038
Type of Facility: Large Quantity Generator (LQG)
Facility Location: 484 Hicks Grove Road, Mooresboro, North Carolina. 28533
Telephone Number: 828-919-3139
County: Rutherford

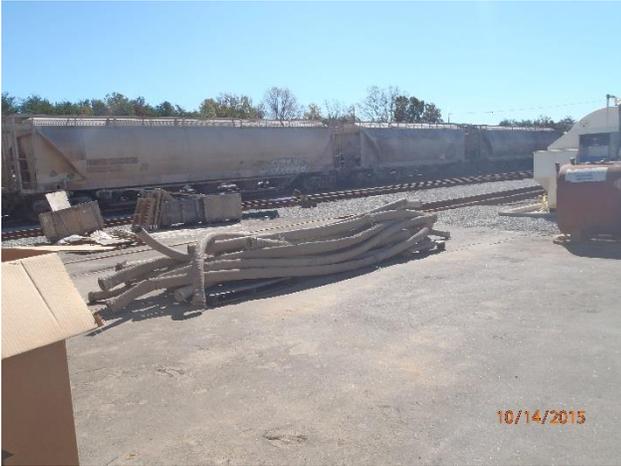
Picture 6 – Rail Yard hazardous waste debris open container

Horsehead Metal Products, Inc. is in violation of this regulation in that there were two trash cans of hazardous waste, located in the WOX Unloading/Rail Yard Area, that were not properly closed in that neither container was equipped with a lid. There was also one small container of hazardous waste, located under a fume hood with the Quality Control Laboratory, that was not properly closed in that the container did not have a cap.

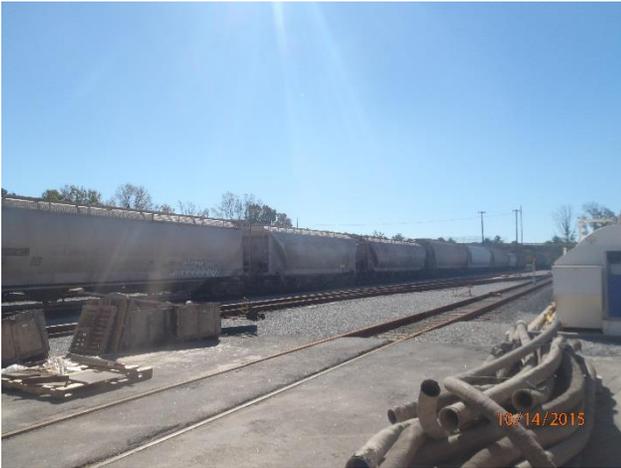
Picture 7 – Rail Yard spent hoses contaminated with WOX

Horsehead Metal Products, Inc. is in violation of this regulation in that there were several spent hoses, located within the WOX Unloading/Rail Yard Area, that were identified as a hazardous waste but were not properly labeled or marked with an accumulation start date.

Horsehead Metal Products, Inc. is in violation of this regulation in that there were several spent hoses, located within the WOX Unloading/Rail Yard Area, that were identified as a hazardous waste and the spent hoses were not properly containerized.

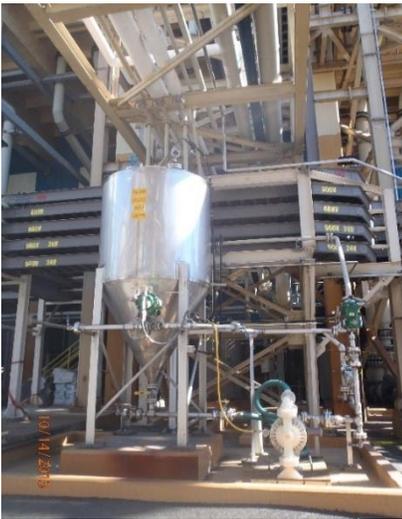
Picture 29 – Recirc Tank – failure area

The inspectors then examined the Recirculation Tank (Picture 29) where rainwater, electrolytes, sulfuric acid (which exceeded the reportable quantity), wash water, drips and overflow that were being stored in the secondary containment area seeped between the tank and the floor seal. The high pH water flowed into the storm water drain and went into Basin 1 and out the storm water discharge pipe. HHMP determined the cause of the seepage was the improperly installed sealant between the floor and the tank. The sealant had eroded away because of the high water pH. The situation was further impaired by the north side sump pump failing and the process water rising higher than normal in the secondary containment area. HHMP stated that the leak was detected in a drain on September 5, 2015, however, the source was not discovered until September 8, 2015. Hazardous and non-hazardous waste roll-offs of the Recirculation Tank spill are located near the depleted solution area. *NCDEQ-Hazardous Waste Section issued Immediate Action NOV Docket #2016-006 to assess the spill area around the Recirculation Tank.

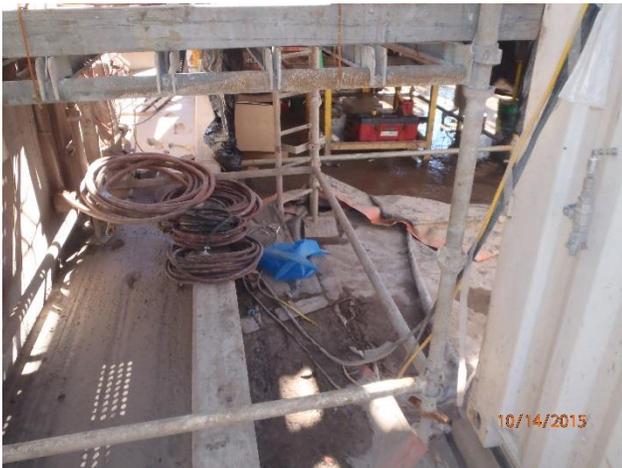
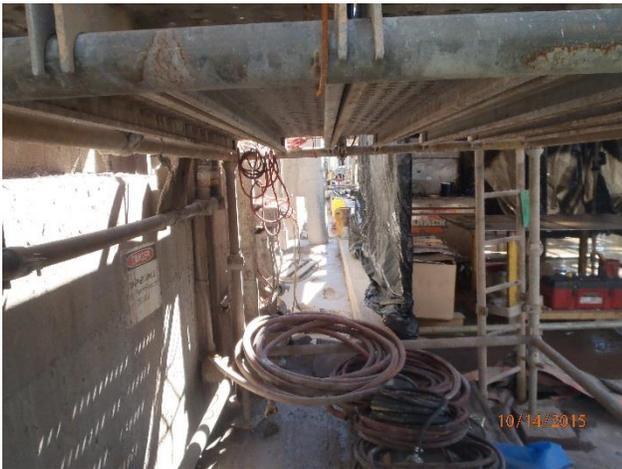
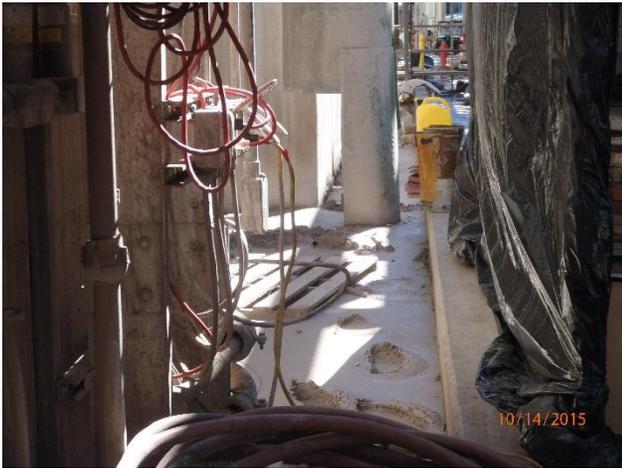
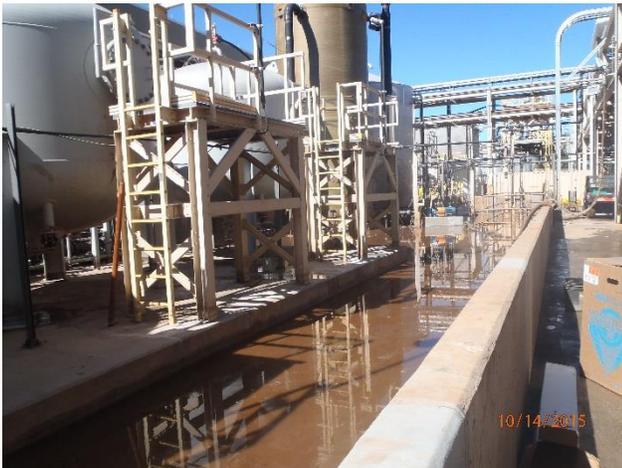
The inspectors also observed that Leach Residue and rain water had accumulated in the 100 Area Reactor and Leach Residue Press secondary containments (Pictures 37-40). Footprints were observed outlined in the Leach Residue discharged to the secondary containment. The inspectors inquired whether the discharged Leach Residue was a waste material. Mr. Harris explained that the Leach Residue was not waste and would be sent to Palmerton and Rockwood facilities and recycled. The PLS secondary containment was also filled with rainwater (Picture 41).

The inspectors expressed concern that the Leach Residue is stored inside the secondary containment instead of a tank or roll-off prior to shipping to other Horsehead facilities. Additionally, the HHMP employees and contractors are exposed openly to the cadmium, lead and zinc in the Leach Residue in the form of dust, mud and contaminated water. The EPA and NC DEQ advised Mr. Harris that the Leach Residue contained hazardous constituents zinc, lead, cadmium and chromium, and releasing the residue into the secondary containment was not considered to be in-process or to be properly stored and/or contained. The EPA and NC DEQ recommends that the residue be stored in appropriate containers until such time that it can be shipped off or used in the process. (See Site Deficiencies)

Picture 37 – 100 Area Reactor secondary containment with accumulated leach residue

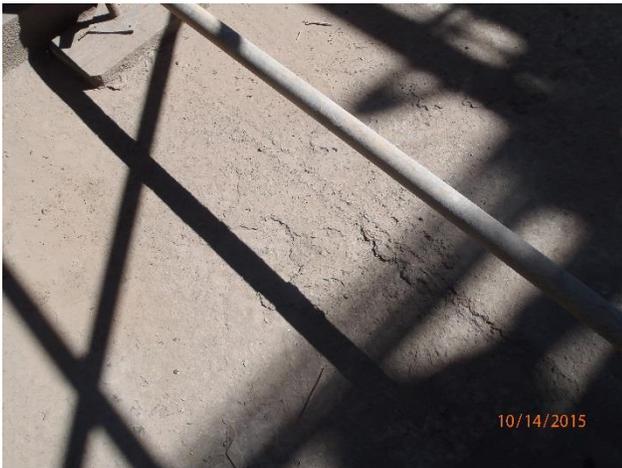
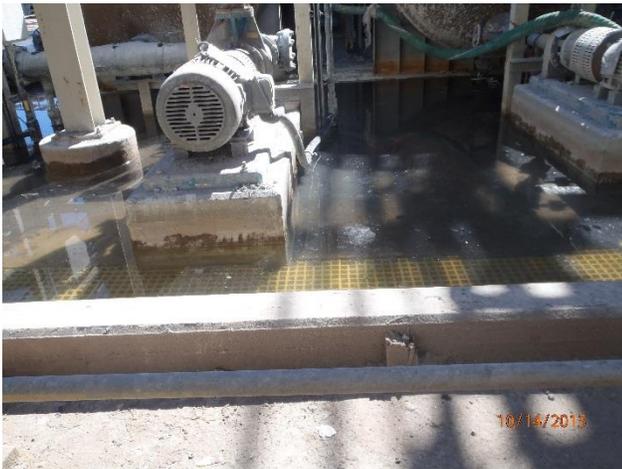
The 100 Area main secondary containment was observed covered in unknown dust and mud (Pictures 42-44). When asked, Mr. Harris explained that dust and mud was residue from the Reactors, the Leach Residue Press and other processes. The inspectors expressed concern that the residue containing cadmium, lead, and silver was being tracked out of the area and around the facility. In addition, the discarded residue was not being used for its intended purpose, thus making the residue on the ground of the 100 Area main secondary containment a hazardous waste. This material was noted on Horsehead's Waste Stream Inventory as being a hazardous waste if disposed (See Site Deficiencies).

Horsehead Metal Products is in apparent violation of this regulation in that process materials/residues were observed at the 100 Area, Raffinate Area and WOX Wash Clarifier Area. Specifically, materials/residues in the form of dust, mud, tank overflow liquids and/or rainwater were found on the ground or being accumulated within secondary containment units within these areas. Additionally, the facility's storm water ponds were being used to accumulate process liquids and sediments until such a time that the materials could be reintroduced back into the process. The process residues were not being properly stored and/or contained. The process materials/residues were not being properly stored and/or contained and based on Horsehead's written Waste Stream Inventory document, the process materials/residues described above would meet the definition of a hazardous waste; and therefore were not being managed in a manner to minimize the possibility of a release of hazardous waste constituents to the air, soil, or surface water.

Picture 43 – 100 Area main secondary containment covered in unknown dust and mud

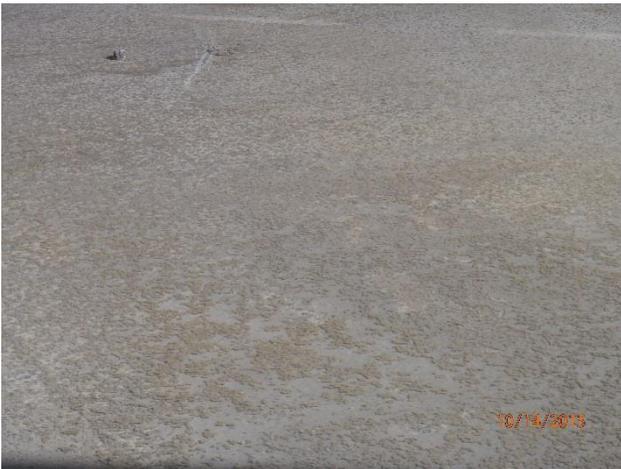
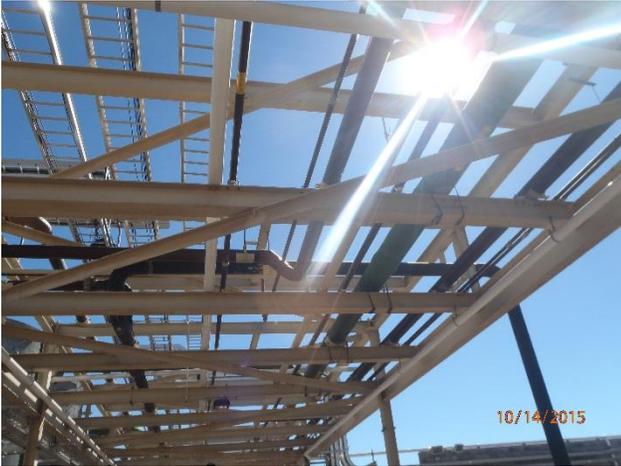
The inspectors observed that the 200 Area Raffinate secondary containment was filled with rainwater. Upon closer examination, it was observed that the secondary containment concrete was etched (Pictures 45-48). The inspectors expressed concern over the etching in the concrete and asked what caused the etching. Mr. Harris explained that overflow of the Raffinate tanks due either to operation error or process issue upset. Mr. Harris indicated that a coating contractor had been obtained and was ready to coat the secondary containment.

The inspectors expressed concern that the in-process material that HHMP is storing is causing etching in the secondary containment system. Secondary containment areas are required to have a base that must underlie the containers which is free of cracks or gaps and is sufficiently impervious to contain leaks, spills, and accumulated precipitation until the collected material is detected and removed. The EPA advised Mr. Harris that releasing the acidic aqueous solution into a permeable structure was not considered to be properly stored and/or contained. The EPA and NC DEQ recommends that the Raffinate secondary containment be re-coated prior to any further releases or upsets. This material was noted on Horsehead's written Waste Stream Inventory as being a hazardous waste if disposed" (See Site Deficiencies).

Picture 47 – Raffinate Area secondary containment with etched concrete under rainwater

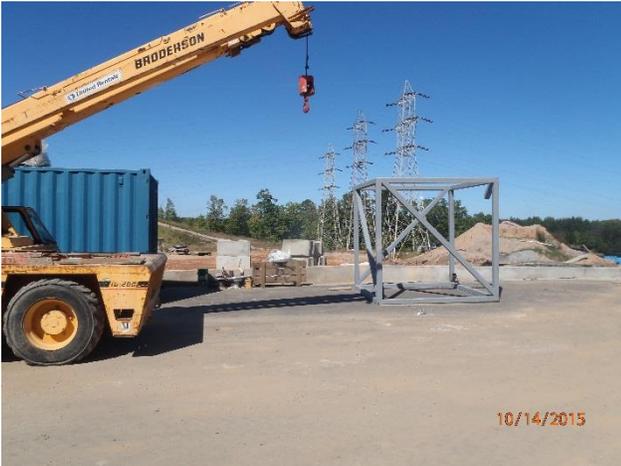
Picture 49 – Raffinate Area depleted solution pipe that was broken in May 2015

In May 2015, HHMP had a release of depleted solution from a ruptured elbow in the piping. The solution filled the secondary containment before overflowing onto the ground and down the drainage channel (Pictures 49-52). The release was reported as hydrogen sulfide and zinc solution to the National Response Center (Incident Report # 1116915). HHMP neutralized the ground and removed the solution contaminated soil into roll-offs in July 2015.

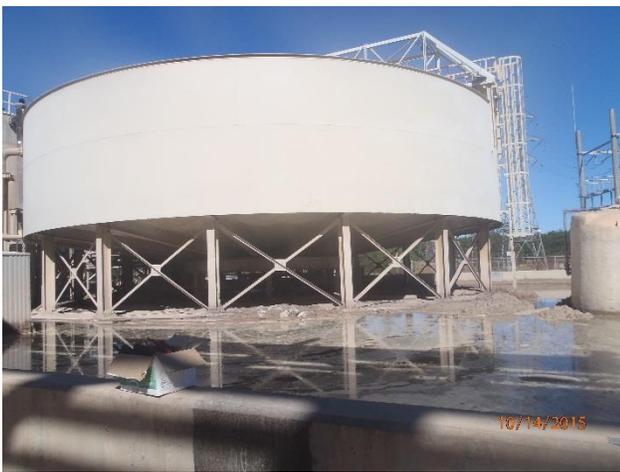
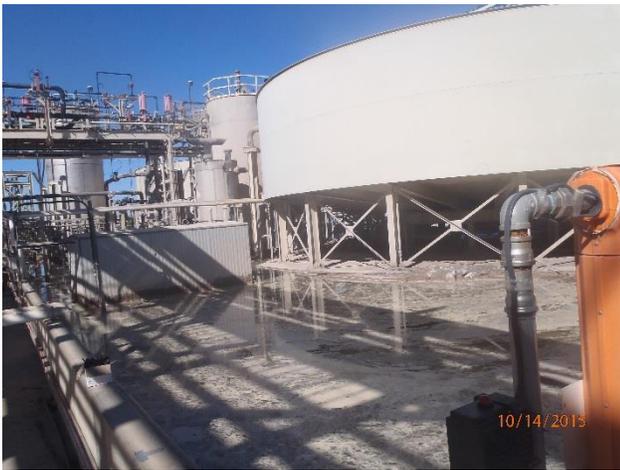
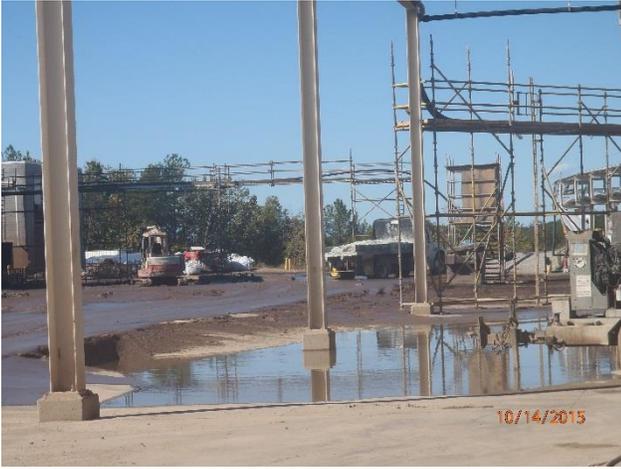
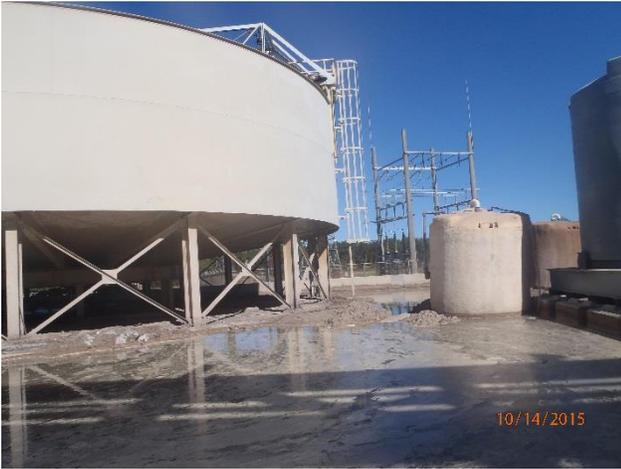
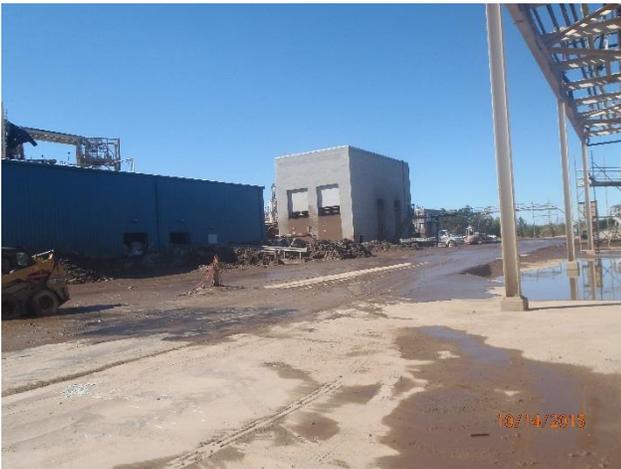
The inspectors observed that the WOX Wash Clarifier secondary containment was filled with rain water and tank overflow material (Pictures 77, 79-85). The ground surrounding the clarifier contained residue dust, mud and rainwater. The area had been recently covered in concrete six months previous.

The inspectors are concerned that the Final Press Residue is stored on the ground prior to shipping to other Horsehead facilities. Additionally, the HHMP employees and contractors are exposed openly to any constituents in the Final Press Residue in the form of dust, mud and contaminated water. The EPA and NC DEQ observed that releasing the residue onto the ground was not considered to be in-process or to be properly stored and/or contained. The EPA and NCDEQ explained that the residue be stored in appropriate containers until such time that it can be shipped off or used in the process. This material was noted on Horsehead's written Waste Stream Inventory as being a hazardous waste if disposed" (See Site Deficiencies).

Picture 79 – WOX Clarifier residual from full basin tank overflow

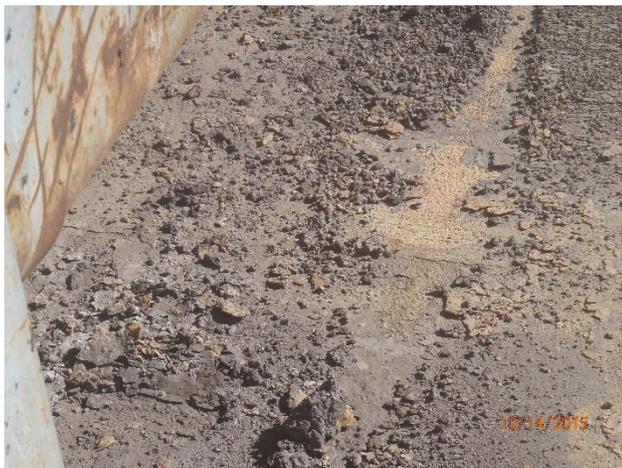
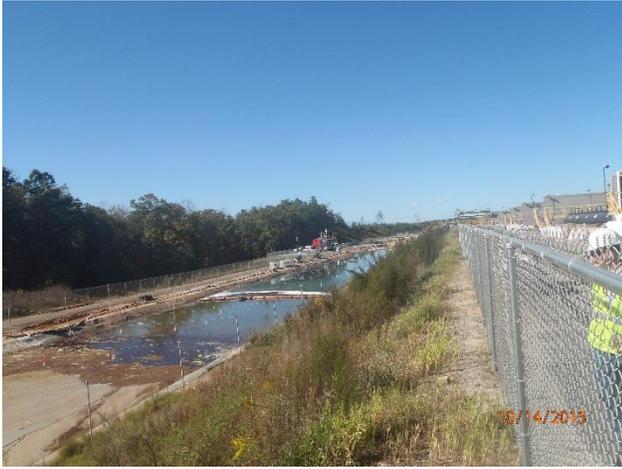
Horsehead Metal Products is in violation of this regulation in that there was an unknown mud found around the base of a roll-off container, located at the Crude Press Area, and the facility had failed to determine if the mud is a hazardous waste. In addition, there was dust and mud, from the 100 Area's main secondary containment unit being tracked out of the Area and around the facility. The dust and mud originated from 100 Area's reactors, Leach Residue Press and other processes and was not being used for its intended purpose; and therefore is subject to a hazardous waste determination.

Picture 97 – Crude Press Area roll-off material release on the ground

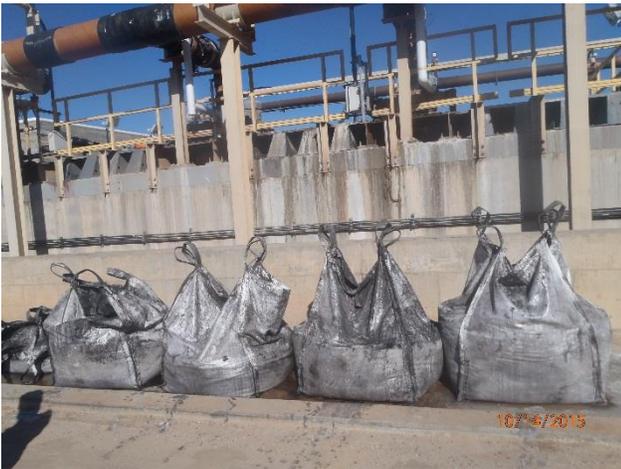
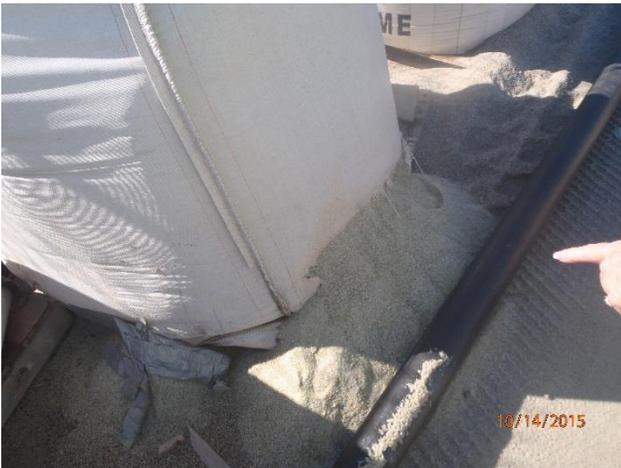
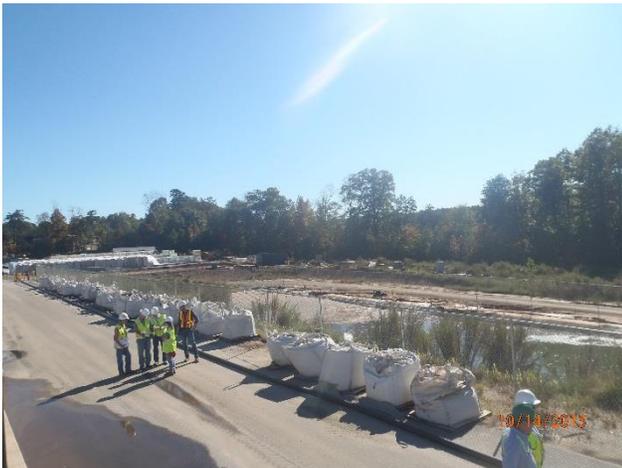
At the time of the inspection, the facility was storing 57 super sacks of spent manganese along the Process Ponds driveway (Pictures 103-105, 108). Mr. Harris explained that the spent manganese was from the cell house cleanout and would be sold because of the lead and silver concentrate. The inspectors expressed concern that many of the supersacks were open and none of the bags were labeled as hazardous material prior to shipping out. In addition, the inspectors noted that a broken super sack of high end sand to be used in the sand and carbon filters (Pictures 106-107). The inspectors expressed concern over the management and improper storage of the raw product.

Picture 103 – Process Ponds bags of spent manganese

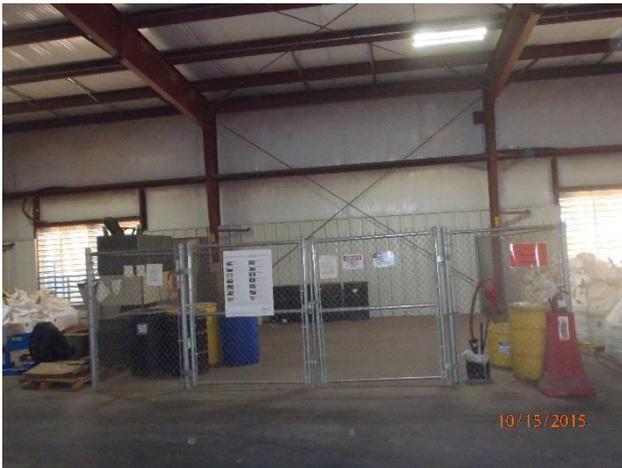
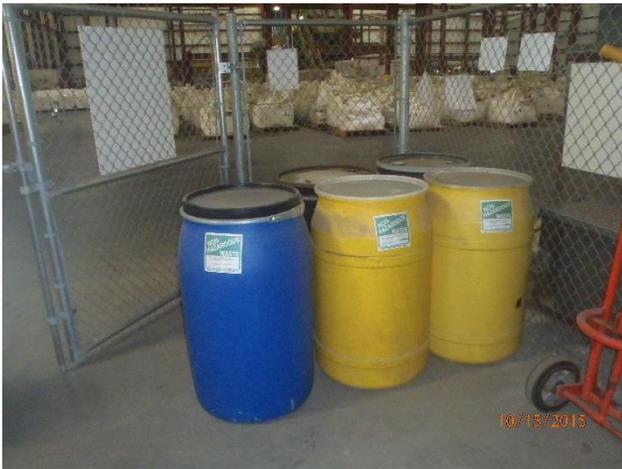
Inside the enclosure was four 55-gallon drums of used oil, oily water, oily rags and oily cleanup and one drum of neutralized acid spill cleanup. The drums were observed labeled and closed (Pictures 127-128).

Picture 127 – Less 90 Day HWSA
