# FACILITY COMPLIANCE INSPECTION REPORT

## Division of Waste Management

**Date of Site Inspection:** 5/5/2016

Highlands MSW Transfer Station  
1080 Rich Gap Rd  
Highlands, NC 28741

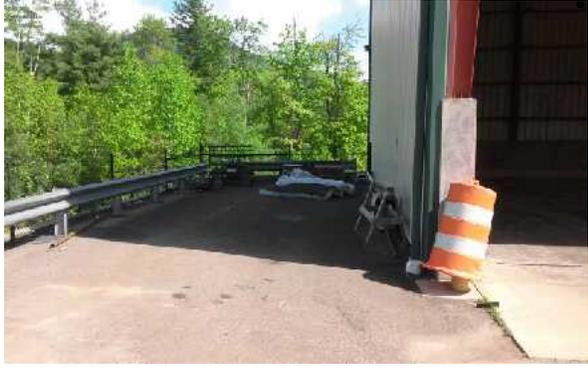
Location	Photo 1
<p data-bbox="164 632 233 657">NOTES</p>

Macon County is in violation of 15A NCAC 13B .0203(d) by failing to deposit all waste onto the tipping floor. Mattresses were observed deposited and stored outside on the west side of the transfer building.

<p data-bbox="797 632 1203 657">NOTES Mattresses outside transfer station</p>
Photo 2	Photo 3

- **\*\*Mattresses were observed outside of the transfer building. All waste must be deposited on the tipping floor or deposited directly into a transfer container. Please see observed violation section of this report.\*\***
- No unacceptable material was observed on the tipping floor at the time of inspection.
- Trench drains were clear and appeared to be working properly.
- Minimal windblown material was observed at the time of inspection. Facility staff were actively policing the grounds for windblown litter at the time of inspection.
- Loaded trailers are parked on concrete pads with trench drains connected to the leachate collection system.
- Pallets are collected to the southwest of the transfer station.

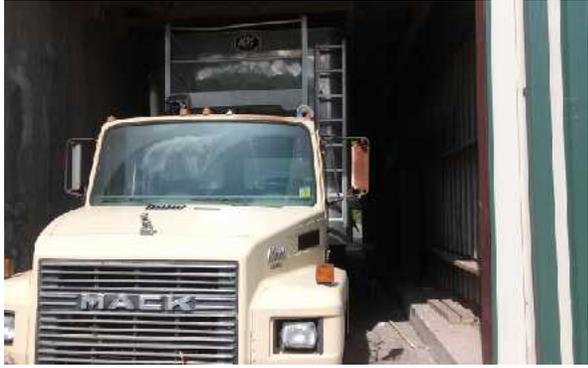
- The facility consists of a pre-engineered steel building with a single loading bay.
- The tipping floor and push walls were observed and appeared to be in good condition.
- Residential and commercial customers dump their waste directly onto the tipping floor.

<p data-bbox="164 1188 548 1213">NOTES Transfer Station Walls and Floor</p>

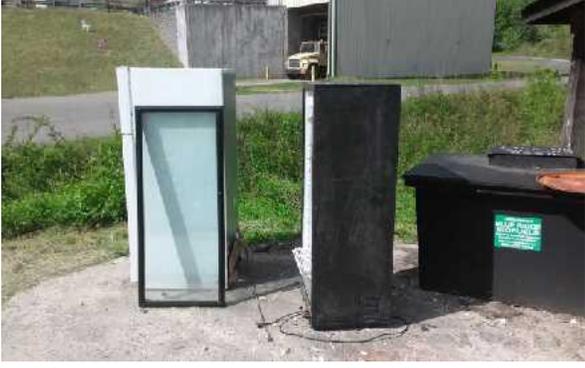
<p data-bbox="797 1188 1013 1213">NOTES Receiving Bay</p>
Photo 4	Photo 5
