FACILITY COMPLIANCE INSPECTION REPORT

Division of Waste Management

Solid Waste Section

City of Brevard Public Works Department
232 Cashiers Valley Rd
Brevard, NC 28712

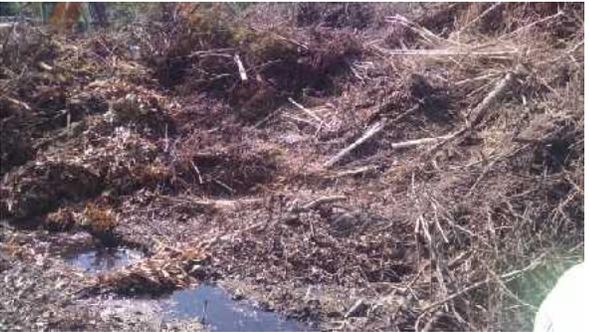
The City of Brevard is in violation of 15A NCAC 13B .1406(3) by failing to divert surface water from the storage area. Ponding water was observed in the unground material storage area.

- Minimal unacceptable material was observed in recently dumped loads. Please continue to remove any unacceptable material and dispose of it properly.
- Standing water was observed on the northwest side of the unground material. Positive drainage must be maintained to prevent standing water from occurring. **Please see observed violations section of this report.**

<p>NOTES Impounded water in unground stockpile</p>

The City of Brevard must immediately divert surface water and grade the area to ensure positive drainage so that water will not be impounded.

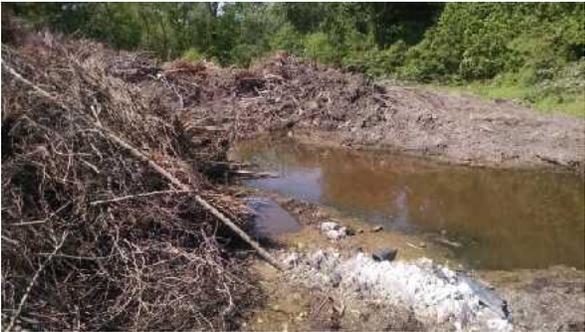
<p>NOTES Impounded water in unground stockpile</p>
Photo 4	Photo 5

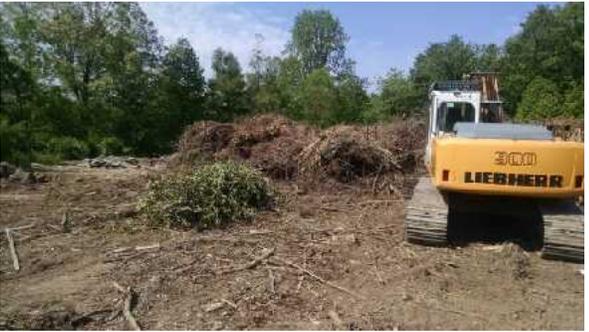
- The unground material stockpile consisted of yard trash and land clearing debris.
- Cantrell Construction of Brevard grinds the material on an as needed basis.

<p>NOTES Unground material stockpile</p>	<p>NOTES</p>
