Reference: **TASK ORDER 375DP-5**
Remedial Investigation – Media Sampling and Wetland/Floodway
Determination
Stedman Landfill
2550 Page Road
Stedman, Cumberland County, North Carolina
ID # NONCD0000375
State Contract # N13001S
ESP Project No. E6-BN12.611.003

This Remedial Investigation – Media Sampling and Wetland/Floodway Determination report has been prepared by ESP Associates, P.A. (ESP) to present the results of cover soil resampling and analysis to confirm total chromium concentrations previously identified and to determine presence of hexavalent chromium at the Stedman Landfill (NONCD0000375) located at 2550 Page Road, Stedman, Cumberland County, North Carolina. In addition, this report presents the results of a wetlands delineation and a topographic survey in the near vicinity of the waste disposal area as well as Preliminary Notices of an Inactive Hazardous Substance or Waste Disposal Site (“Preliminary Plats”) for the impacted properties. The activities presented in this report were performed in accordance with ESP’s work plan for Task Order 375DP-4 dated January 11, 2016, and ESP’s Standard Operating Procedures (SOP) and Quality Assurance (QA) Manual dated April 18, 2013

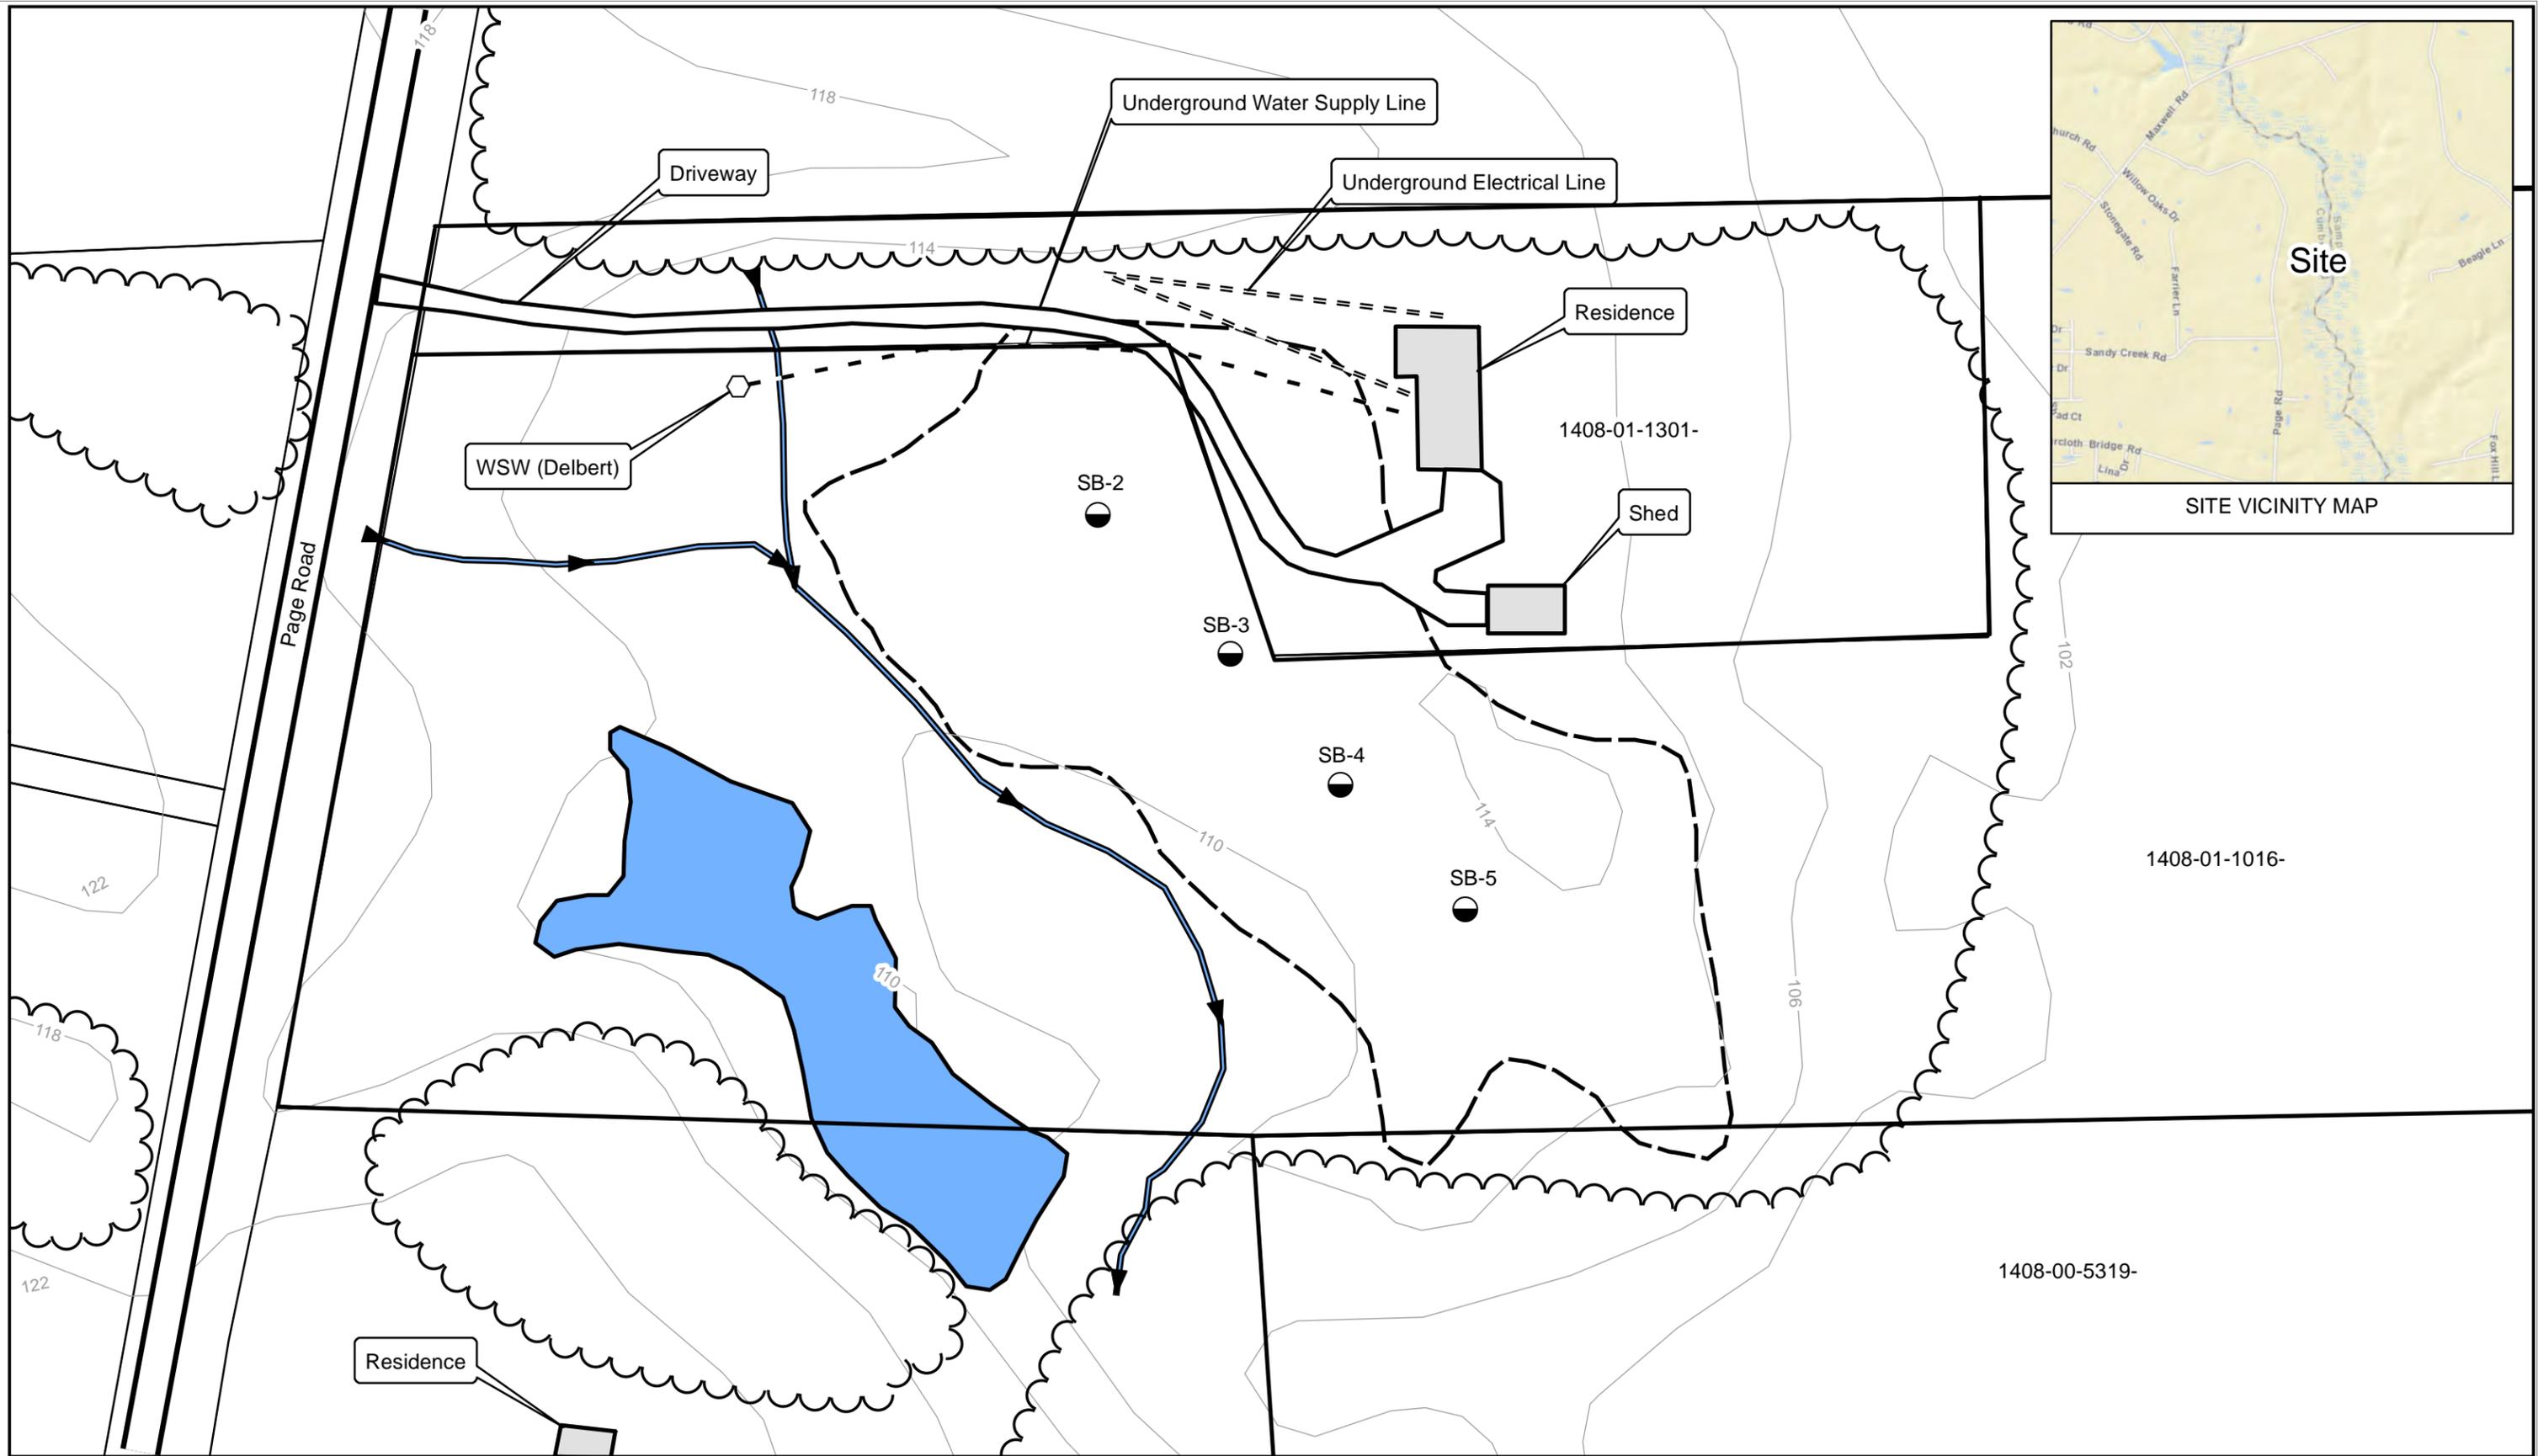
On February 11, 2016, ESP advanced four soil borings (designated SB-2 through SB-5) to various depths ranging from 2 to 3 feet (ft) below ground surface (ft bgs) using a decontaminated stainless steel hand auger to collect cover soil samples. Figure 1 depicts the locations of the four soil borings.

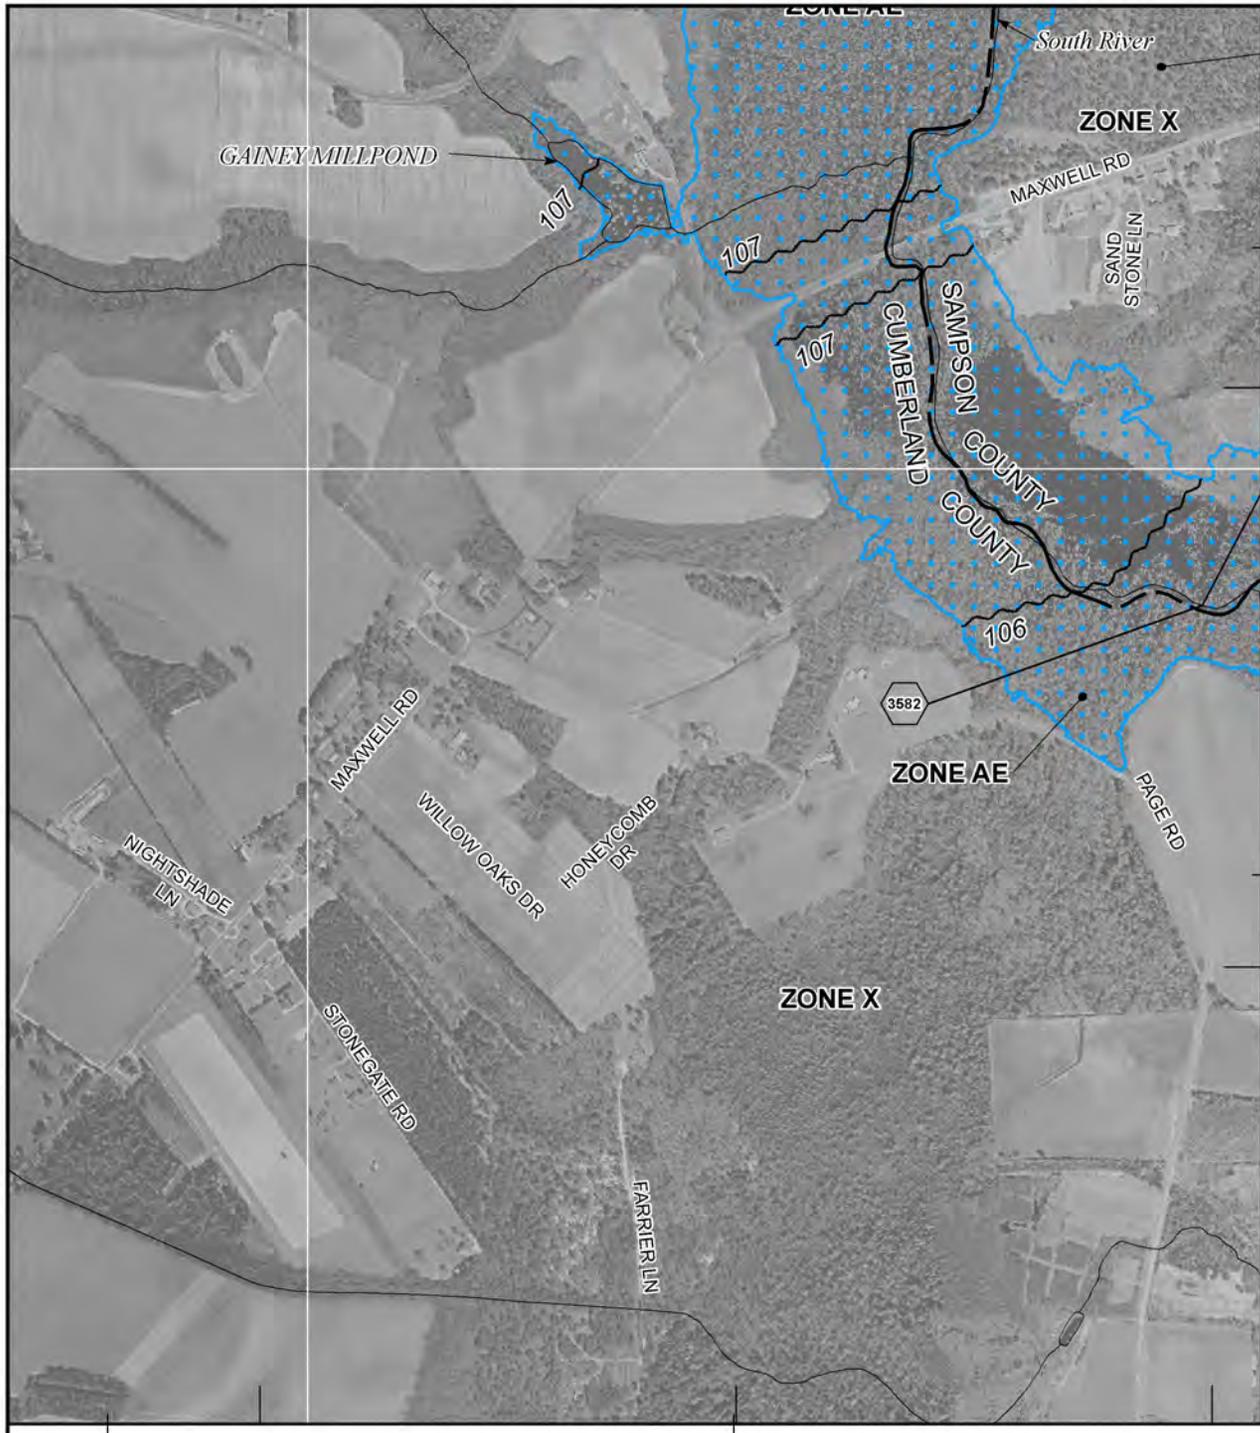
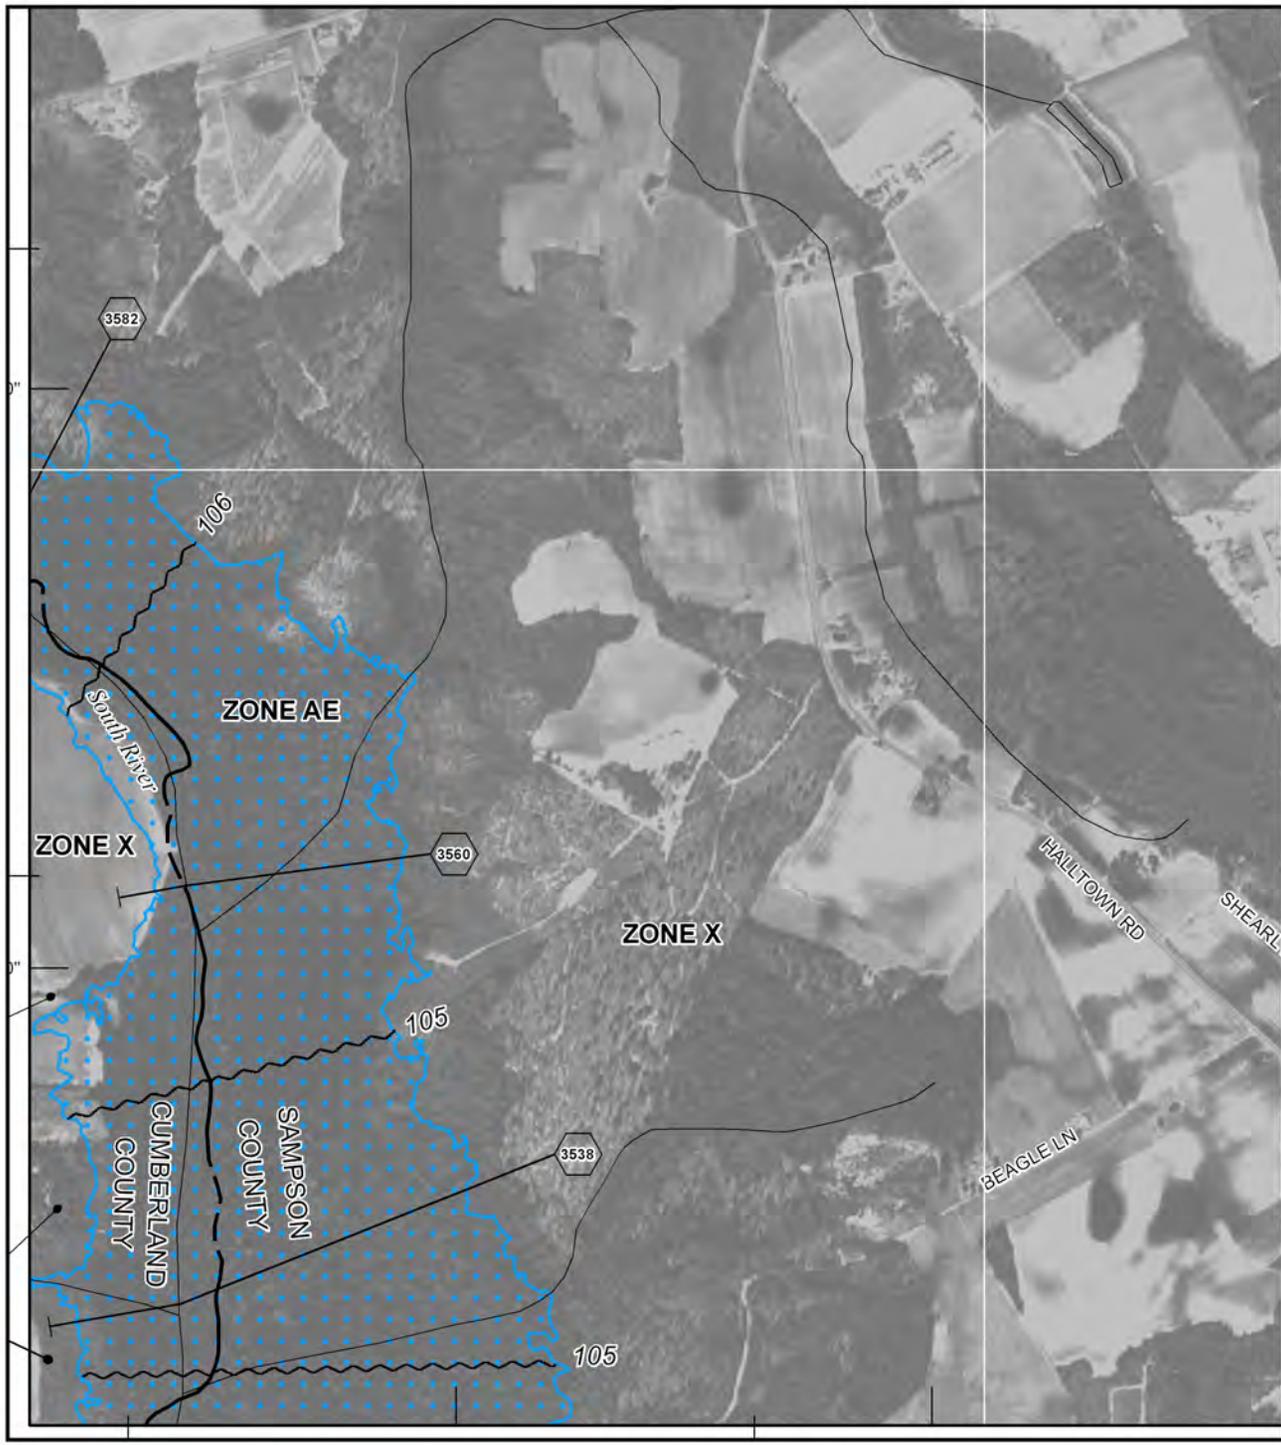
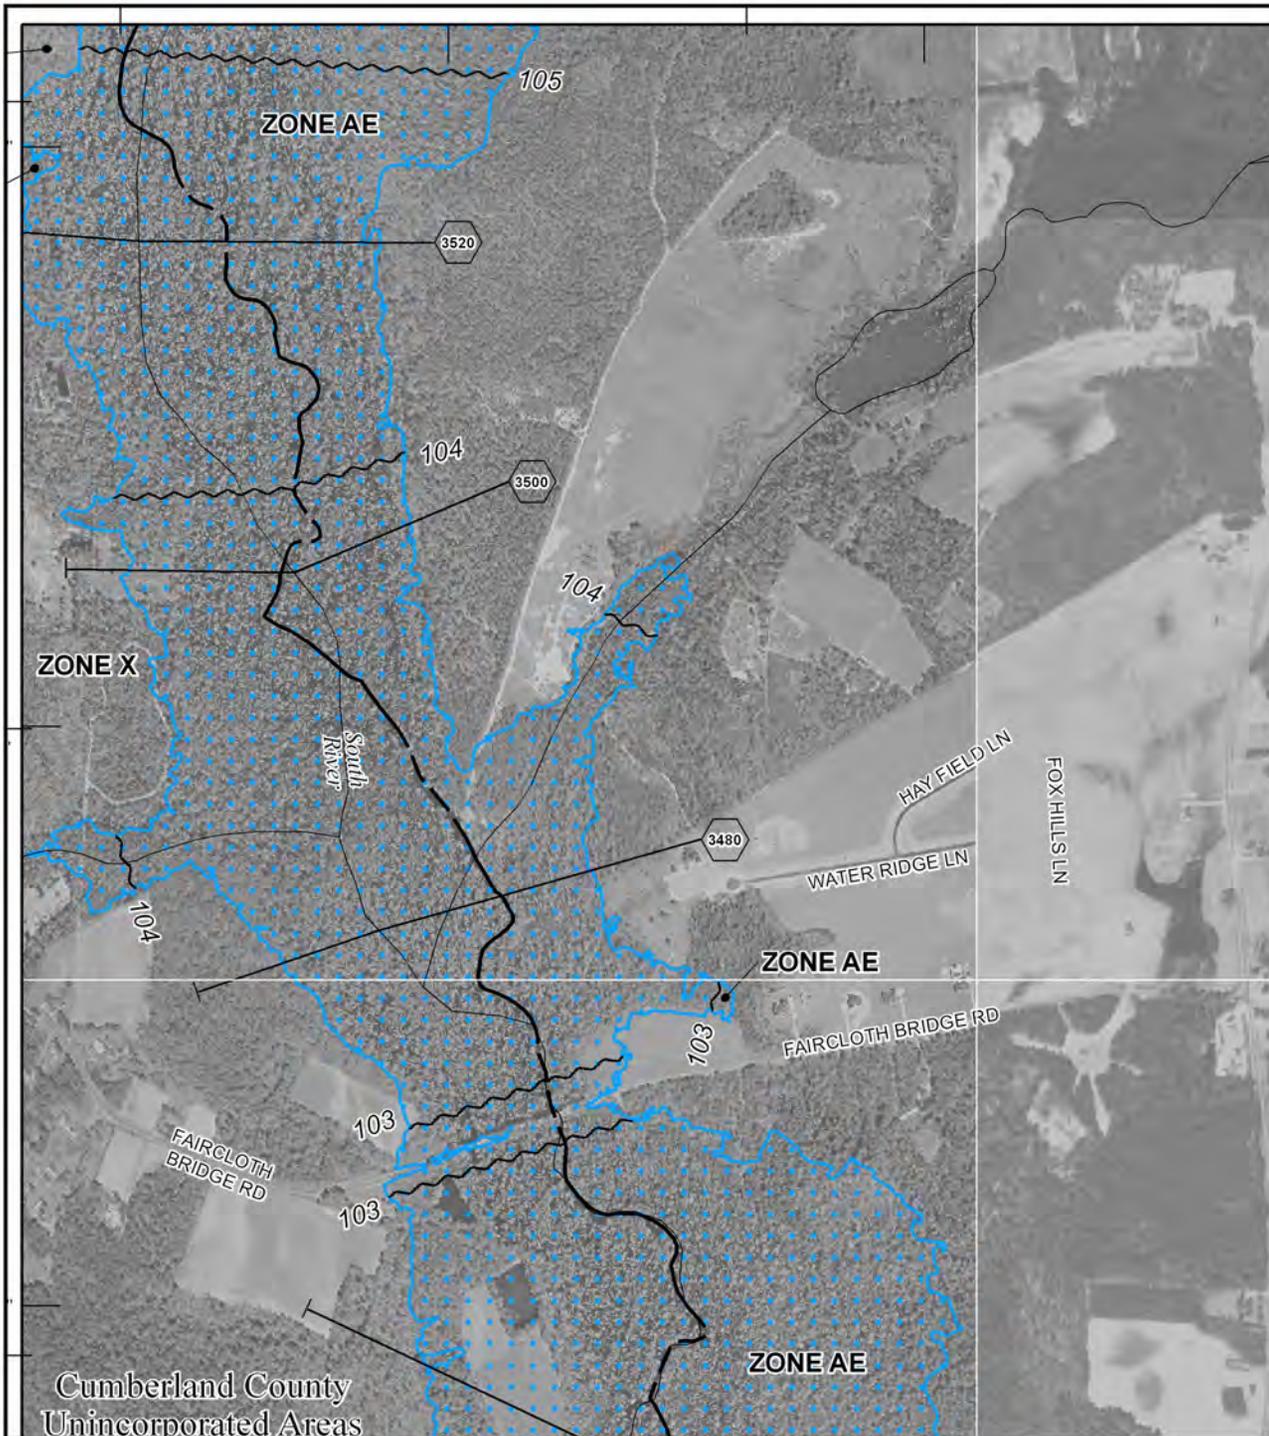
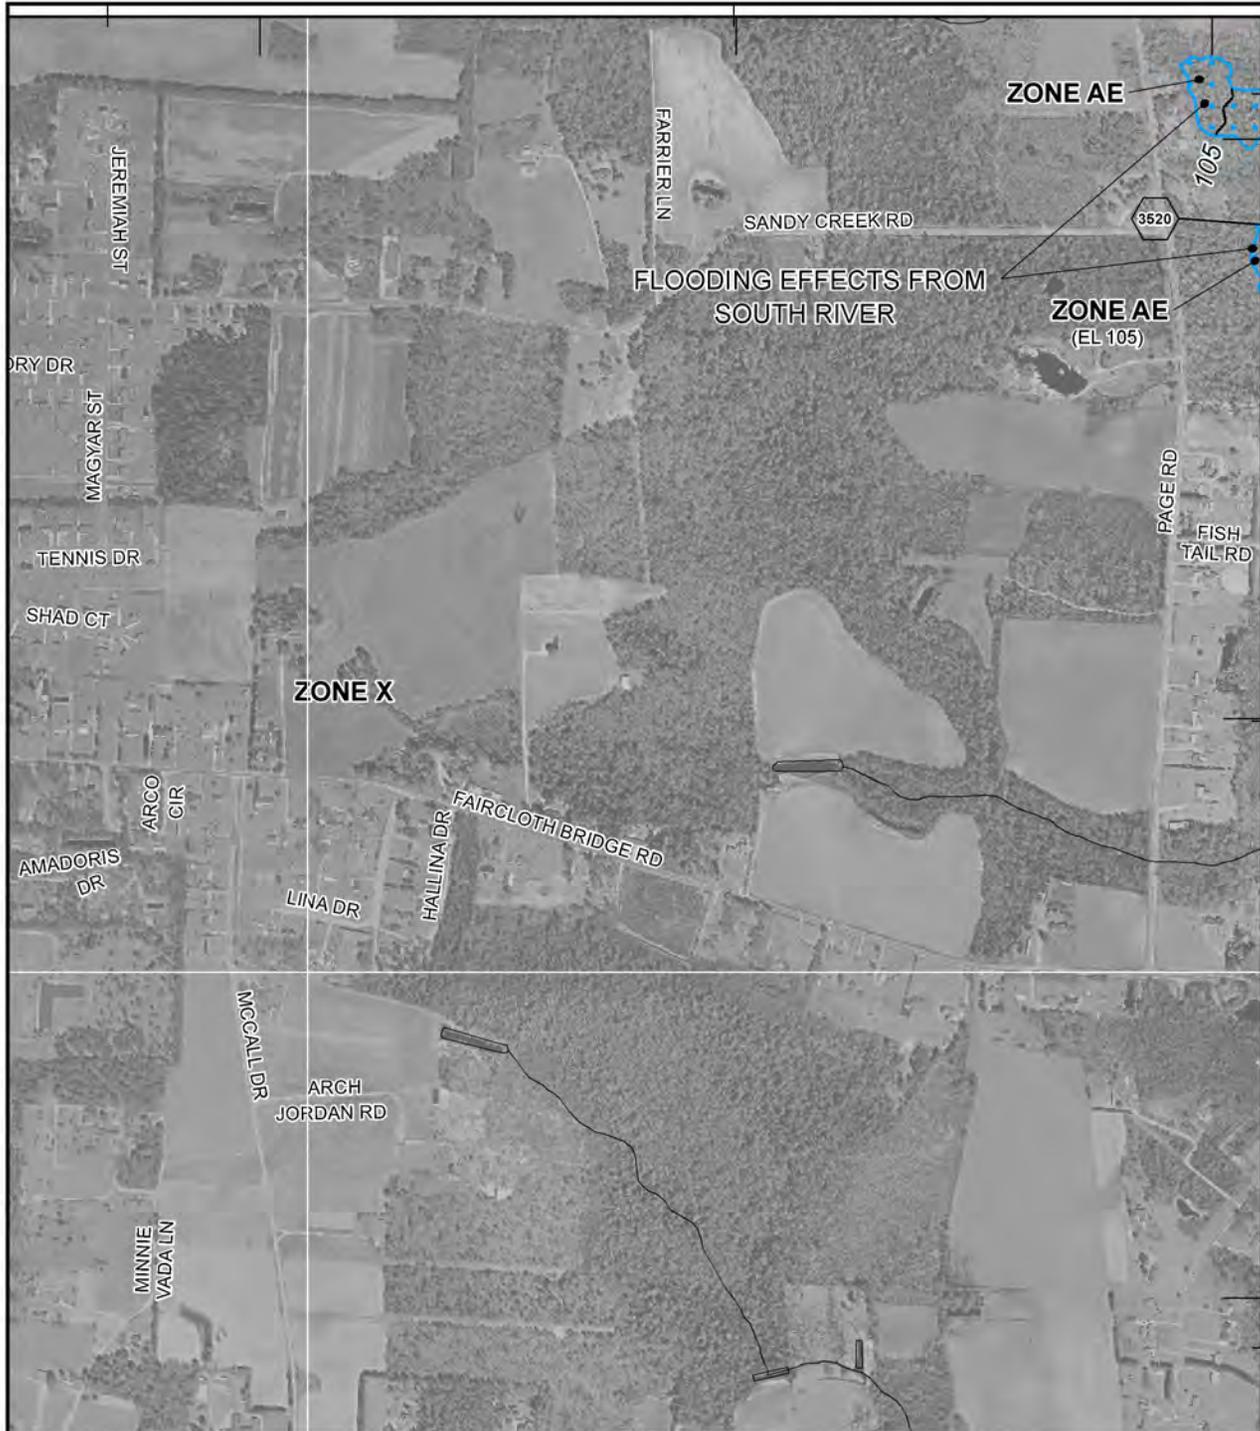
ATTACHMENT E
FEMA FLOOD INSURANCE RATE MAPS

The Federal Emergency Management Agency's (FEMA's) Flood Insurance Rate Maps (FIRMs) showing the floodplain/floodway associated with the South River, located approximately 740 ft east of the waste disposal area boundary (i.e., Map Nos. 3720048800J, 3720140800J, 3720140600J, and 3720048600J) are provided in Attachment E. The location of the floodplain within 500 ft of the waste disposal area boundary is shown on the wetlands delineation map in Attachment F.

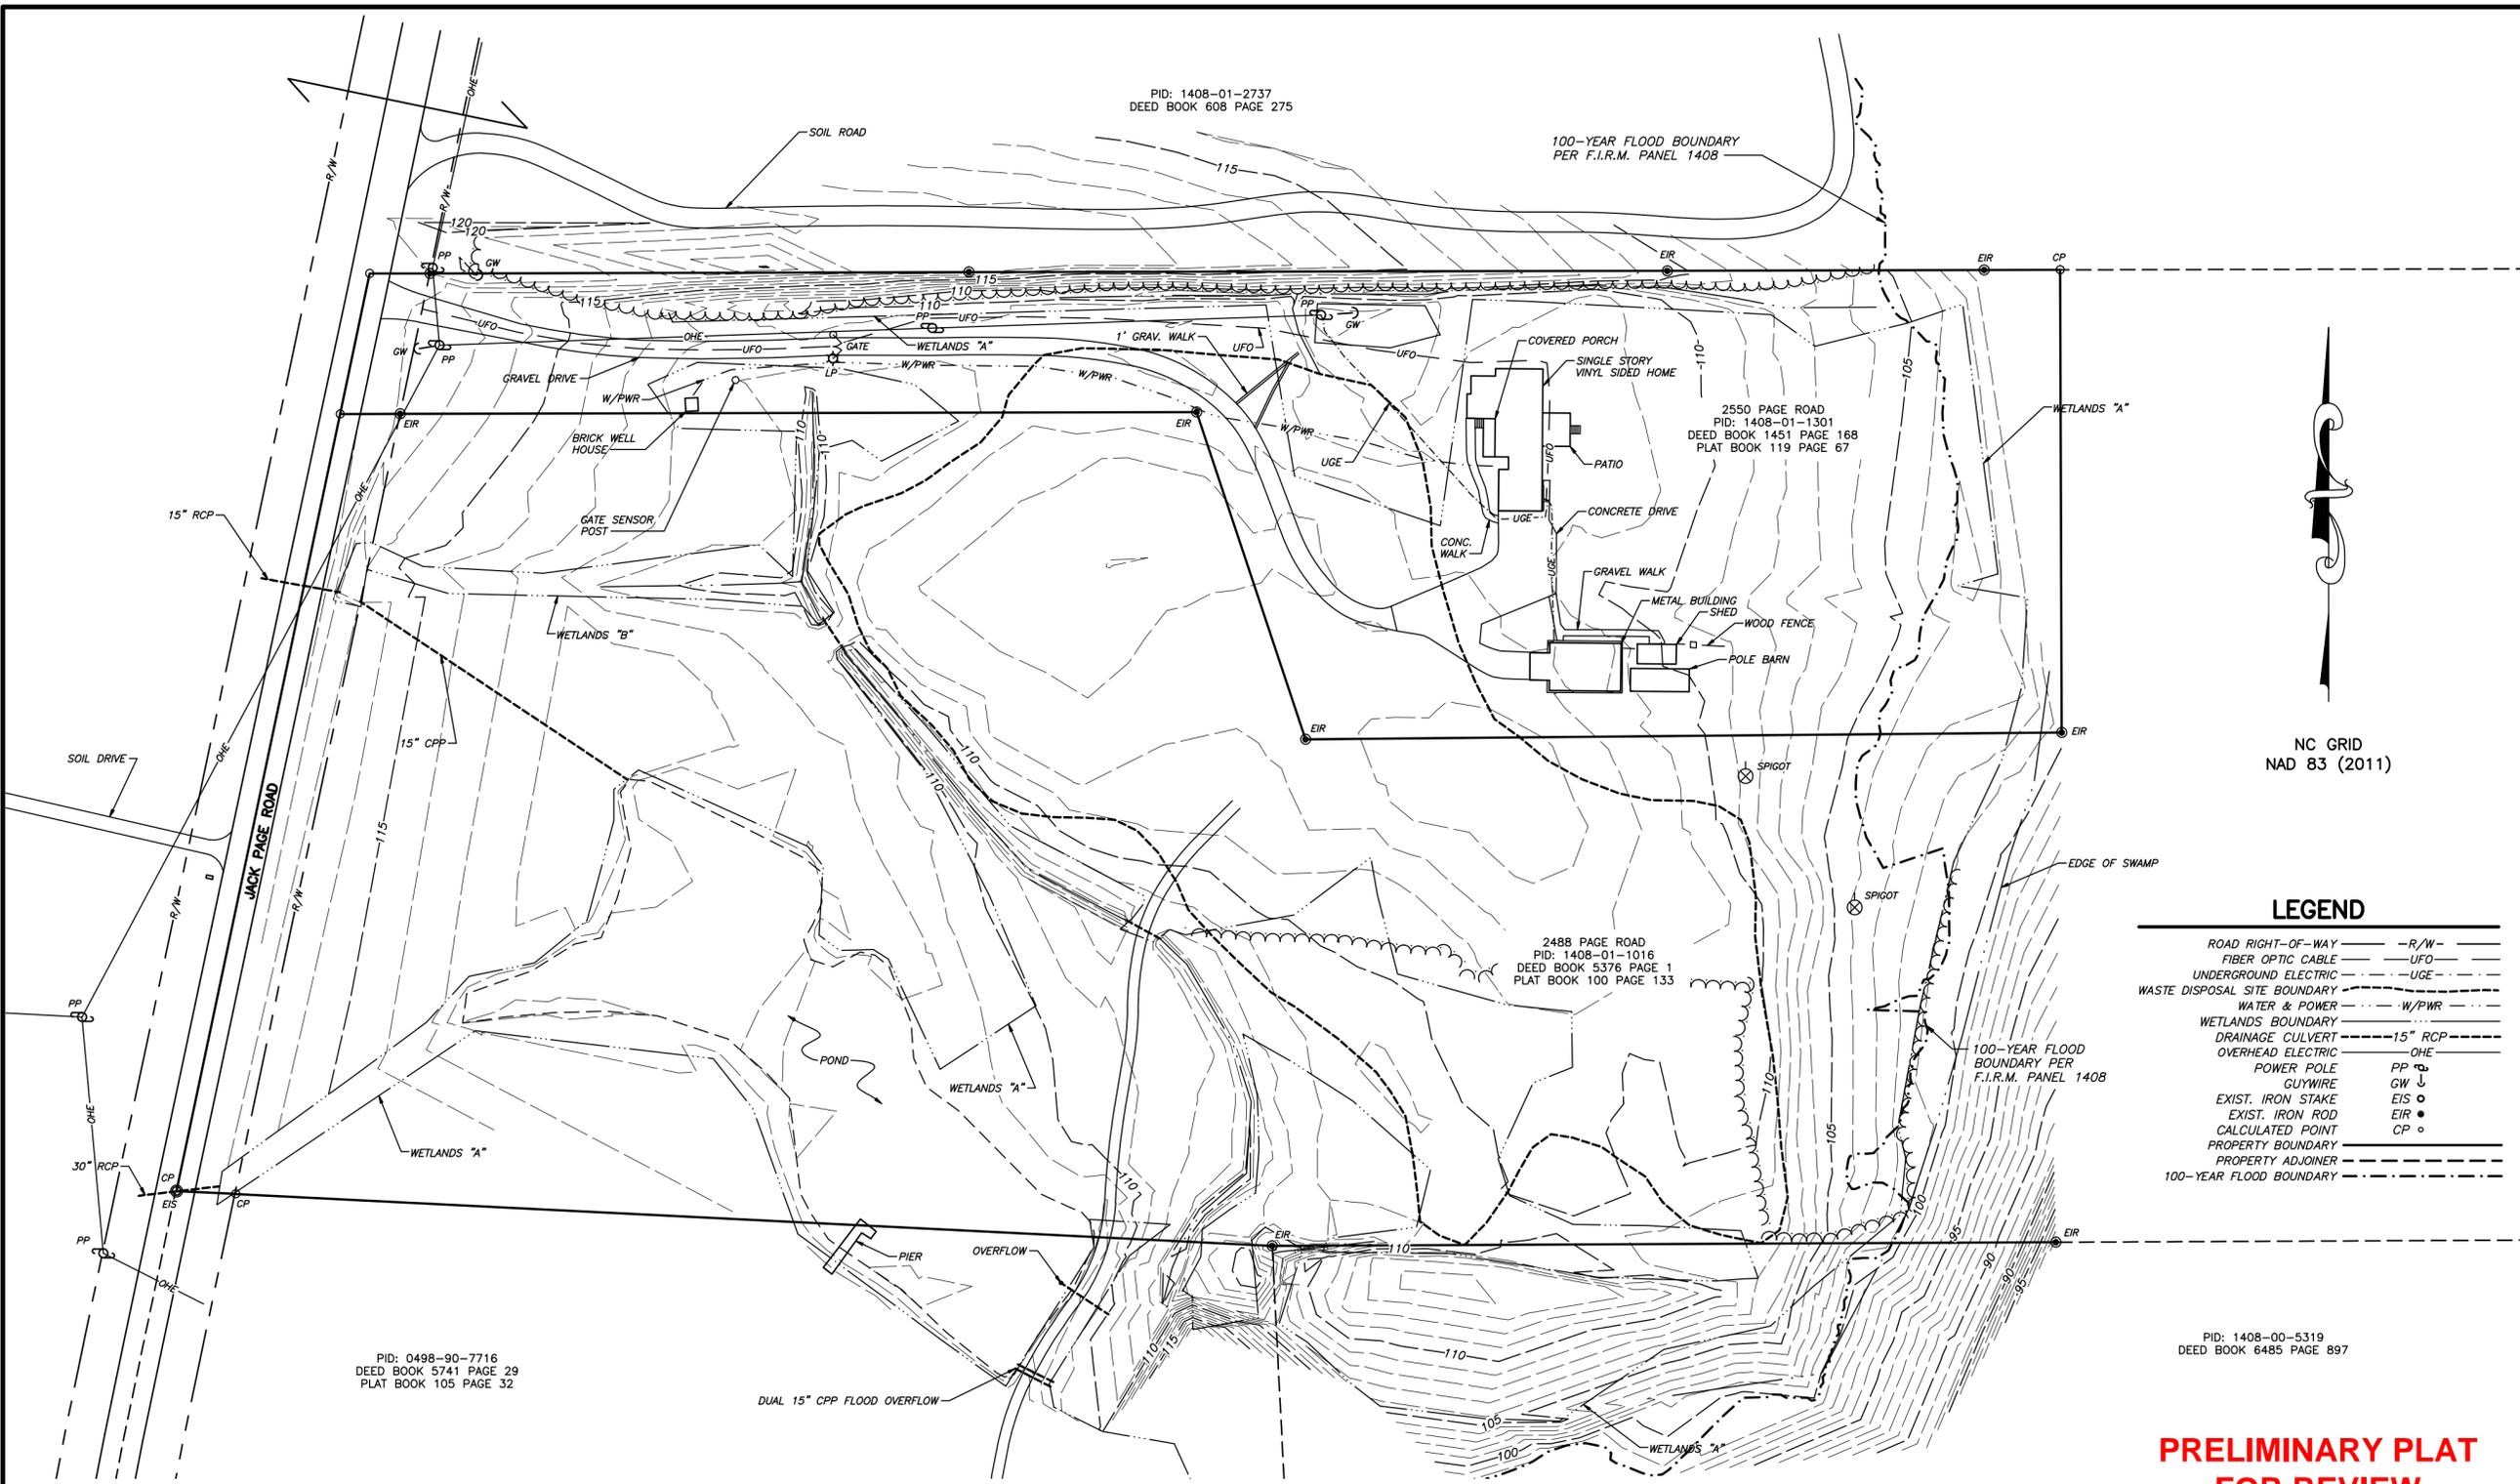
ATTACHMENT F
TOPOGRAPHIC SURVEY AND WETLANDS DELINEATION PLAN

and mapped the wetland delineation flags. The wetland delineation map is provided in Attachment F.

From March 14 to 17, 2016, a North Carolina licensed surveyor, procured by ESP, completed a topographic survey for the area extending out approximately 100 ft from the waste disposal boundary, but restricted to Tax Parcel Nos. 1408-01-1301-, 1408-01-1016-, and 0489-90-7716-. The topographic survey included topographic contours (1-foot intervals), property boundaries, underground utilities and utility right-of-ways/easements, tree line, on-site structures, driveways, and other site features. The completed topographic survey is provided in Attachment F.

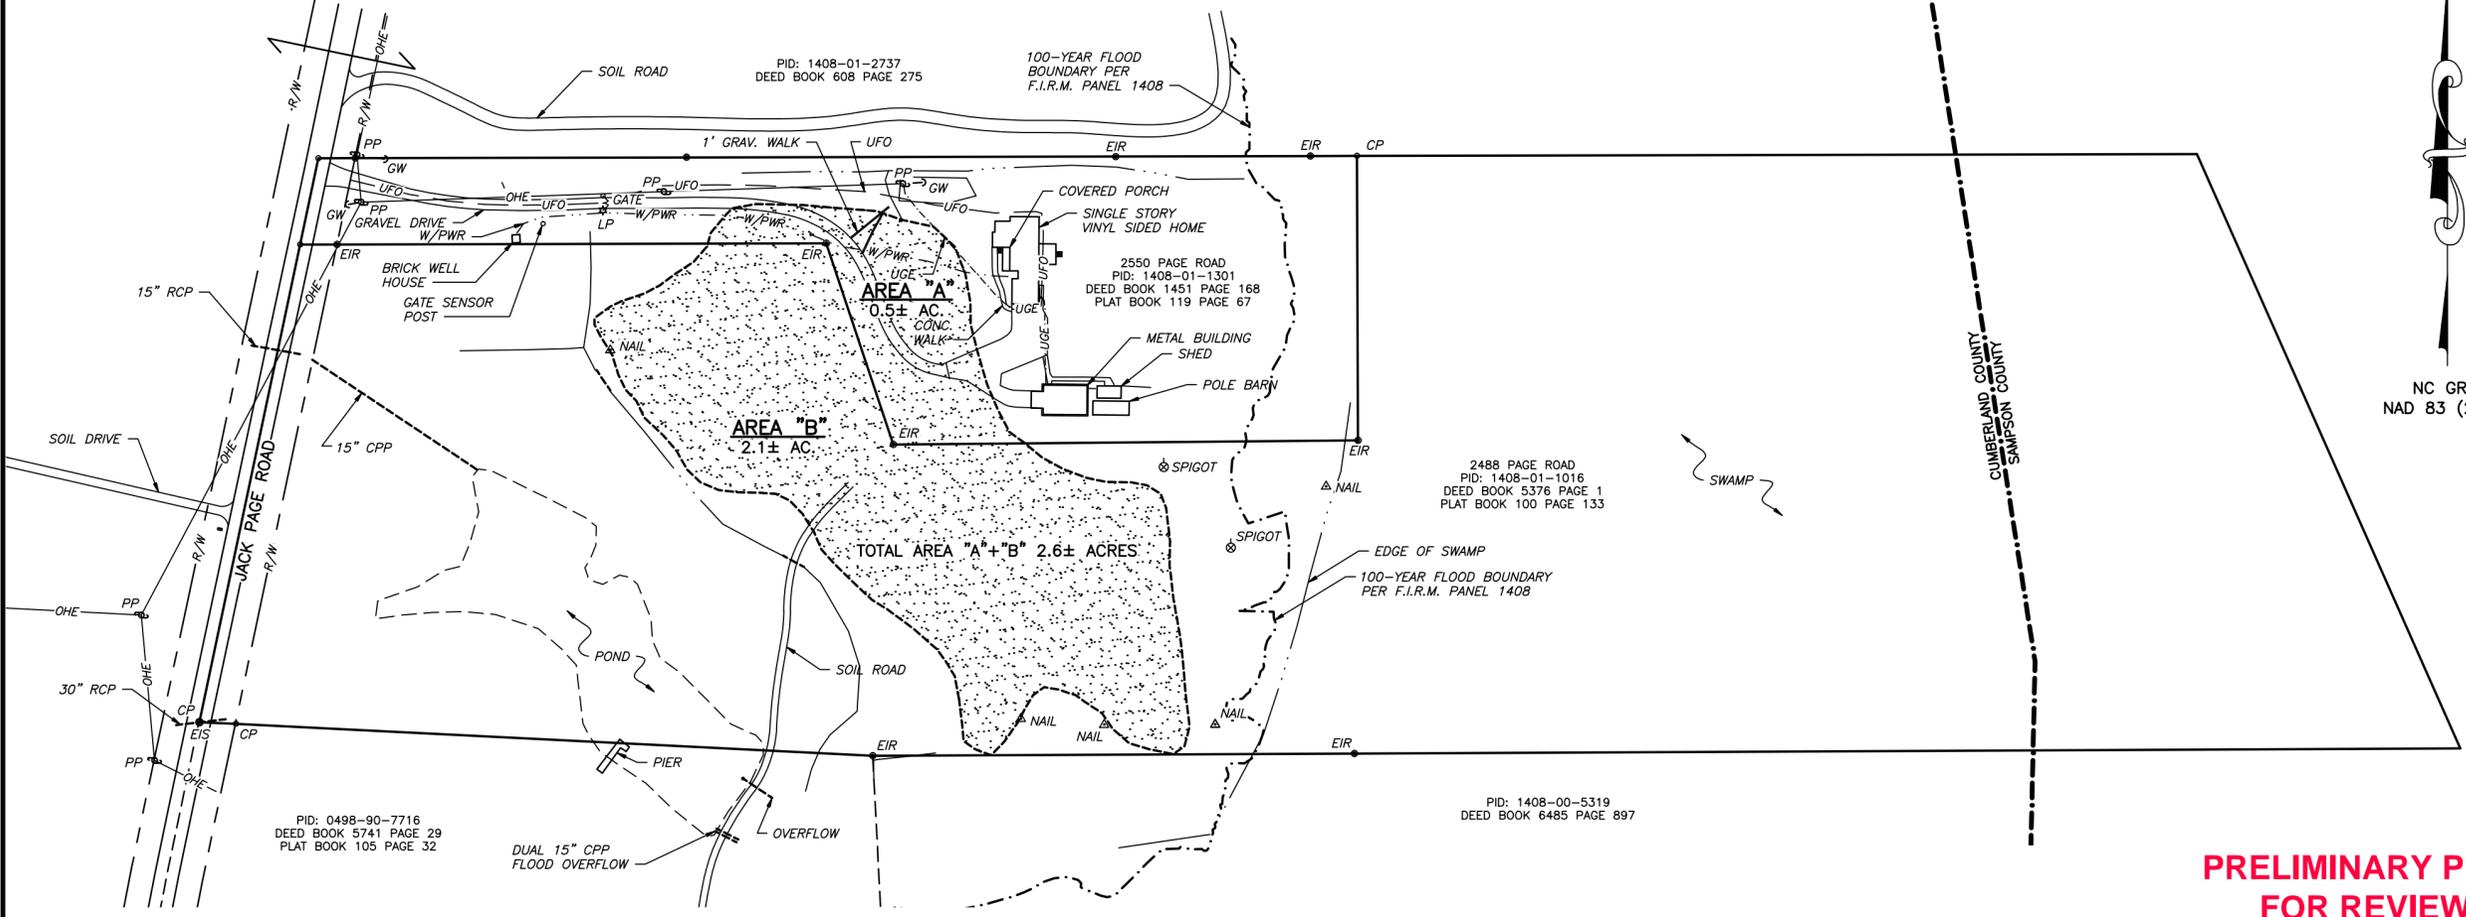
OVERVIEW SITE MAP - STEDMAN LANDFILL

From March 14 to 17, 2016, a North Carolina licensed surveyor, procured by ESP, completed boundary surveys for Tax Parcel Nos. 1408-01-1301- and 1408-01-1016- to prepare Preliminary Plats for each of the properties impacted by the Stedman Landfill. Due the presence of wetlands on the eastern portion of Tax Parcel No. 1408-01-1016-, resurveying the boundary in the eastern portion of that parcel was problematic. Therefore, the Preliminary Plat for Tax Parcel No. 1408-01-1016- depicts a partial boundary survey covering the western portion of the parcel. The Preliminary Plats are provided in Attachment G.
