2014 ANNUAL SITE MONITORING REPORT
FORMER HANCOCK COUNTRY HAMS
3484 NC HIGHWAY 22 NORTH
FRANKLINVILLE, NORTH CAROLINA

**Reference: 2014 Annual Site Monitoring Report
Former Hancock Country Hams
3484 NC Highway 22 North
Franklinville, North Carolina
Environmental Alliance, Inc. Project # 2719A**

**HANCOCK COUNTRY HAMS
SITE MONITORING REPORT**

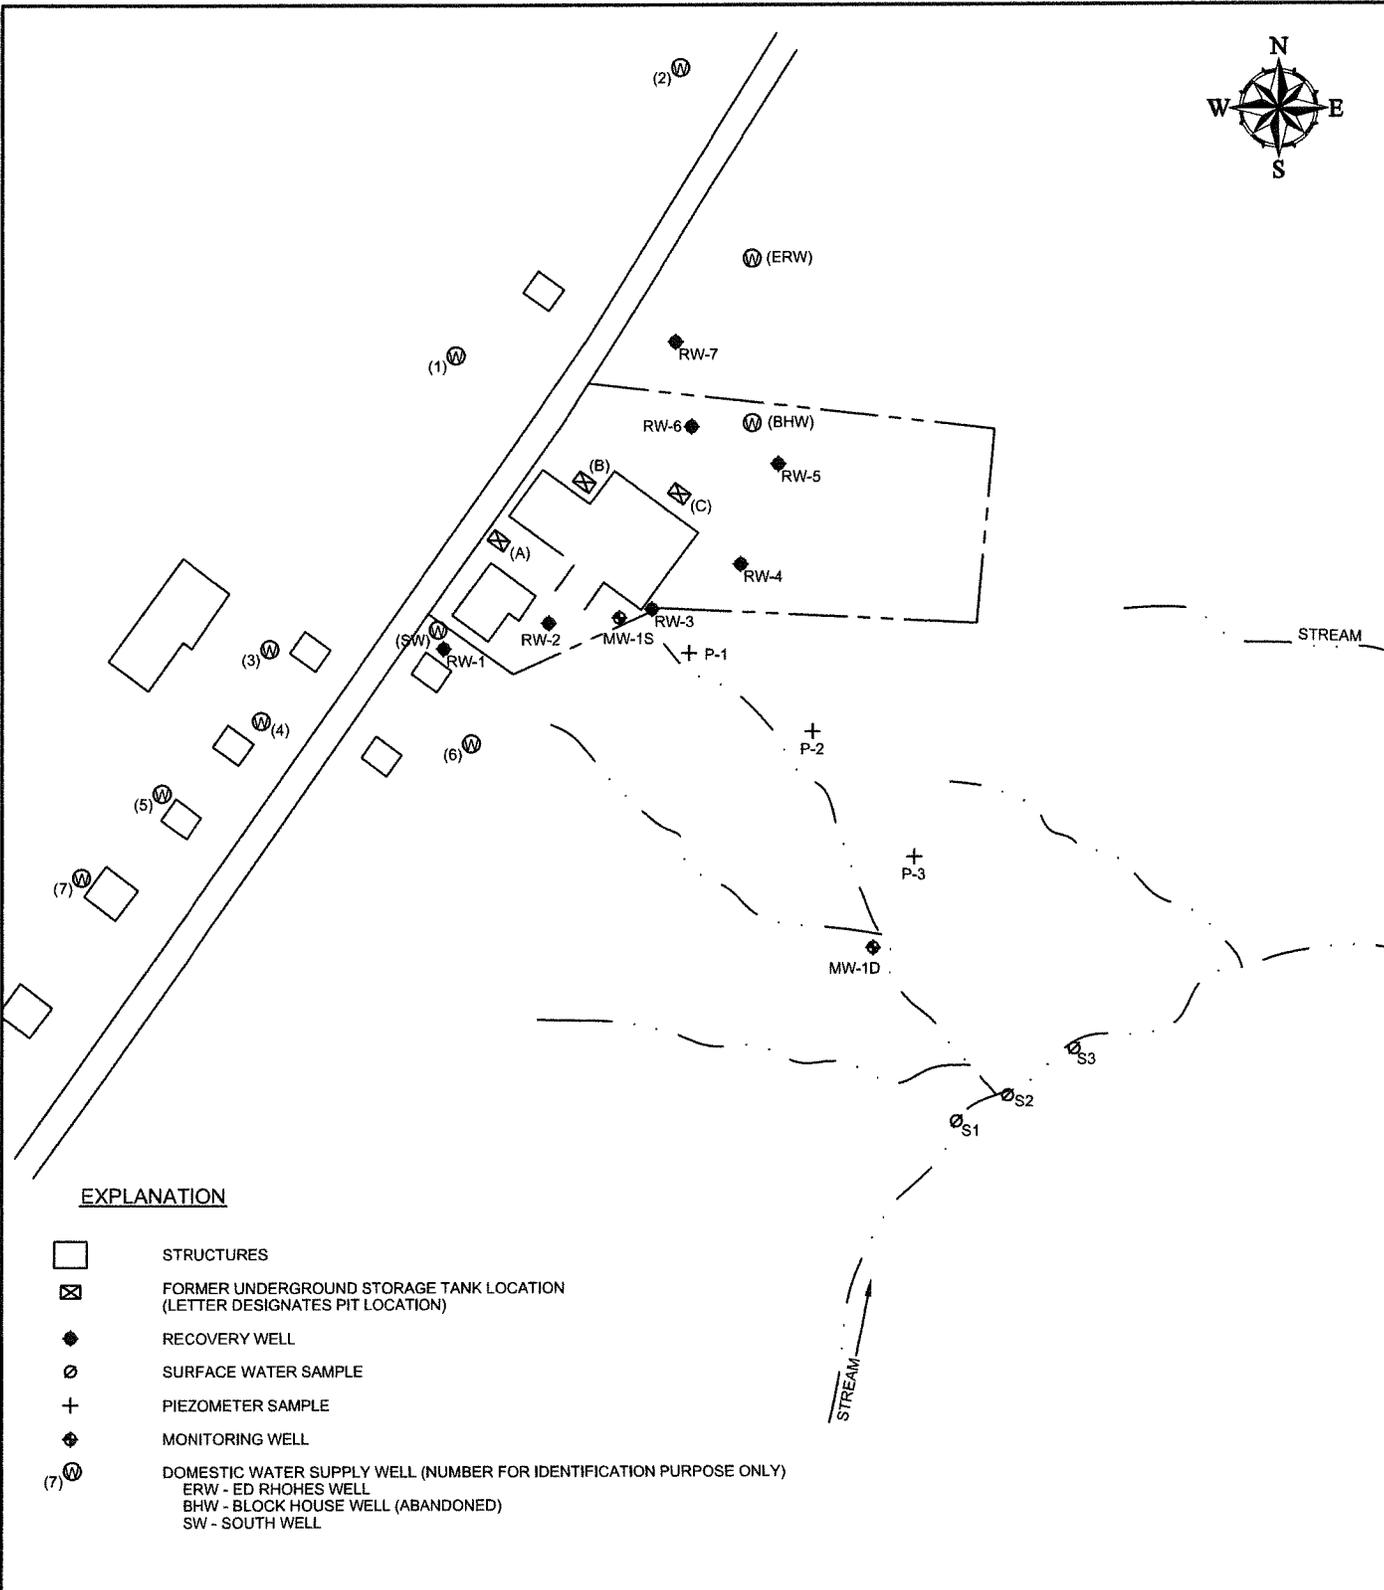
DESIGNED BY: —	DRAWN BY: AGG	UPDATED BY: —	FIGURE NO: 2
APPROVED BY: JSE	PROJECT NO: 2719	DATE: 2/7/2013

SITE MAP

Monitoring well MW-1S and monitoring well MW-1D were sampled on February 20 and February 19, 2014, respectively. Prior to collecting the samples, the water level in each well was measured and recorded and a minimum of three well volumes of water was removed or the well was bailed dry using either a bailer or a peristaltic pump. After purging, monitoring well samples were collected with a new disposable bailer. The samples were collected in laboratory supplied bottles, preserved, and delivered under chain-of-custody to REIC Laboratories of Beaver, West Virginia. The locations of the monitoring wells are presented on Figure 2.

Recovery Wells RW-1, RW-3, RW-4, RW-5, RW-6, and RW-7 were sampled using a Solinst™ Model 425 Discrete Interval Sampler on February 19 and 20, 2014. The samples were delivered to REIC Laboratories of Beaver, West Virginia and analyzed for chloride using EPA Method 300.0. Recovery well locations are presented on Figure 2.

The stream located east of the site was sampled on February 19, 2014, at the upper (S-1), mid (S-2), and lower (S-3) stream locations. The samples were delivered to REIC Laboratories of Beaver, West Virginia and analyzed for chloride using EPA Method 300.0. Stream sample locations are presented on Figure 2.

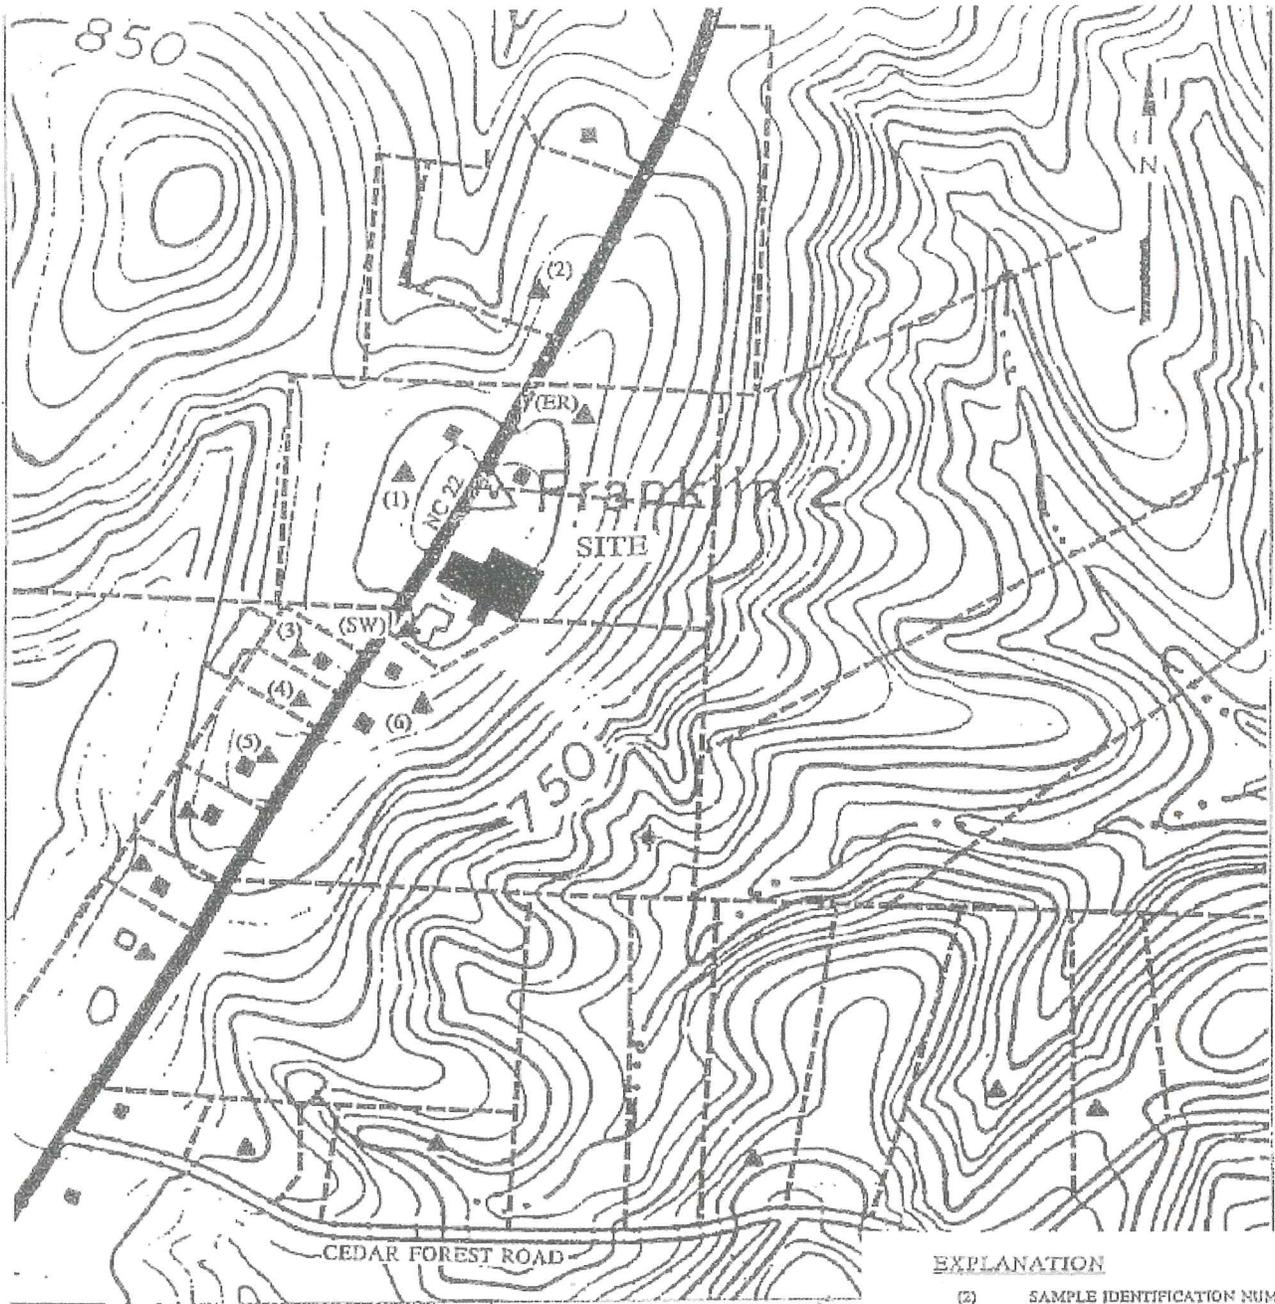
FIGURE
4

Topographic Relationship of Water Wells to the Site

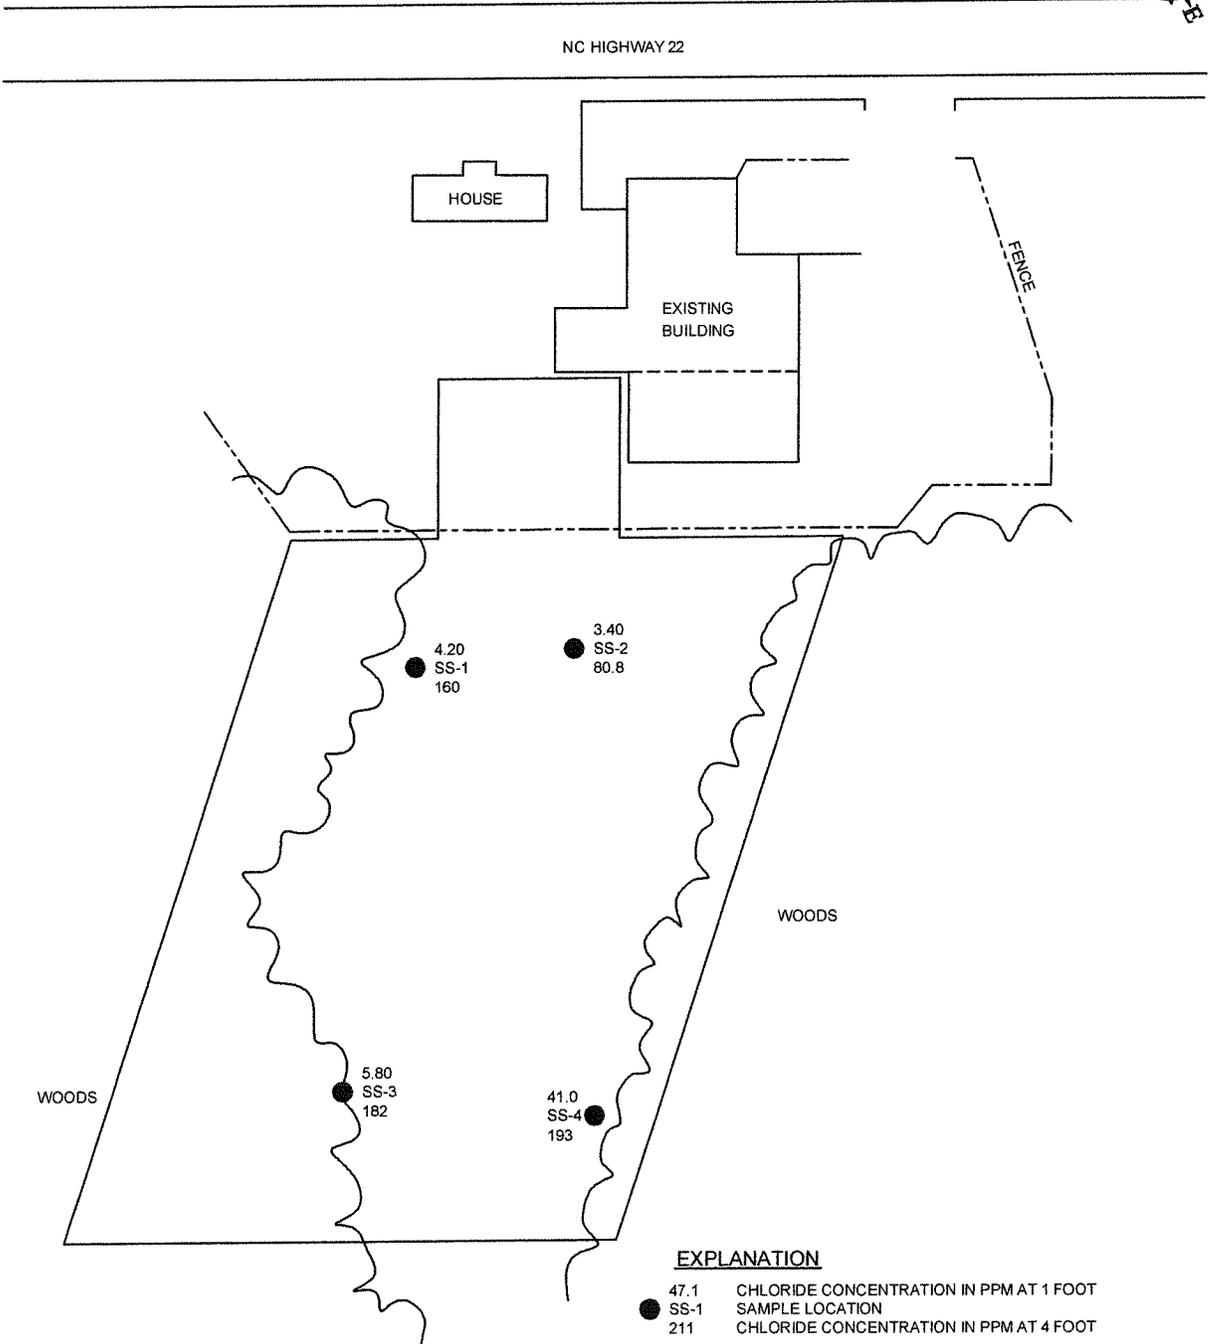
- 47.1 CHLORIDE CONCENTRATION IN PPM AT 1 FOOT
- SS-1 SAMPLE LOCATION
- 211 CHLORIDE CONCENTRATION IN PPM AT 4 FOOT
- BDL BELOW DETECTION LIMIT
- PREVIOUS SOIL SAMPLING AREA

HANCOCK COUNTRY HAMS FRANKLINVILLE, NORTH CAROLINA			
SOIL CHLORIDE CONCENTRATION - 2014			
DESIGNED BY:	DRAWN BY: SKJ	UPDATED BY: —	FIGURE NO: 6
APPROVED BY:	PROJECT NO. 2719	DATE: 3/10/2014

On February 20, 2014, Alliance personnel collected soil samples from the salt/brine disposal area to determine current chloride concentrations. A shallow (1 foot deep) and a deep (4 foot deep) sample were collected at locations SS-1, SS-2, SS-3, and SS-4 with a stainless-steel auger. Each sample was a composite sample made by combining soil from four different borings located approximately five feet apart. The samples were delivered to REIC Laboratories of Beaver, West Virginia and analyzed for chloride using EPA Method 300.0. The approximate locations of the soil samples are shown in Figure 6.

Chloride concentrations were detected in the soil samples (SS-1, SS-2, SS-3, and SS-4) collected on February 20, 2014. Chloride concentrations from the 1-foot sample intervals ranged from a minimum of 3.40 mg/kg (SS-2) to a maximum of 41.0 mg/kg (SS-4). Chloride concentrations in the 4-foot sample interval ranged from a minimum of 80.8 mg/kg (SS-2) to 193 mg/kg (SS-4). Soil sampling analytical data is summarized on Table 4, and the accompanying laboratory analyses and chain-of-custody are included as Appendix A. Historical soil chloride concentrations (1990) are presented on Figure 5 and the 2014 soil chloride concentrations are presented on Figure 6.

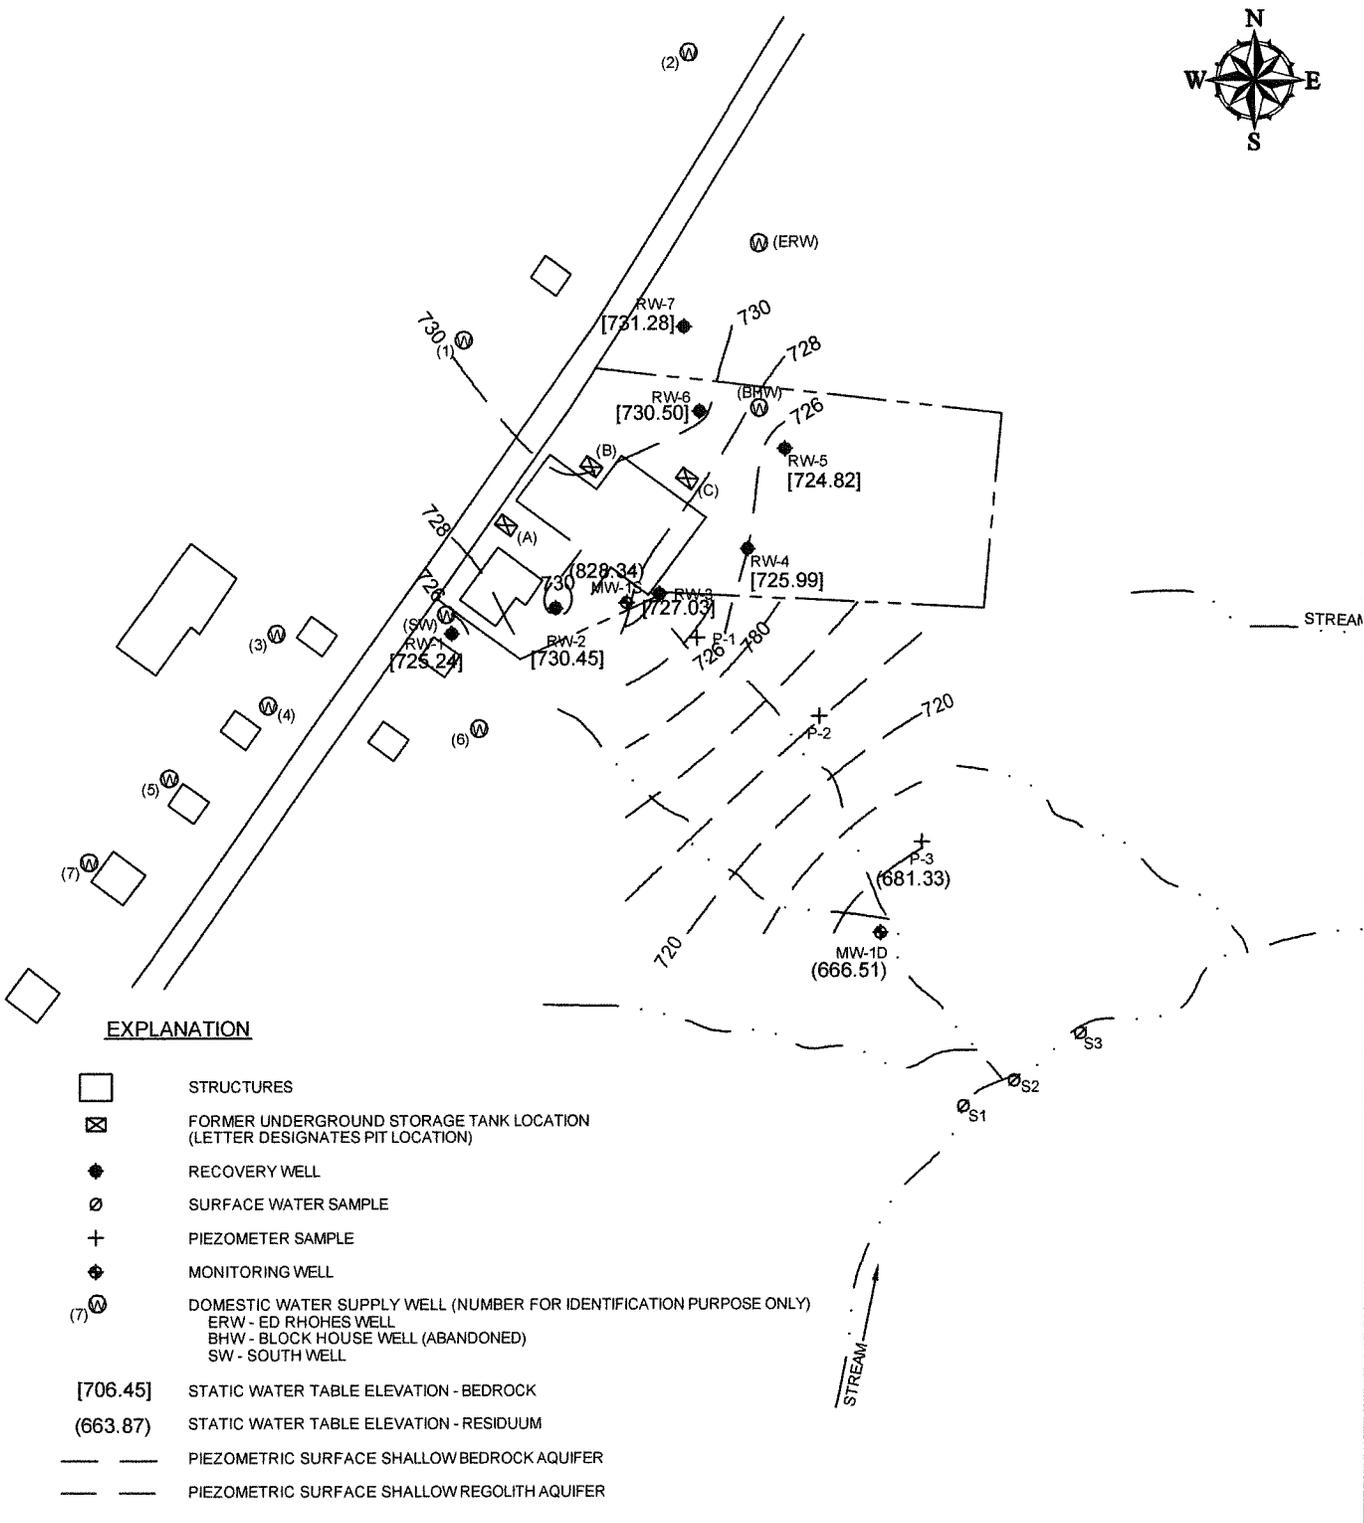
DESIGNED BY: JSE	DRAWN BY: SKJ	UPDATED BY: ---	FIGURE NO. 7
APPROVED BY:	PROJECT NO. 2719	DATE: 3/10/2014

**GROUNDWATER FLOW MAP
 FEBRUARY 20, 2014**

Groundwater measurements collected in February 2014 were used to prepare a groundwater surface contour map (Figure 7). The data indicates groundwater in both the residuum and bedrock are moving generally to the southeast. The water level data are summarized in Table 6.

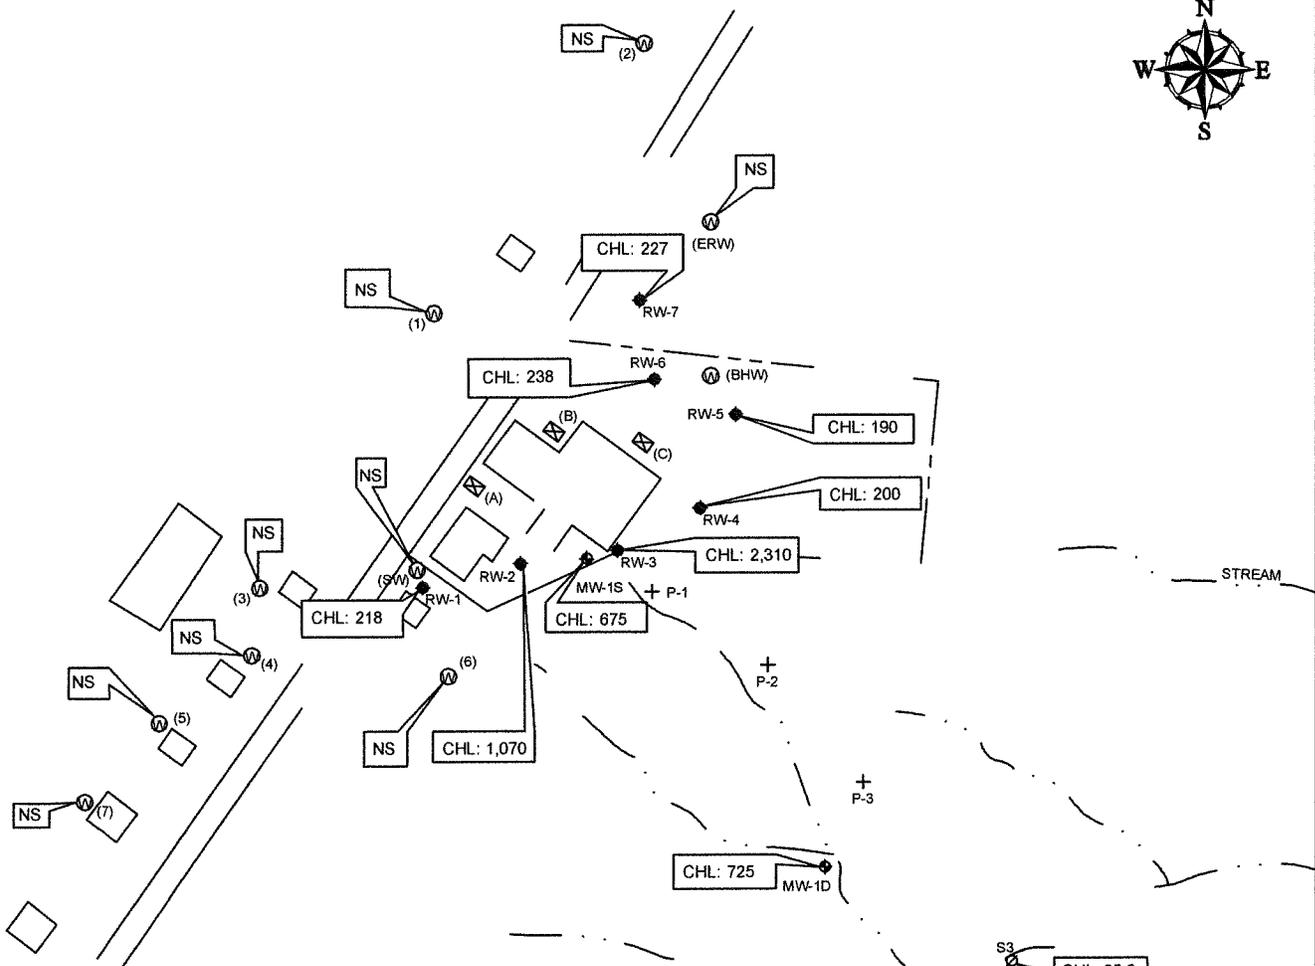
- EXPLANATION**
- STRUCTURES
 - ⊠ FORMER UNDERGROUND STORAGE TANK LOCATION (LETTER DESIGNATES PIT LOCATION)
 - ◆ RECOVERY WELL
 - SURFACE WATER SAMPLE
 - ⊕ PIEZOMETER SAMPLE
 - ◆ MONITORING WELL
 - (7) Ⓜ DOMESTIC WATER SUPPLY WELL (NUMBER FOR IDENTIFICATION PURPOSE ONLY)
 ERW - ED RHOES WELL
 BHW - BLOCK HOUSE WELL (ABANDONED)
 SW - SOUTH WELL
- CHL: CHLORIDE (mg/L)
 NA: NOT ANALYZED
 NS: NOT SAMPLED

Based on the data collected during the February 2014 sampling event, chloride is concentrated in the area immediately southeast of the plant (MW-1S, RW-2, and RW-3) and along a line extending to the southeast toward the stream (MW-1D). A diffuse plume of chloride extends to the north, southwest, and west of the plant. Groundwater chloride results from the February 2014 sampling event are plotted on Figure 8.

Current groundwater chloride concentrations are similar to previous annual sampling events.

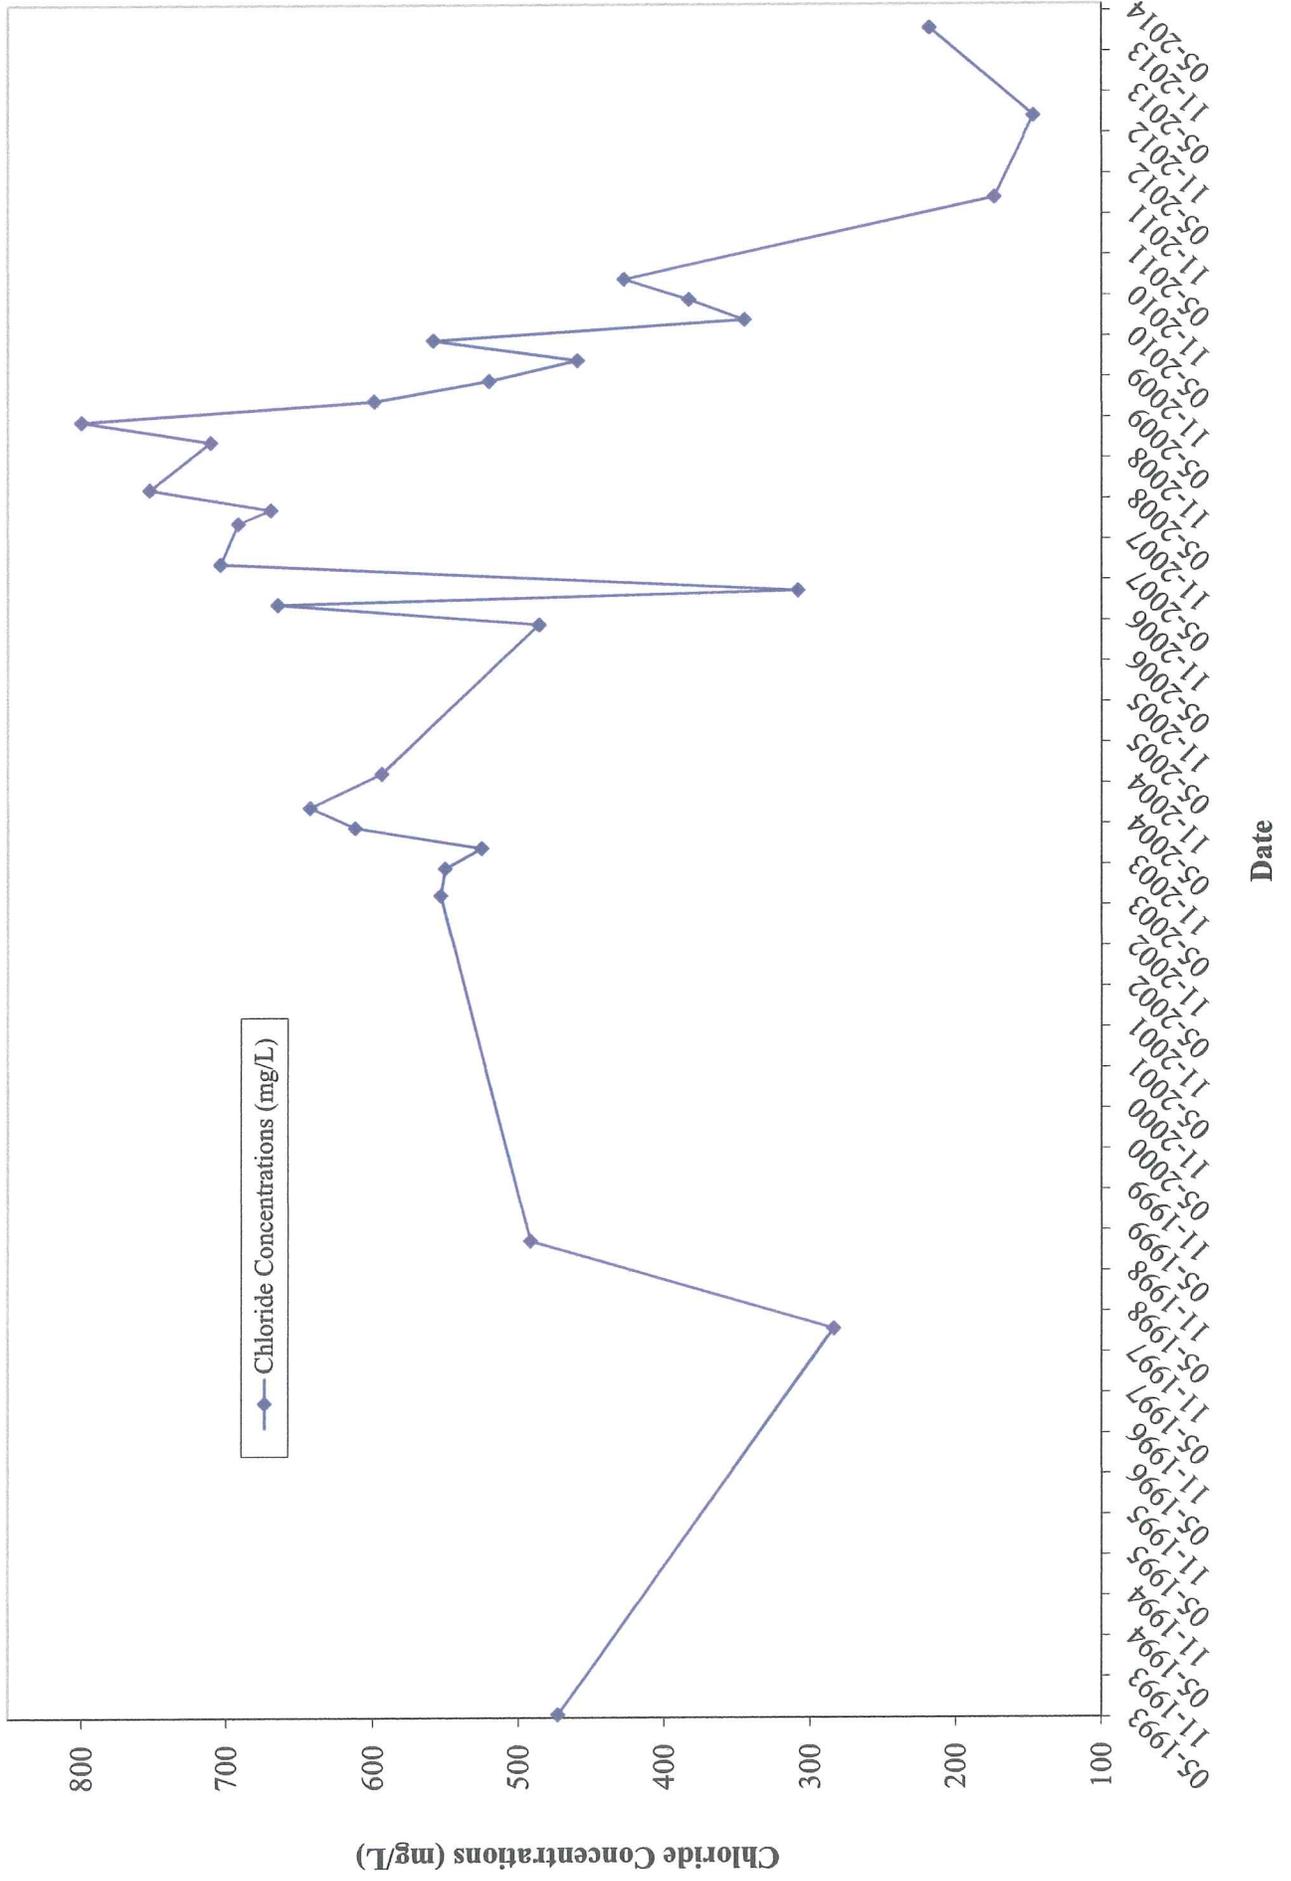
RW-1 Chloride Concentrations Over Time

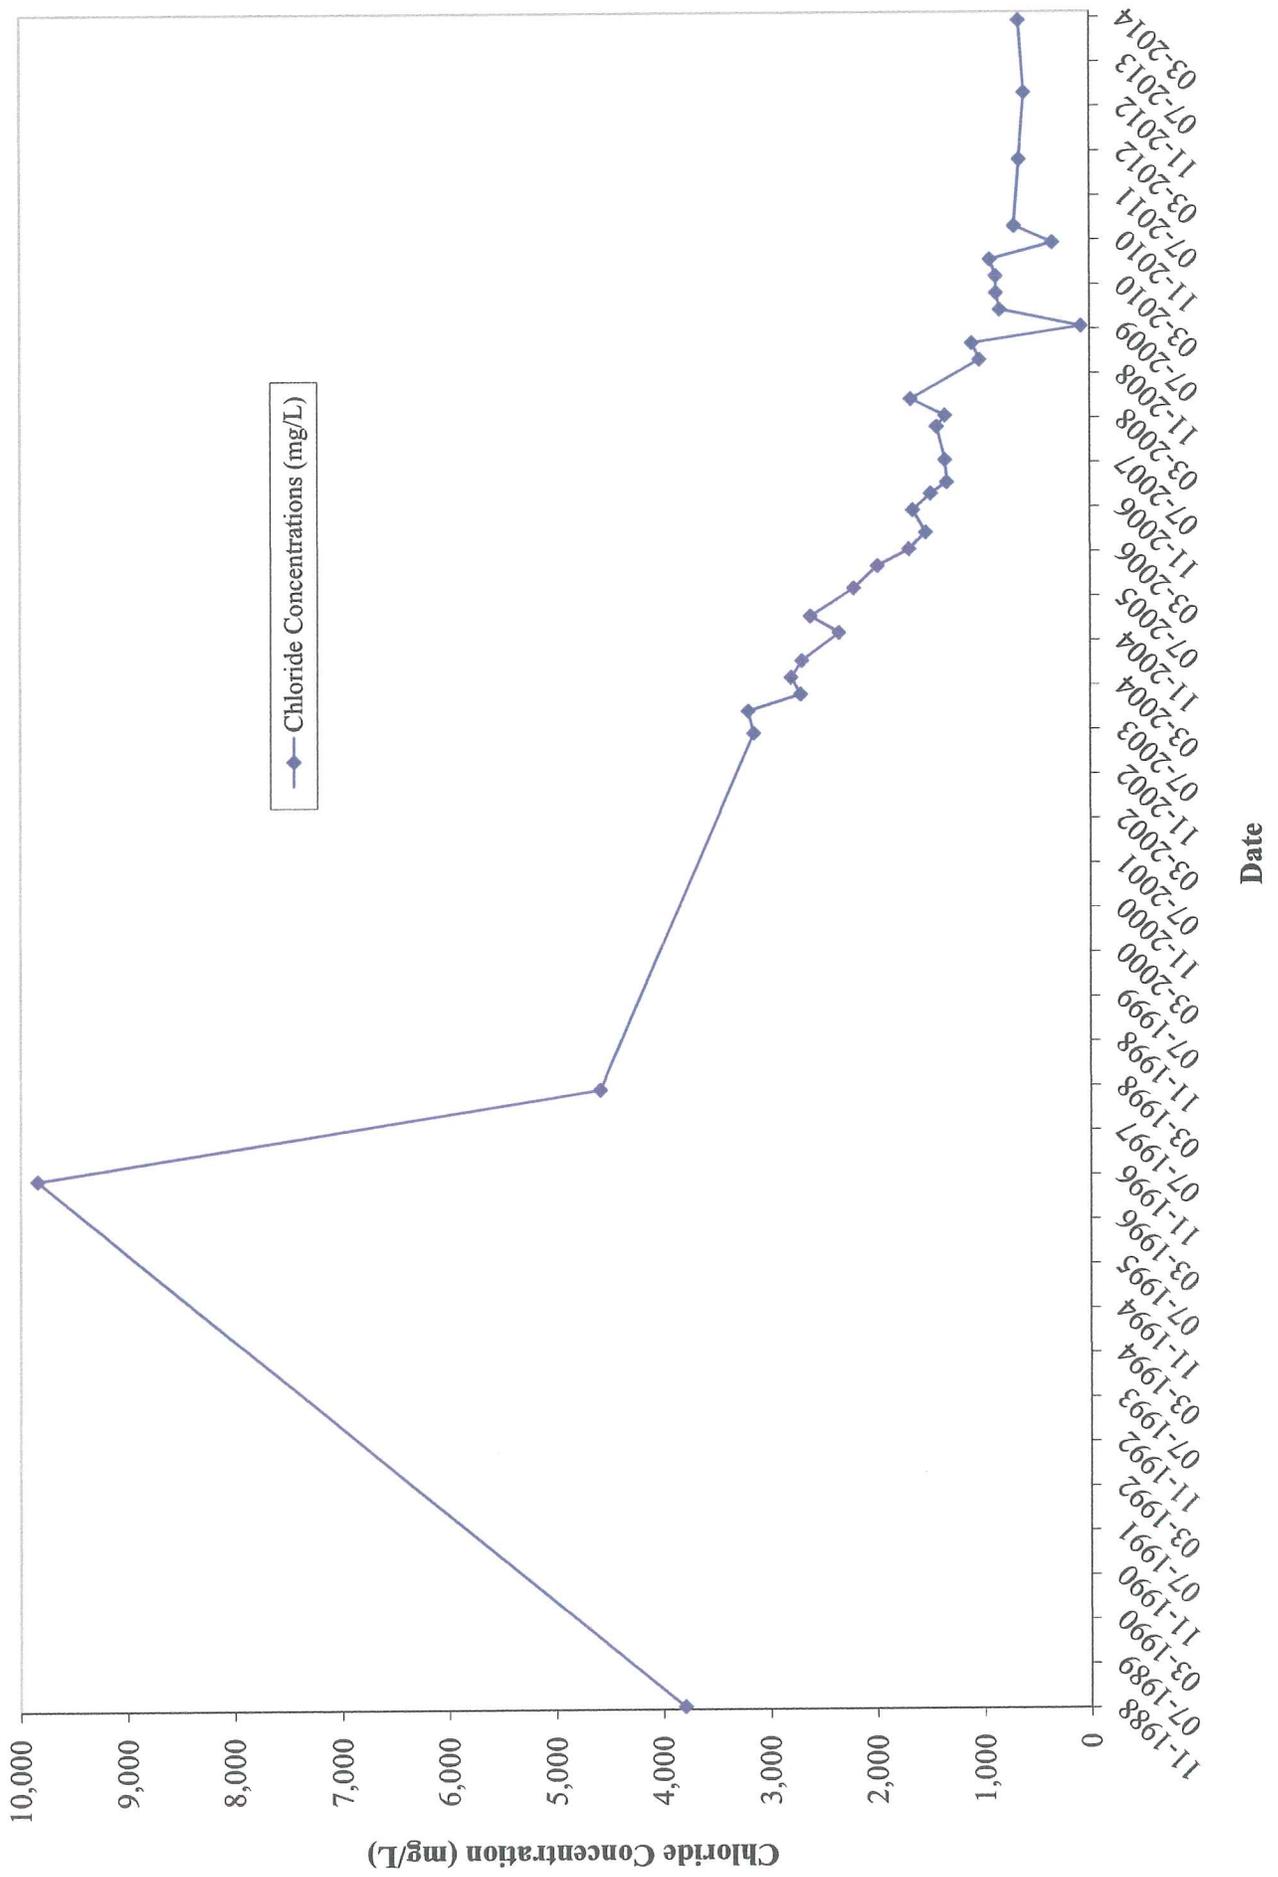
MW-1S Chloride Concentration Over Time

Chloride was detected in monitoring wells MW-1S (675 mg/L) and MW-1D (725 mg/L) above the State's 2L .0202 Standard of 250 mg/L. Laboratory results are summarized in Table 3 and laboratory reports are included as Appendix A.

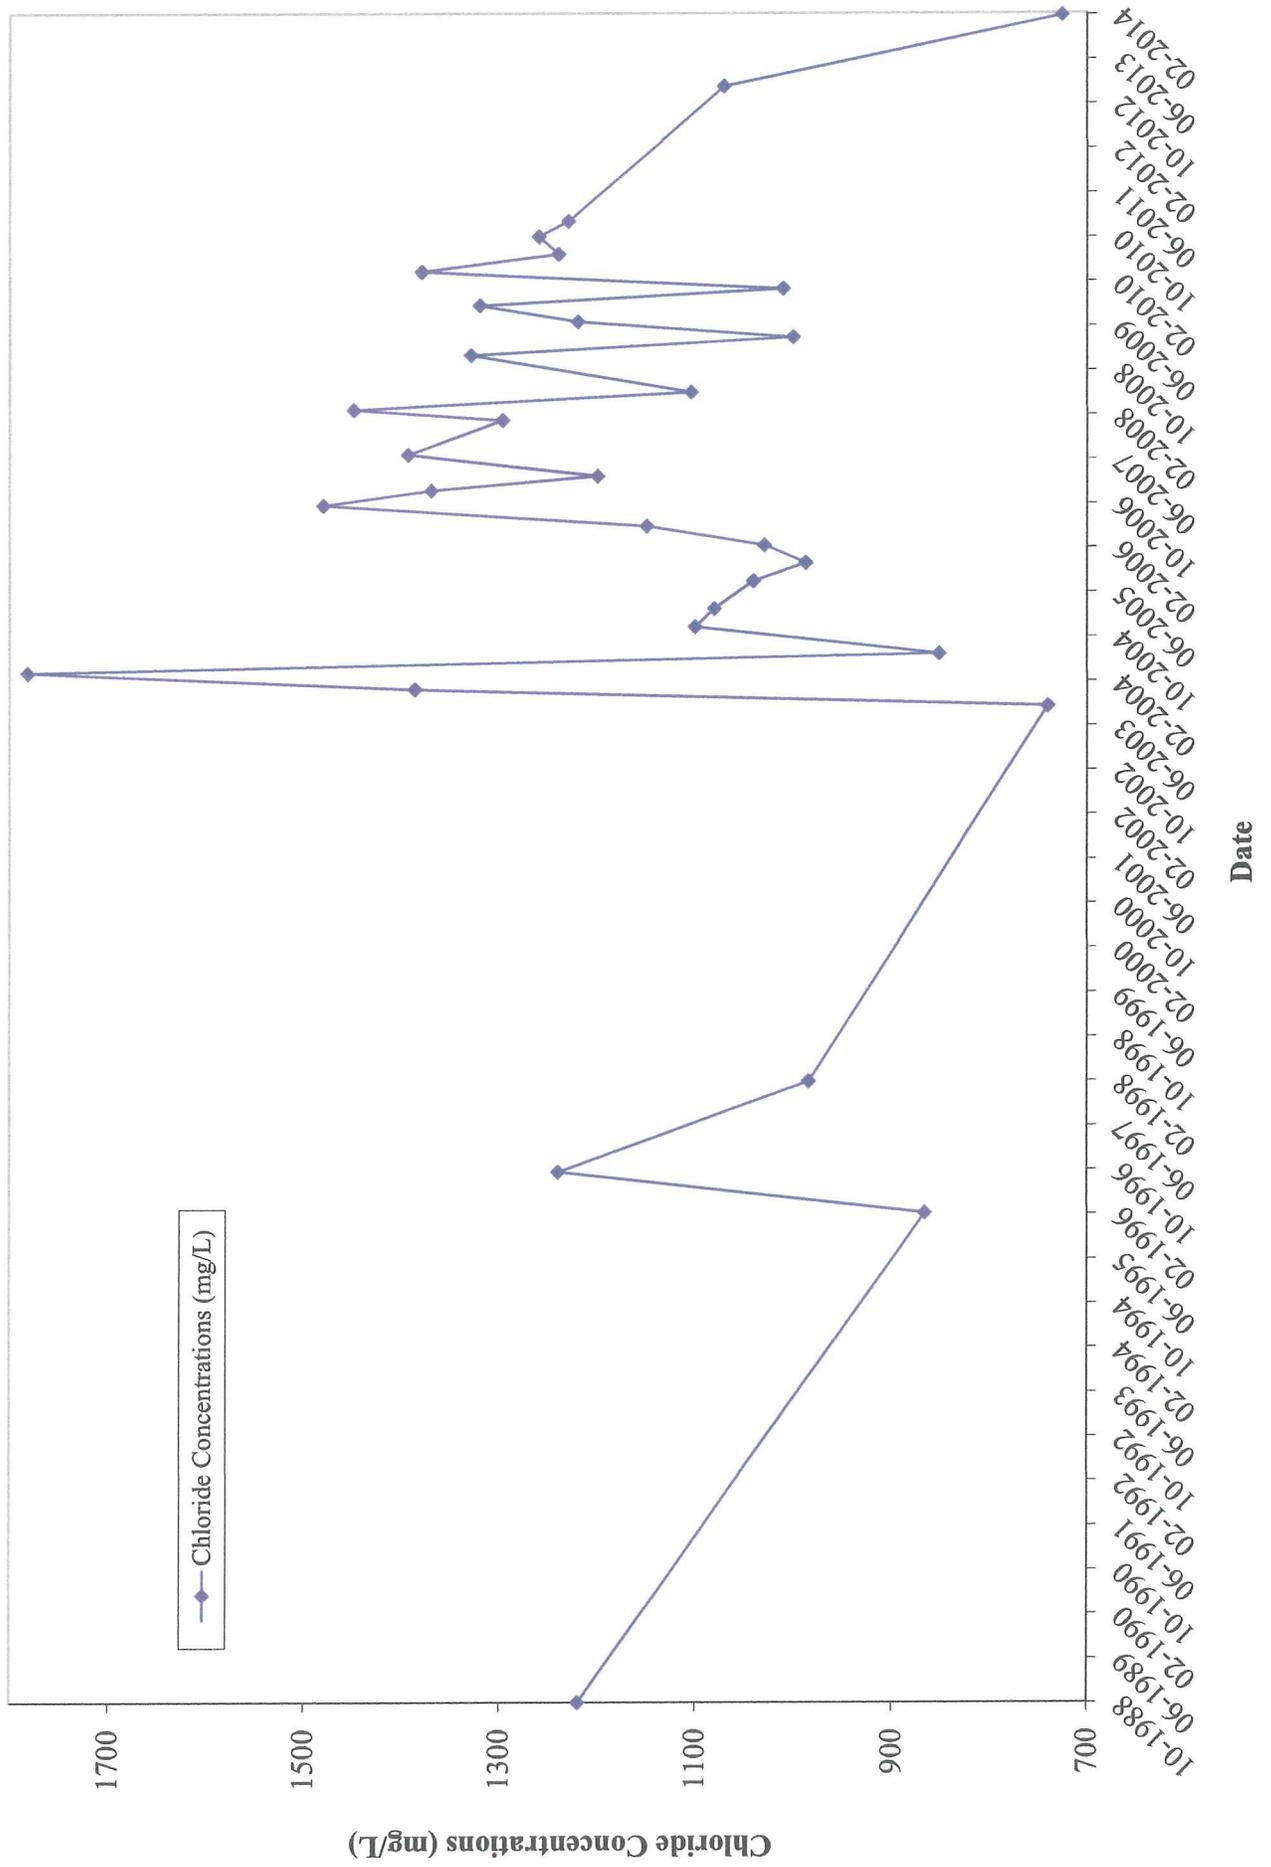
MW-1D Chloride Concentrations Over Time

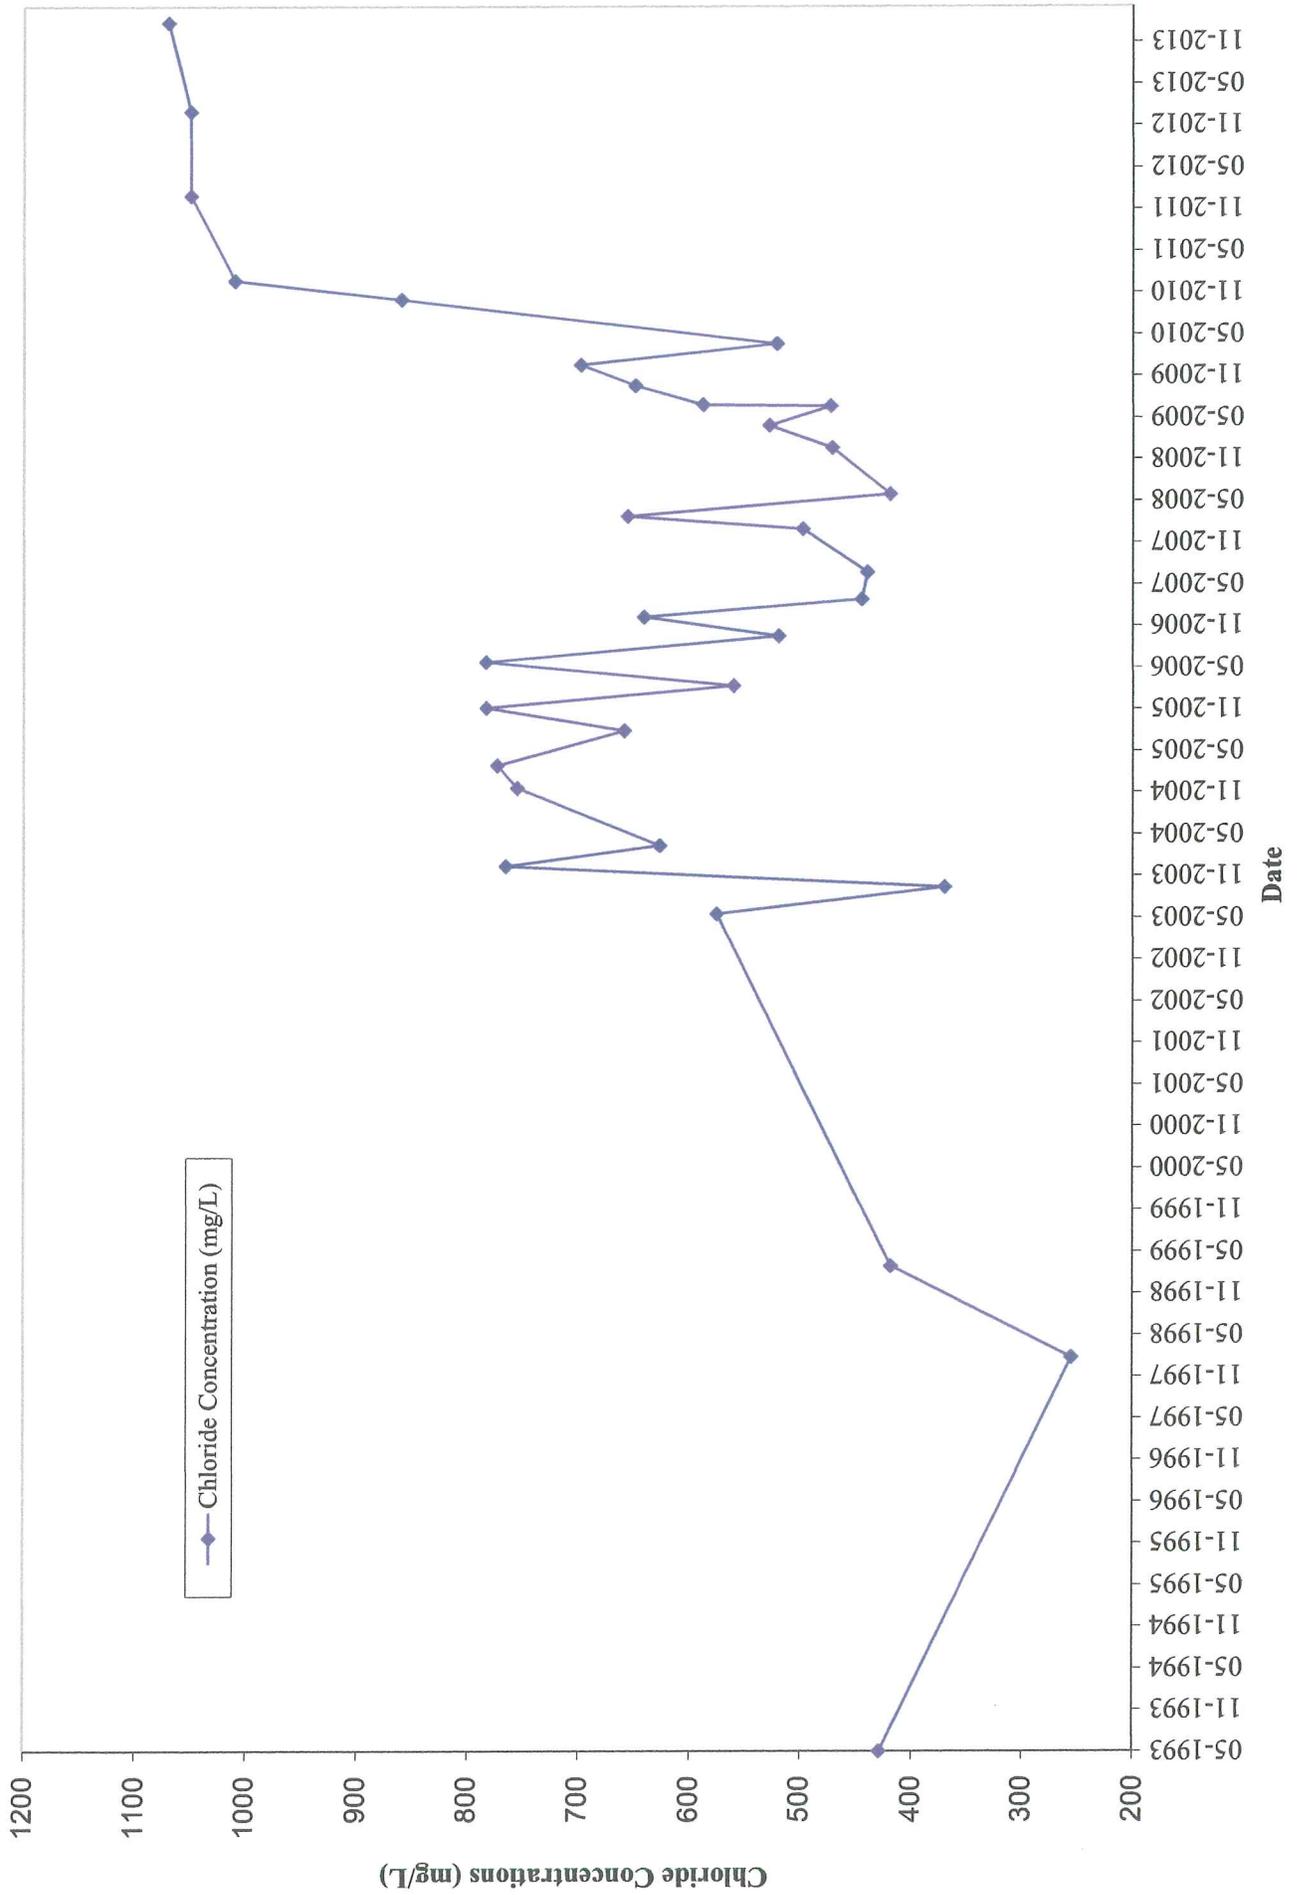
RW-2 Chloride Concentrations Over Time

Chloride was detected in recovery wells RW-2 (1,070 mg/L) and RW-3 (2,310 mg/L) above the State's 2L .0202 Standard of 250 mg/L. Laboratory results are summarized in Table 3 and laboratory reports are included as Appendix A.

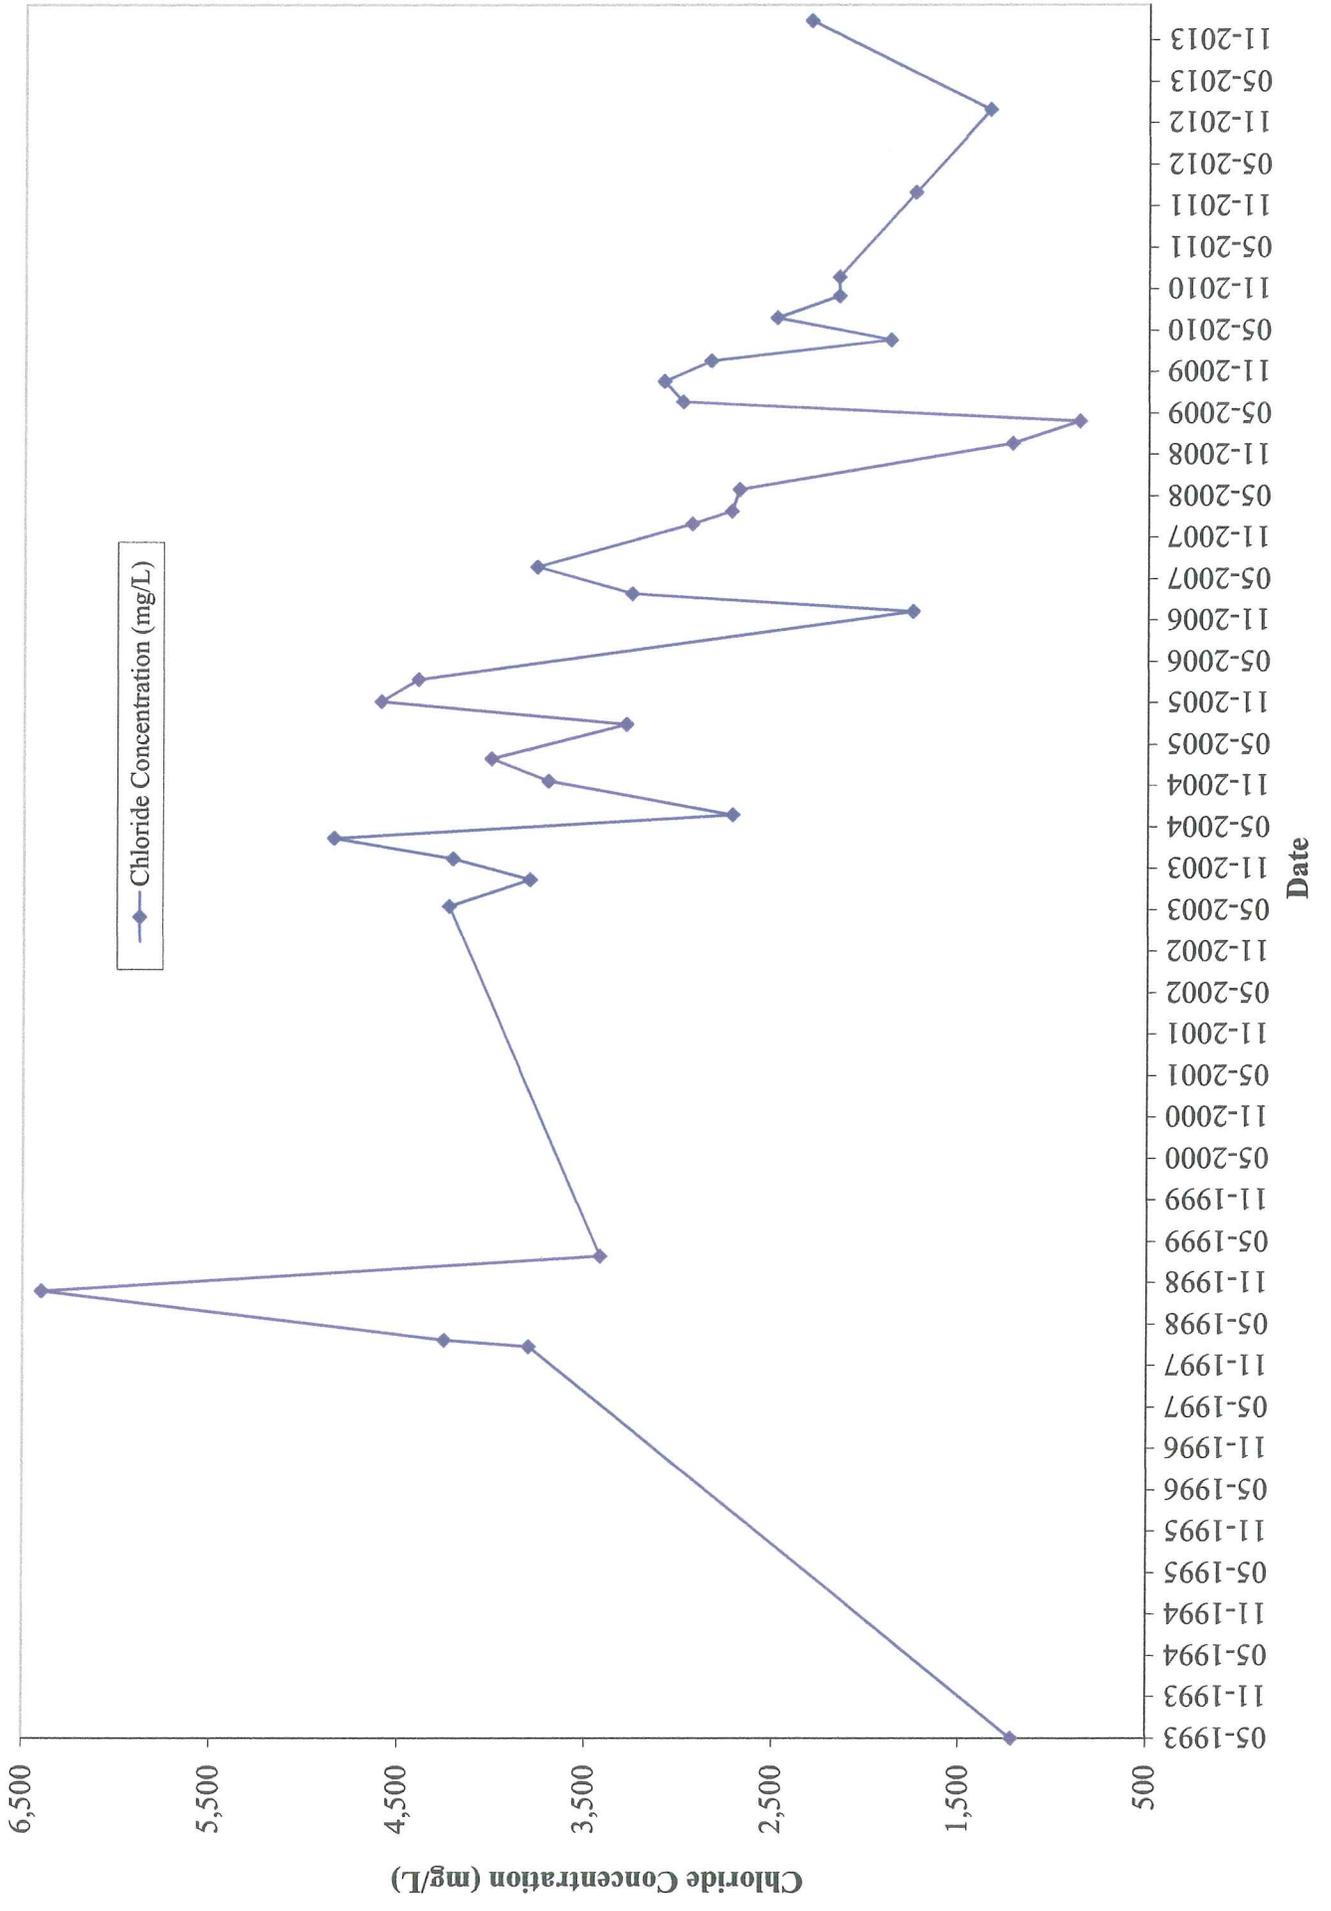
RW-3 Chloride Concentration Over Time
