2014 ANNUAL SITE MONITORING REPORT
FORMER HANCOCK COUNTRY HAMS
3484 NC HIGHWAY 22 NORTH
FRANKLINVILLE, NORTH CAROLINA

**Reference: 2014 Annual Site Monitoring Report
Former Hancock Country Hams
3484 NC Highway 22 North
Franklinville, North Carolina
Environmental Alliance, Inc. Project # 2719A**

**HANCOCK COUNTRY HAMS
SITE MONITORING REPORT**

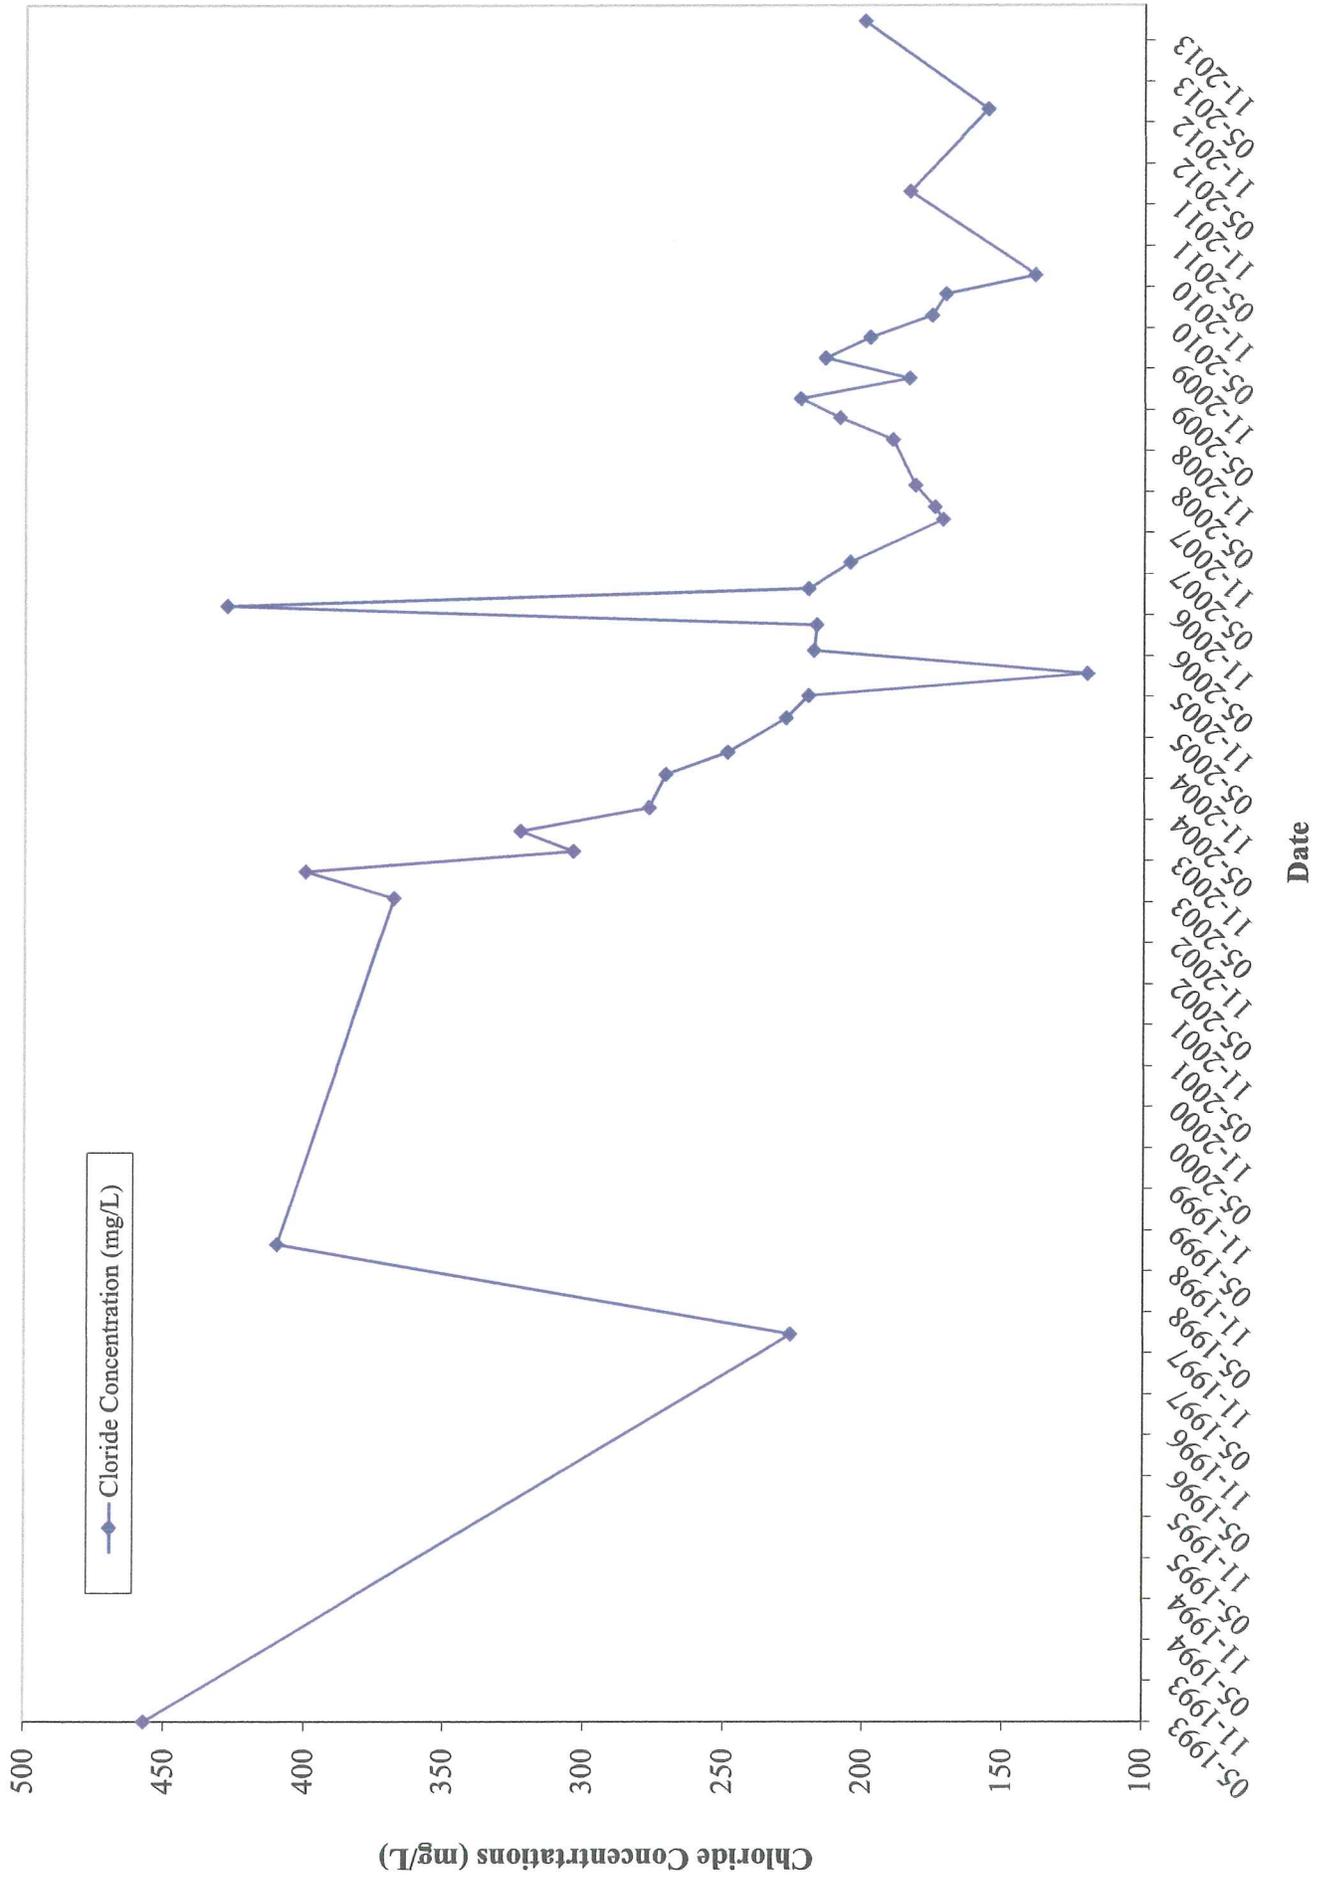
RW-4 Chloride Concentration Over Time

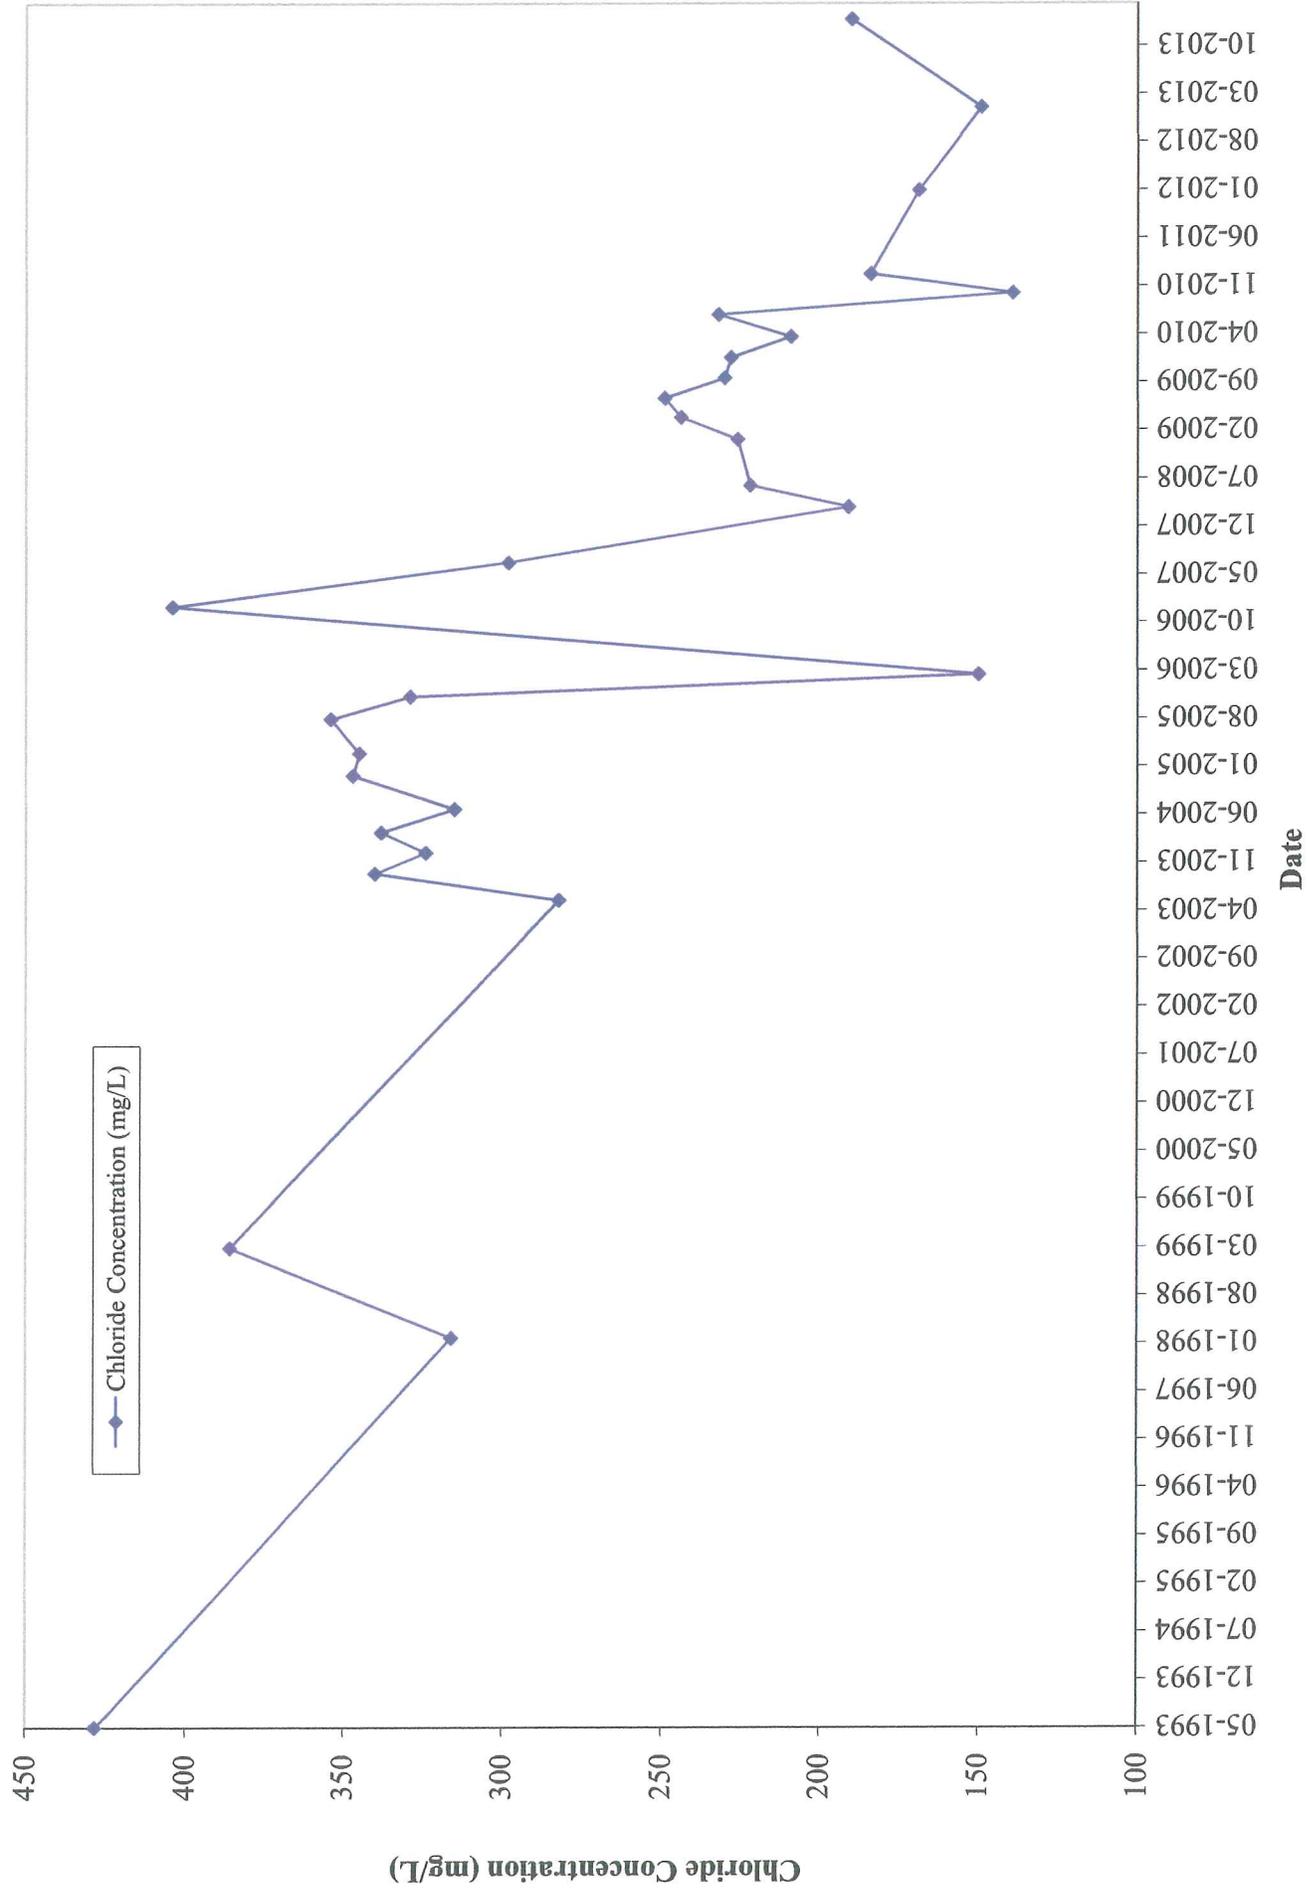
RW-5 Chloride Concentration Over Time

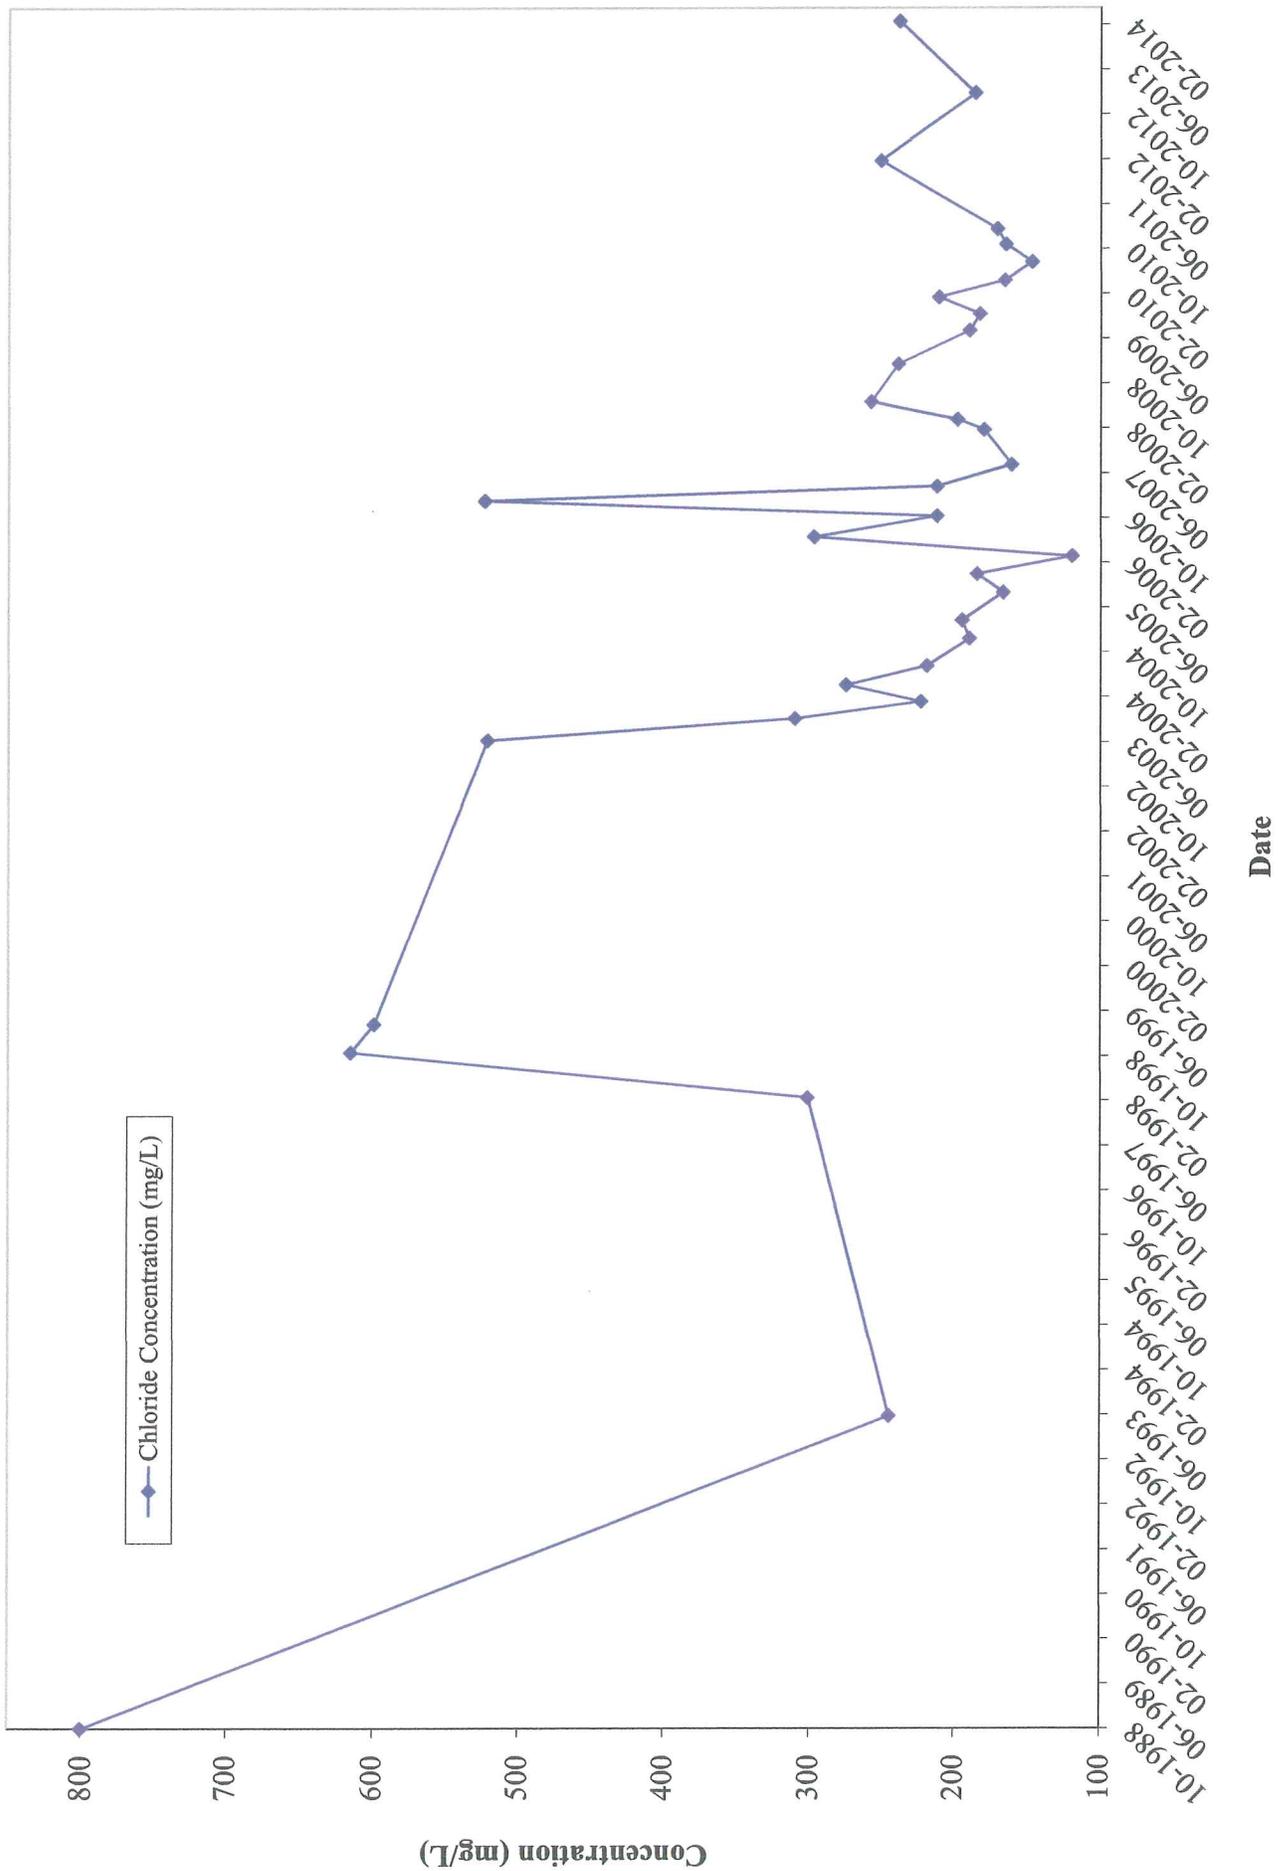
RW-6 Chloride Concentration (mg/L)

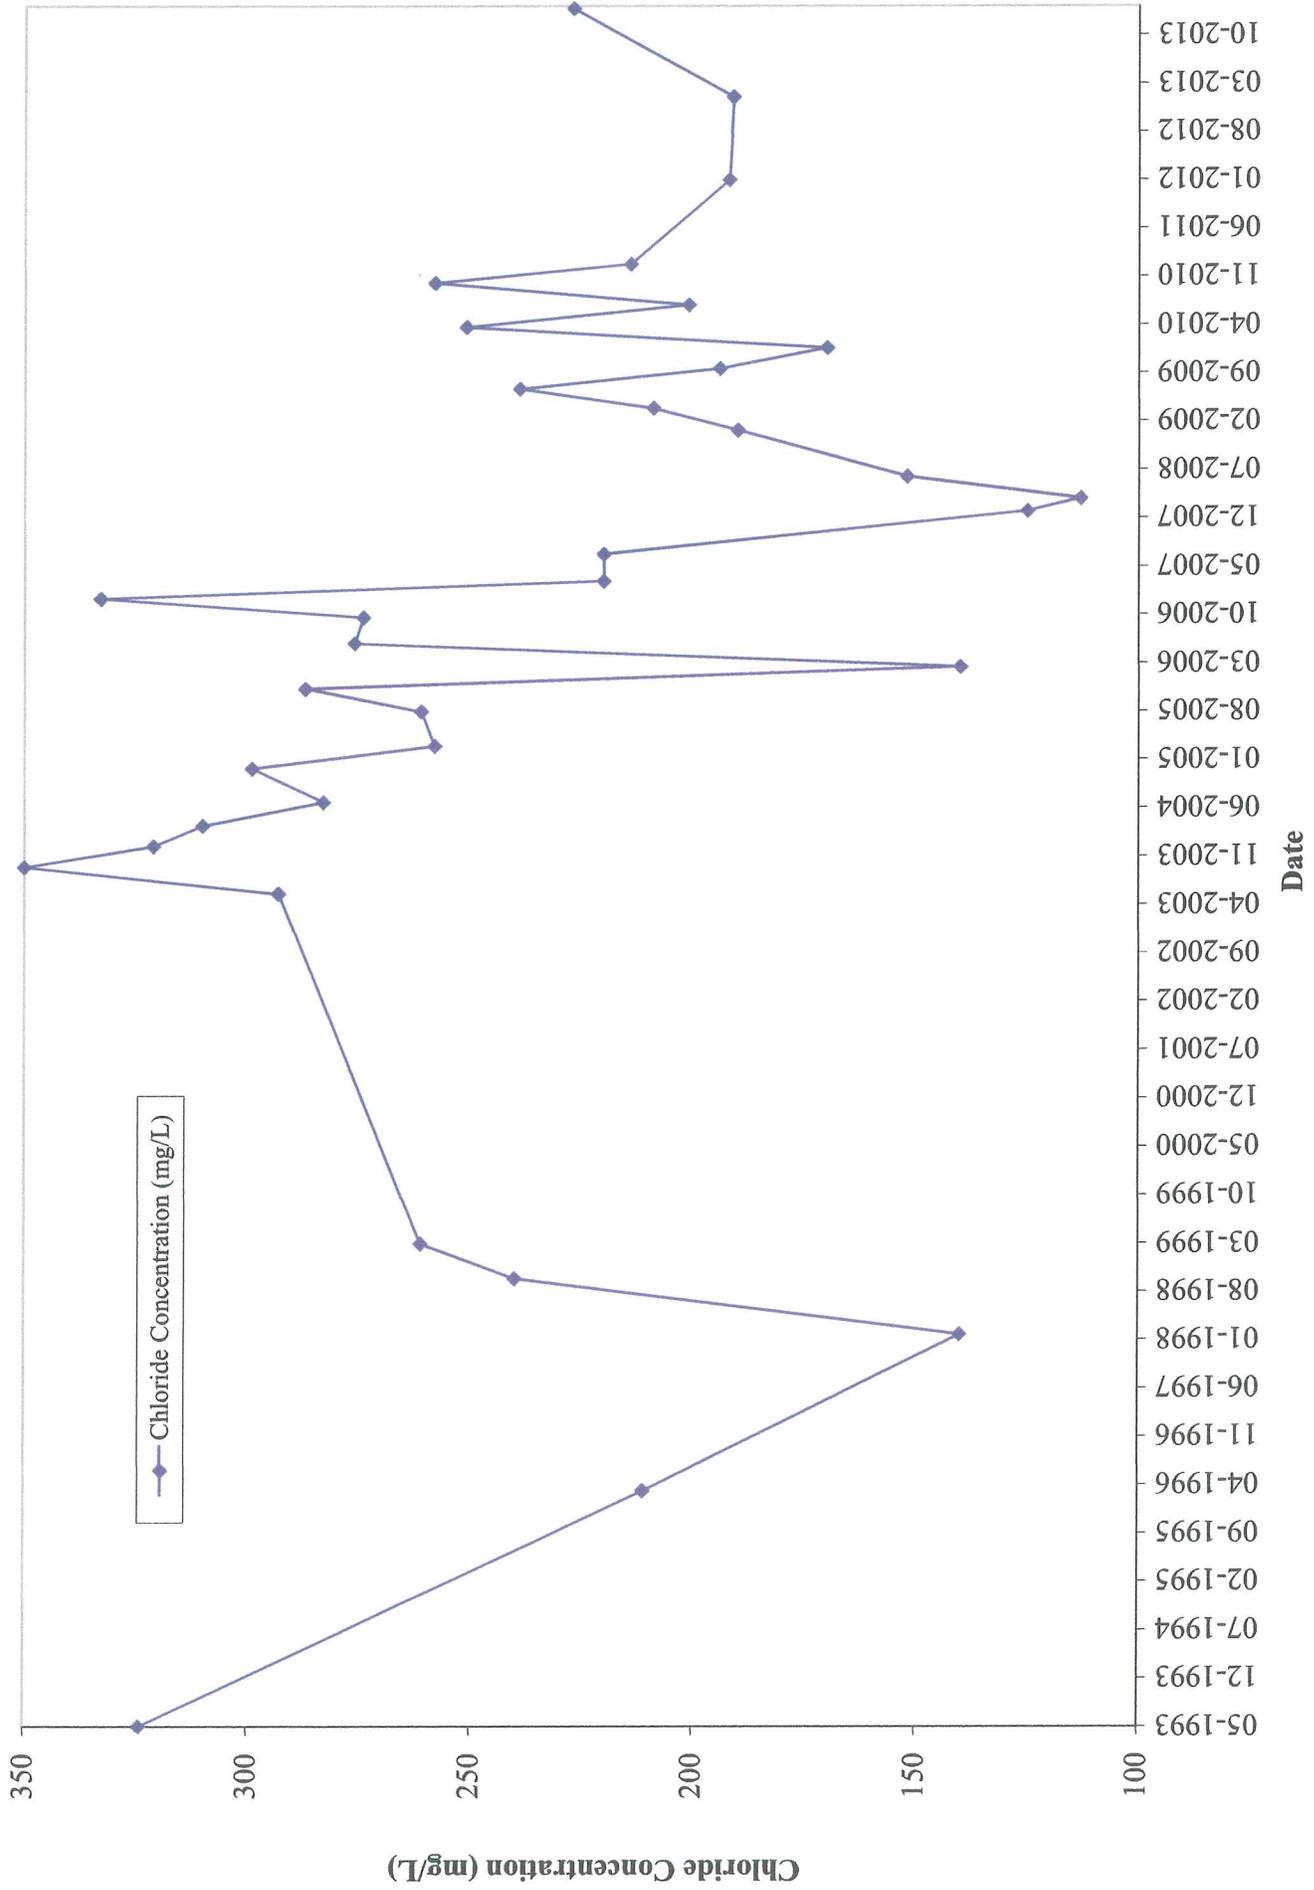
RW-7 Chloride Concentration Over Time
