Phase I ESA for Cooper Tools, Inc.,
3012 Mason Street, Monroe, Union
County, North Carolina

Prepared By Jennifer Jones

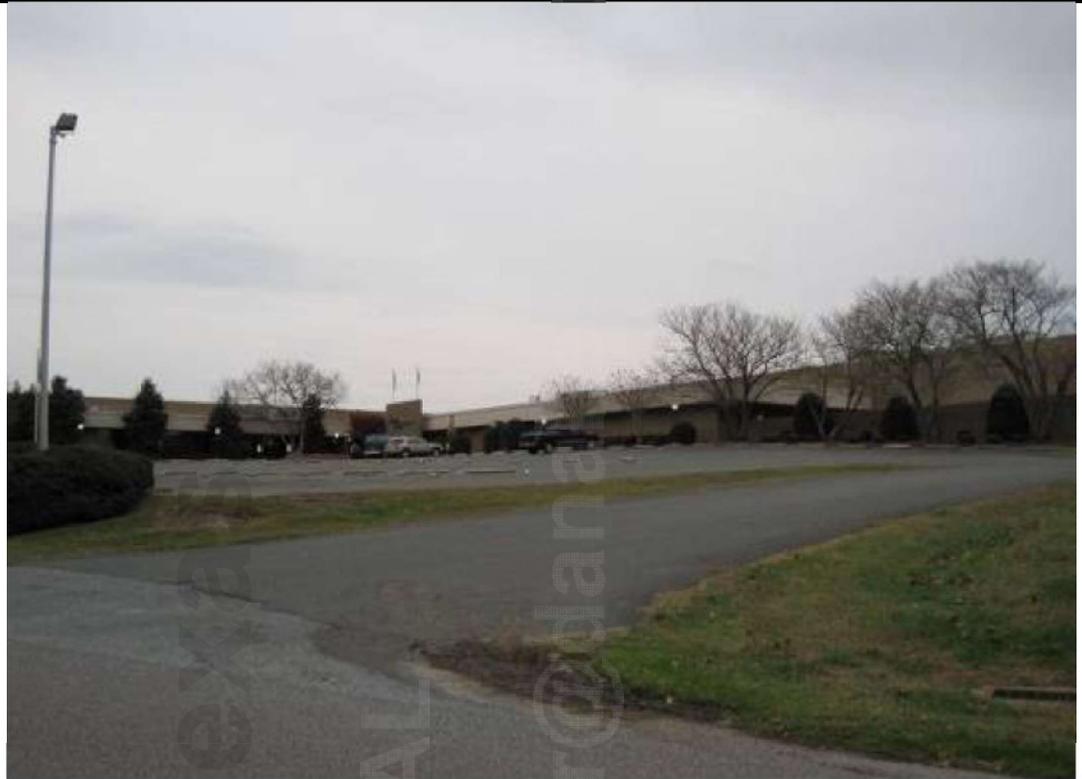
**Photo No.**
2**Date:**
12/4/09**Direction Photo Taken:**

View of the employee parking lot located to the north of the production building. The training building is visible on the left side of the photograph.

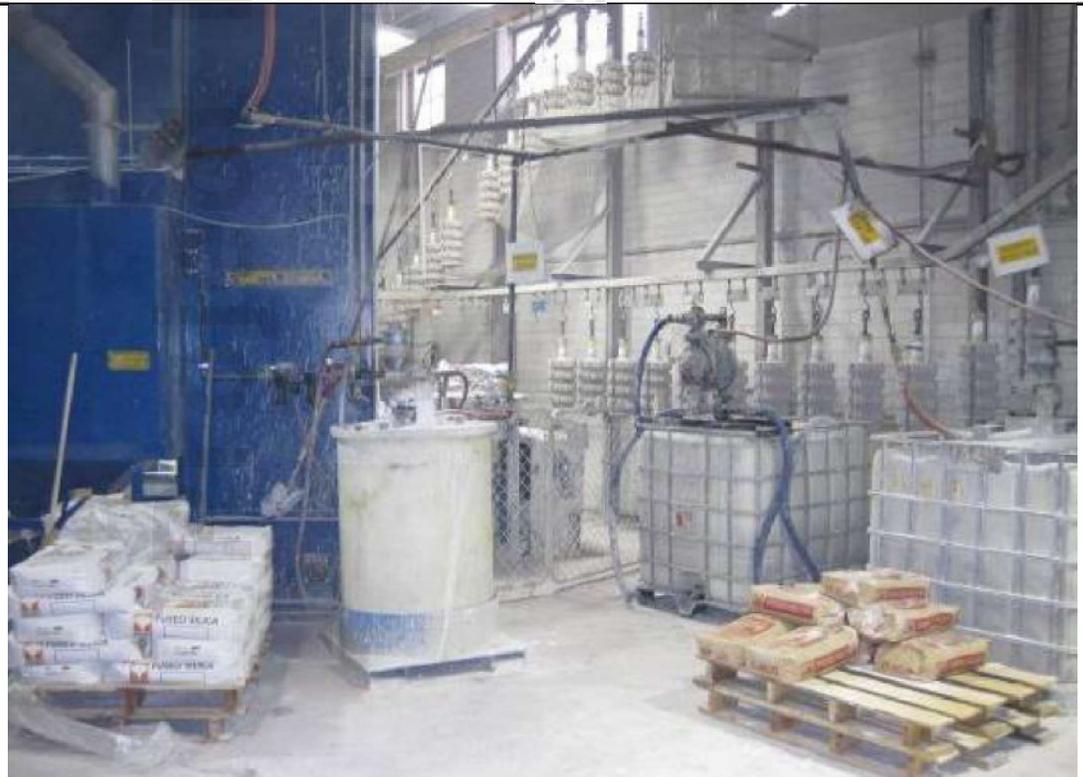
Client Name:
Cooper Industries**Site Location:**
3012 Mason Street, Monroe, North Carolina**Project No.:**
60143901-0015**Photo No.:**
5**Date:**
12/4/09**Direction Photo Taken:**

View of the ASTs and drums located within Bay 2.

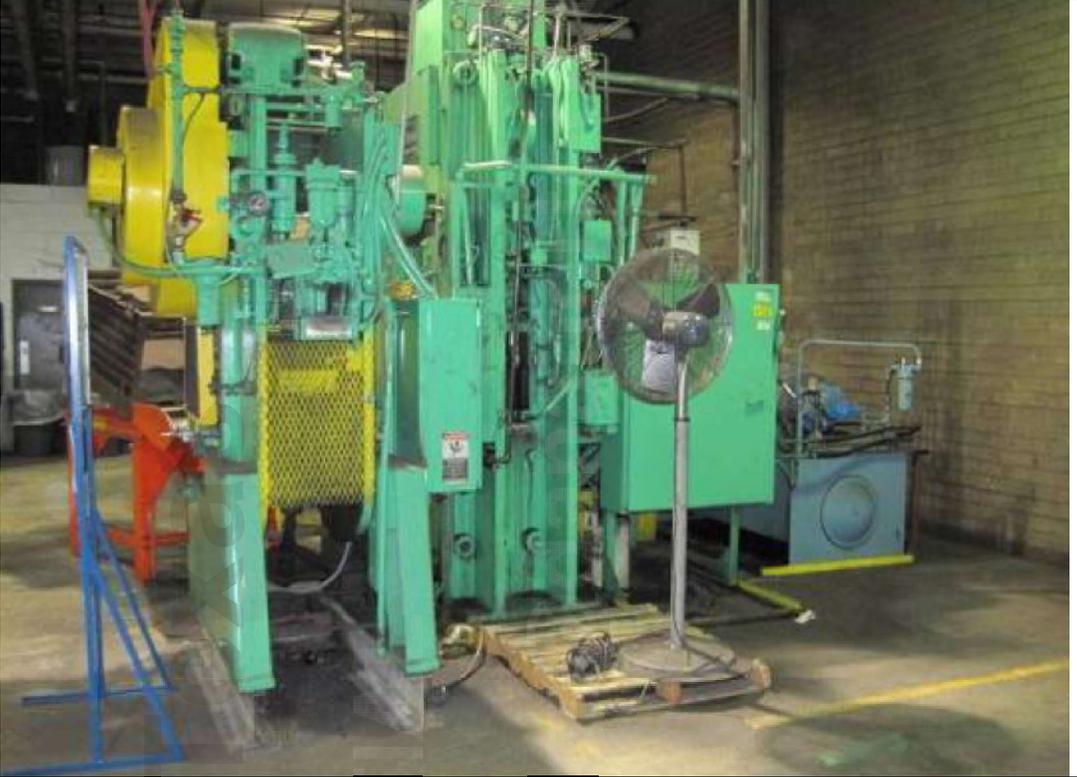
Client Name: Cooper Industries		Site Location: 3012 Mason Street, Monroe, North Carolina	Project No.: 60143901-0015
Photo No.: 7	Date: 12/4/09

Direction Photo Taken: N/A			
Description: View of a press in Bay 4 that utilizes hydraulic power units with oil reservoirs (located on the right side of the photograph).

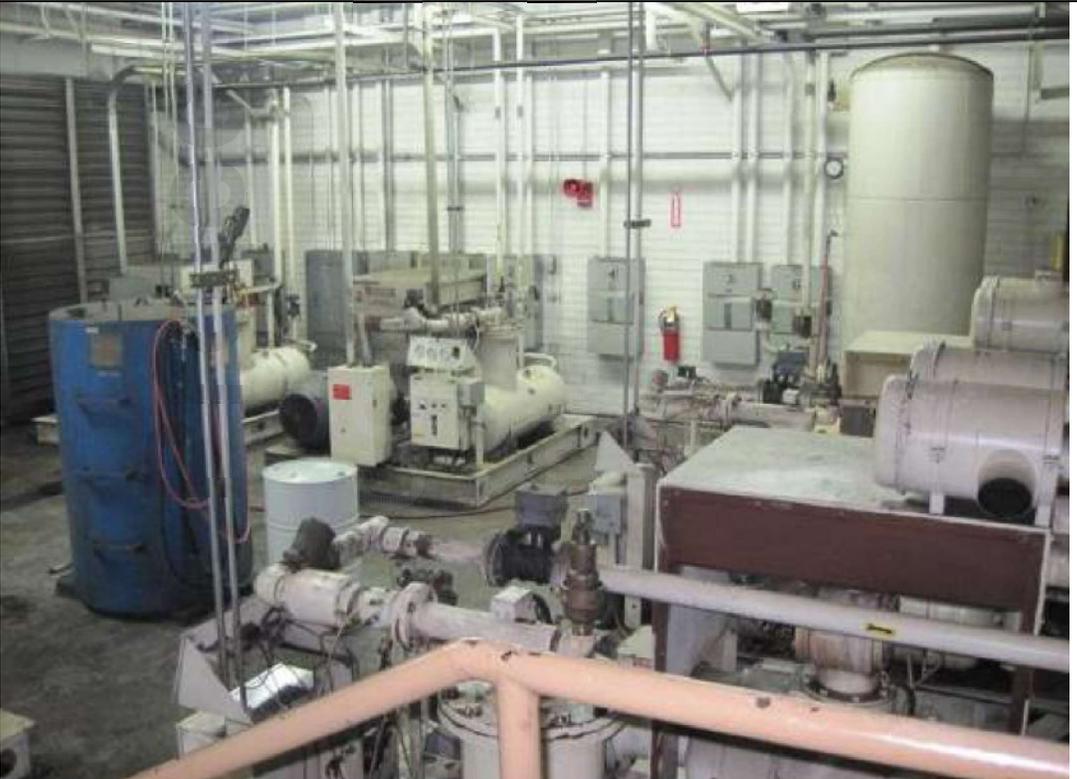
Photo No.: 8	Date: 12/4/09

Direction Photo Taken: N/A			
Description: Interior view of the air compressor room. The 500-gallon AST containing transmission fluid and 55-gallon drum containing synthetic lubricant are visible on the left side of the photograph.

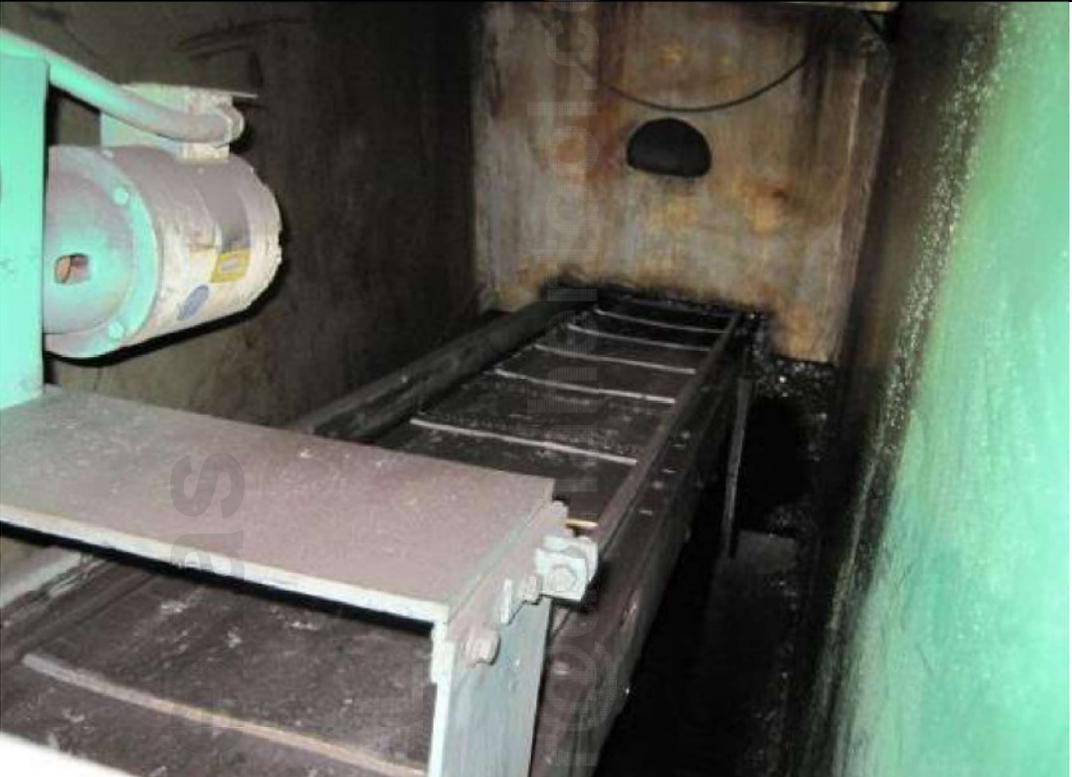
Client Name: Cooper Industries		Site Location: 3012 Mason Street, Monroe, North Carolina	Project No.: 60143901-0015
Photo No.: 9	Date: 12/4/09

- In-ground pits were noted underneath one coining press; a furnace quench tank; and two progressive presses. The pits are constructed of concrete and while periodically cleaned out, it was not made clear that they are routinely inspected for cracks or breaches in the concrete. The machinery within the pits utilizes various petroleum products and heat transfer products. Oil was noted within the pit associated with the coining press machine. The unknown integrity of the in-ground pits represents a REC for the subject site.

Direction Photo Taken: N/A			
Description: View of the oil located within the coin press pit in Bay 4.

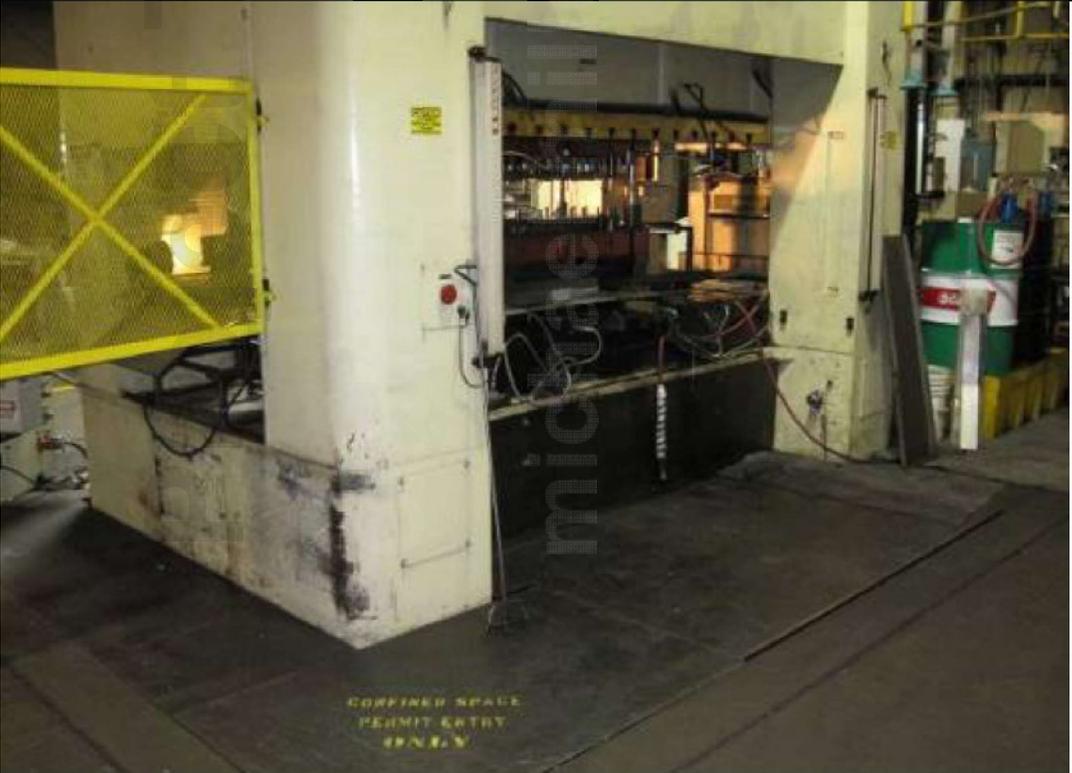
Photo No.: 10	Date: 12/4/09

Direction Photo Taken: N/A			
Description: View of a progressive press located within the Butler Building. The press is located above an in-ground pit.

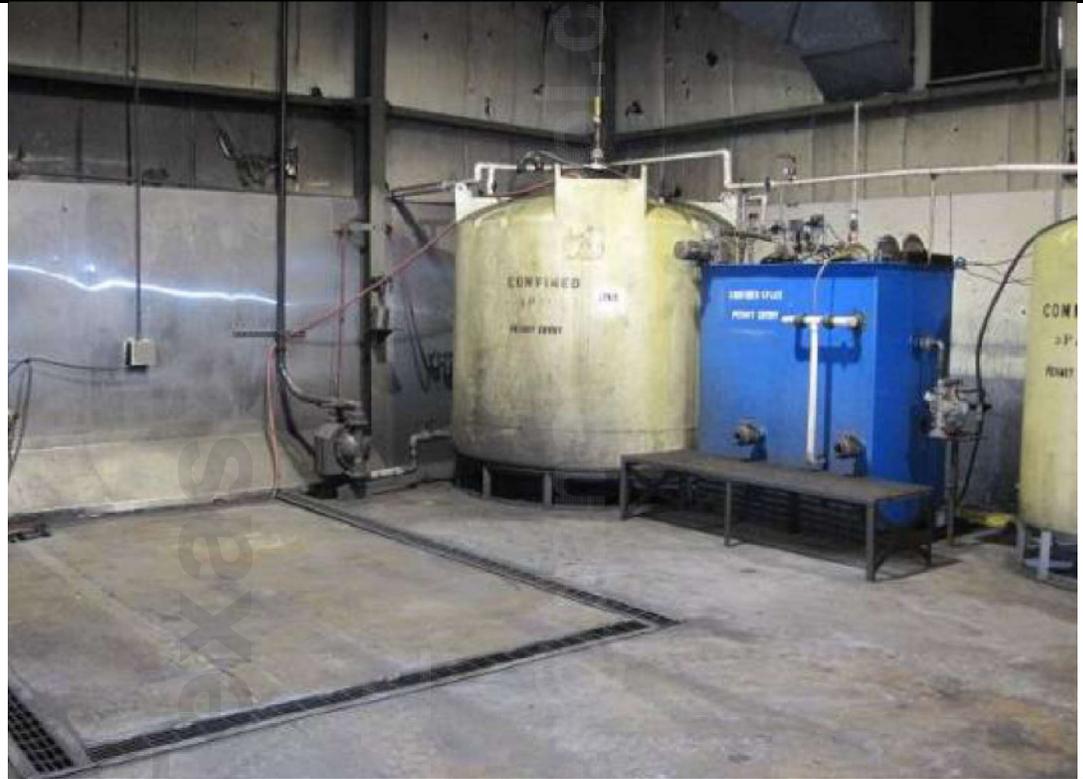
Client Name:
Cooper Industries**Site Location:**
3012 Mason Street, Monroe, North Carolina**Project No.:**
60143901-0015**Photo No.:**
11**Date:**
12/4/09**Direction Photo Taken:**

View of the steam cleaning area and oil/water separator system (waste treatment area) located within the fenced area in the Butler Building.

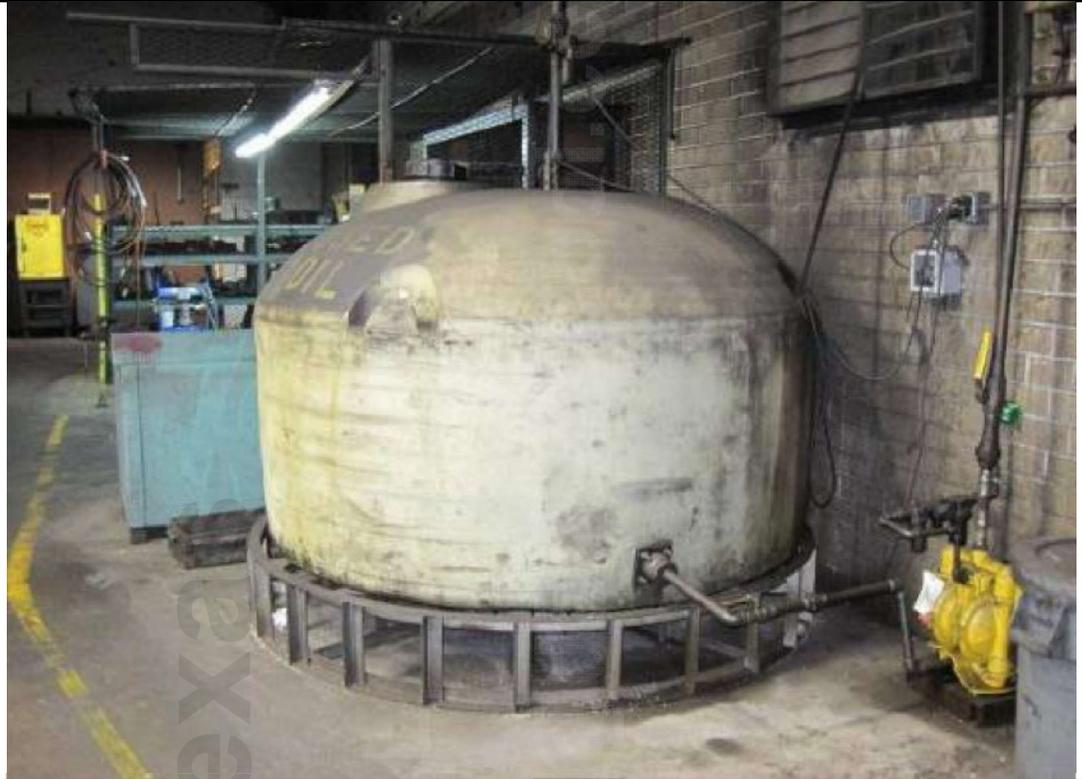
Client Name:
Cooper Industries**Site Location:**
3012 Mason Street, Monroe, North Carolina**Project No.**
60143901-0015**Photo No.**
13**Date:**
12/4/09**Direction Photo Taken:**

View of the 1,200-gallon plastic AST located in along the eastern wall of Bay 6. The tank is used to collect oil from the utility trenches.

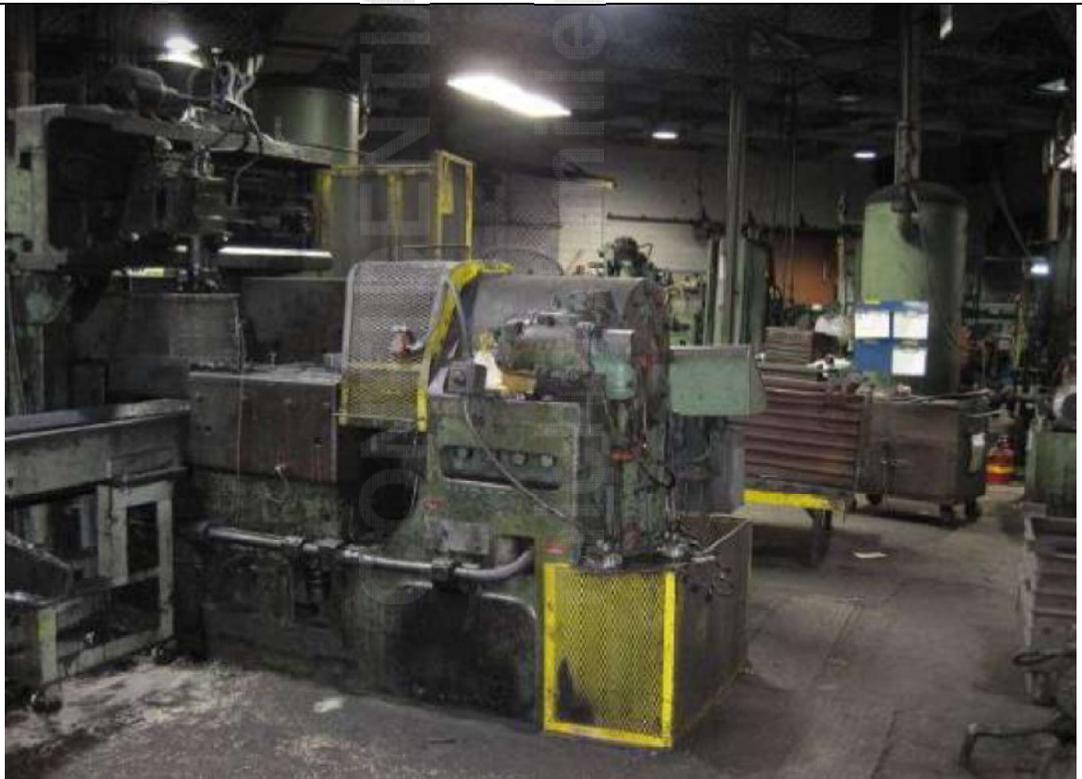
**Photo No.**
14**Date:**
12/4/09**Direction Photo Taken:**

- Floor trenches are located in areas throughout the facility and utilized as secondary containment. The trenches are located in the area of electrical discharge machine (EDM) fluid tanks; nine impactor forging machines; the air compressor room; the forge shop; and the waste treatment cleaning area. Waste streams in these areas consist of hazardous substances and petroleum products, including but not limited to hydraulic oils, lubricating oils, motor oil, used oils, antifreeze, coolant oil, propylene glycol, and oily water. Based on the age of the building (approximately 1969), the potential exists for materials collected in the containment units to have potentially seeped through cracks in the concrete to the subsurface.

Interior view of the impactor area within Bay 6. The utility trenches are visible in the area of the impactors.

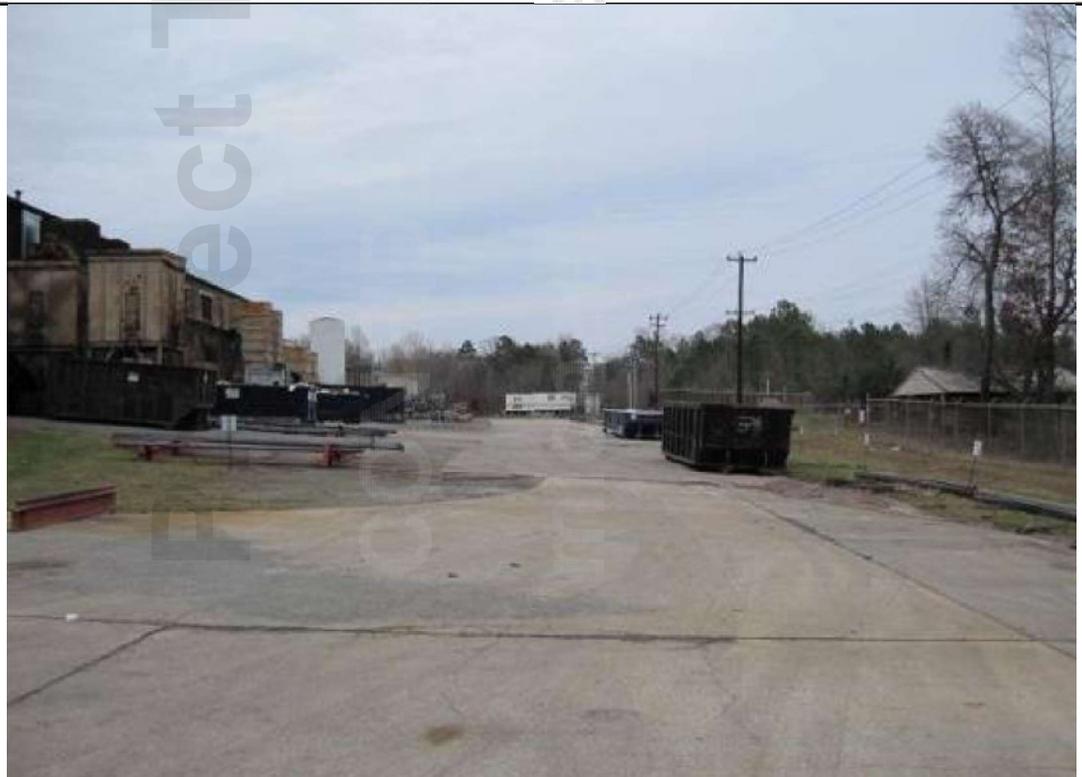
View near the southwest corner of the subject site. Spud Smith Street is visible in the background followed by the west adjoining property (Carolina Truss & Manufacturing).

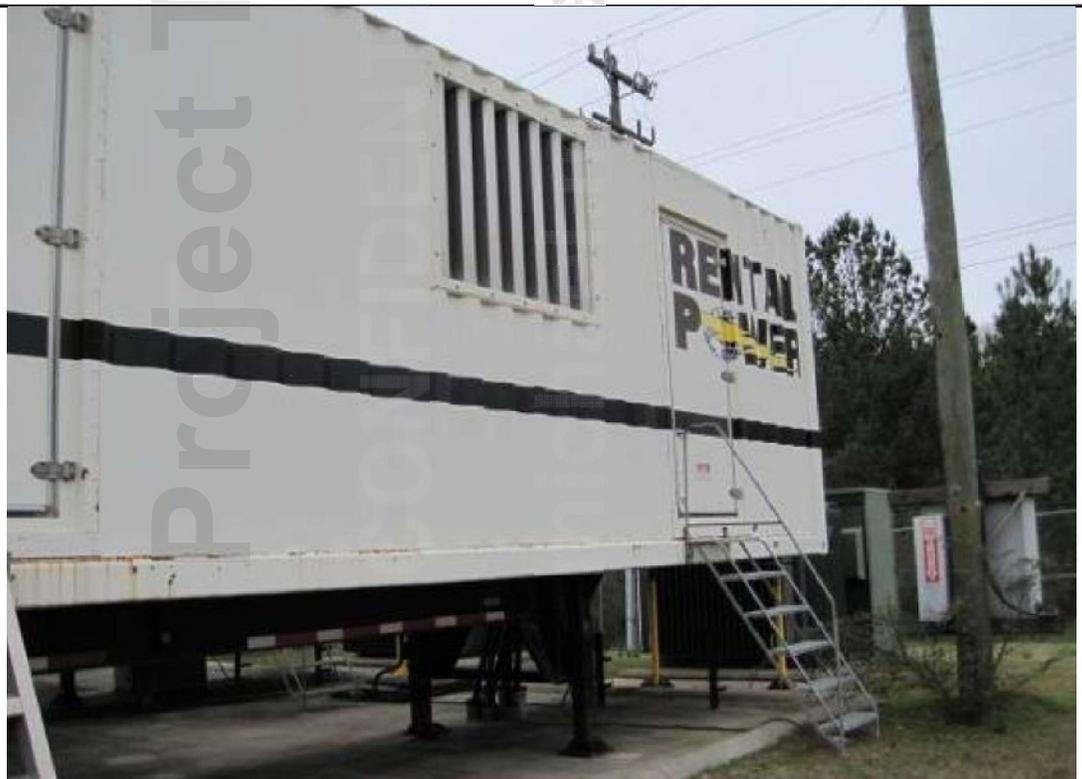
Photo No.
18

View of the mobile trailers (referred to as the generating plant), which house the diesel engines (located within the mobile trailers) that power generators mounted in the mobile trailer enclosures. The 1,250-gallon diesel tanks are located within the south end of the trailers.

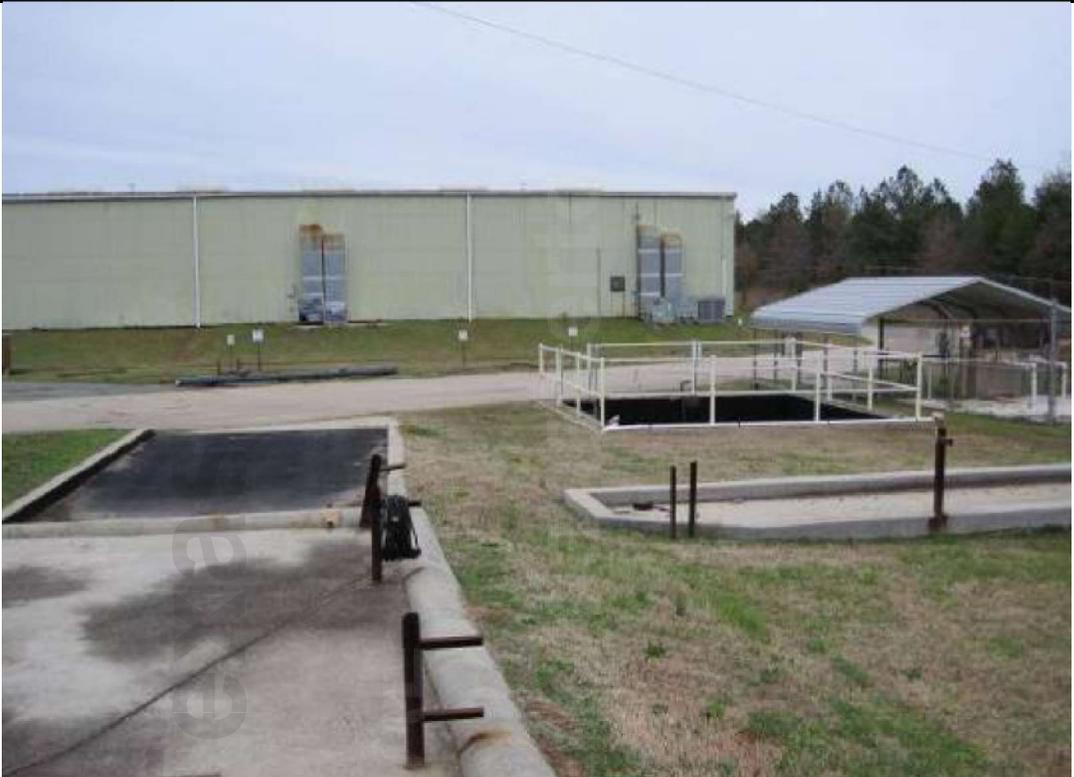
Client Name: Cooper Industries		Site Location: 3012 Mason Street, Monroe, North Carolina	Project No.: 60143901-0015
Photo No.: 19	Date: 12/4/09

Direction Photo Taken: North			
Description: View of the diked concrete pad (located underneath the generator plant) and the adjacent containment pit. The propane refilling station and the containment structure for the former 3,000-gallon diesel AST are visible on the right side of the photograph.

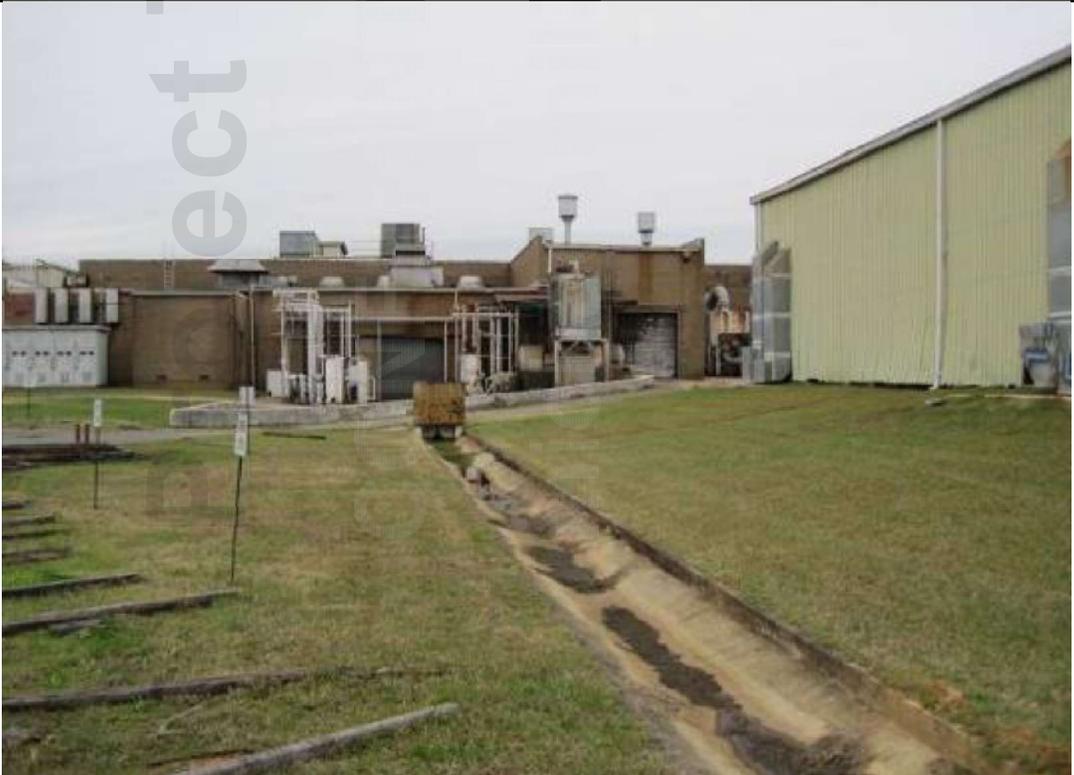
Photo No.: 20	Date: 12/4/09

Direction Photo Taken: West		
Description: Visible in the background is a view of the air-cooled heat exchange units and 3,000-gallon AST containing oil/water located adjacent to the air compressor room and along the exterior southeast wall of the building. The units and the AST are situated within a concrete containment structure, which is connected to the concrete drainage ditch.
