Re: Soil Gas Sampling Report Cunningham Cleaners Charlotte, Mecklenburg County DSCA ID: DC600013 H&H Job No. DS0-76D

#### 1.0 Introduction

## APPENDIX A PHOTOGRAPHIC LOG

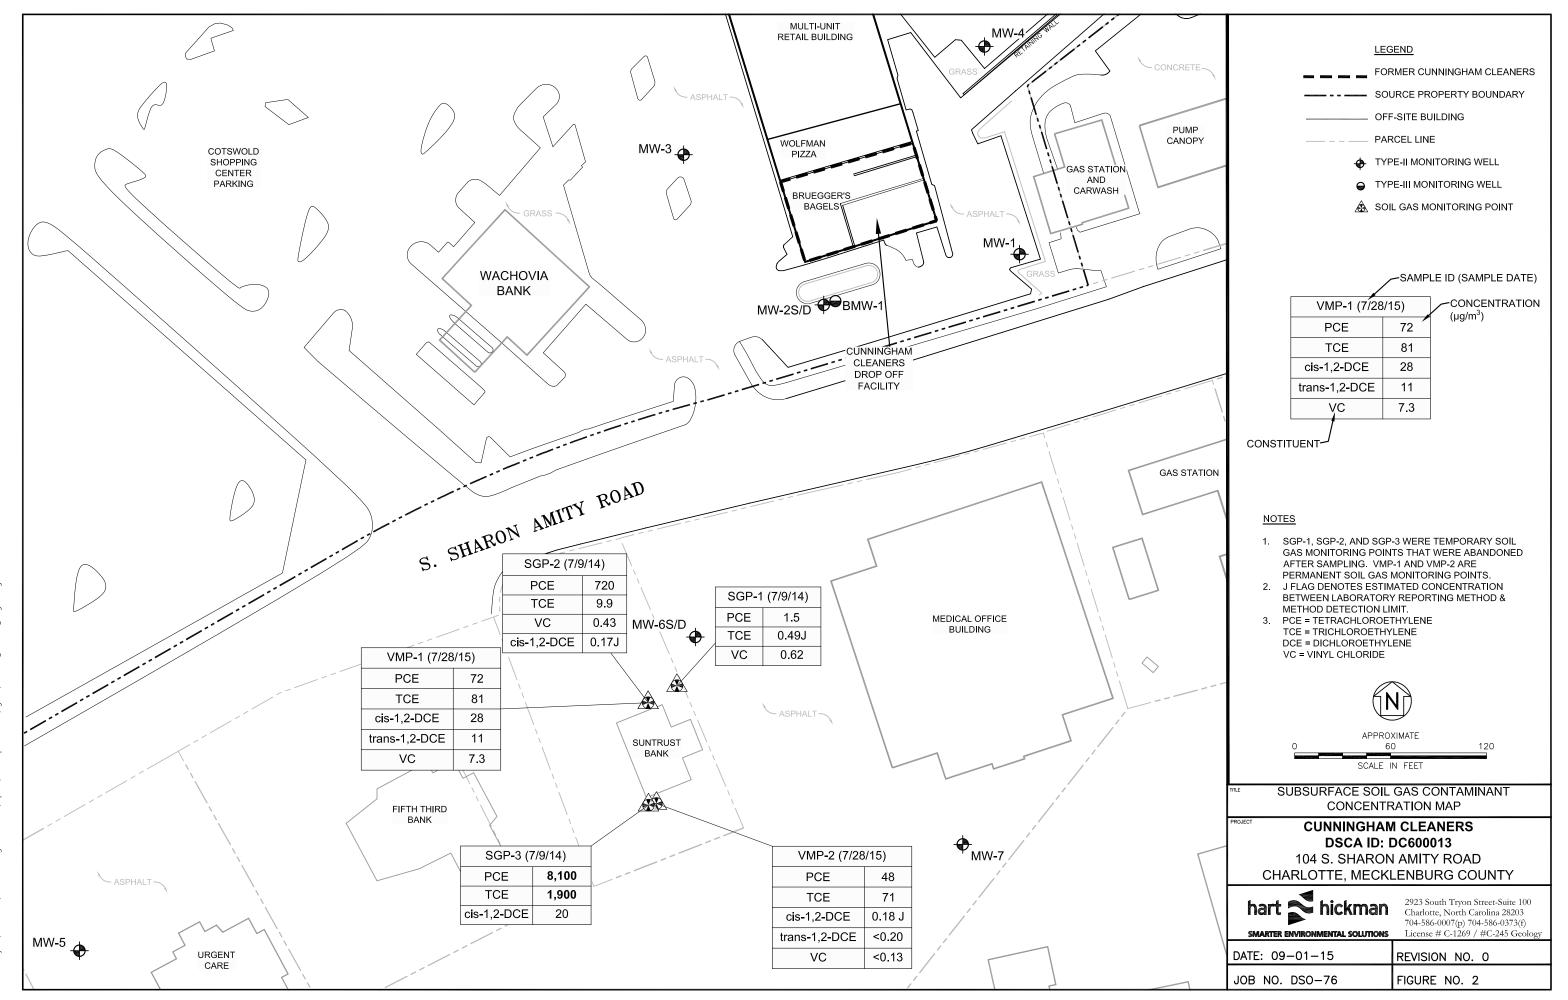
On July 27, 2015, H&H contracted Carolina Soil Investigations, LLC (CSI) to install two permanent subsurface soil vapor monitoring points (VMP-1 and VMP-2) at SunTrust. VMP-1 was installed along the northern side of the building, and VMP-2 was installed near the southwestern corner of the building. The VMPs were installed above the capillary fringe to evaluate potential vapor impacts from groundwater. The sample locations are depicted on Figure 2, and photographs are provided in Appendix A.

The dry-cleaning solvent PCE and its degradation products TCE and cis-1,2-DCE were detected in each of the soil vapor samples collected adjacent to the SunTrust building and degradation products trans-1,2-DCE and VC were detected in sample VMP-1. Slightly higher concentrations were detected in VMP-1 located on the north side of the building closer to the Cunningham Cleaners source property with concentrations of 72  $\mu$ g/m³ for PCE, 81  $\mu$ g/m³ for TCE, 28  $\mu$ g/m³ for cis-1,2-DCE, 11  $\mu$ g/m³ for trans-1,2-DCE, and 7.3  $\mu$ g/m³ for VC. Slightly lower concentrations of 48  $\mu$ g/m³ for PCE, 71  $\mu$ g/m³ for TCE, and 0.18  $\mu$ g/m³ for cis-1,2-DCE were detected in VMP-2 located near the southwestern corner of the building. The concentrations detected in VMP-1 and VMP-2 are notably lower than the previous concentrations detected in SGP-1 through SGP-3. The analytical results for the current and previous soil gas samples are summarized in Table 4 and presented on Figure 2.

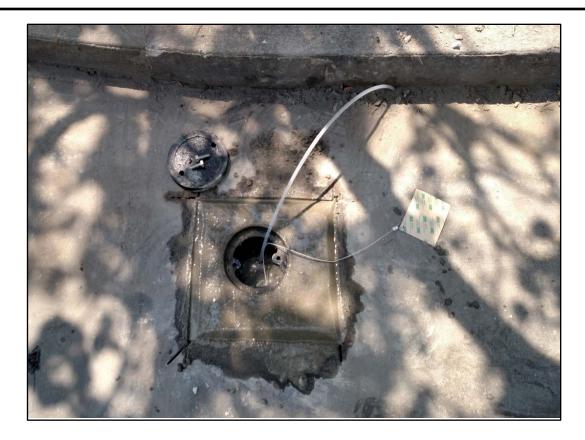
Photograph 1: VMP-1, following installation.

The VMP sampling points were installed approximately 2-3 ft above the capillary fringe at depths of approximately 5.5 ft below ground surface (bgs) utilizing hand auger methods. Each VMP was constructed with a 6-inch stainless steel screen set at the bottom of the borehole and ¼-inch Teflon® tubing extending from the screen to above the ground surface. Well filter sand was placed around the annulus of the screened interval of the sample point and extended to approximately 6 inches above the top of the screen interval. A granular bentonite seal was placed above the sand pack and hydrated. The remaining portion of the borehole annulus was filled with cement grout to grade. The monitoring points were completed with flush-mount housings and 6-inch steel man-hole covers secured within a one-ft by one-ft concrete pad. Upon completion, the end of the Teflon® tubing sampling assembly was secured inside the flush mount

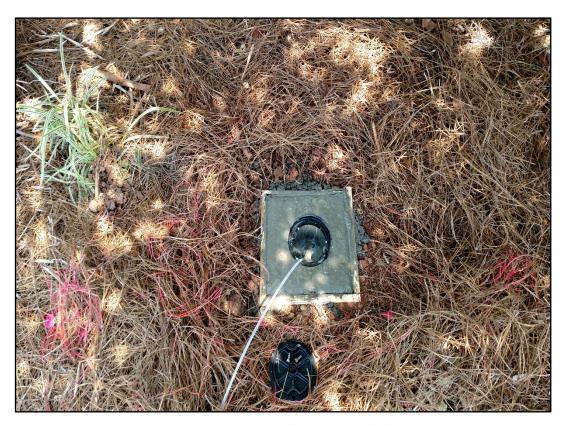
Photograph 2: VMP-2, following installation.

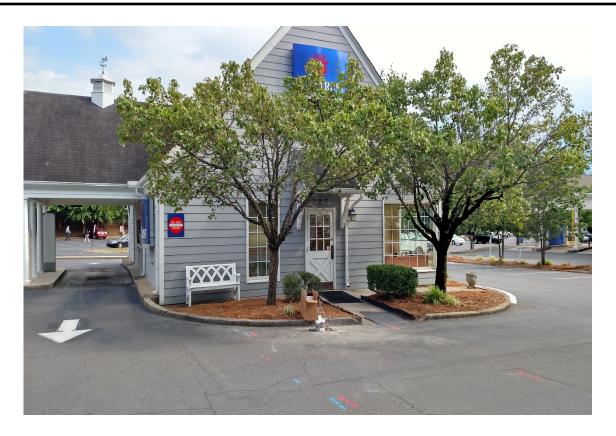
Photograph 3: VMP-1, during sampling activities.

On July 28, 2015, H&H mobilized to the site to collect soil gas samples from VMP-1 and VMP-2. Prior to sample collection, each sample point was purged and a leak check was performed. A minimum of three volumes of air was purged from each location using a syringe. The purge volumes were calculated to include the screen, tubing, and sand pack for each subsurface soil vapor monitoring point. A leak check was conducted at each location by constructing a shroud around the sampling point and flooding the air within the shroud with helium gas. H&H utilized a syringe to collect a sample of the gas in the shroud into a Tedlar<sup>®</sup> bag and analyzed the sample for helium using a helium gas detector. Vapor from the monitoring points was collected outside of the shroud into a separate Tedlar<sup>®</sup> bag and analyzed using the helium gas detector to confirm that helium concentrations were less than 10% of the helium concentrations detected in the shroud. Both of the sample points passed the leak check criteria.

Following purging and a successful leak check, vapor samples were collected from each location using a laboratory-supplied 6-liter Summa canister and airflow regulator calibrated to collect the samples at a rate of approximately 100 mL/min. The Summa canister and airflow regulator were connected to the tubing at each monitoring point using a brass nut and ferrule assembly to form an airtight seal. Subsequently, the canister's intake valve was opened to collect the subsurface soil gas sample. Vacuum readings on the Summa canister were recorded prior to and following the sampling period to confirm adequate sample volume was collected.

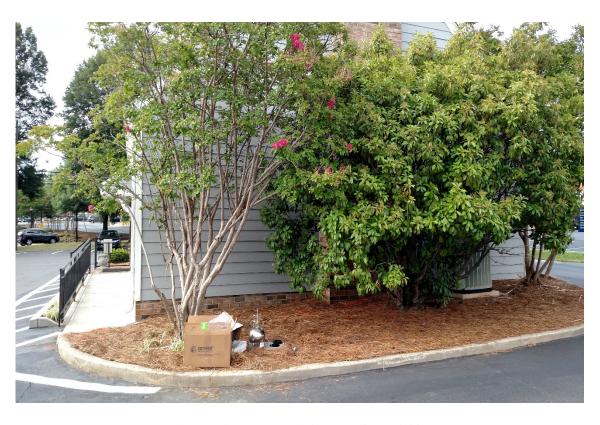
Photograph 4: VMP-2, during sampling activities.
