Limited Site Assessment

Project: The Perfect Image (Incident #12634)
Hickory, NC
Caldwell County
Latitude N 35° 44' 23"
Longitude W 81° 21' 32"

Limited Site Assessment Report

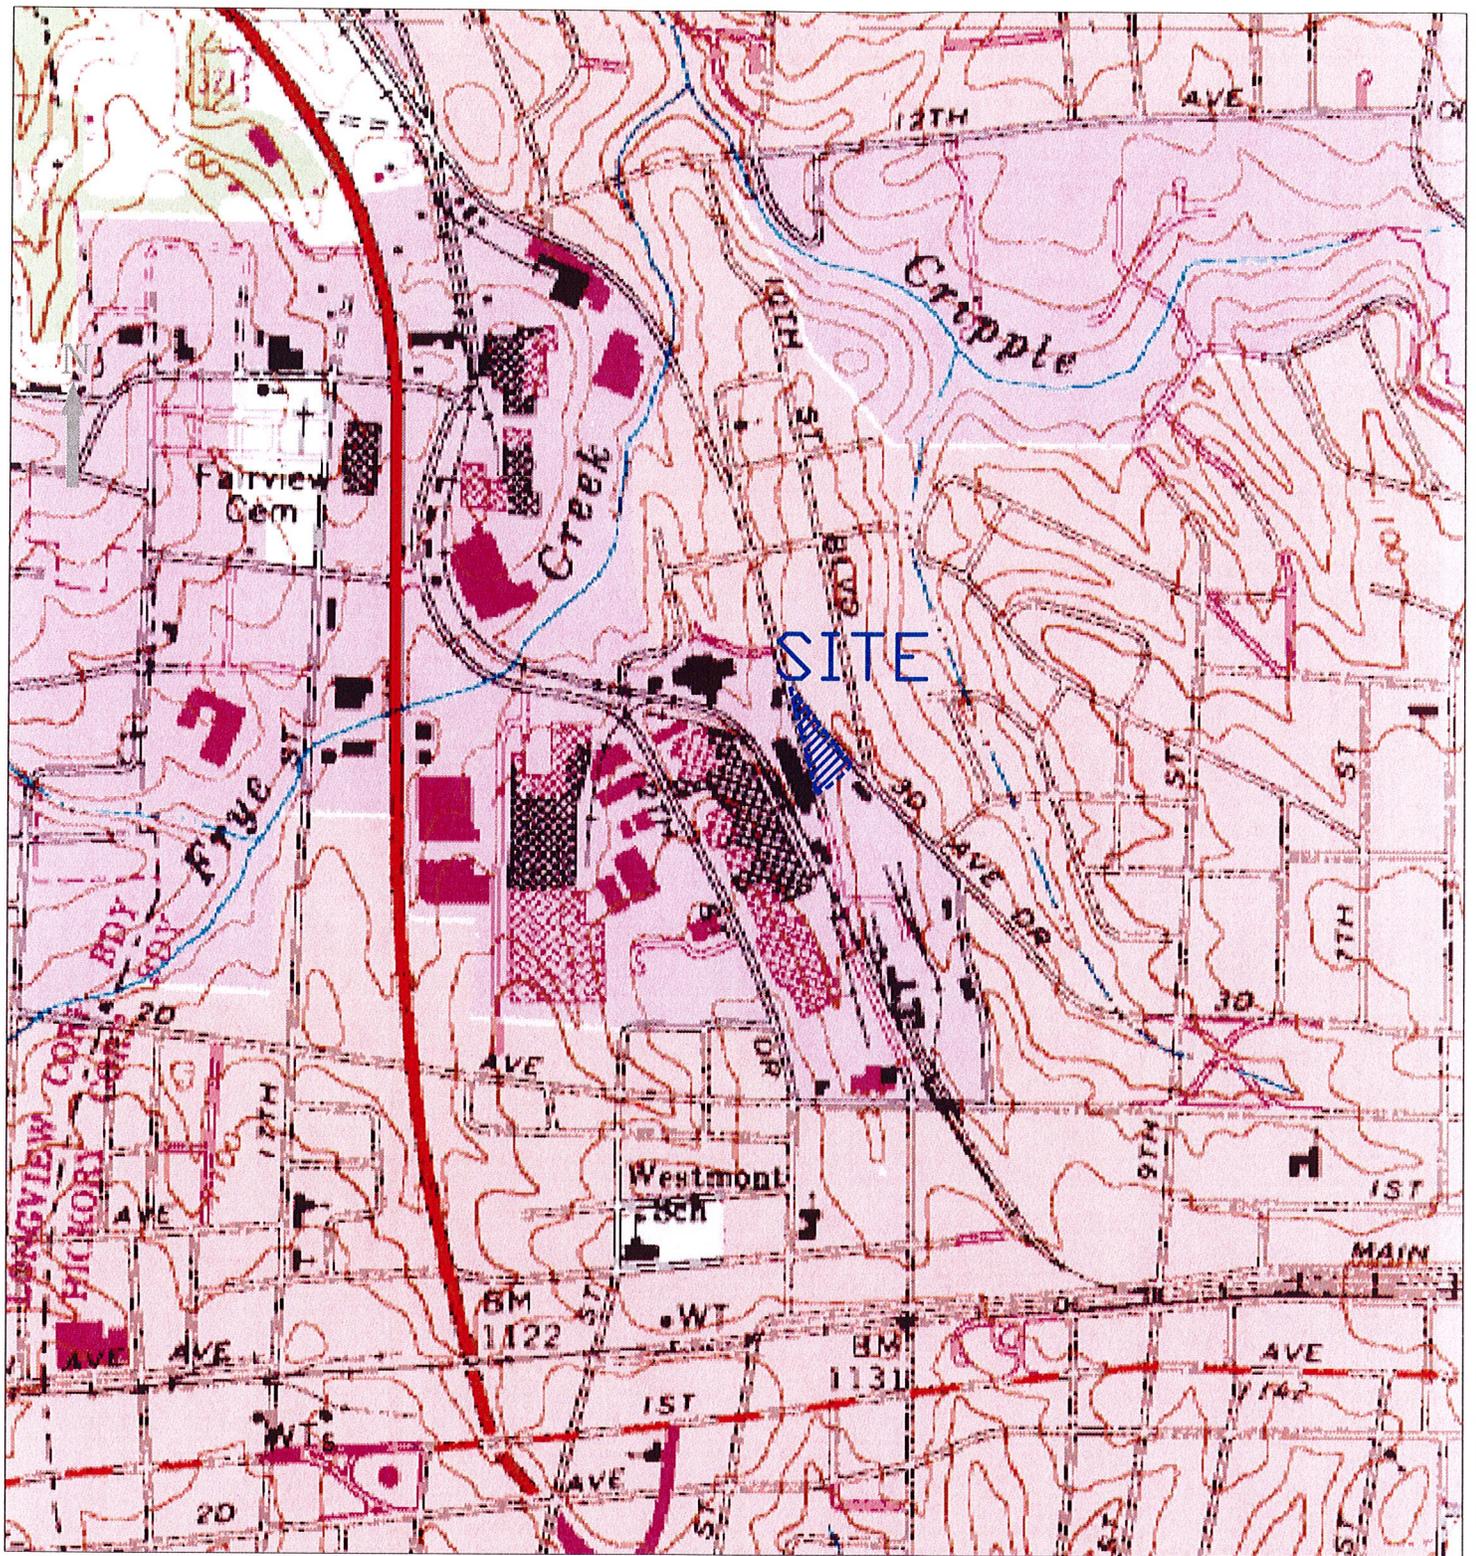
Figure 1: Site Map
 The Perfect Image

All drawings and maps are in the Figures section that follows the text of this report. The location map, Figure 1, a portion of the USGS Hickory, NC quad sheet, shows the general features of the area around the site. There are no water supply wells on the site or on adjacent properties. The nearest down gradient surface water is located greater than 1,100 feet west.

Please refer to the Location Map, a section of the Hickory USGS quadrangle. The likely receptor of surface drainage is an Frye Creek a tributary to the Catawba River that lies northwest of the property and runs southwest to northeast from Hwy 321. Drainage from the site flows to this

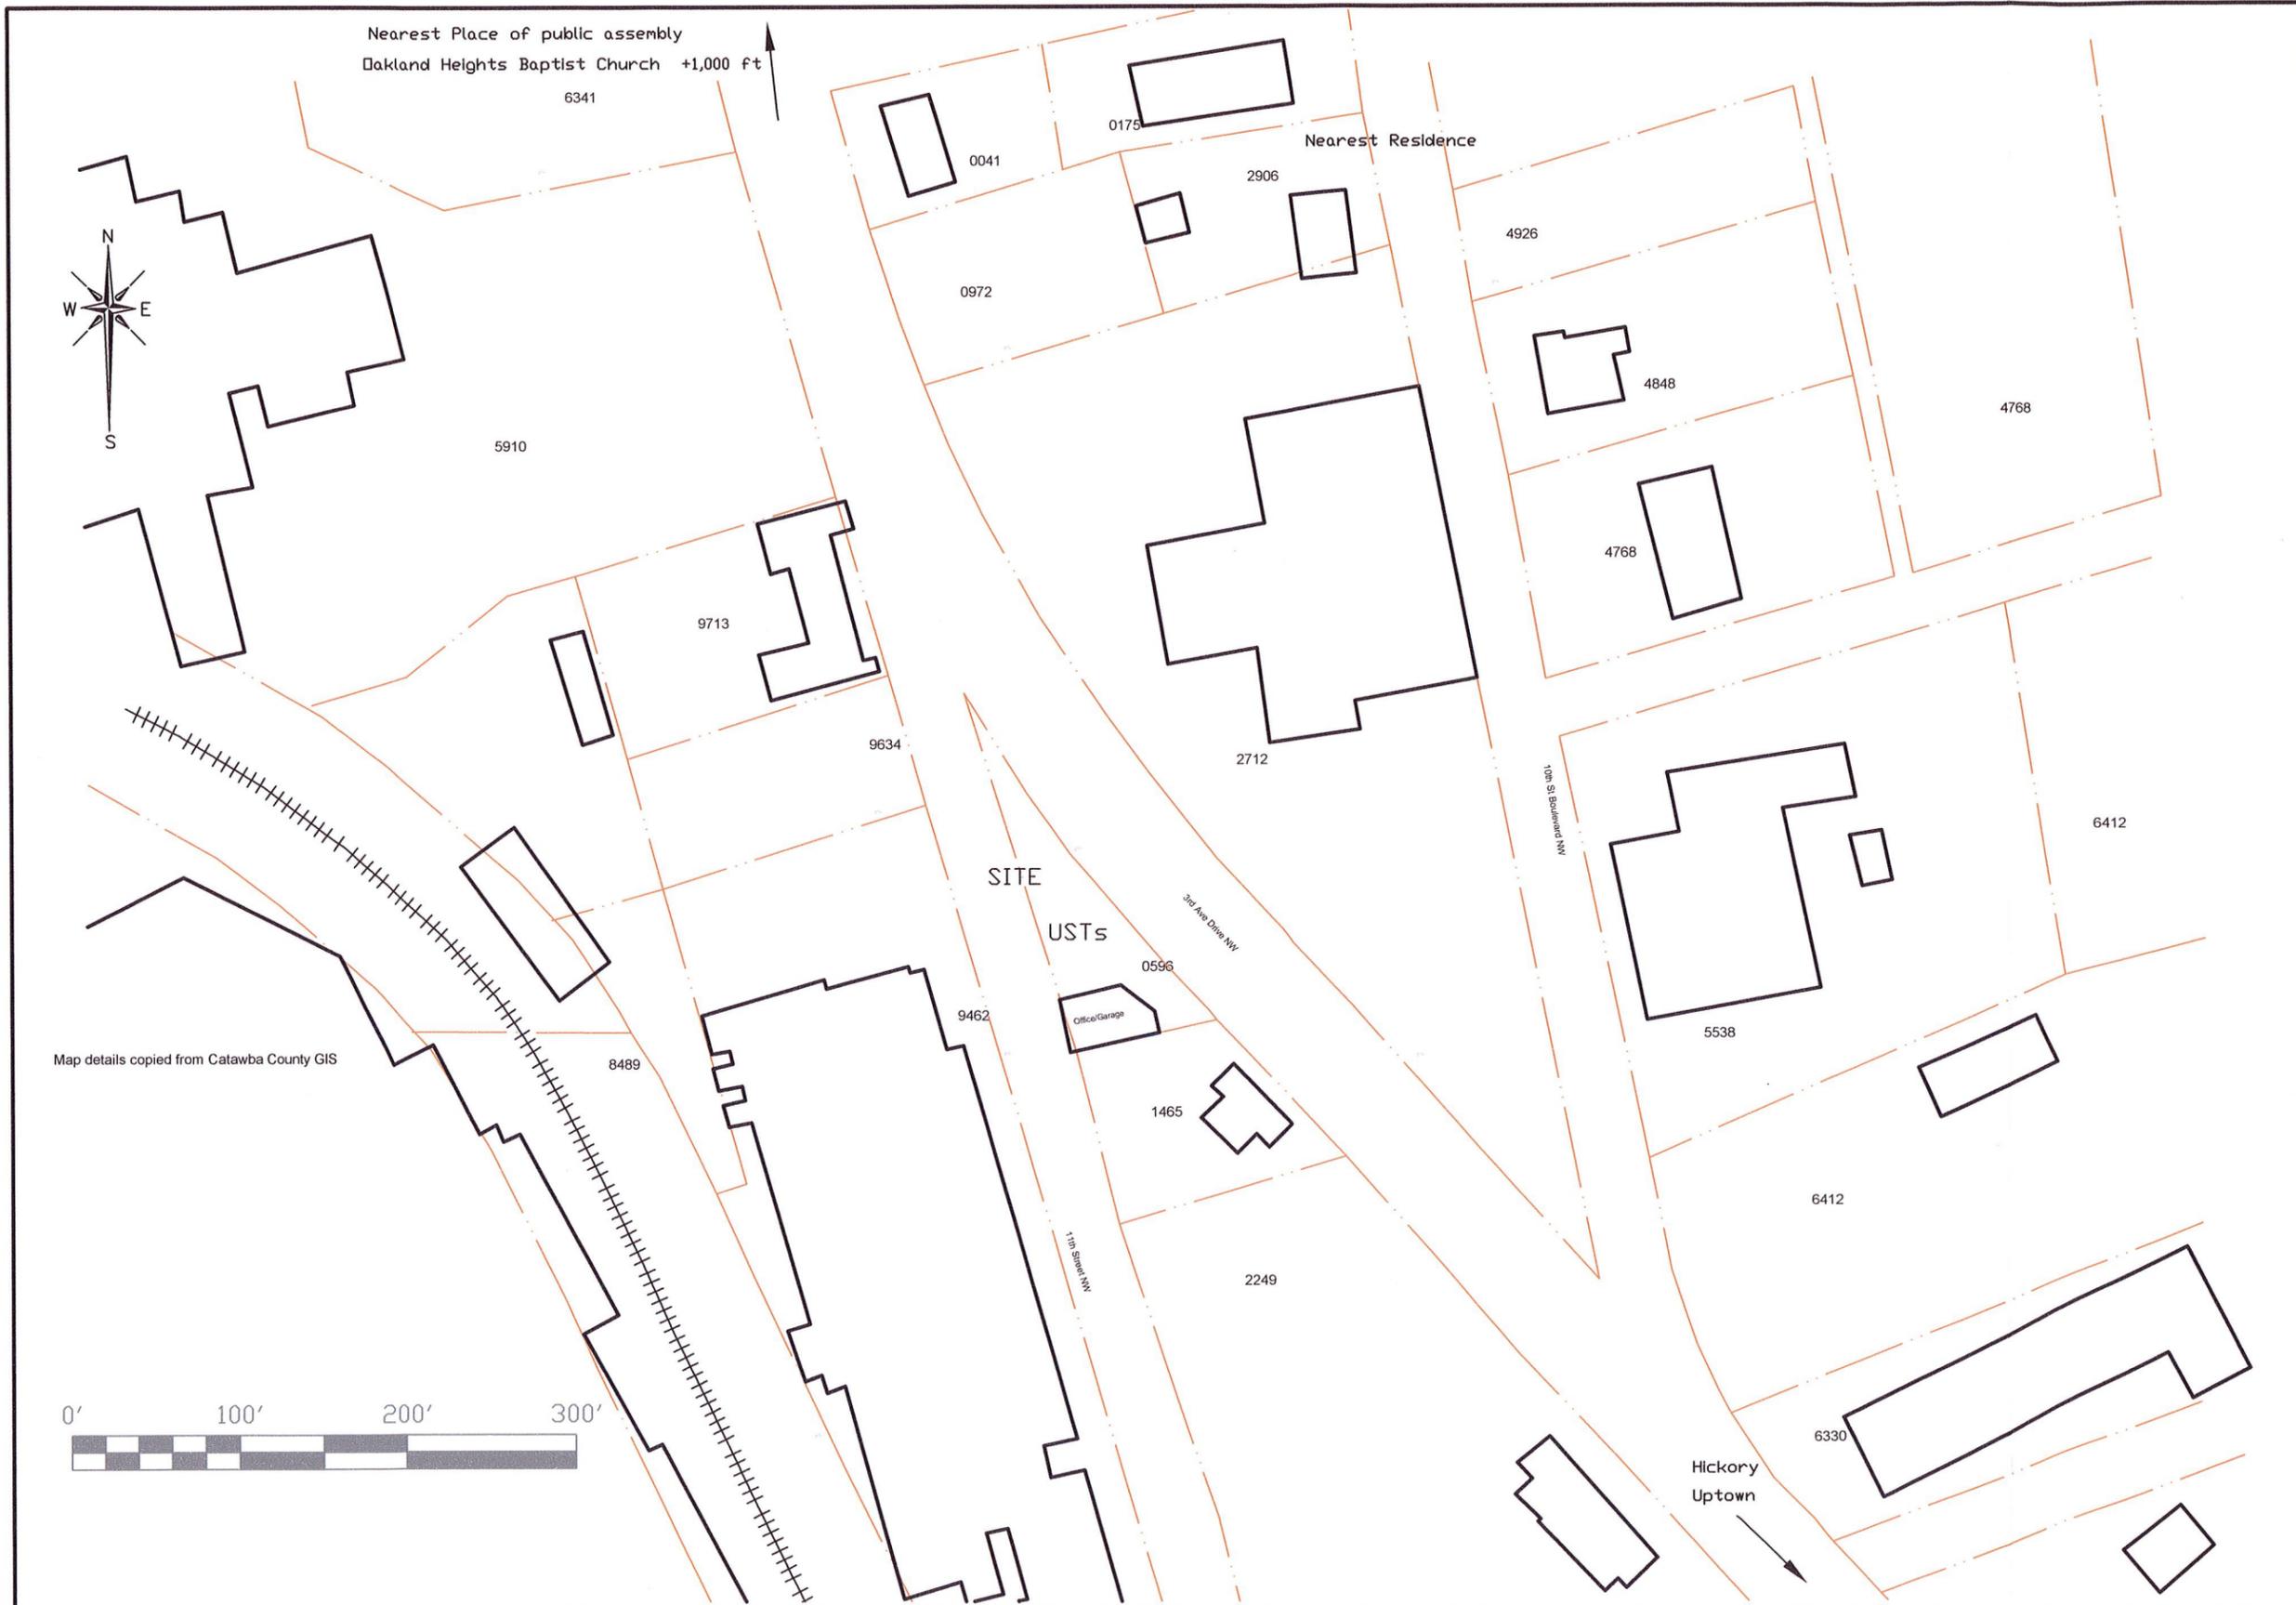
SHEET TITLE: *AREA MAP*

Sheet 1 of the drawings is a Site Map shows detail of the local area. The site is in the area of west Hickory in a commercial/industrial setting. The commercial buildings, homes and churches in the local area are typically older than 50 years. Sheet 2 shows the location of the former USTs. Sheet 3 shows the boring location for the existing monitoring well. A table on Sheet 3 summarizes the groundwater samples analytical results for the 2007 and 1994 groundwater samples. There are no underground utilities that traverse the former tank beds, and no additional pathways identified for contamination migration.

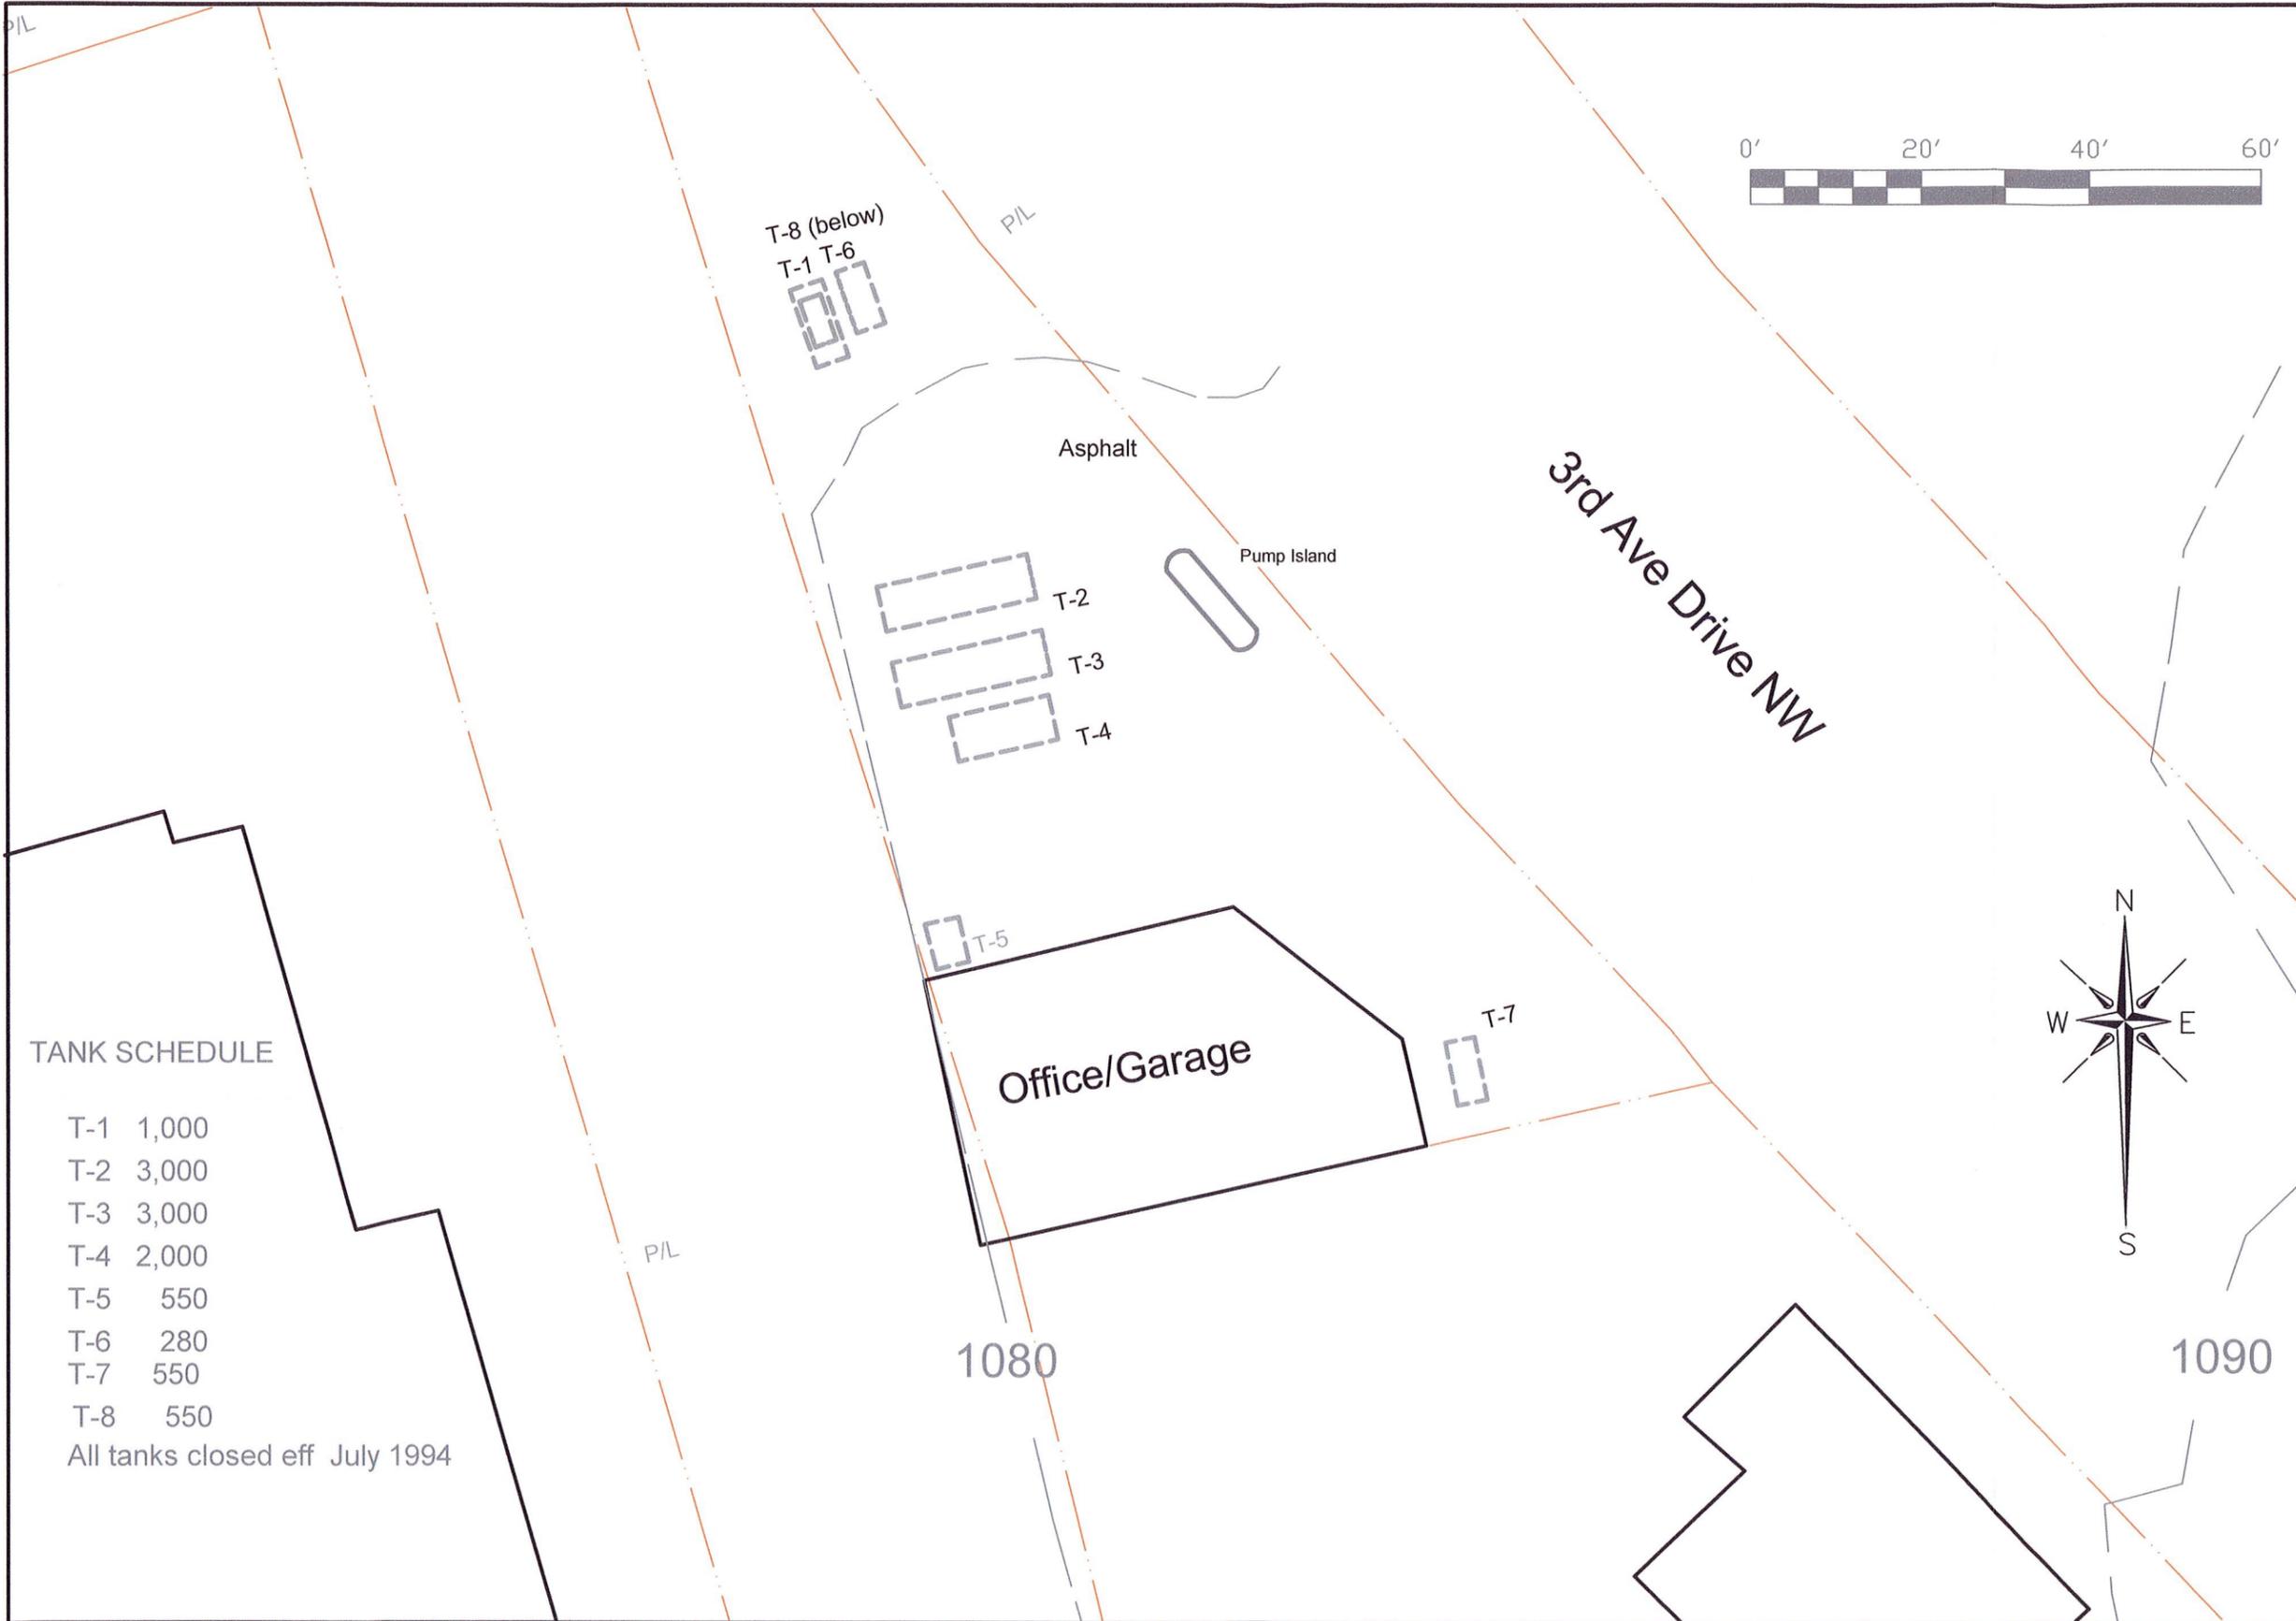
NAME: *The Perfect Image Incident # 12634*
 SHEET TITLE: *SITE PLAN*

T-1	1,000
T-2	3,000
T-3	3,000
T-4	2,000
T-5	550
T-6	280
T-7	550
T-8	550

All tanks closed eff July 1994

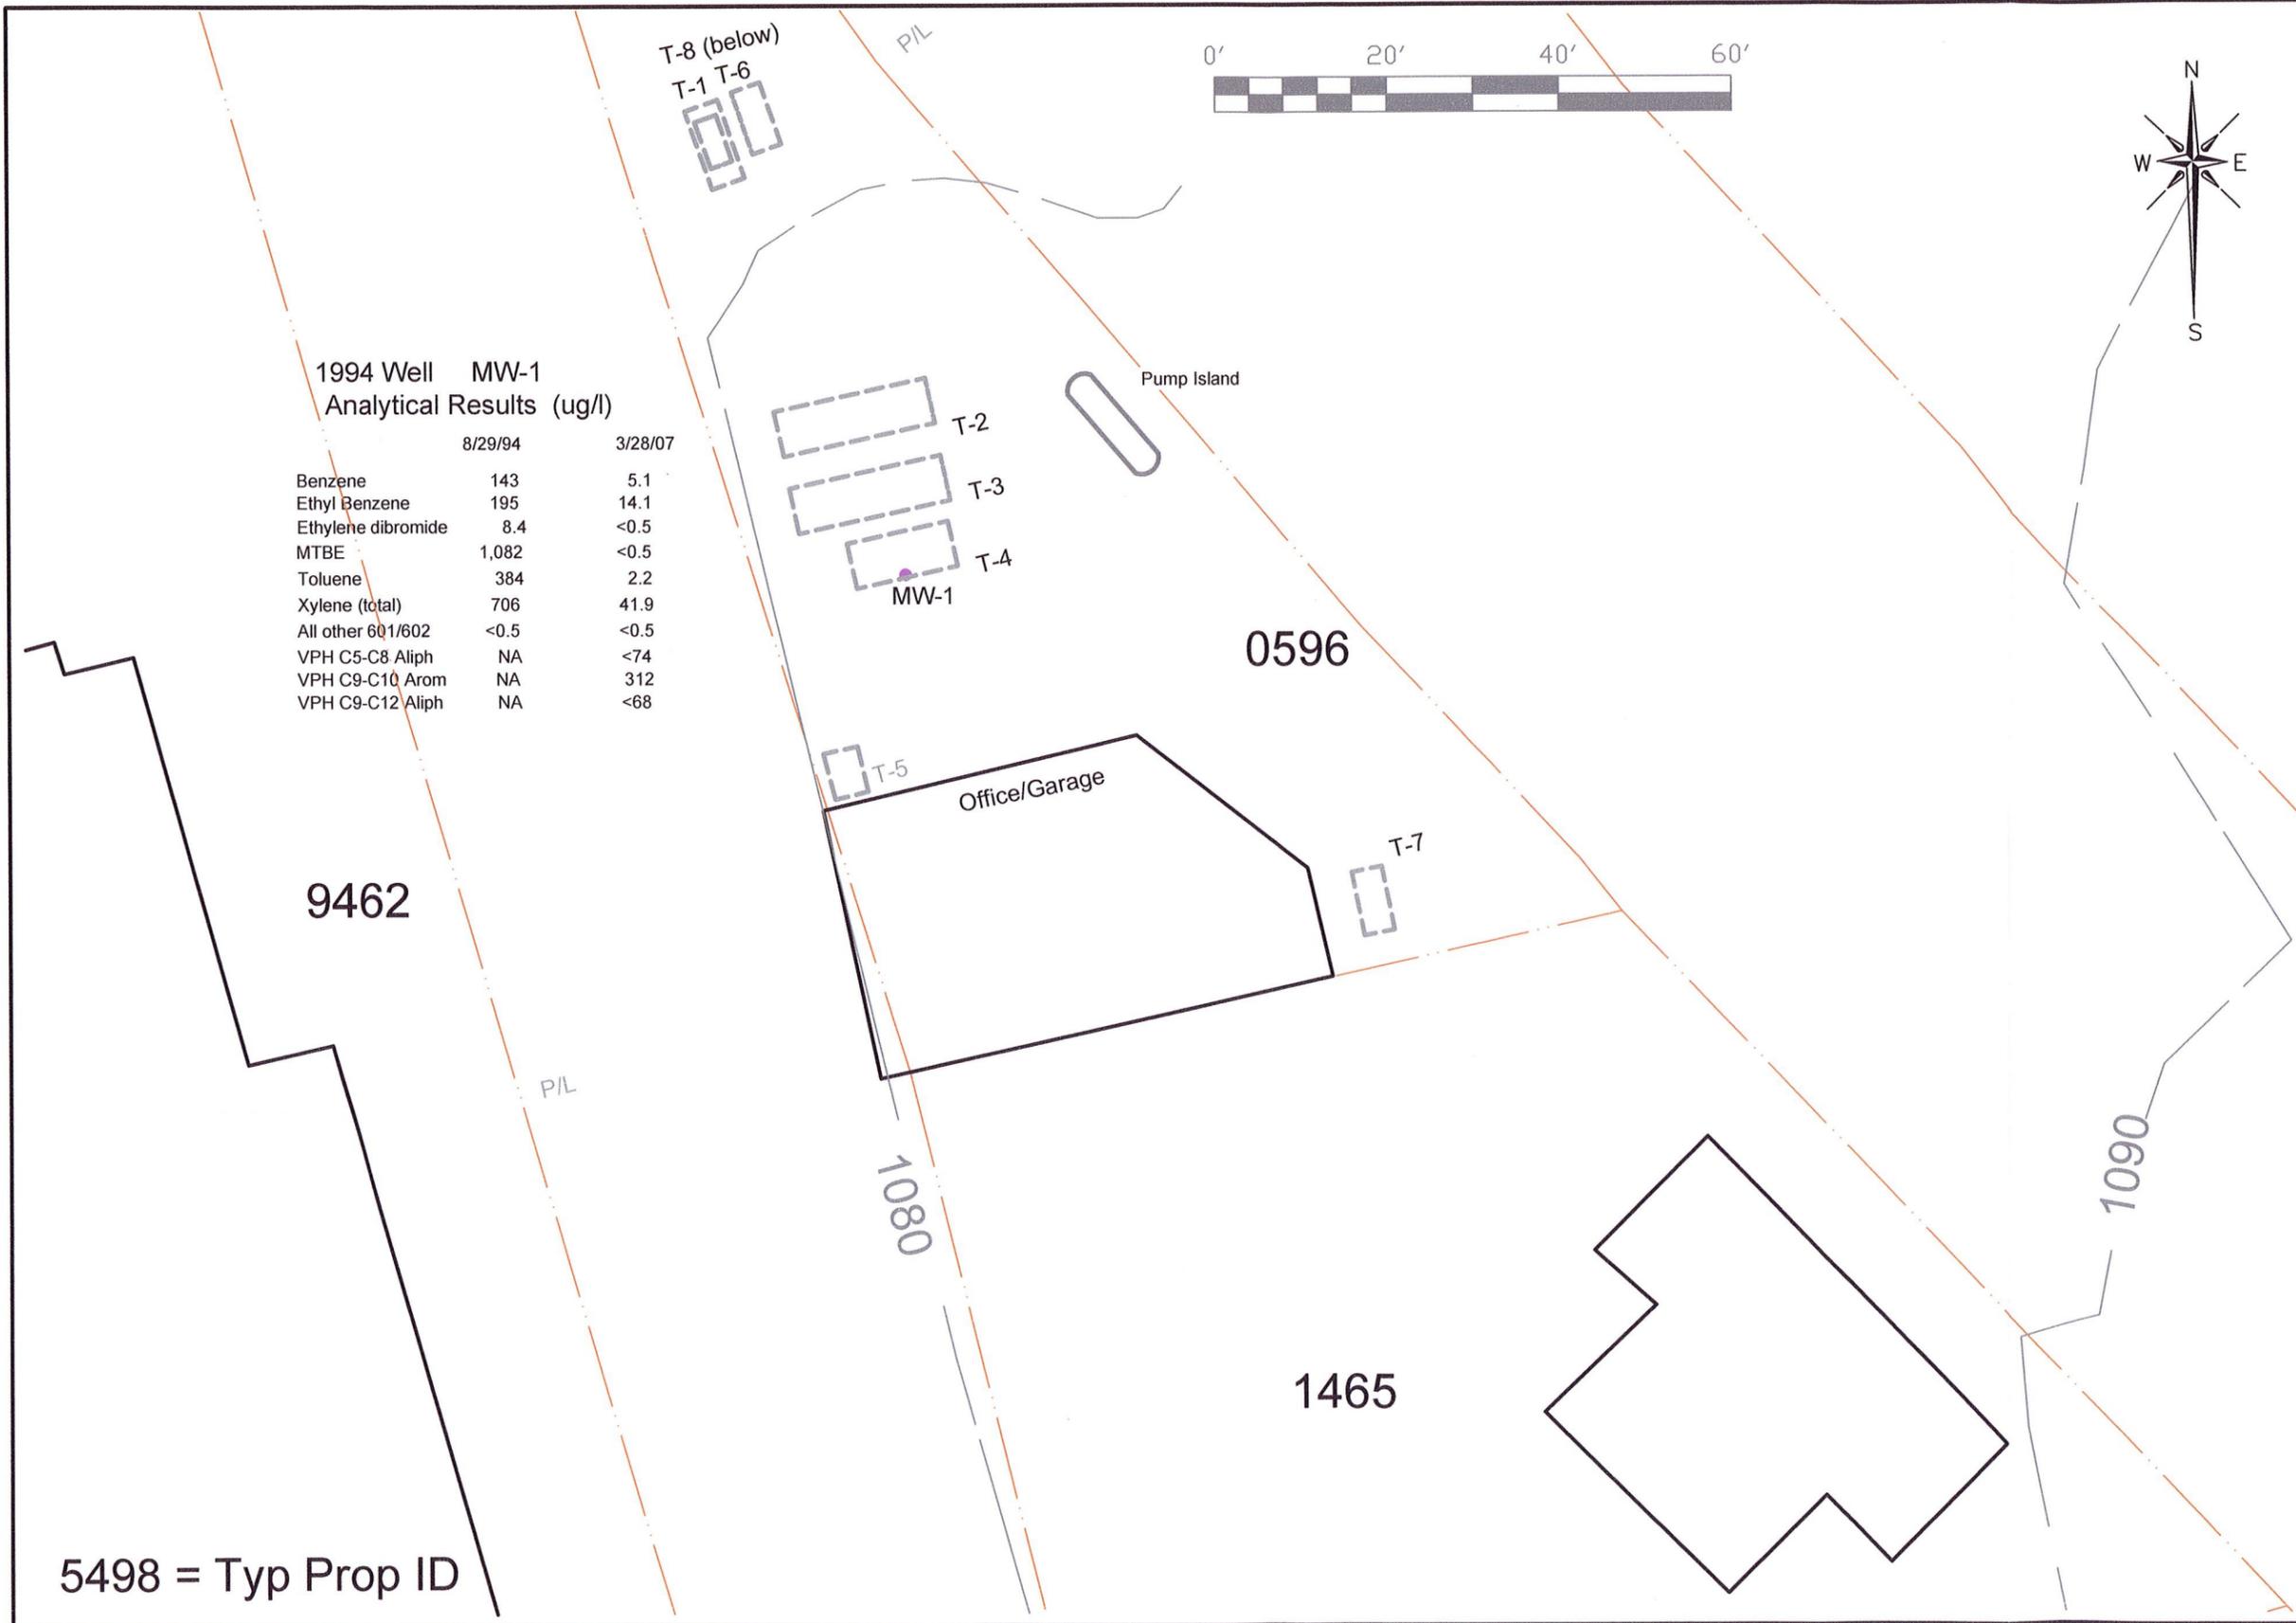
NAME: The Perfect Image Incident # 12634
 SHEET TITLE: MONITORING WELLS GW DATA

1994 Well MW-1 Analytical Results (ug/l)

8/29/94	3/28/07
Benzene	143	5.1
Ethyl Benzene	195	14.1
Ethylene dibromide	8.4	<0.5
MTBE	1,082	<0.5
Toluene	384	2.2
Xylene (total)	706	41.9
All other 601/602	<0.5	<0.5
VPH C5-C8 Aliph	NA	<74
VPH C9-C10 Arom	NA	312
VPH C9-C12 Aliph	NA	<68

The groundwater sample analytical results from the well in the former tank area showed contamination greater than 2L standards. The VPH C9-C10 aromatics concentration and benzene concentration for the current sample are less than 10 times the 2L standards and they did not exceed the gross contamination levels (GCL).
