RE: Certification of Final Closure
International Paper Rieglewood
Industrial Landfill Permit 2402

CLOSURE CERTIFICATION and POST-CLOSURE MAINTENANCE PLAN
INDUSTRIAL LANDFILL PERMIT 2402
INTERNATIONAL PAPER
RIEGELWOOD MILL FACILITY
RIEGELWOOD, NORTH CAROLINA

CLOSURE CERTIFICATION and POST-CLOSURE MAINTENANCE PLAN
INDUSTRIAL LANDFILL PERMIT 2402

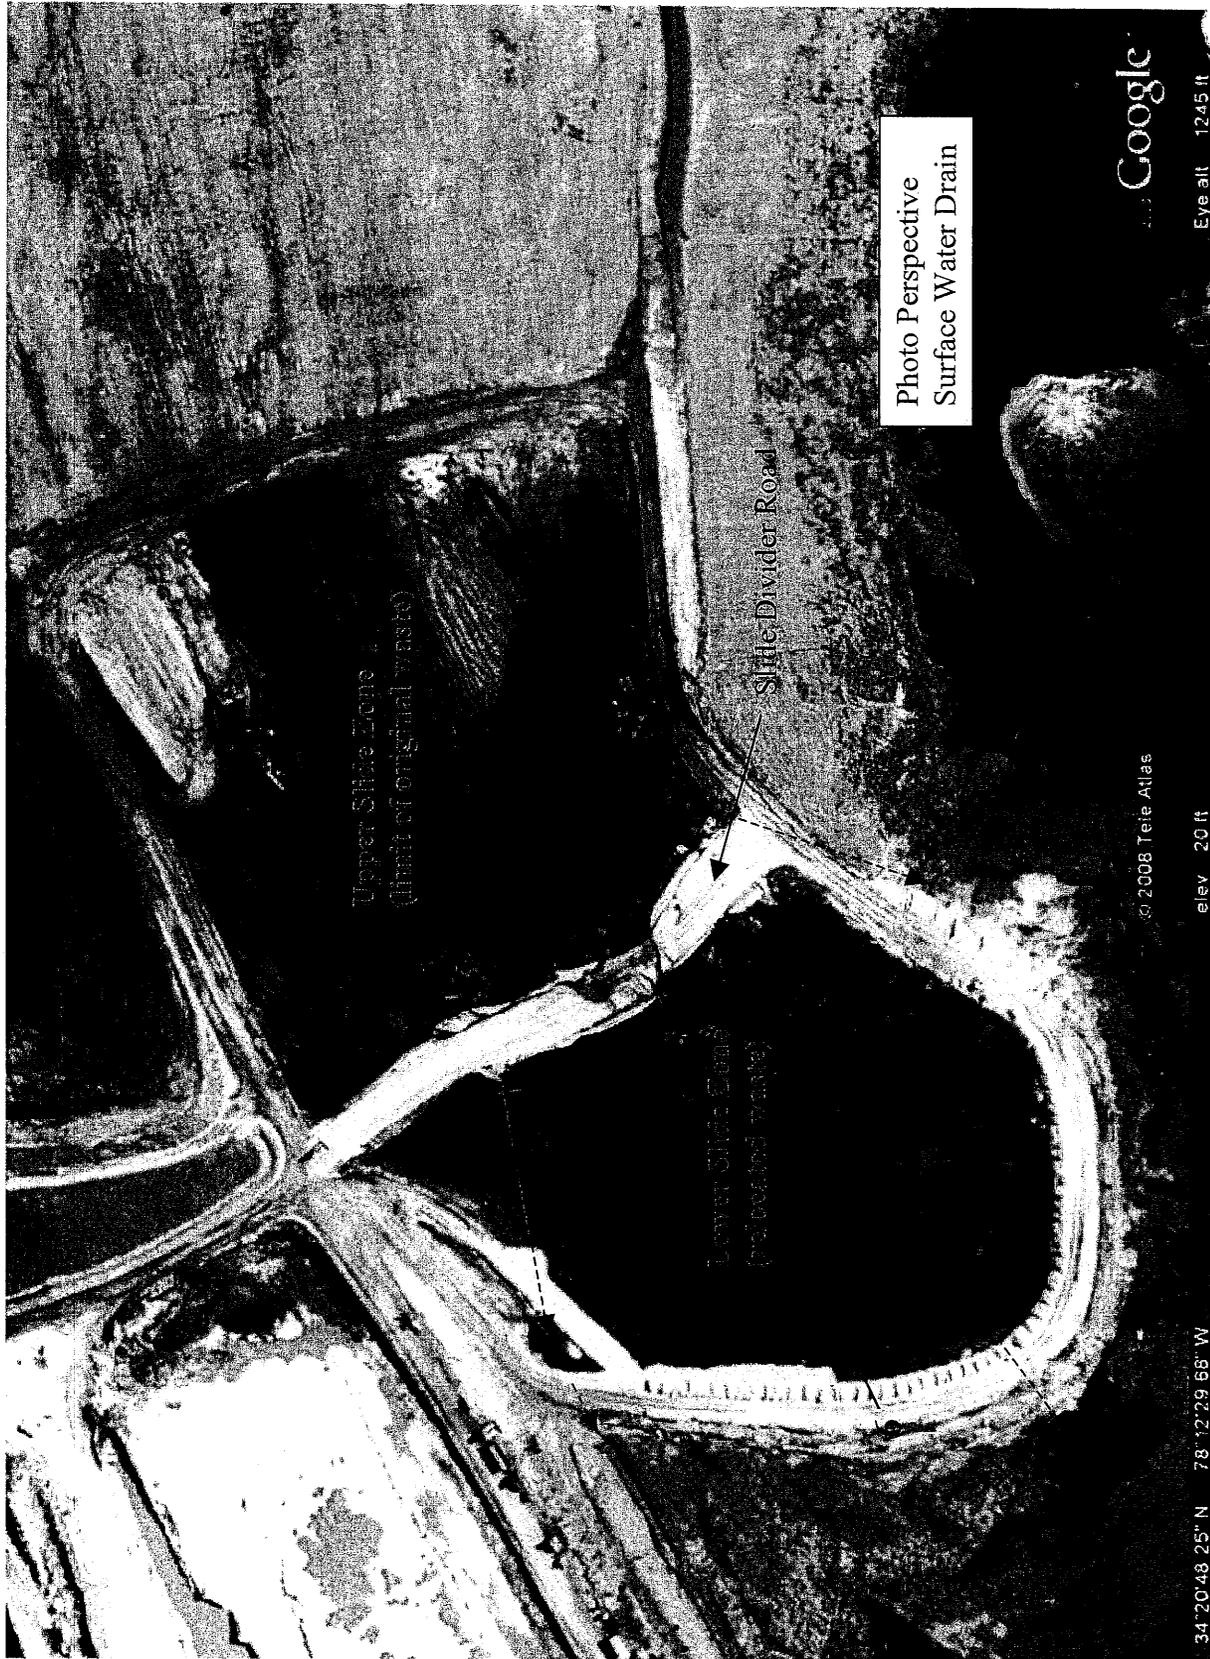
Photo 2 Aerial of Slide Zone

As previously described in Section 2.2, the Slide Zone was divided by an access road placed approximately at the edge-of-waste limits before the slide, see Photo 2. A drainage ditch north of the roadway direct runoff from the Slide Zone north of the road to an 18-inch corrugated plastic pipe (CPP) that drains to the southwest into the South Pond, see Photos 3 and 4. Proposed surface water precast concrete drainage sumps serving the Secondary Sludge Zones were replaced with a 18-inch vertical perforated pipe to better tolerate fines accumulation that occurs prior to establishing vegetation, see Photos 13,14, and 16. Two emergency storm water spillways or chutes were added to the Secondary Sludge Zones to handle potential historic peak hurricane related surface water flows. These are located on Photo 12 and shown on Photo 17.

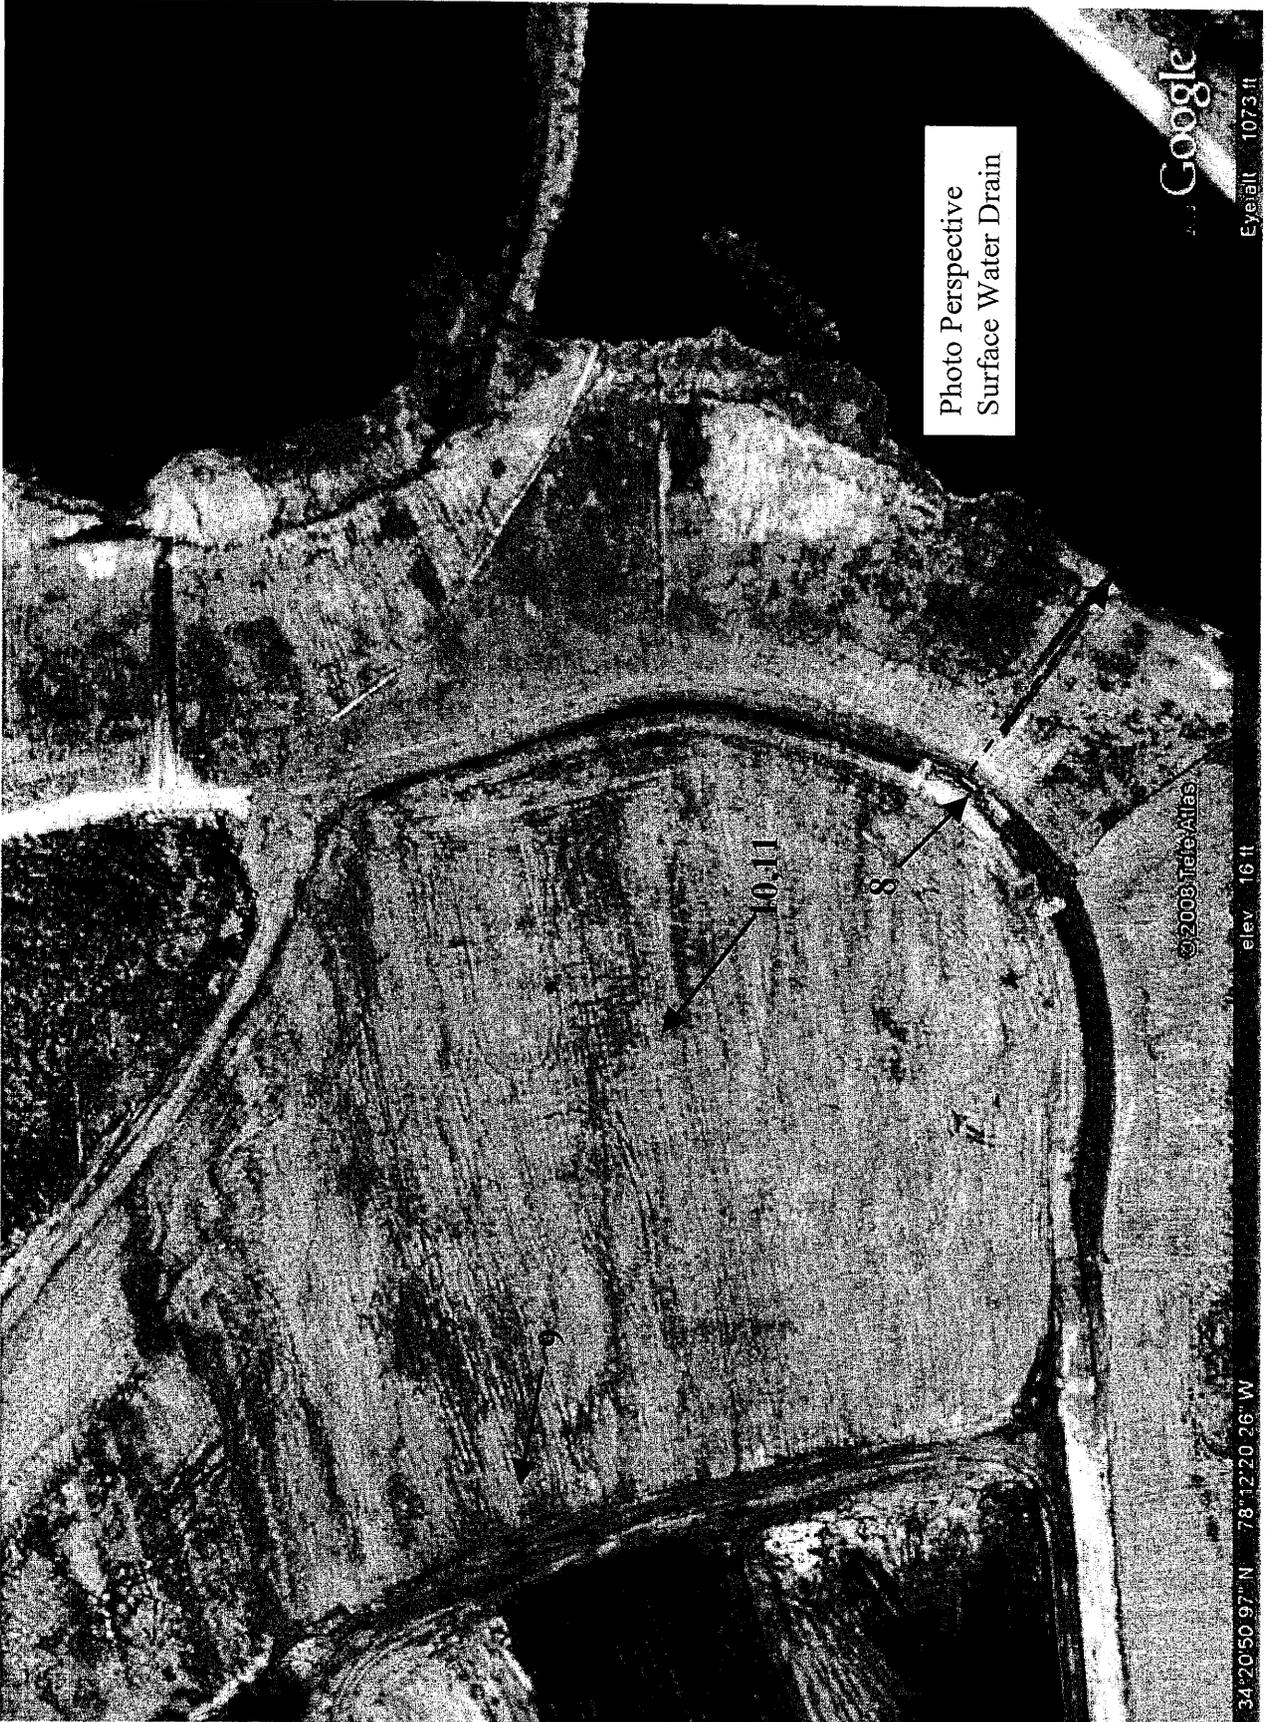
Photo 7 Aerial Stable Zone and Surface Water Features

As shown on Figure 1, the Stable Surface Zone was the first zone to be completed under the 2003 Closure Plan. A minimum 2% slope was obtained with much of the zone having a 3% slope. Photos 7 to 11 show the following current conditions of this zone:

- Surface vegetation is thin indicating a lack of nutrients in the sandy soil/beneficial reuse material vegetative layer, and
- Much of the eastern half of the Stable Surface Zone is currently being used as a staging area for conditioning of soil/beneficial reuse cover and the ash/secondary sludge vegetative topsoil being used in other zones of the final cover

Upon completion of the closure upgrades to the Slide and Secondary Sludge Zones, the contours of the Stable Surface Zone will be restored to a minimum 4% grade, receive a 6-inch layer of the ash/secondary sludge vegetative topsoil, and be completely reseeded.
