**HAZARDOUS WASTE SECTION - COMPLIANCE BRANCH
FILE TRANSMITTAL & DATA ENTRY FORM**

Facility Name: Revlon Consumer Products Corporation

COMPLIANCE EVALUATION INSPECTION (CEI) REPORT

4. DATE OF INSPECTION: January 28, 2016

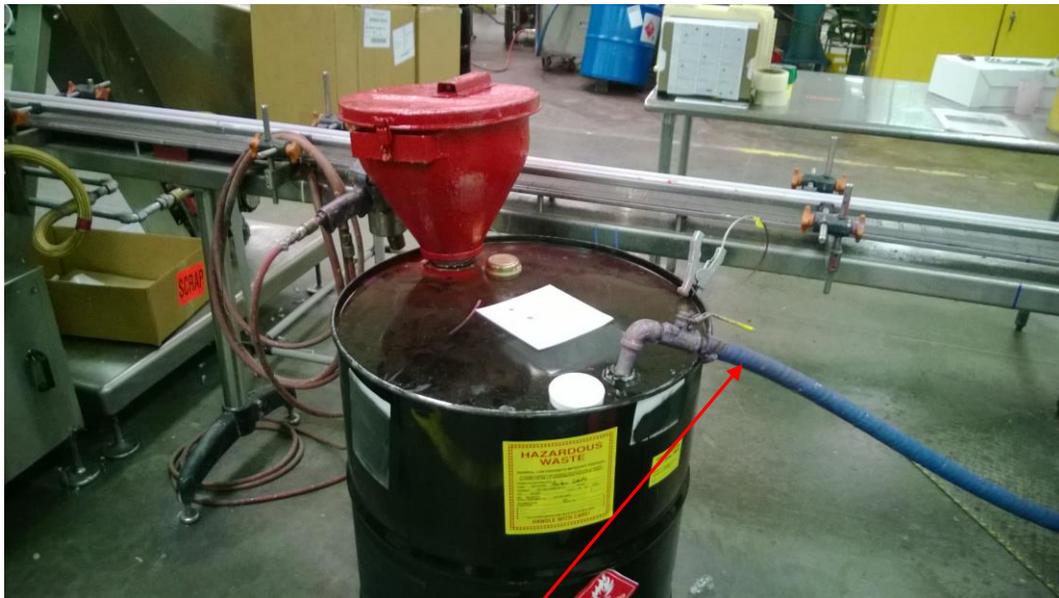
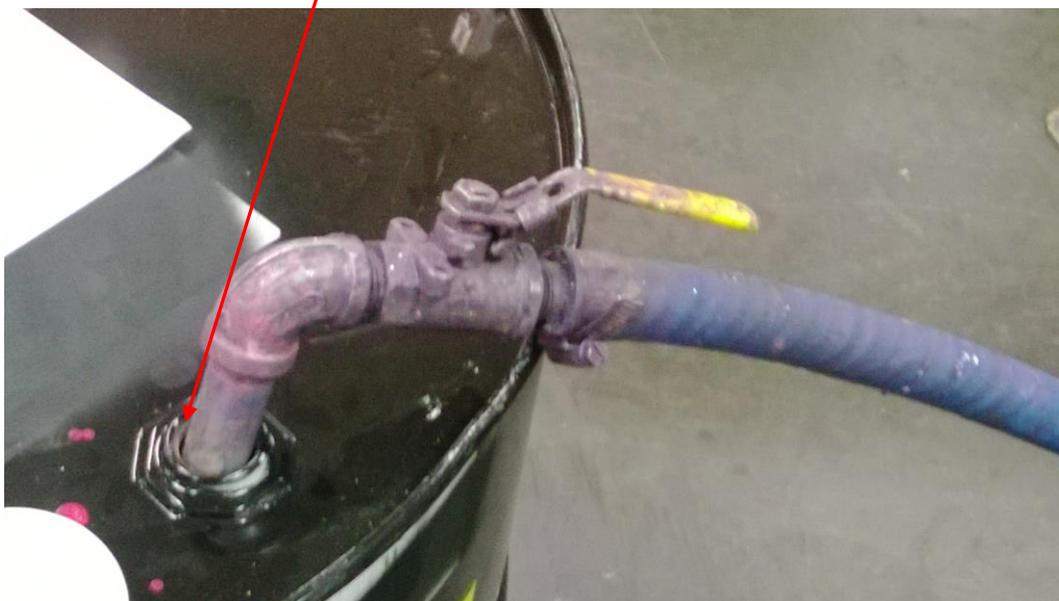
1. Trash Room A – Not inspected
2. Boiler Room
3. Boiler Room
4. Nail Enamel Line # 1110 - 55-gallon containers
5. Nail Enamel Line # 1115 – 55-gallon containers
6. Nail Enamel Line # 1120 – *Refer to pictures(s) below and the Deficiencies section of the report.*
7. Line #1125 – *Refer to pictures(s) below and the Deficiencies section of the report.*
8. Line #1403 – two 55-gallon containers
9. Colorsilk Line #1405 – two 55-gallon containers

The drum at Line 1120 containing waste solvent. The hose used to pump the waste into the container was not in use but was observed still in the small bung hole on the drum. No one was working on the line at the time of inspection.

40 CFR 262.34(c)(1)(i) – 265.173(a) A generator may accumulate as much as 55 gallons of hazardous waste containers at or near any point of generation (the satellite accumulation area) and under the control of the operator provided that each container of hazardous waste remain closed, unless waste is being added or removed from the container. On the day of inspection, one 55-gallon drum container located at Line 1120 and one 55-gallon drum located at Line 1125 were observed open. A hose used to pump waste into each respective container was observed in the small bung hole of each drum. No one was working at either line at the time of inspection. The valve to each of the two hoses was left open but no waste was being pumped into the containers at the time of inspection.

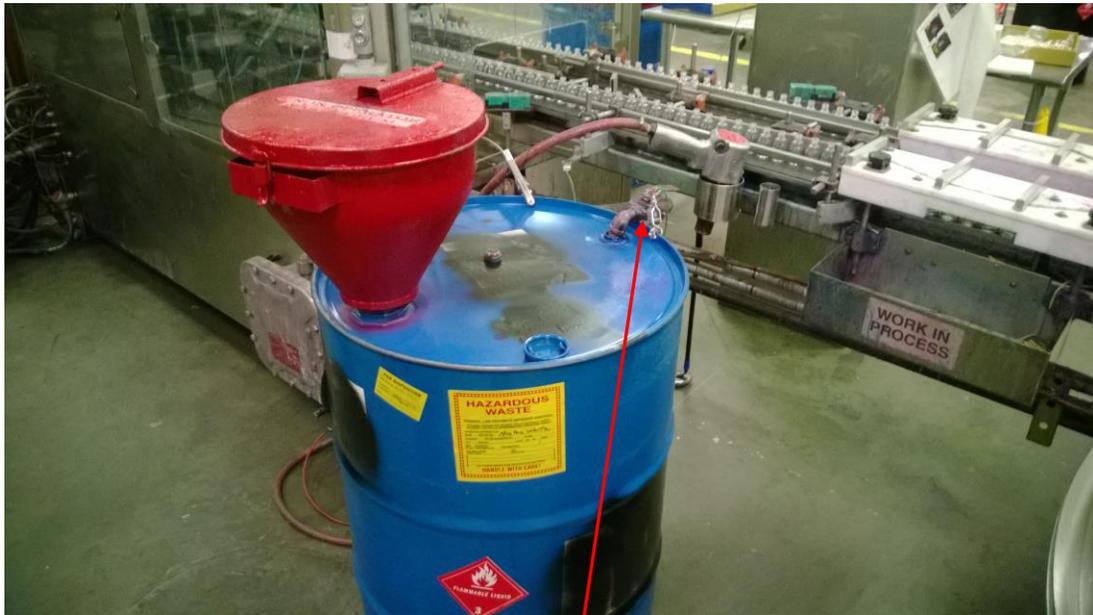
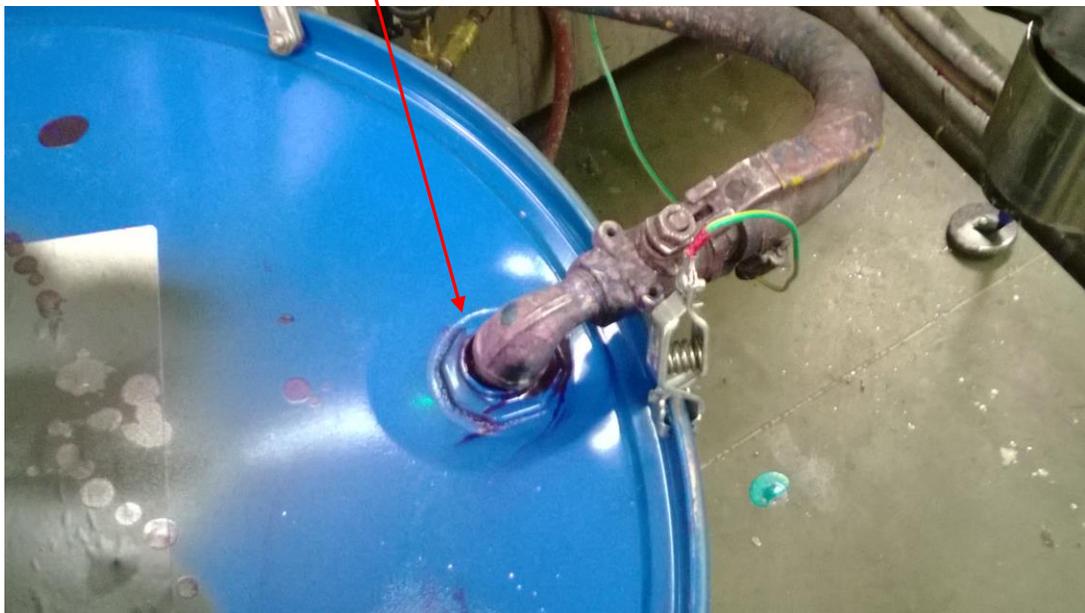
The drum at Line 1120 containing waste solvent. The hose used to pump the waste into the container was not in use but was observed still in the small bung hole on the drum. No one was working on the line at the time of inspection.
