**Veolia ES Technical Solutions, L.L.C.
Permit Renewal Application Table of Contents**

Veolia ES Technical Solutions, L.L.C. (hereafter known as Veolia) owns and operates a hazardous waste storage and treatment facility located at the corner location of State Routes 1104 and 1106 near Butner, North Carolina. Veolia received its Part B hazardous waste storage permit from the North Carolina Department of Environment and Natural Resources (hereafter known as NCDENR) on August 24, 2012. This permit expires on August 24, 2017. As required, Veolia is submitting this permit renewal application by August 24, 2016 as requested by NCDEQ in an August 10, 2015 letter to Veolia.

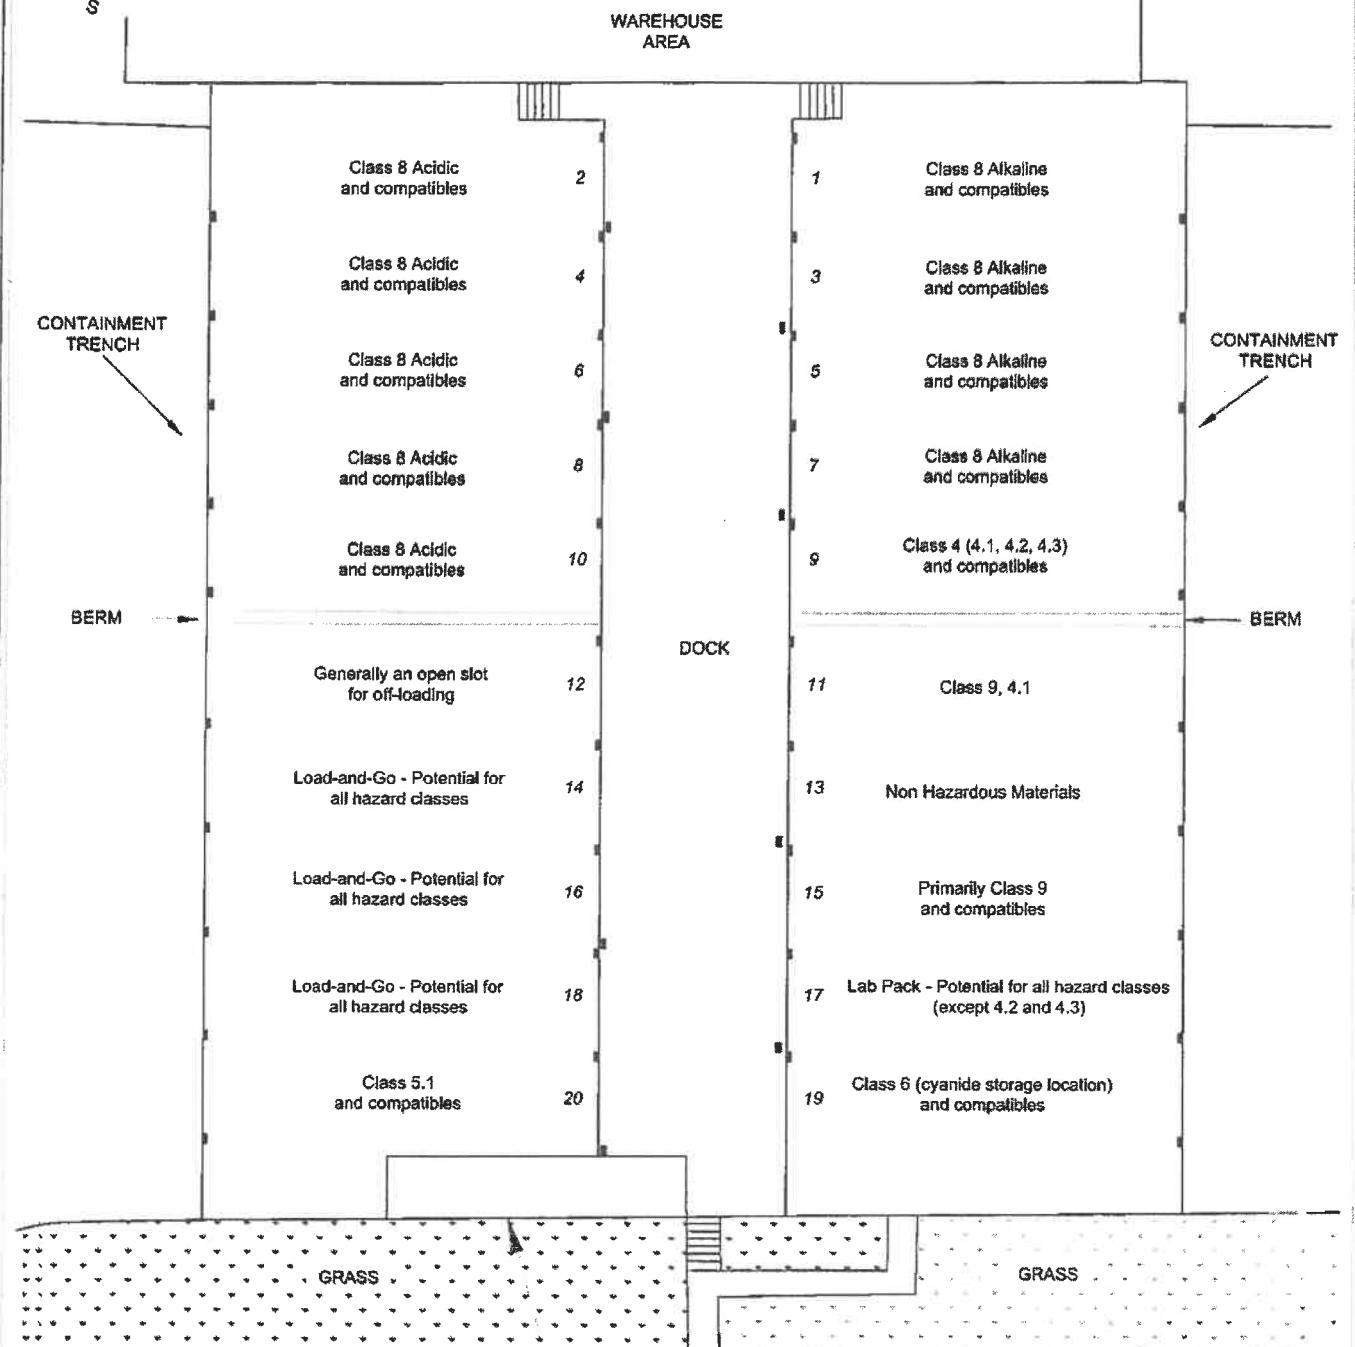
Veolia, Creedmoor, NC
Loading Dock Layout Map
Waste Storage Areas

20 STORAGE TRAILER AND ID NUMBER

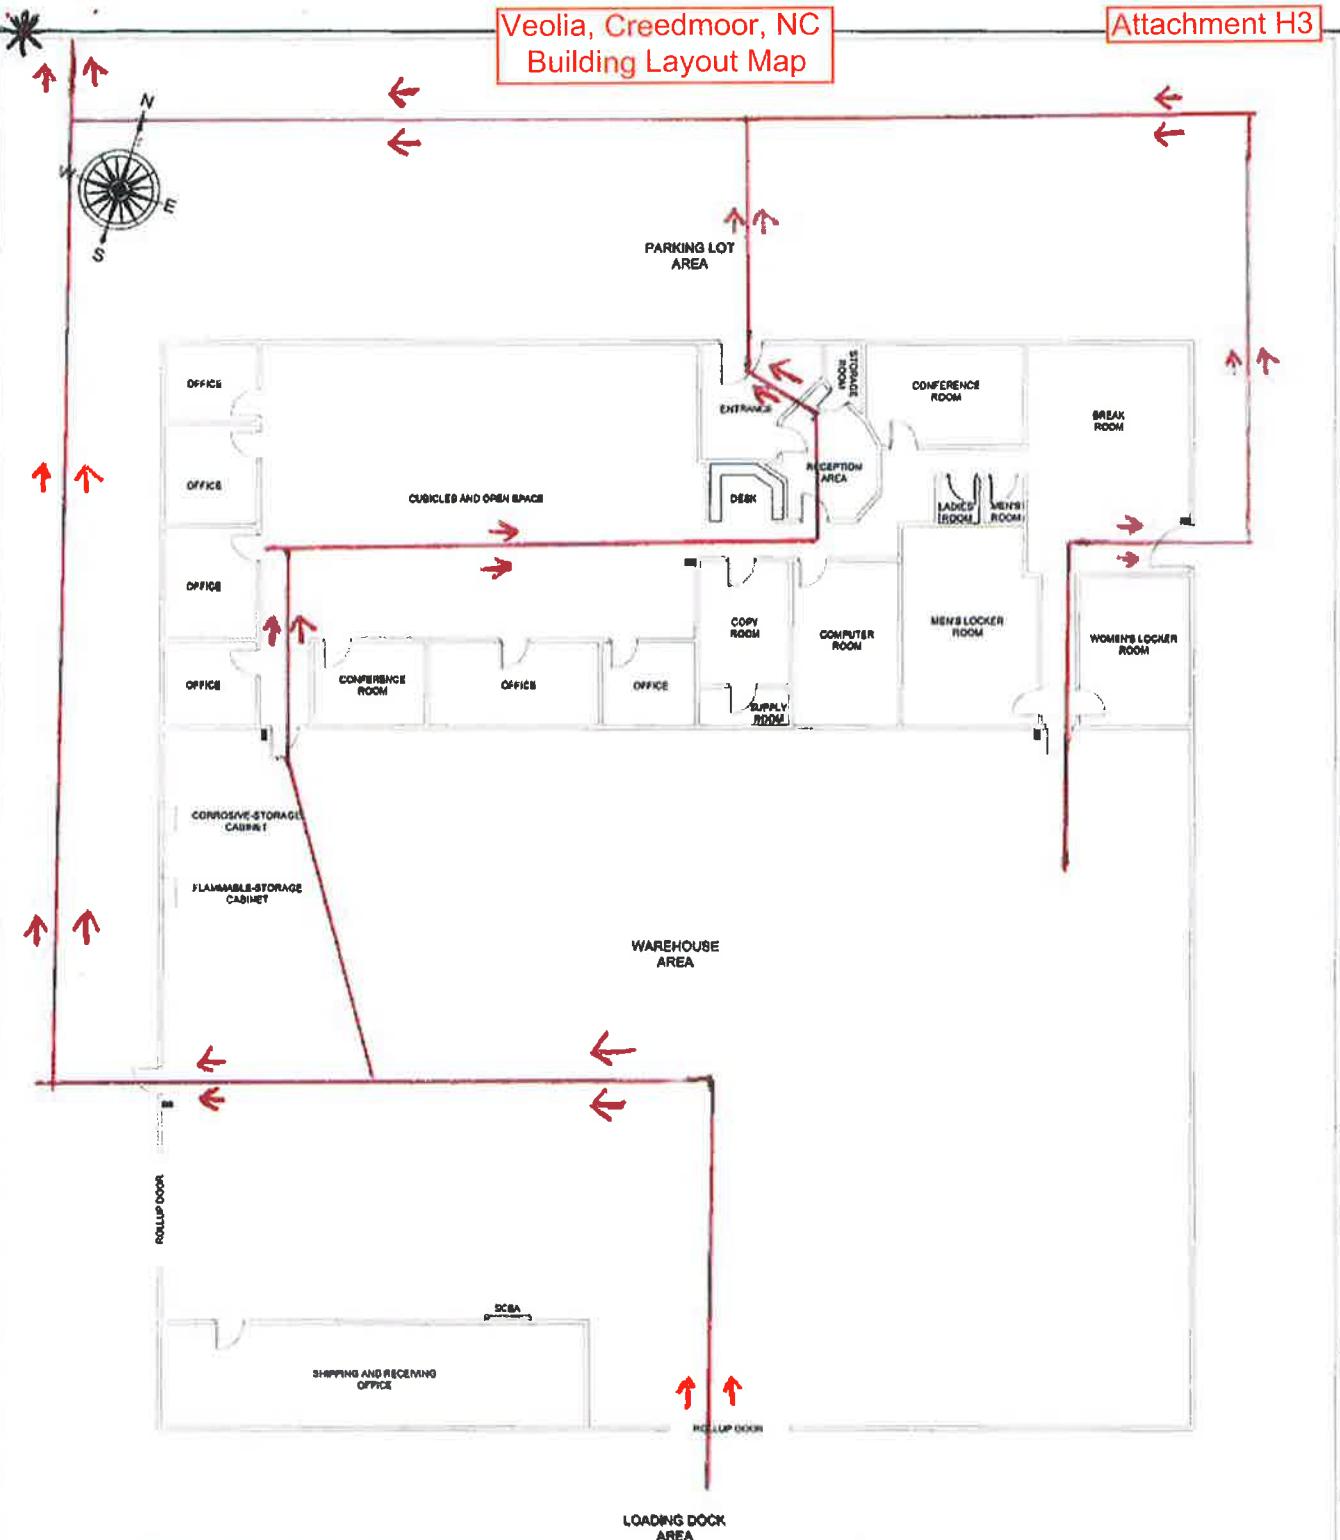
Attachment H3

Veolia, Creedmoor, NC
Building Layout Map

Evacuation Routes are indicated
with red arrows.

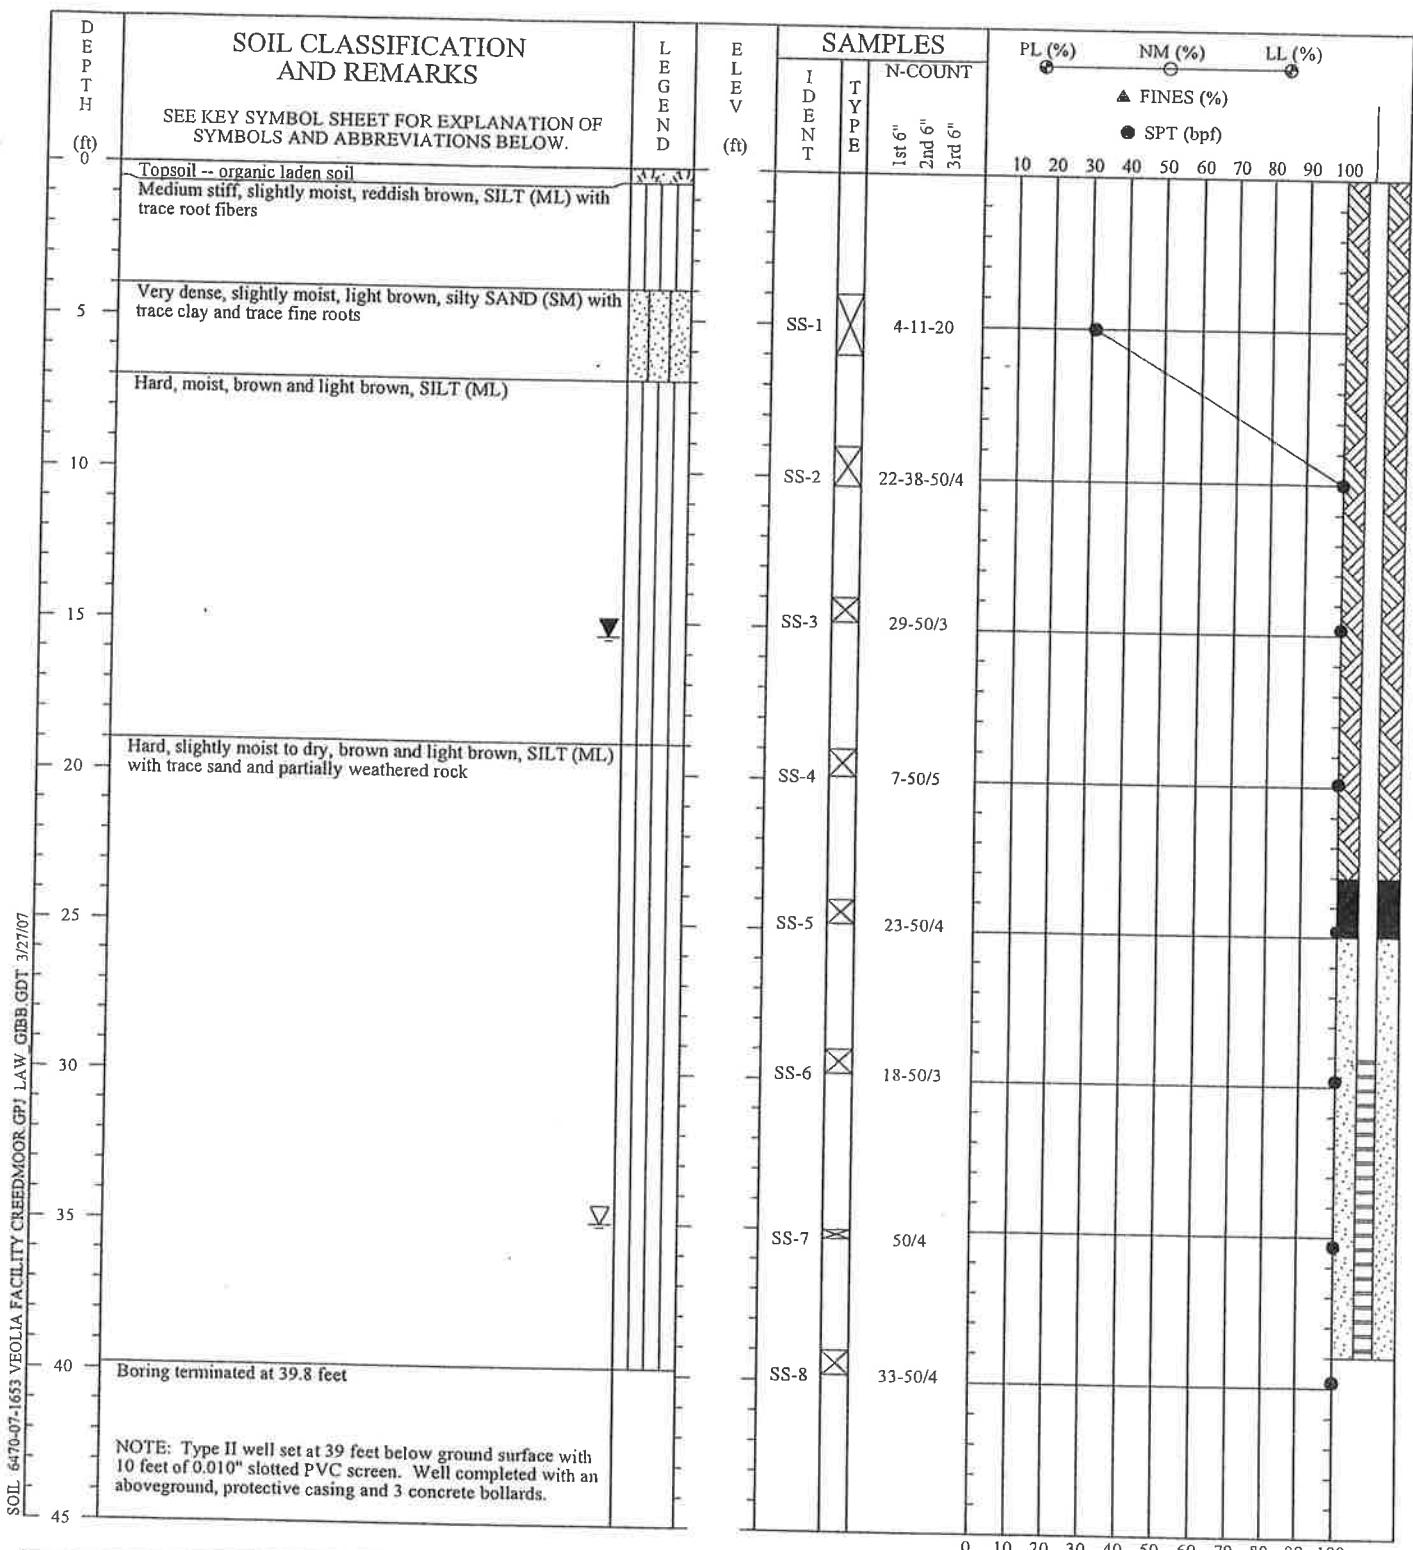
Project:	Veolia Facility, Creedmoor N	Boring No:	MW-3
Coord N:			
Coord E:			
Drilled:	February 6, 2007		
Project #:	6470-07-1653		
Page 1 of 1

DRILLER: Rich Lemire / SAEDACCO, Inc.
 EQUIPMENT: Diedrich D-50 track rig
 METHOD: HSA ID 3-3/4"
 HOLE DIA.: 7" WELL: Stickup 2.5' Size 2"
 REMARKS: Groundwater encountered during drilling activities from 35 to 40 feet.

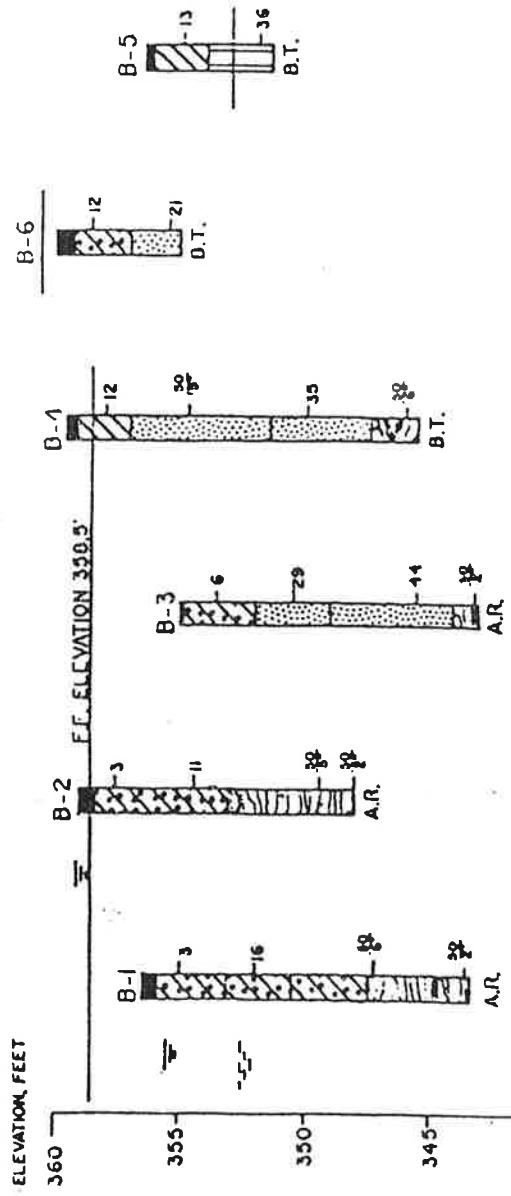
GENERALIZED SUBSURFACE PROFILE

- TOPSOIL
- SANDY CLAY (CL) OR CLAYEY SAND (SC)
- SILTY MEDIUM TO FINE SAND (SM)
- SILTY CLAY (CL) OR (CH)
- FINE SANDY SALT (ML)
- PARTIALLY WEATHERED ROCK

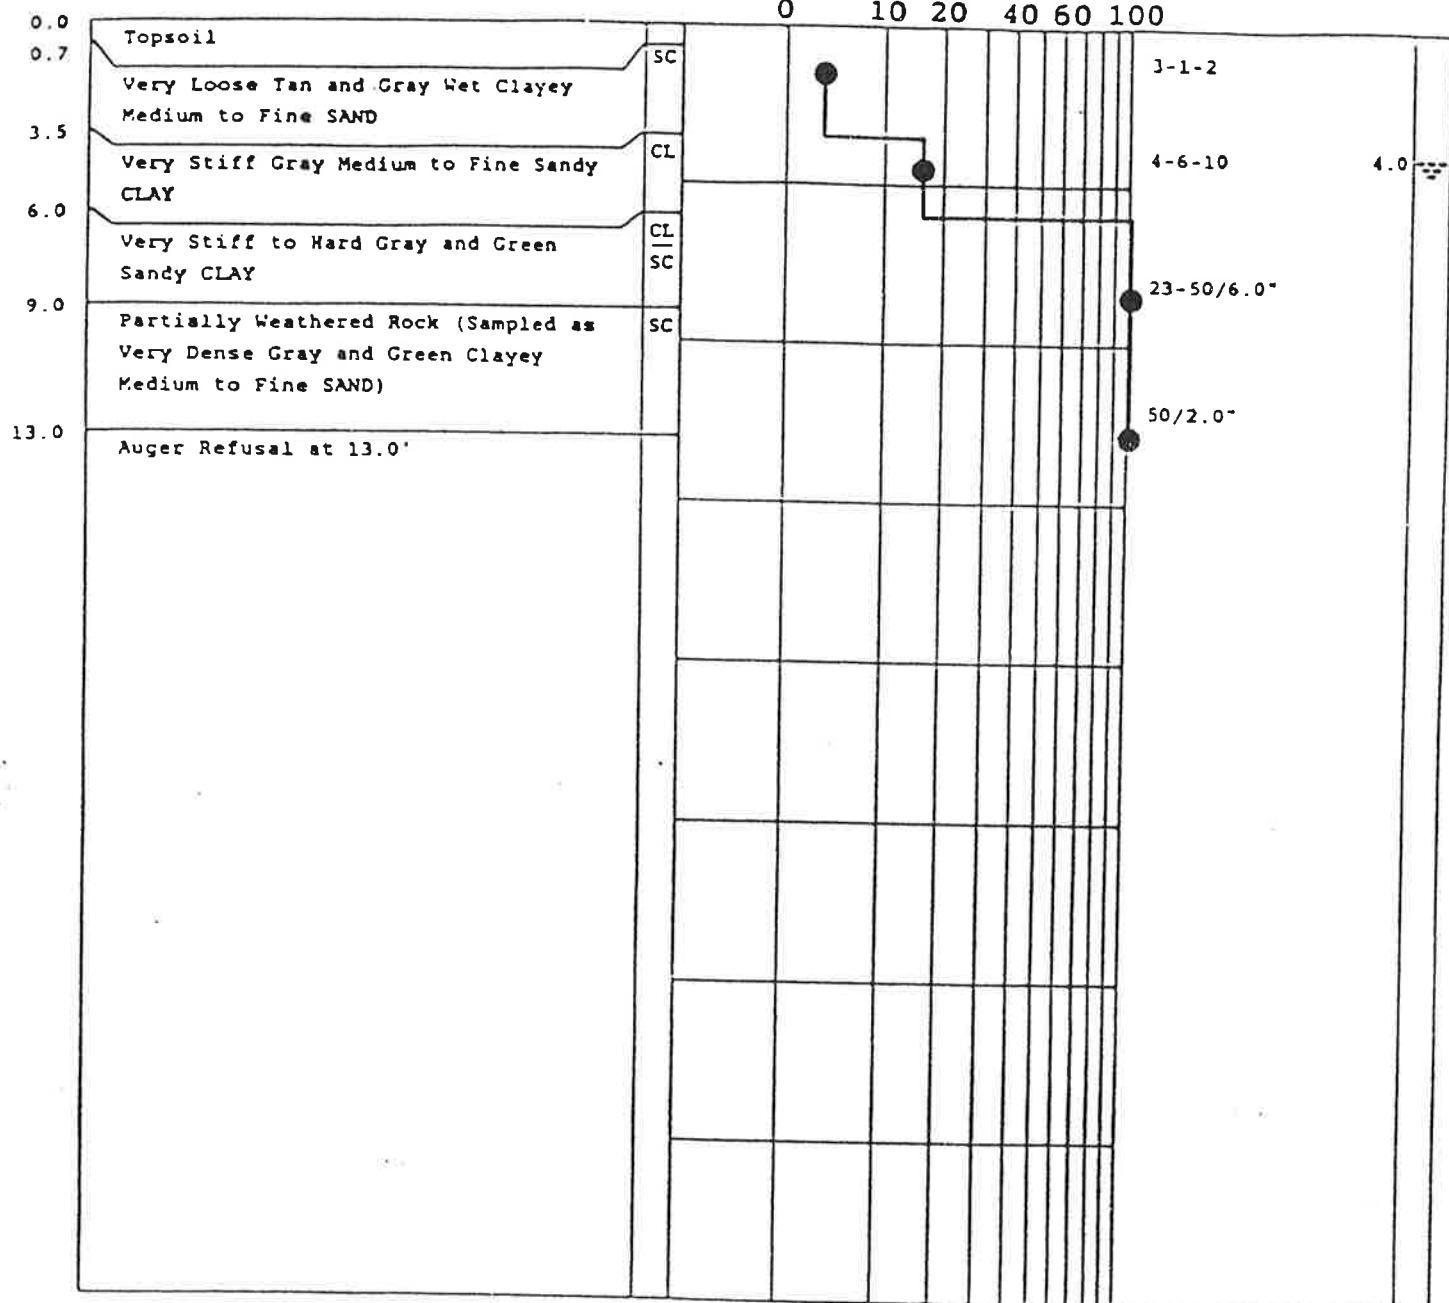
JOB NUMBER 051-88-232
 BORING NUMBER B-1
 DATE 04-13-88

DEPTH (FT.)	DESCRIPTION	ELEVATION (FT.)	PENETRATION (BLOWS/FT.)	BLOWS PER SIX IN.
		0	10 20 40 60 100

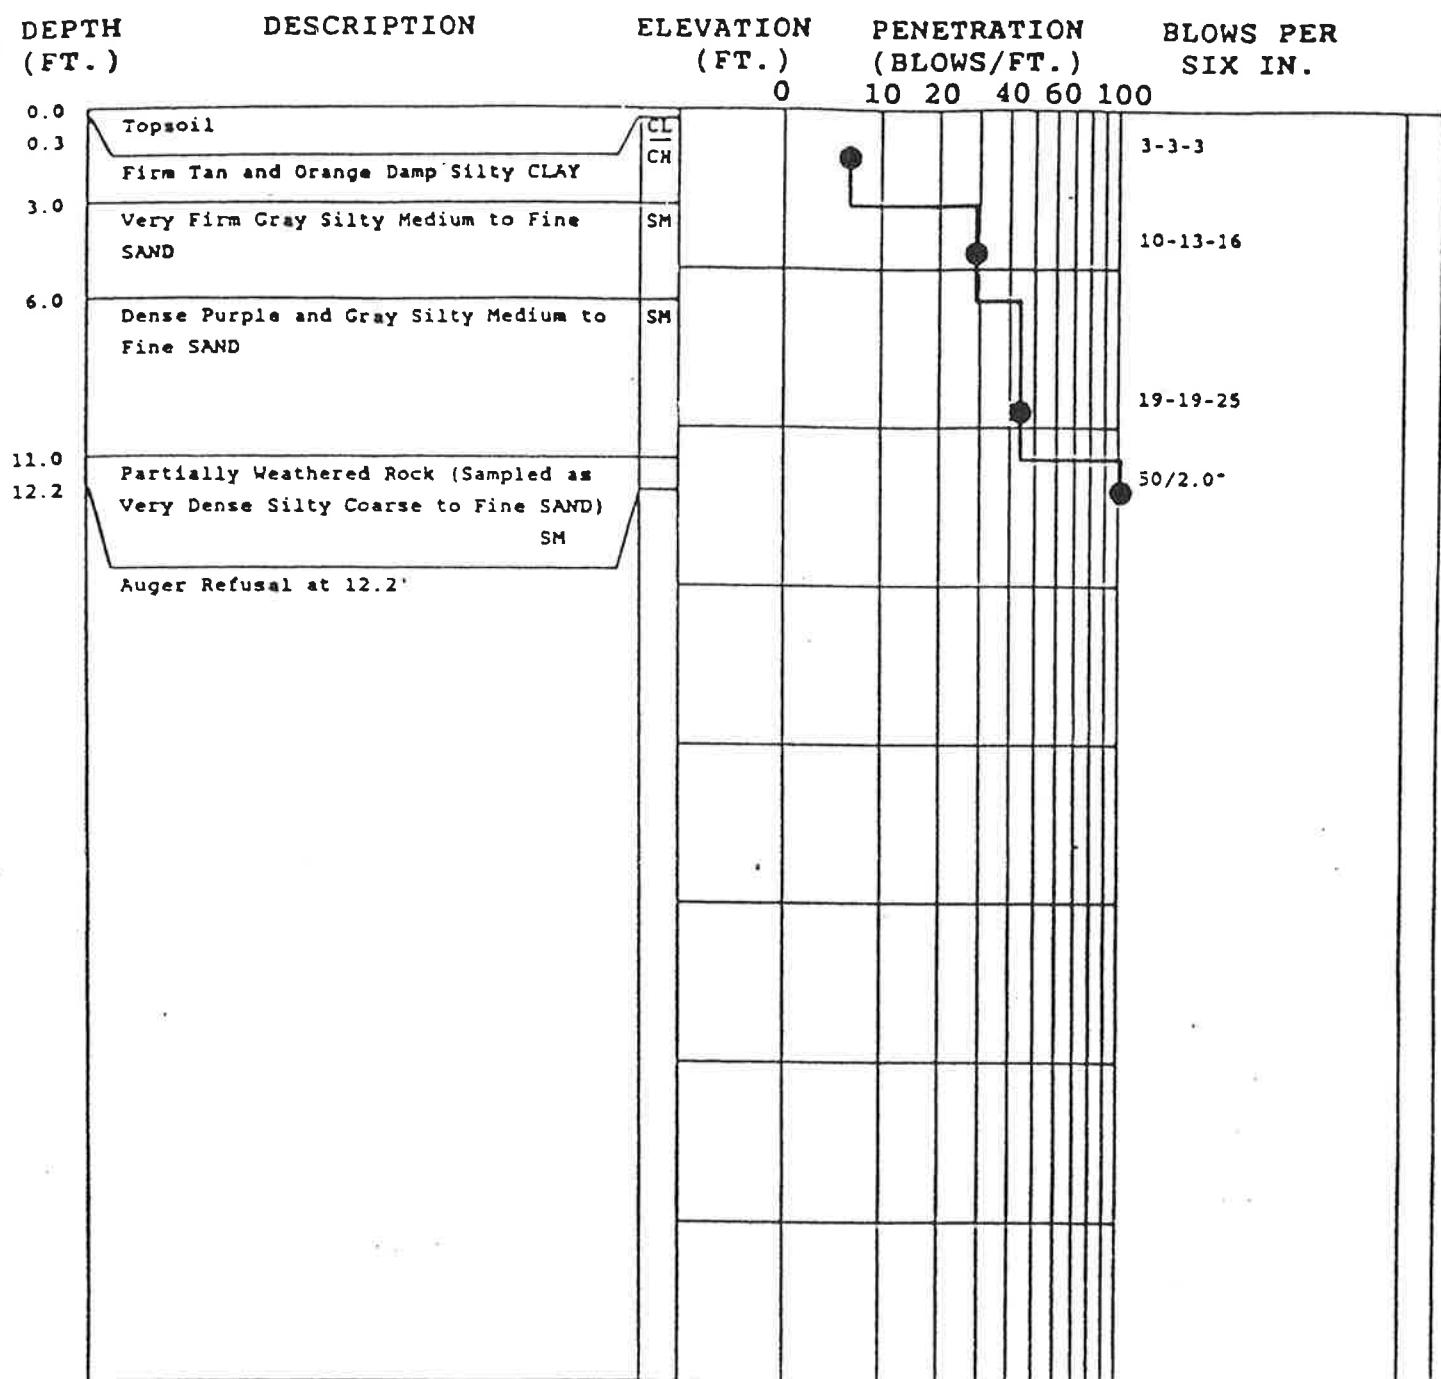
JOB NUMBER 051-88-232
 BORING NUMBER B-3
 DATE 04-13-88

TEST BORING RECORD

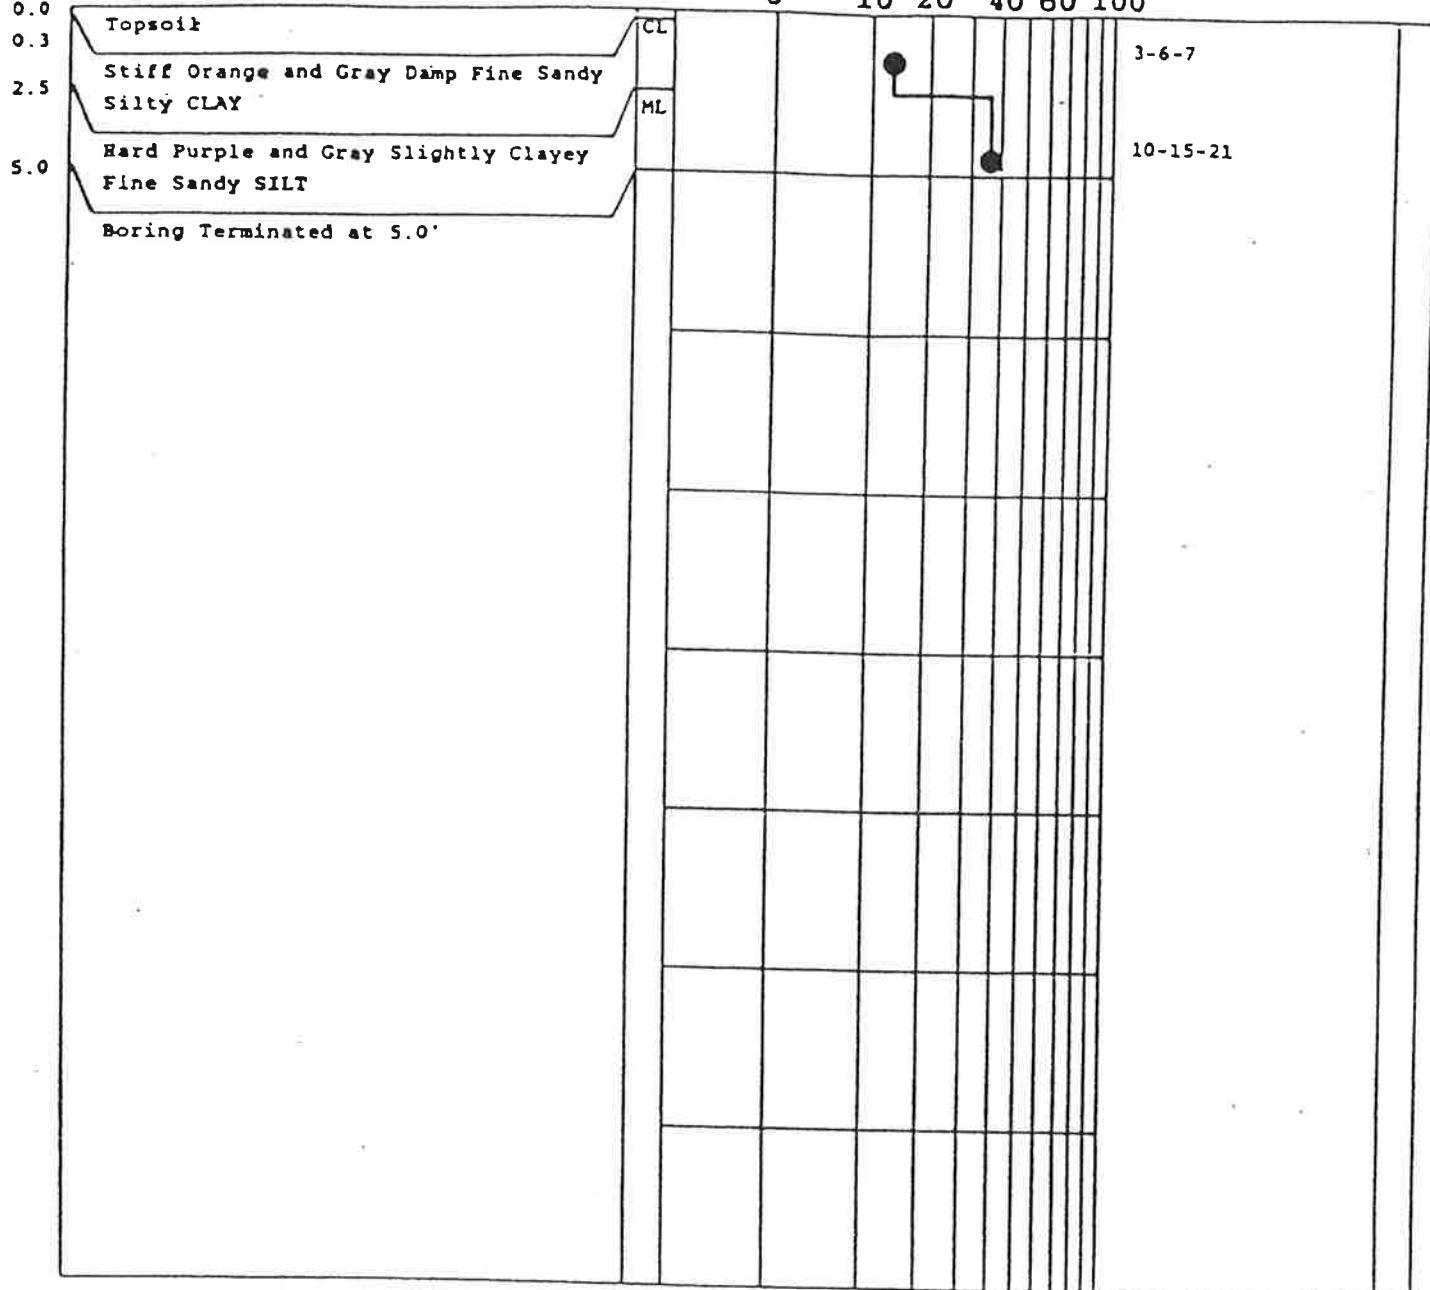
JOB NUMBER 051-88-232
 BORING NUMBER B-5
 DATE 04-13-88

DEPTH (FT.)	DESCRIPTION	ELEVATION (FT.)	PENETRATION (BLOWS/FT.)	BLOWS PER SIX IN.
		0	10 20 40 60 100
