**COMPLIANCE EVALUATION INSPECTION REPORT**

Facility Name: **SHORT JOURNEY CENTER  
JOHNSTON COUNTY PUBLIC SCHOOLS**

Compliance Evaluation Inspection to determine compliance with 40 CFR 262, 265, 268 and with the Post-Closure Corrective Action Plan for the site. The last compliance evaluation inspection was conducted at the site on January 14, 2015.

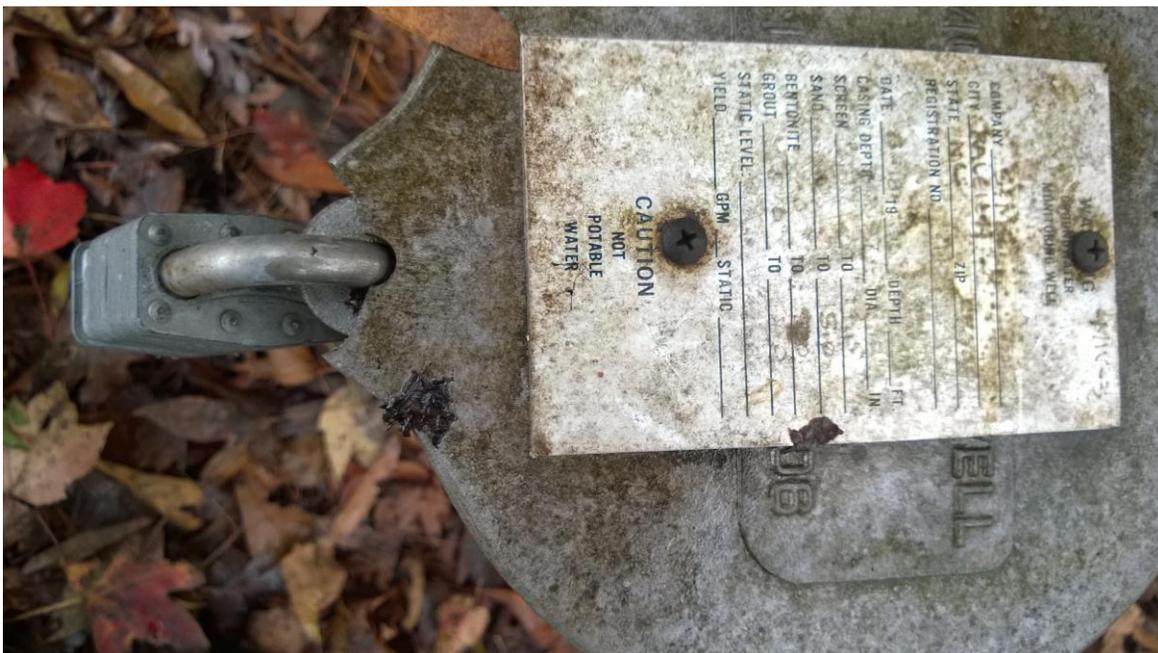
The area around each well was free of undergrowth. MW1 and MW3 were not secure due to compromised security caps (photos included). It is not clear what the status of MW7 is although the condition of the well is an area of concern. There was no evidence of an identity plate on MW1.

MW3 - Cap is compromised and not secure.

- Well MW7 must be repaired or replaced to meet the well construction standards in 15A NCAC 02C .0108 (construction) or 15A NCAC 02C .0112 (well maintenance).
- Repair compromised well security caps at MW1 and MW3 per the standards stipulated in 15A NCAC 02C .0108 (r)(2)
- Ensure all wells are properly labeled with identity plates per the standards stipulated in 15A NCAC 02C .0108 (o)(1-6).

Photographs of the repairs must be sent to the inspector no later than sixty calendar days from receipt of this report.

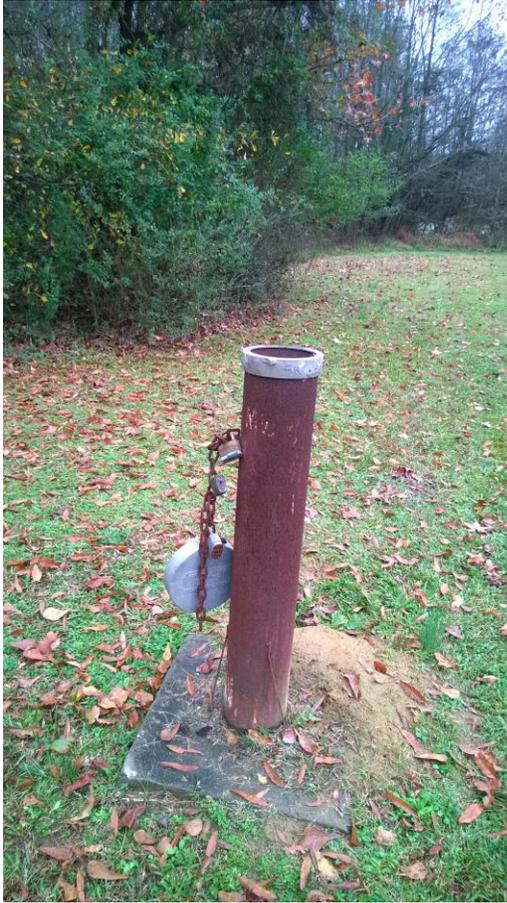
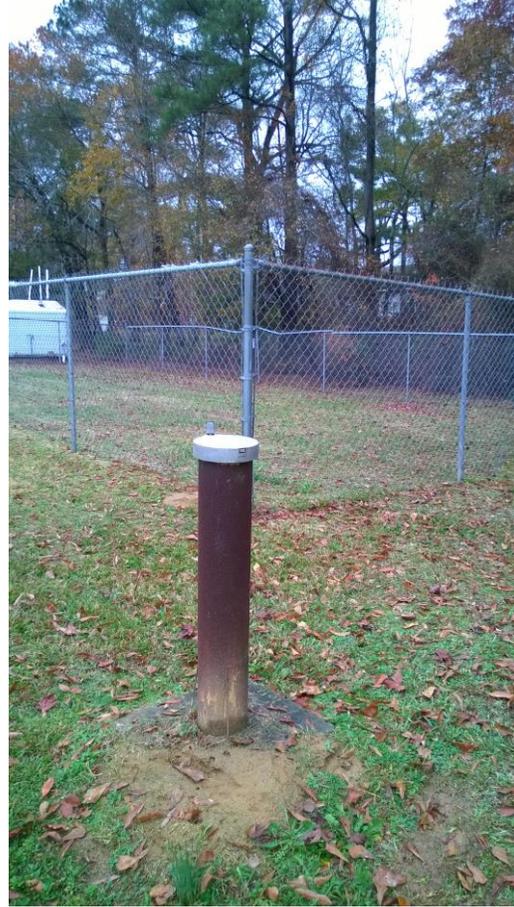
**MW1 - Cap is compromised and not secure, no identifier observed.**

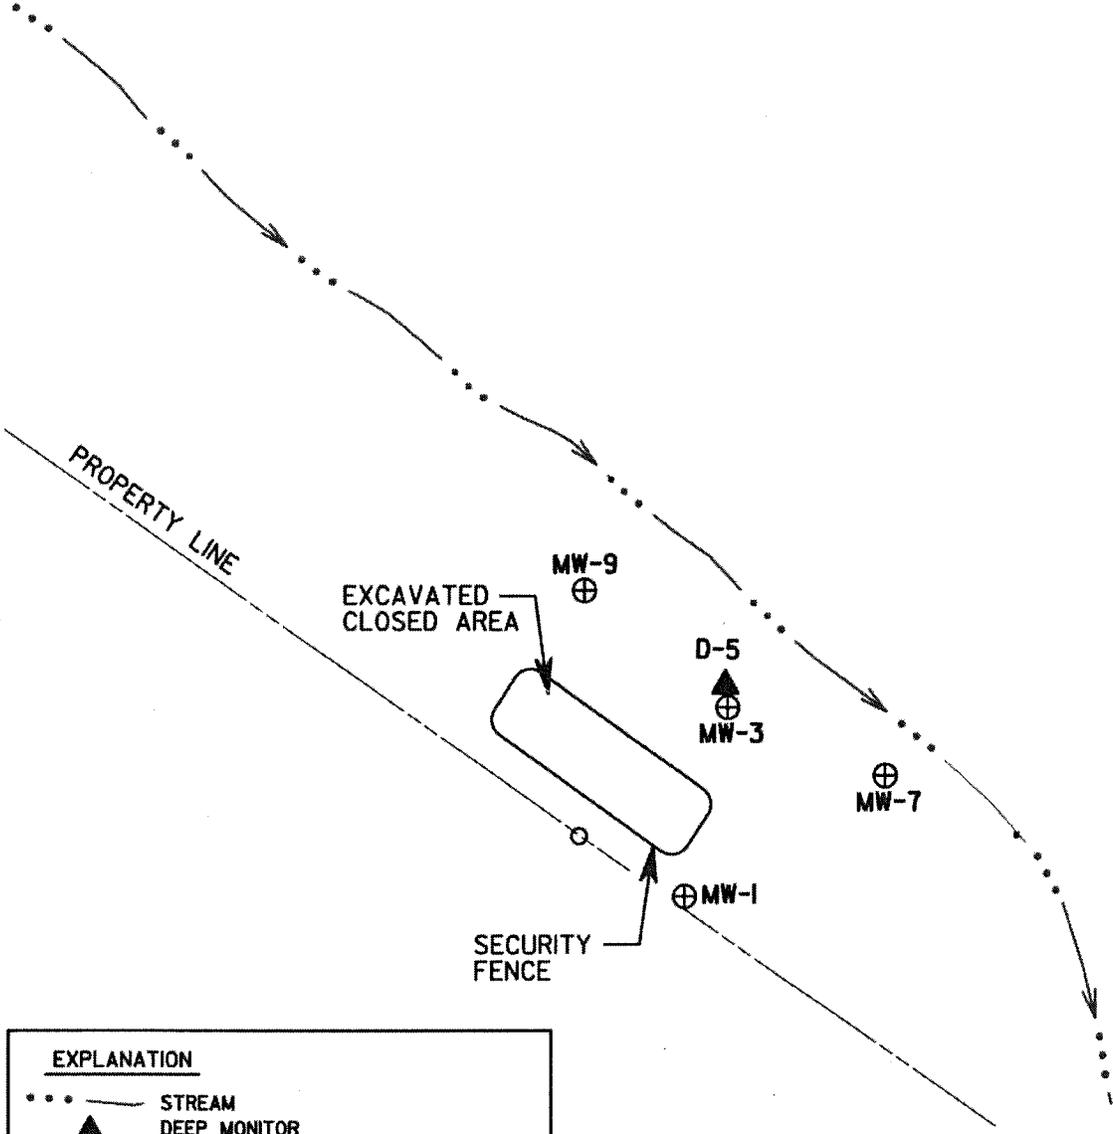
FIGURE 2  
SITE BASE MAP  
SHORT JOURNEY CENTER- SMITHFIELD, N.C.  
JULY 2011 60184478

EXPLANATION	
.....	STREAM
▲	DEEP MONITOR WELL
⊕	SHALLOW MONITOR WELL
