RE: Facility Compliance Audit Report  
White Oak Municipal Solid Waste Landfill  
Permit # 44-07  
Haywood County, North Carolina

On behalf of Haywood County, North Carolina, we are providing this response to the Facility Compliance Audit Report received May 12, 2010. Based on McGill Associates review of the specific site conditions, we have prepared this response to generally correspond with the identified Noted Violations and Areas of Concern.

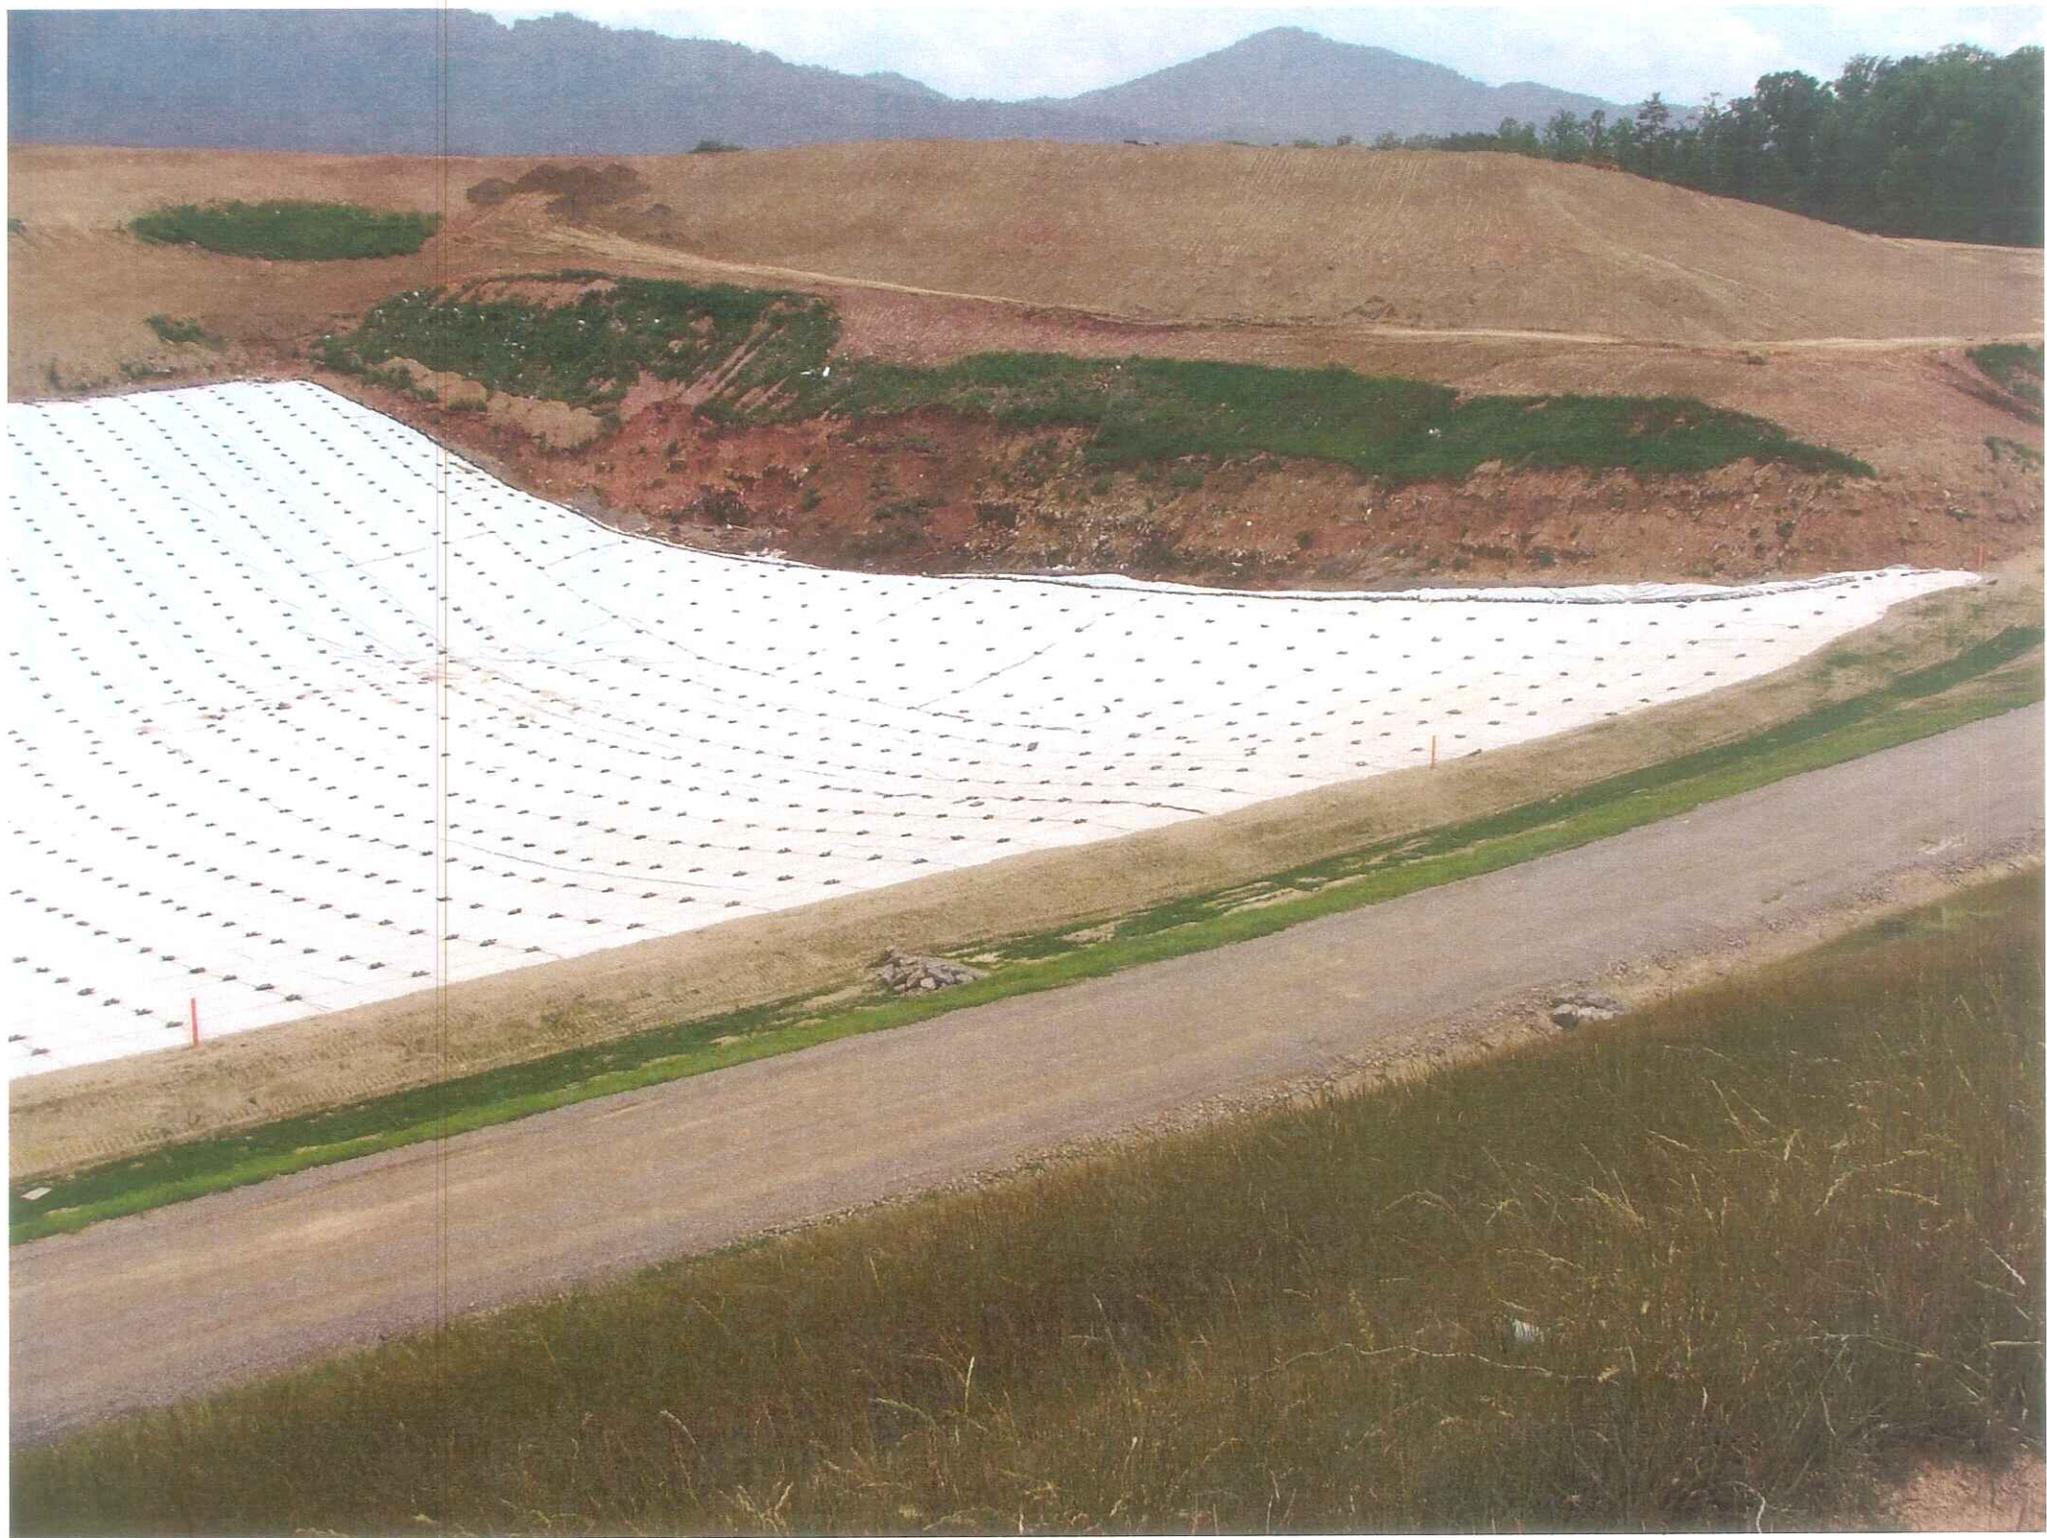
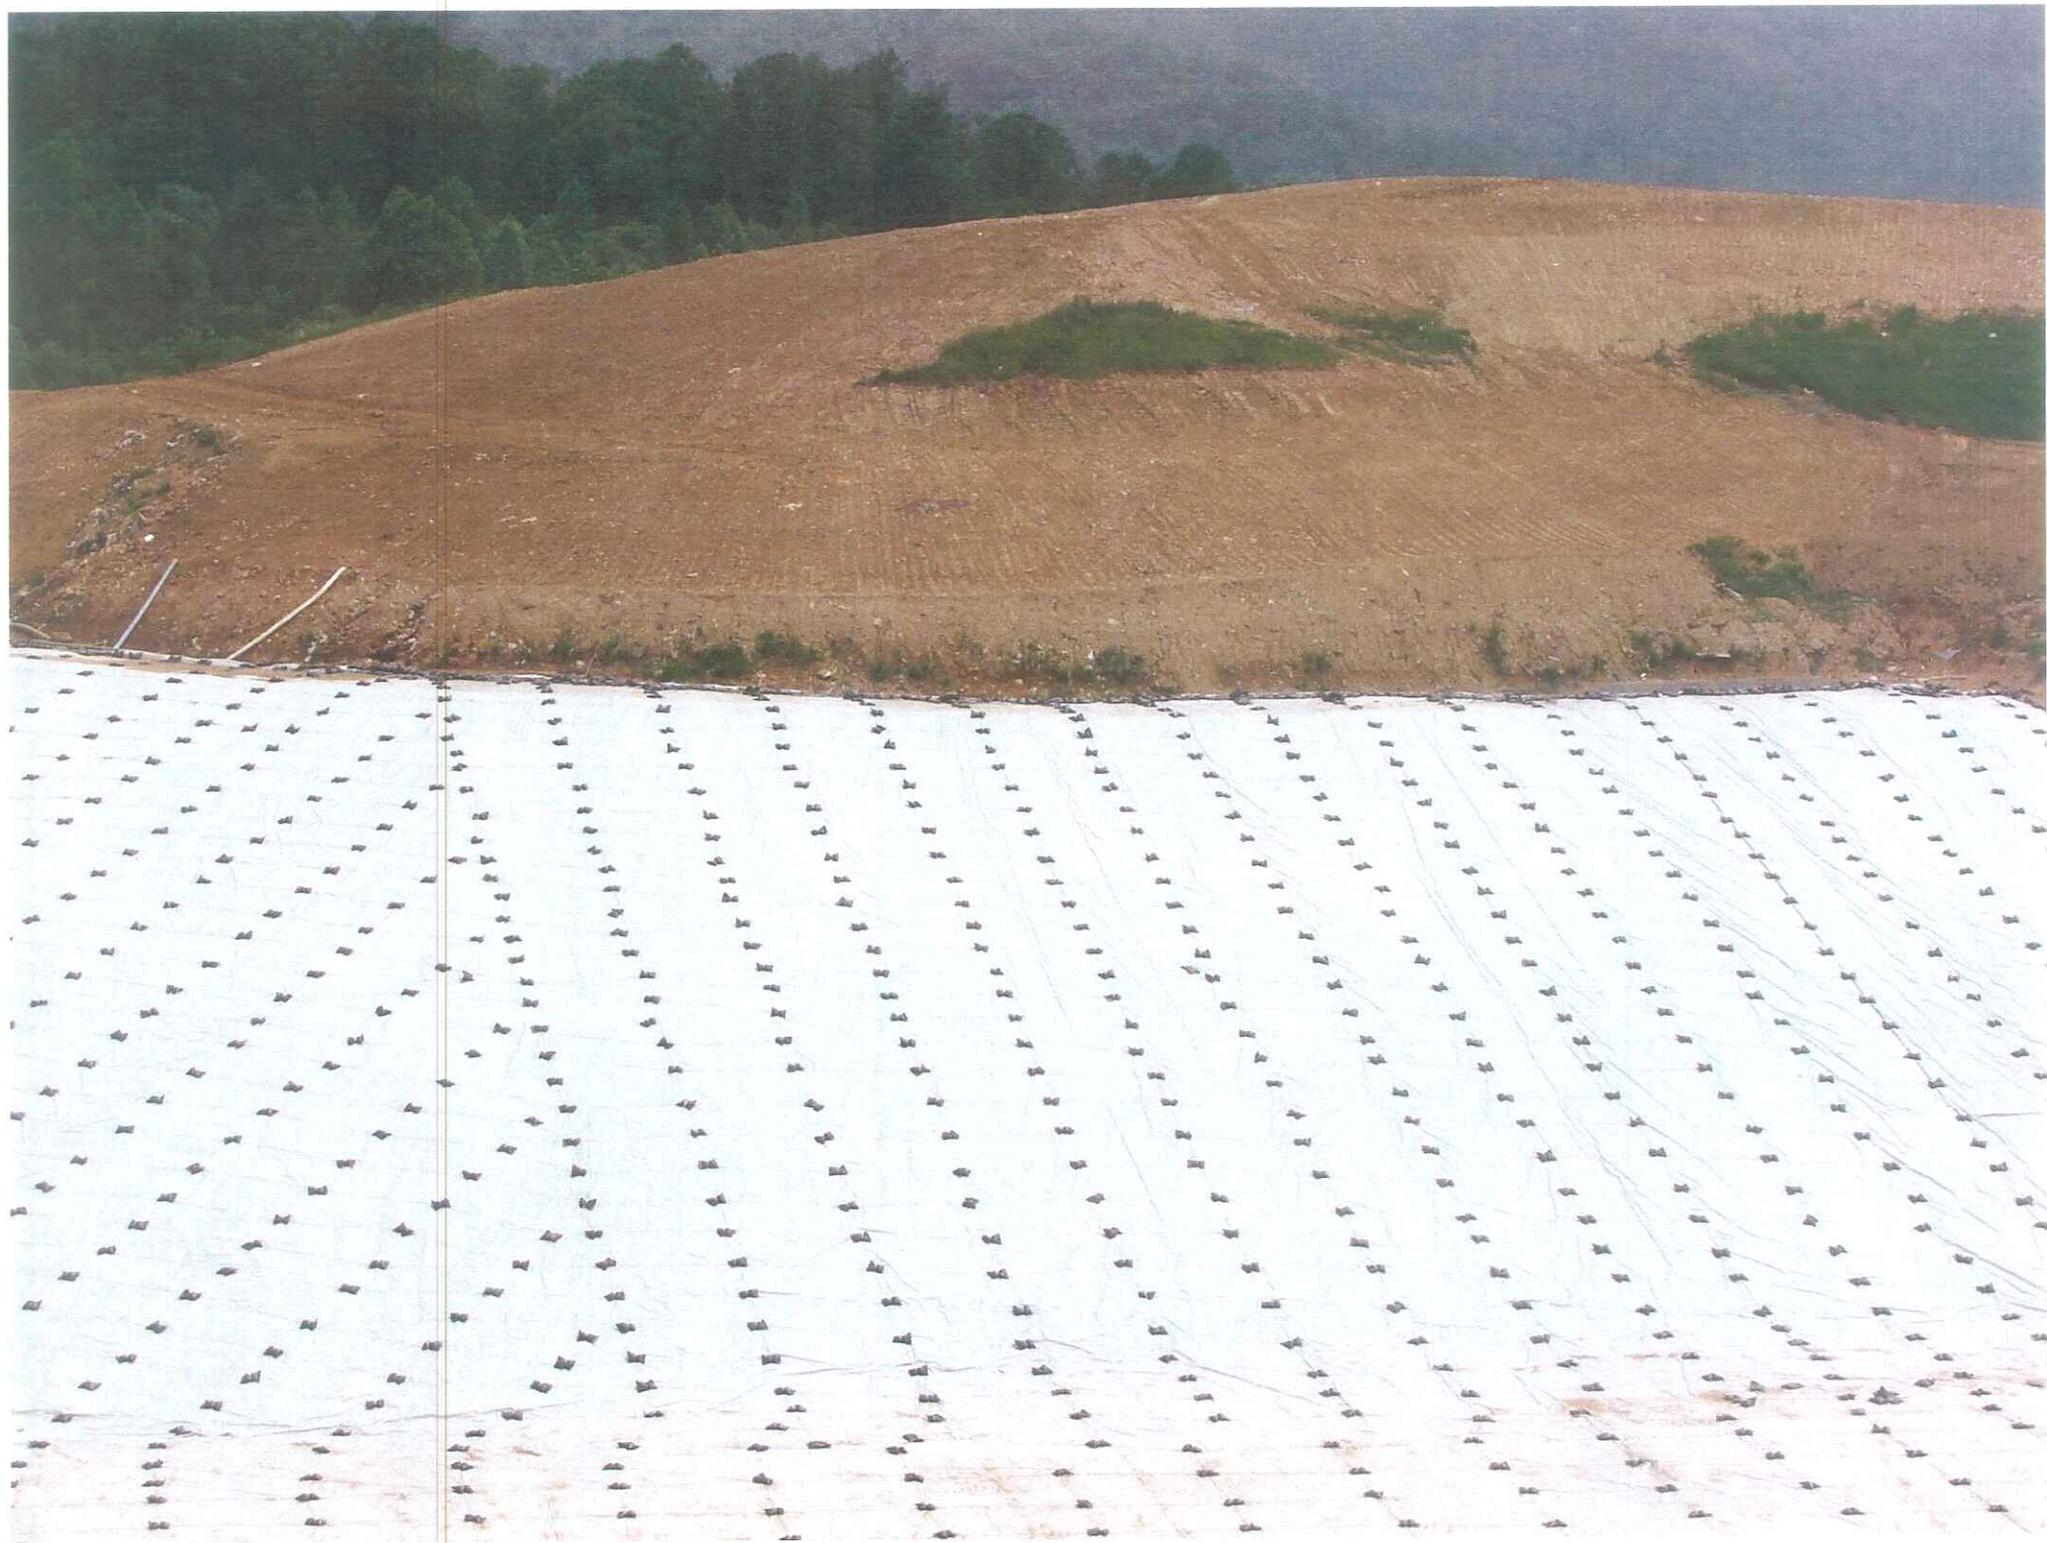
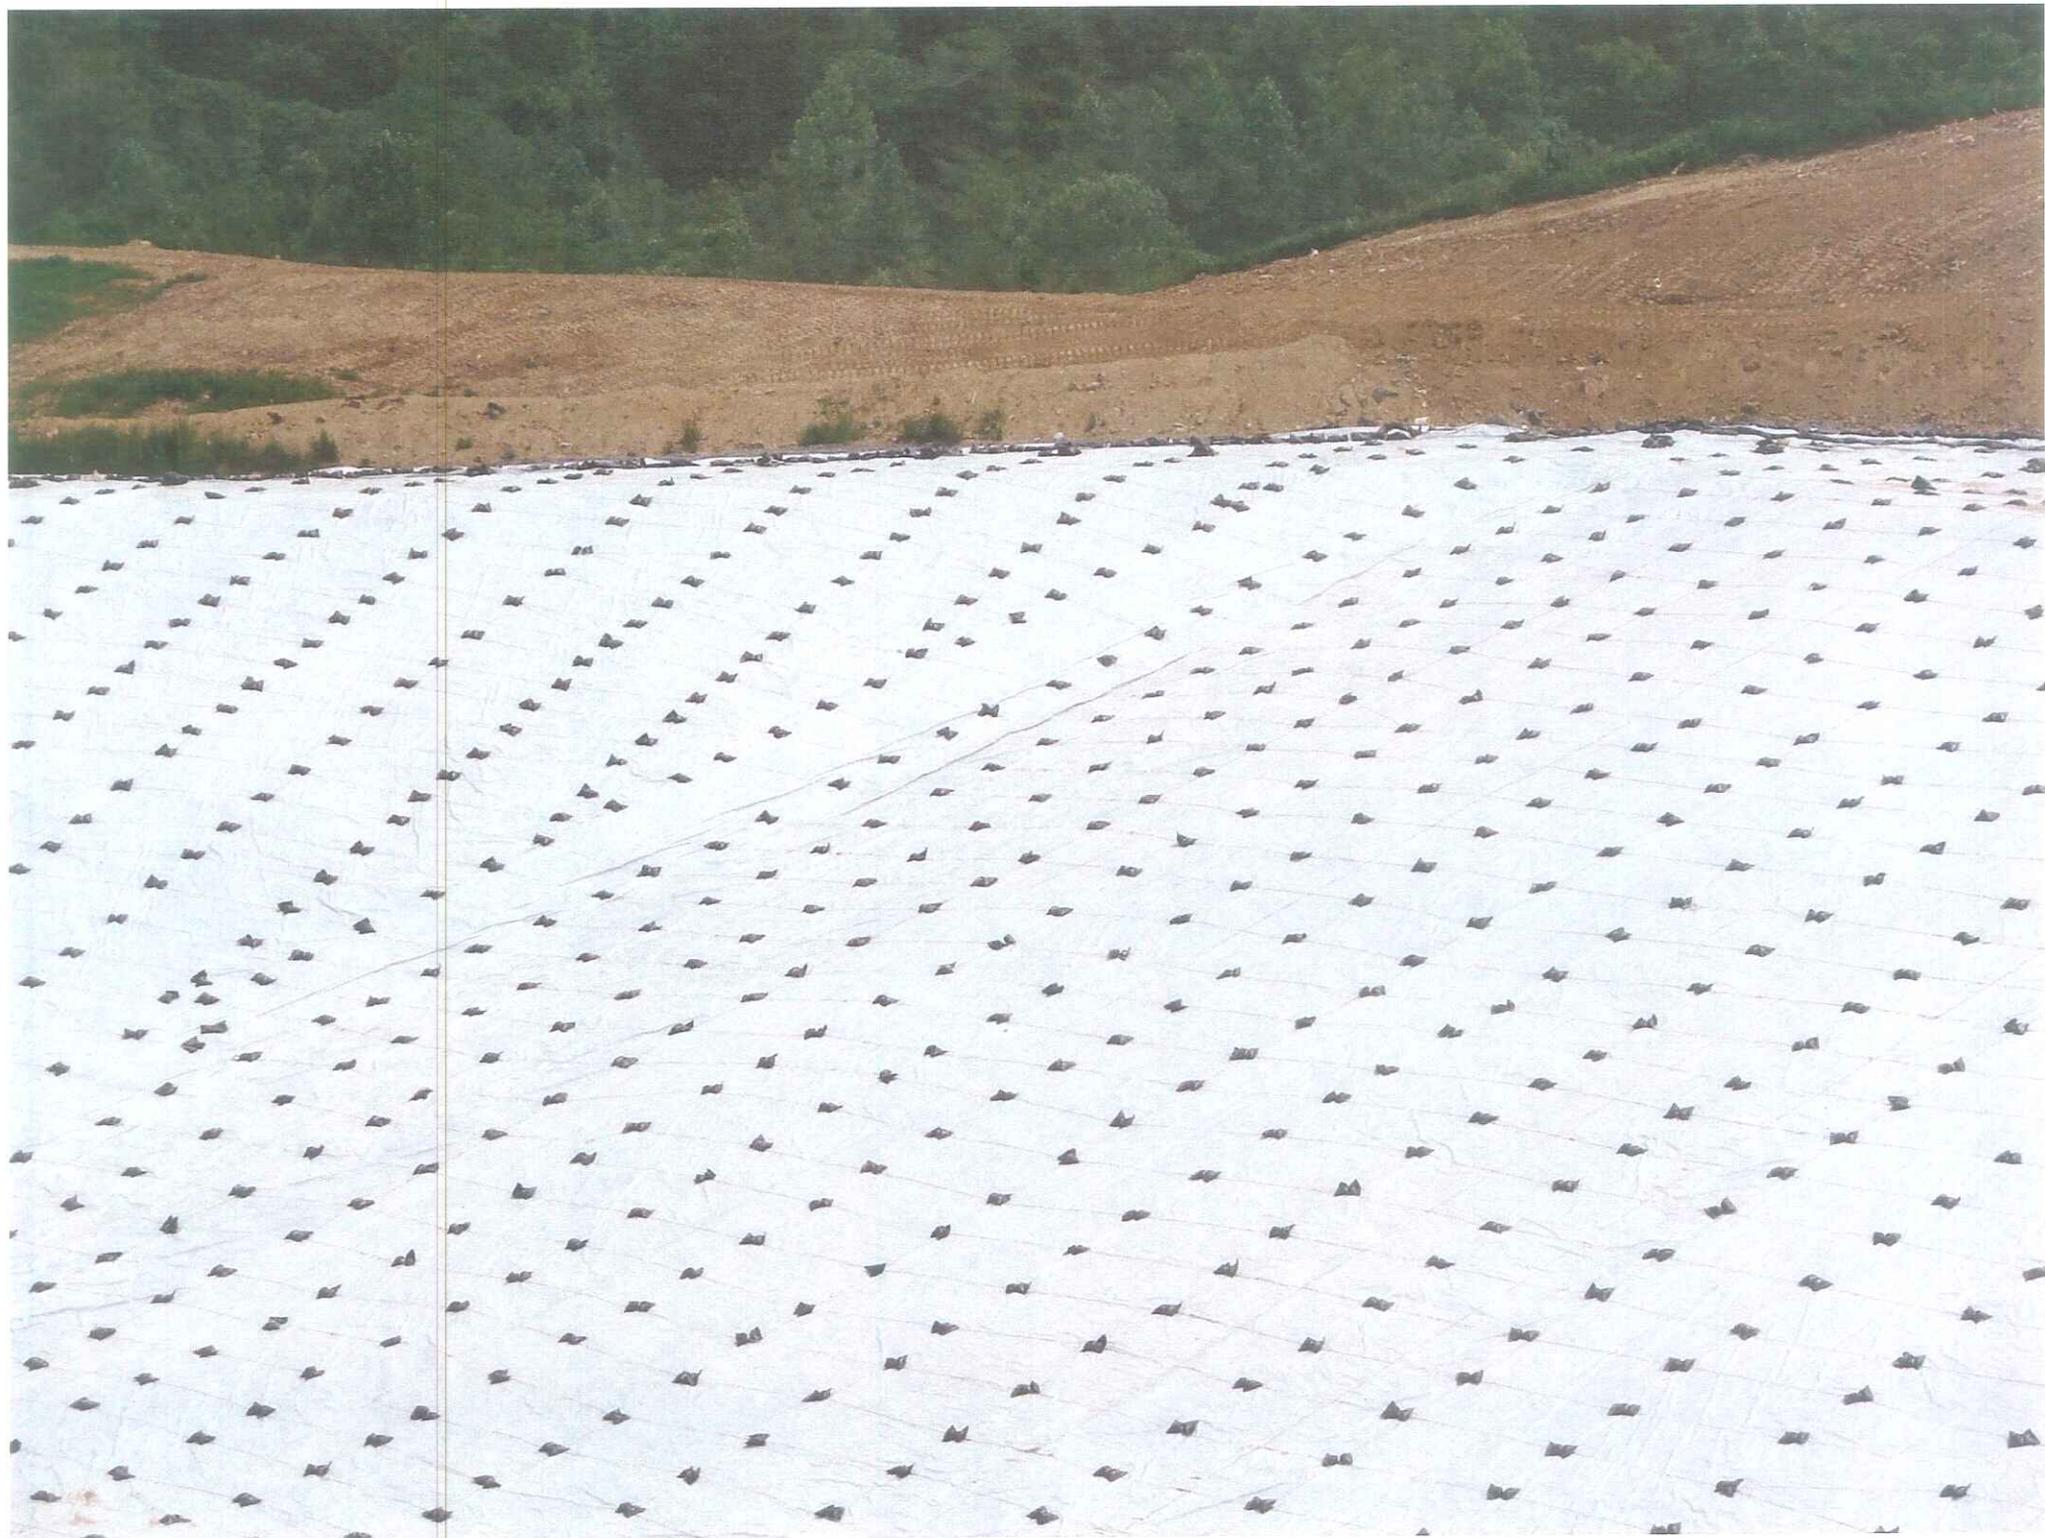
As described above, waste was relocated from the Areas 1 and 2, as depicted in the Audit Report, for the construction of the new Phase 3 waste area. During the waste removal, a portion of the area was not re-covered with the required soil cover. Haywood County has now covered a majority all of the area with soil cover with the exception of the area noted as Area 2 (along the northern limits of Phase 2), as shown on the attached photos.

In area along the Phase 2 limits, a proper soil cover can not be established at this time due to the existing steep slope and inaccessibility to the location by construction equipment. As noted above, waste had to be relocated to construct the Phase 3 waste area tie-in to the Phase 2 liner. Due to the existing condition of the Phase 2 waste fill, it was not feasible to relocate enough waste to establish a slope suitable for placement of soil cover material. Based on the current condition, the County proposes to cover the exposed waste along the northern slope of Phase 2 with a plastic tarp. The plastic tarp will remain in-place until such time as the Phase 3 area is permitted to receive waste and access can be established through Phase 3 to the uncovered waste along Phase 2. Once access is established a proper soil cover can be placed. The Phase 2 soil cover will be established with 60 days of issuance of the Permit to Operate for Phase 3.
