**Construction Certification Report  
 DuPont Kinston Ash Landfill Cap Construction Project  
 Kinston, North Carolina**

This letter report summarizes construction activities associated with the DuPont Kinston Ash Landfill Cap Construction Project, located at the Unifi (formerly DuPont) Kinston Plant (Facility) in Kinston, North Carolina. The construction was performed based on the Design Drawings entitled, *Cap Construction Project, Kinston Ash Landfill, Kinston, North Carolina*, prepared by URS Corporation, dated February 25, 2003, and associated construction documents.

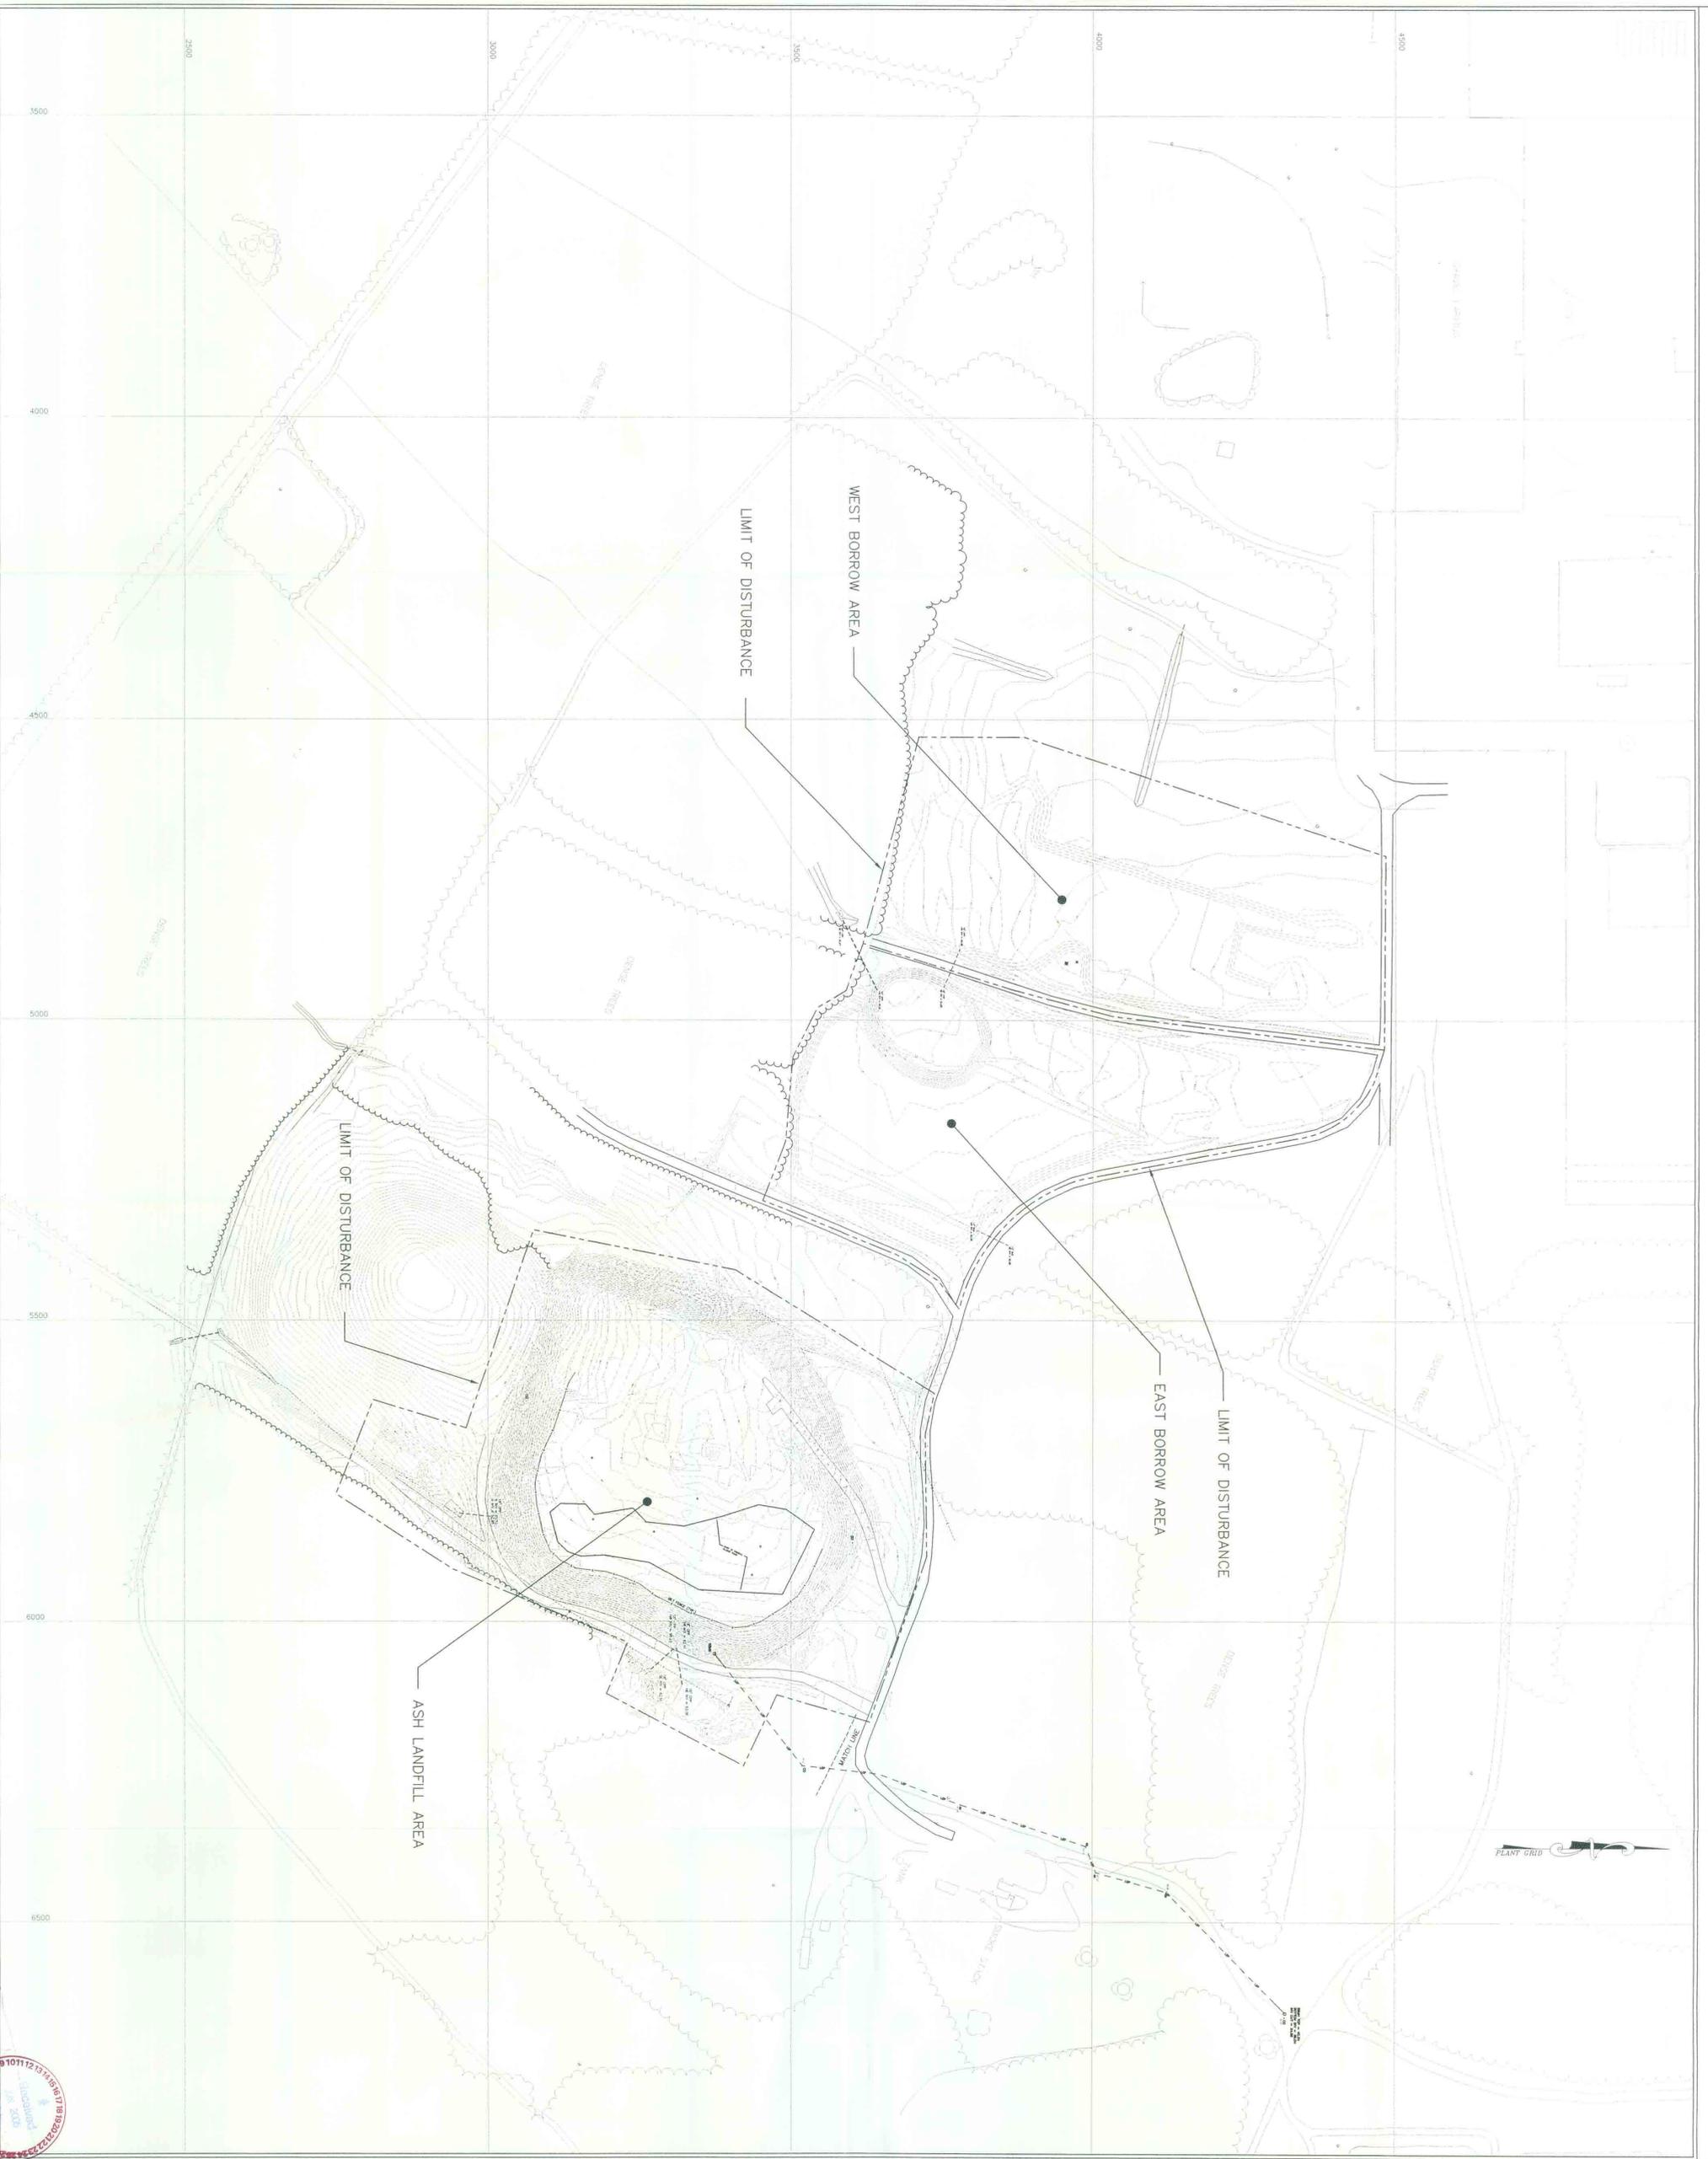
**SU1**

**SITE LOCATION PLAN**

A site location plan is presented as Drawing SU1.

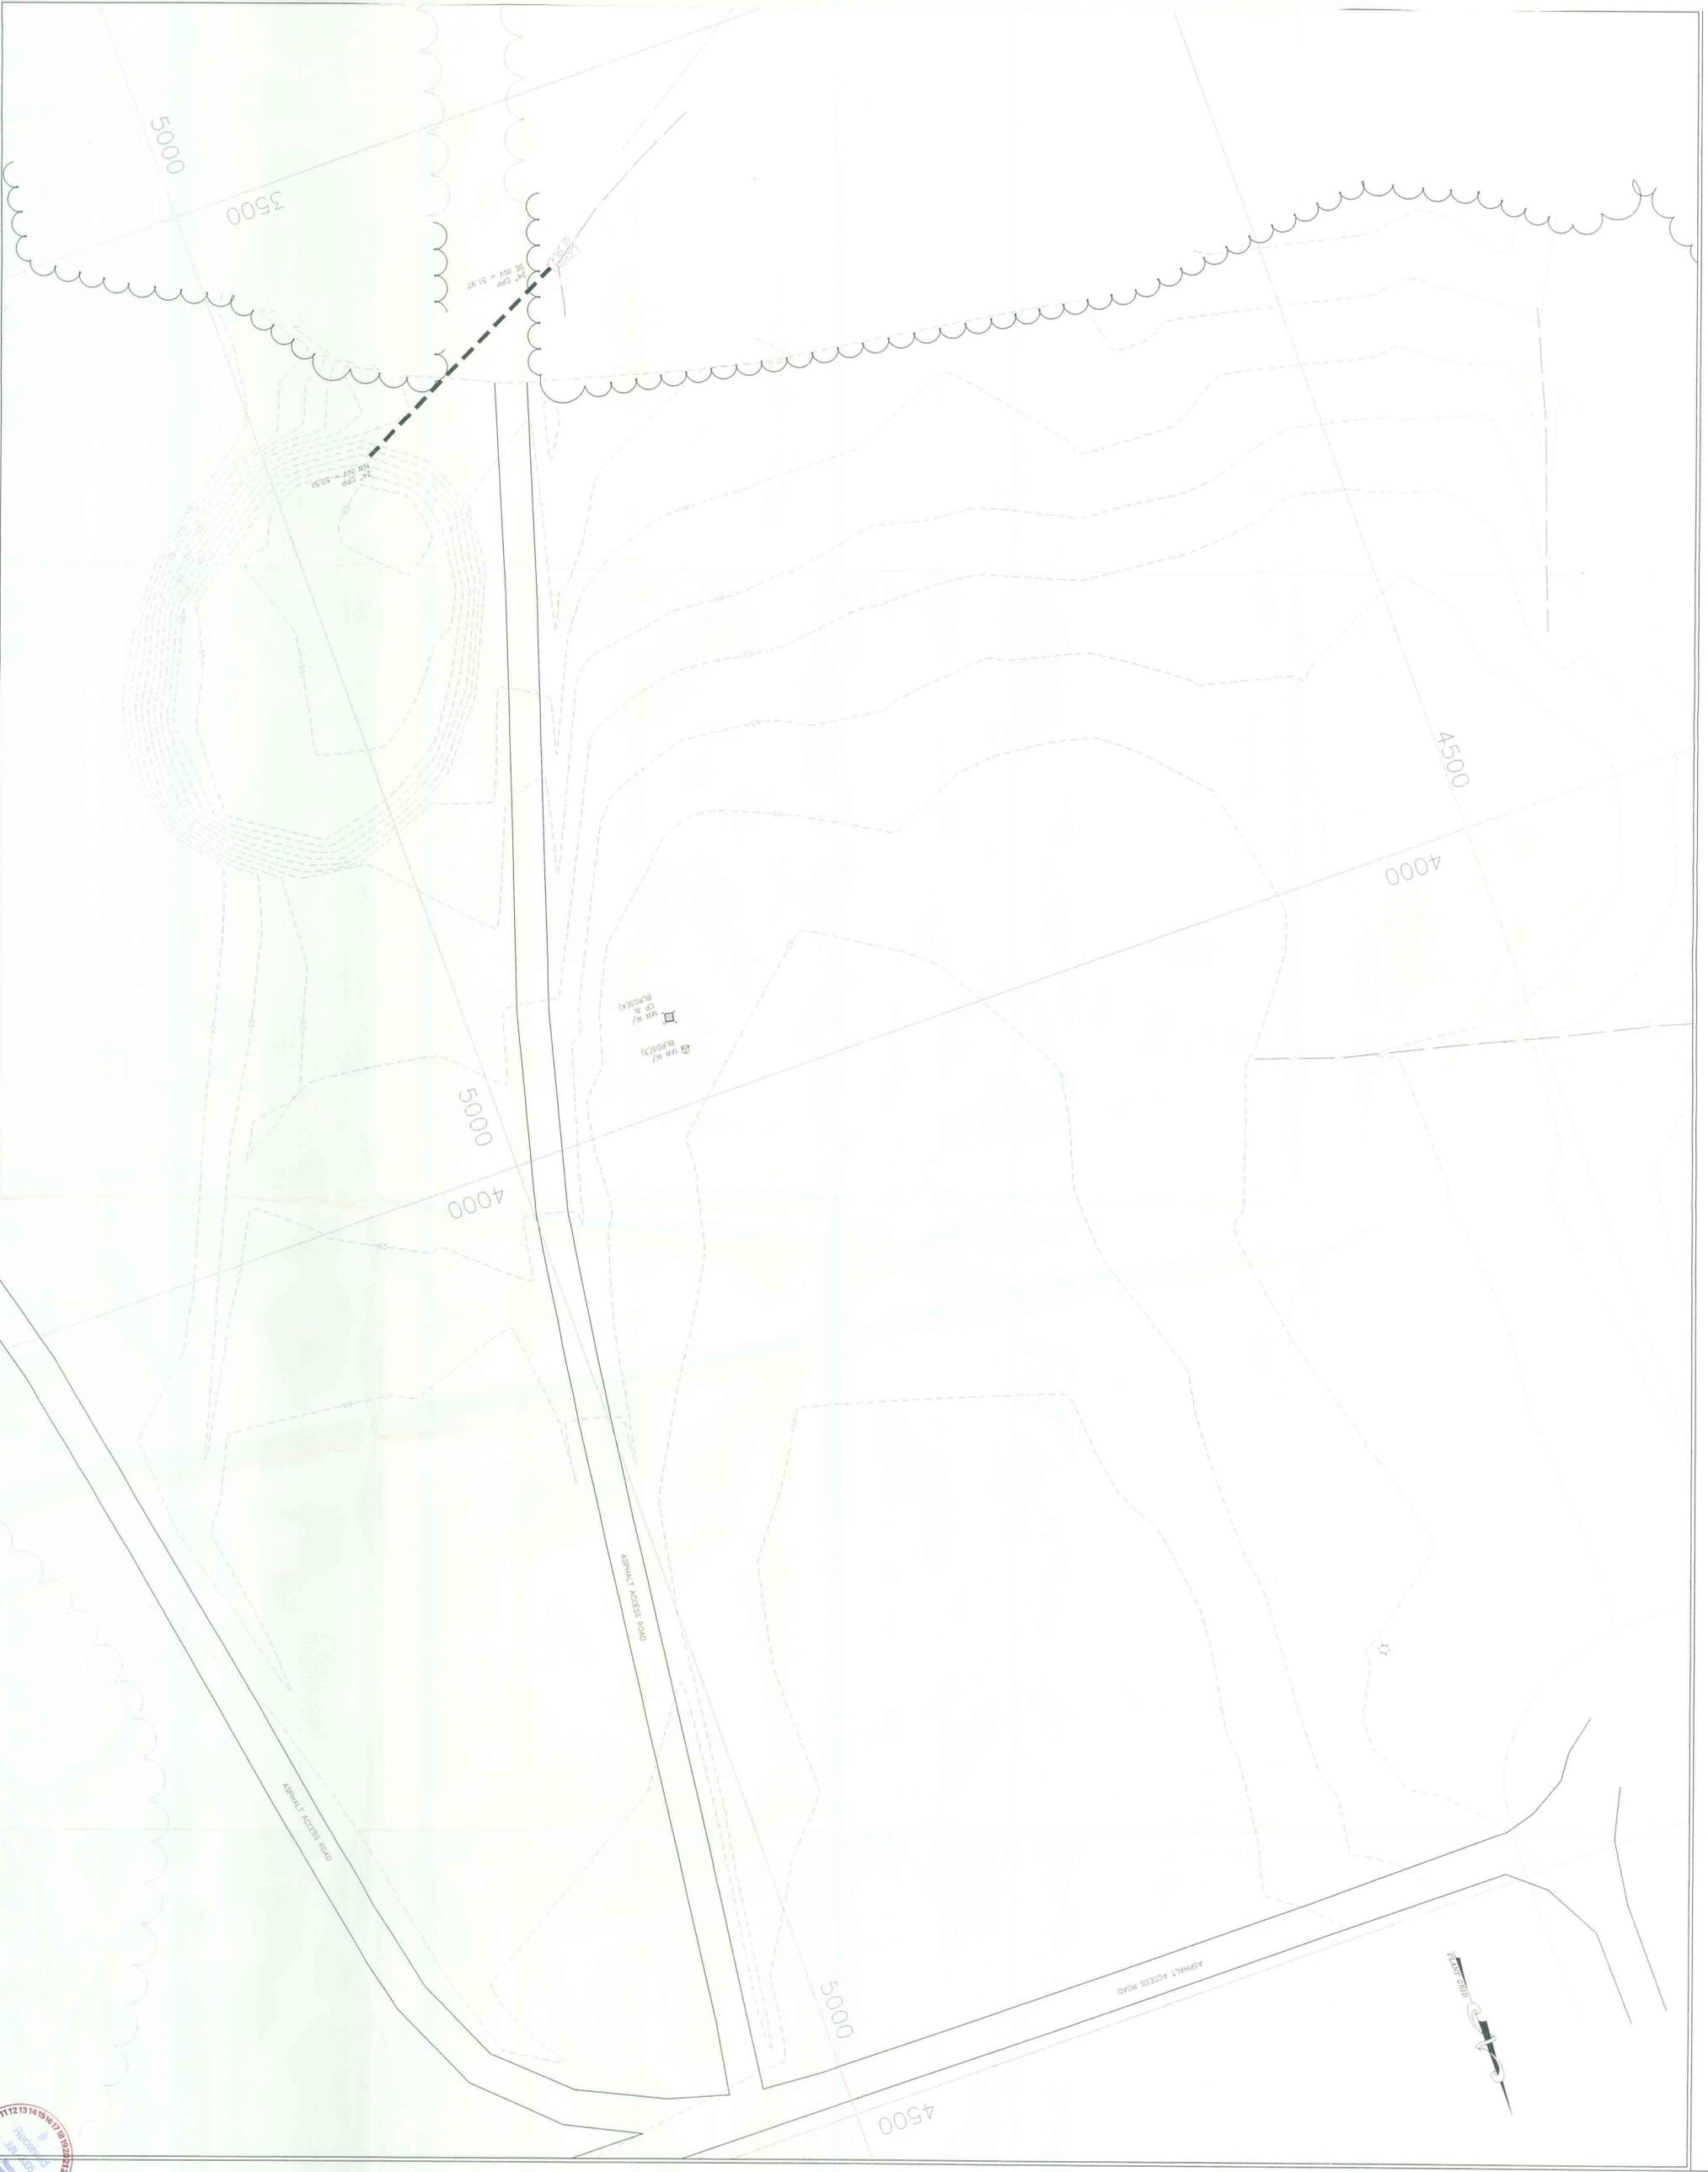
SU2A

WEST BORROW AREA  
 EXISTING CONDITIONS

The Site survey, clearing and grubbing operations, E&S controls installation, and installation of other site control structures were performed between September 3 and 24, 2003. Existing conditions surveys of the West Borrow Area, East Borrow Area, and Ash Landfill are presented as Drawings SU2A, SA3A, and SU4A respectively.

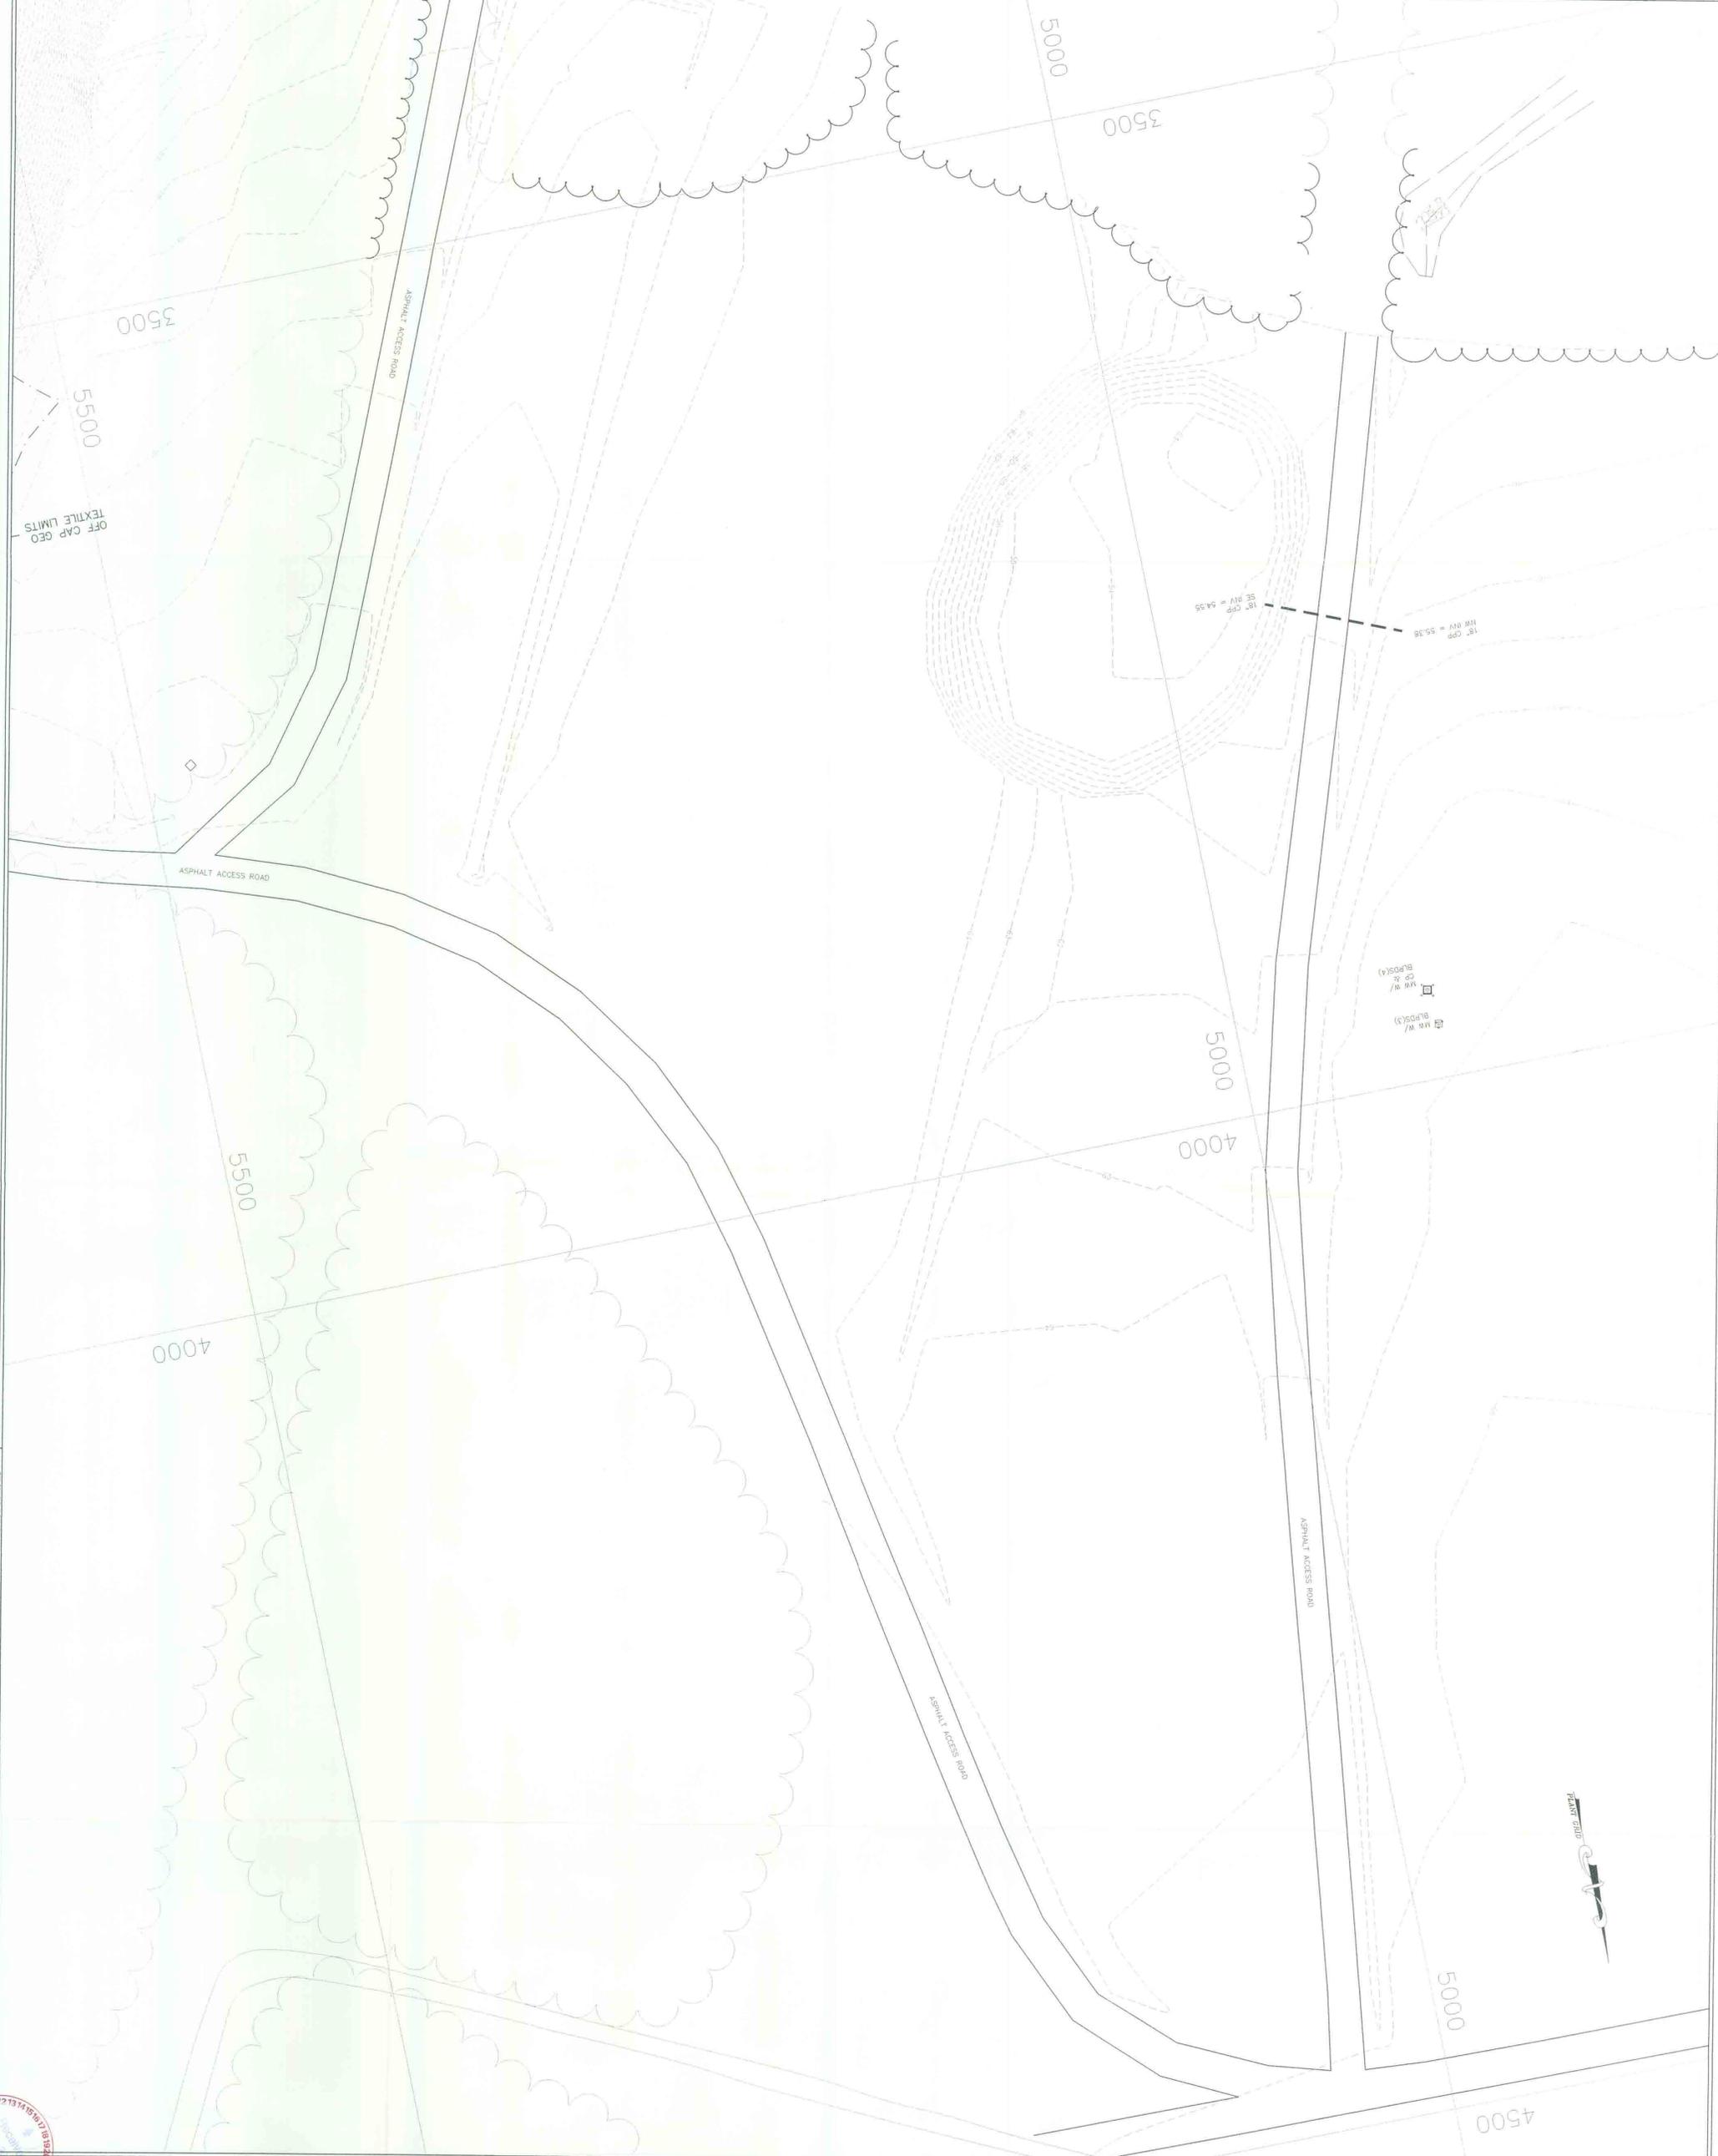
SCALE	1" = 30'
DATE	AUGUST 2003 - MAY 2005
PROJECT NO.	00030187
PROJECT NAME	SU3A

**EAST BORROW AREA  
EXISTING CONDITIONS**

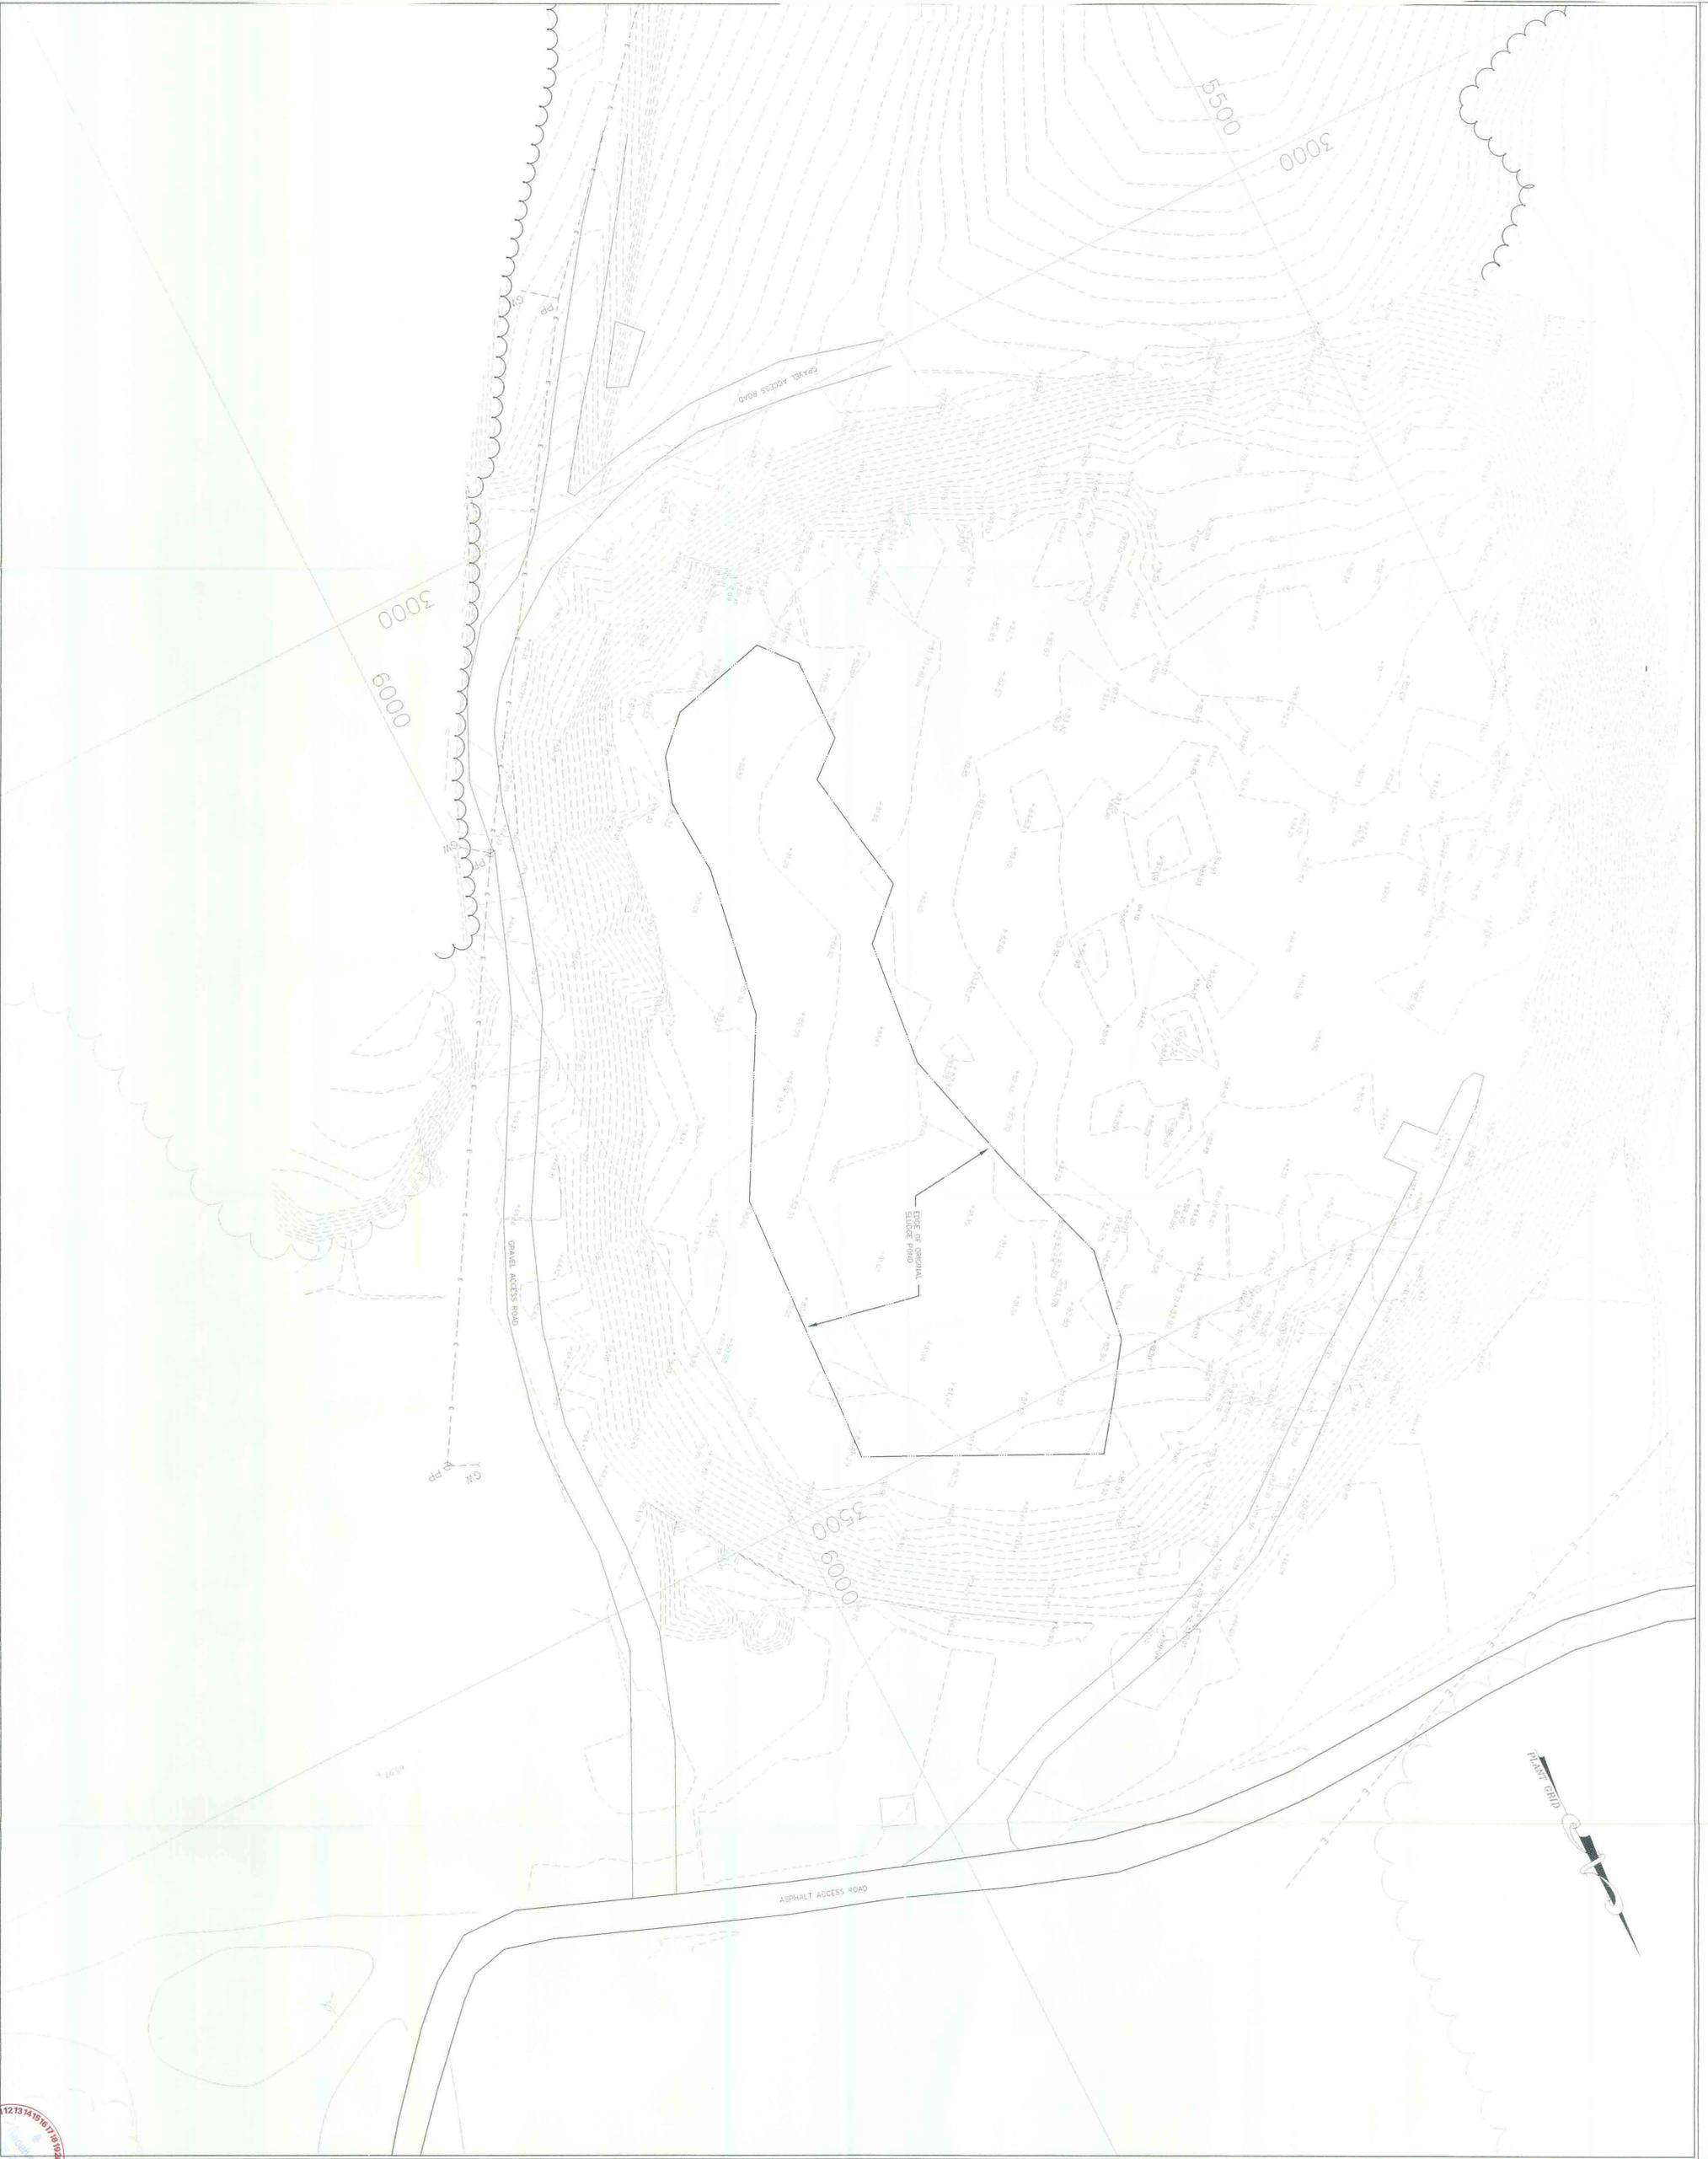
SCALE 1" = 30'	DATE PLOTTED AUGUST 2003	DEPARTMENT SURVEY
DRAWN BY MMH	SHEET NO. 6 OF 7	DRAWING NO. SU4A
DATE AUGUST 2003	DATE MAY 2005	
PROJECT NO. 0030187

NOTES:  
 1) THE LOCATION OF THE ASH LANDFILL CONVERSION COVERWALL AS DETERMINED BY SOIL BORINGS PERFORMED BY URS CORP AND OAKER INC.

ASH LANDFILL AREA  
 EXISTING CONDITIONS

As previously mentioned, the eastern half of the Ash Landfill contains a wastewater sludge pond. This sludge was in a "jello-like" condition and had essentially zero shear strength. As a result, to safely permit foot traffic or construction equipment to travel over the sludge pond, the area had to be structurally stabilized. The stabilization of the sludge pond area began on October 13, 2003, with the delivery of the high-strength (Type 1) geotextile manufactured by Huesker, Inc. of Gescher, Germany. URS-ROS employed subcontractor Flint Industries (Flint) to perform staging, sewing, and deployment of the high-strength geotextile. Flint staged each panel of prefabricated high-strength geotextile in the sequence provided in the panel layout submittal, then started to assemble the entire geotextile layer by sewing together each adjacent panel continuously in the warp (strong) direction using their industry standard sewing machine. Each seam consisted of double parallel stitches with high-strength polyester thread. The specified number of QC samples were taken and tested with each sample developing the required seam strengths. Once the high-strength geotextile was assembled, URS-ROS used two tracked hydraulic excavators and two high-strength cables to deploy the geotextile over the sludge pond area. URS-ROS then used a bulldozer and straps to set the geotextile into its final position over the sludge pond. The Type 1 geotextile was deployed to a distance of approximately 15 feet beyond the sludge pond limits. The approximate limits of the sludge pond are presented on the Ash Landfill Existing Conditions Drawing SU4A.

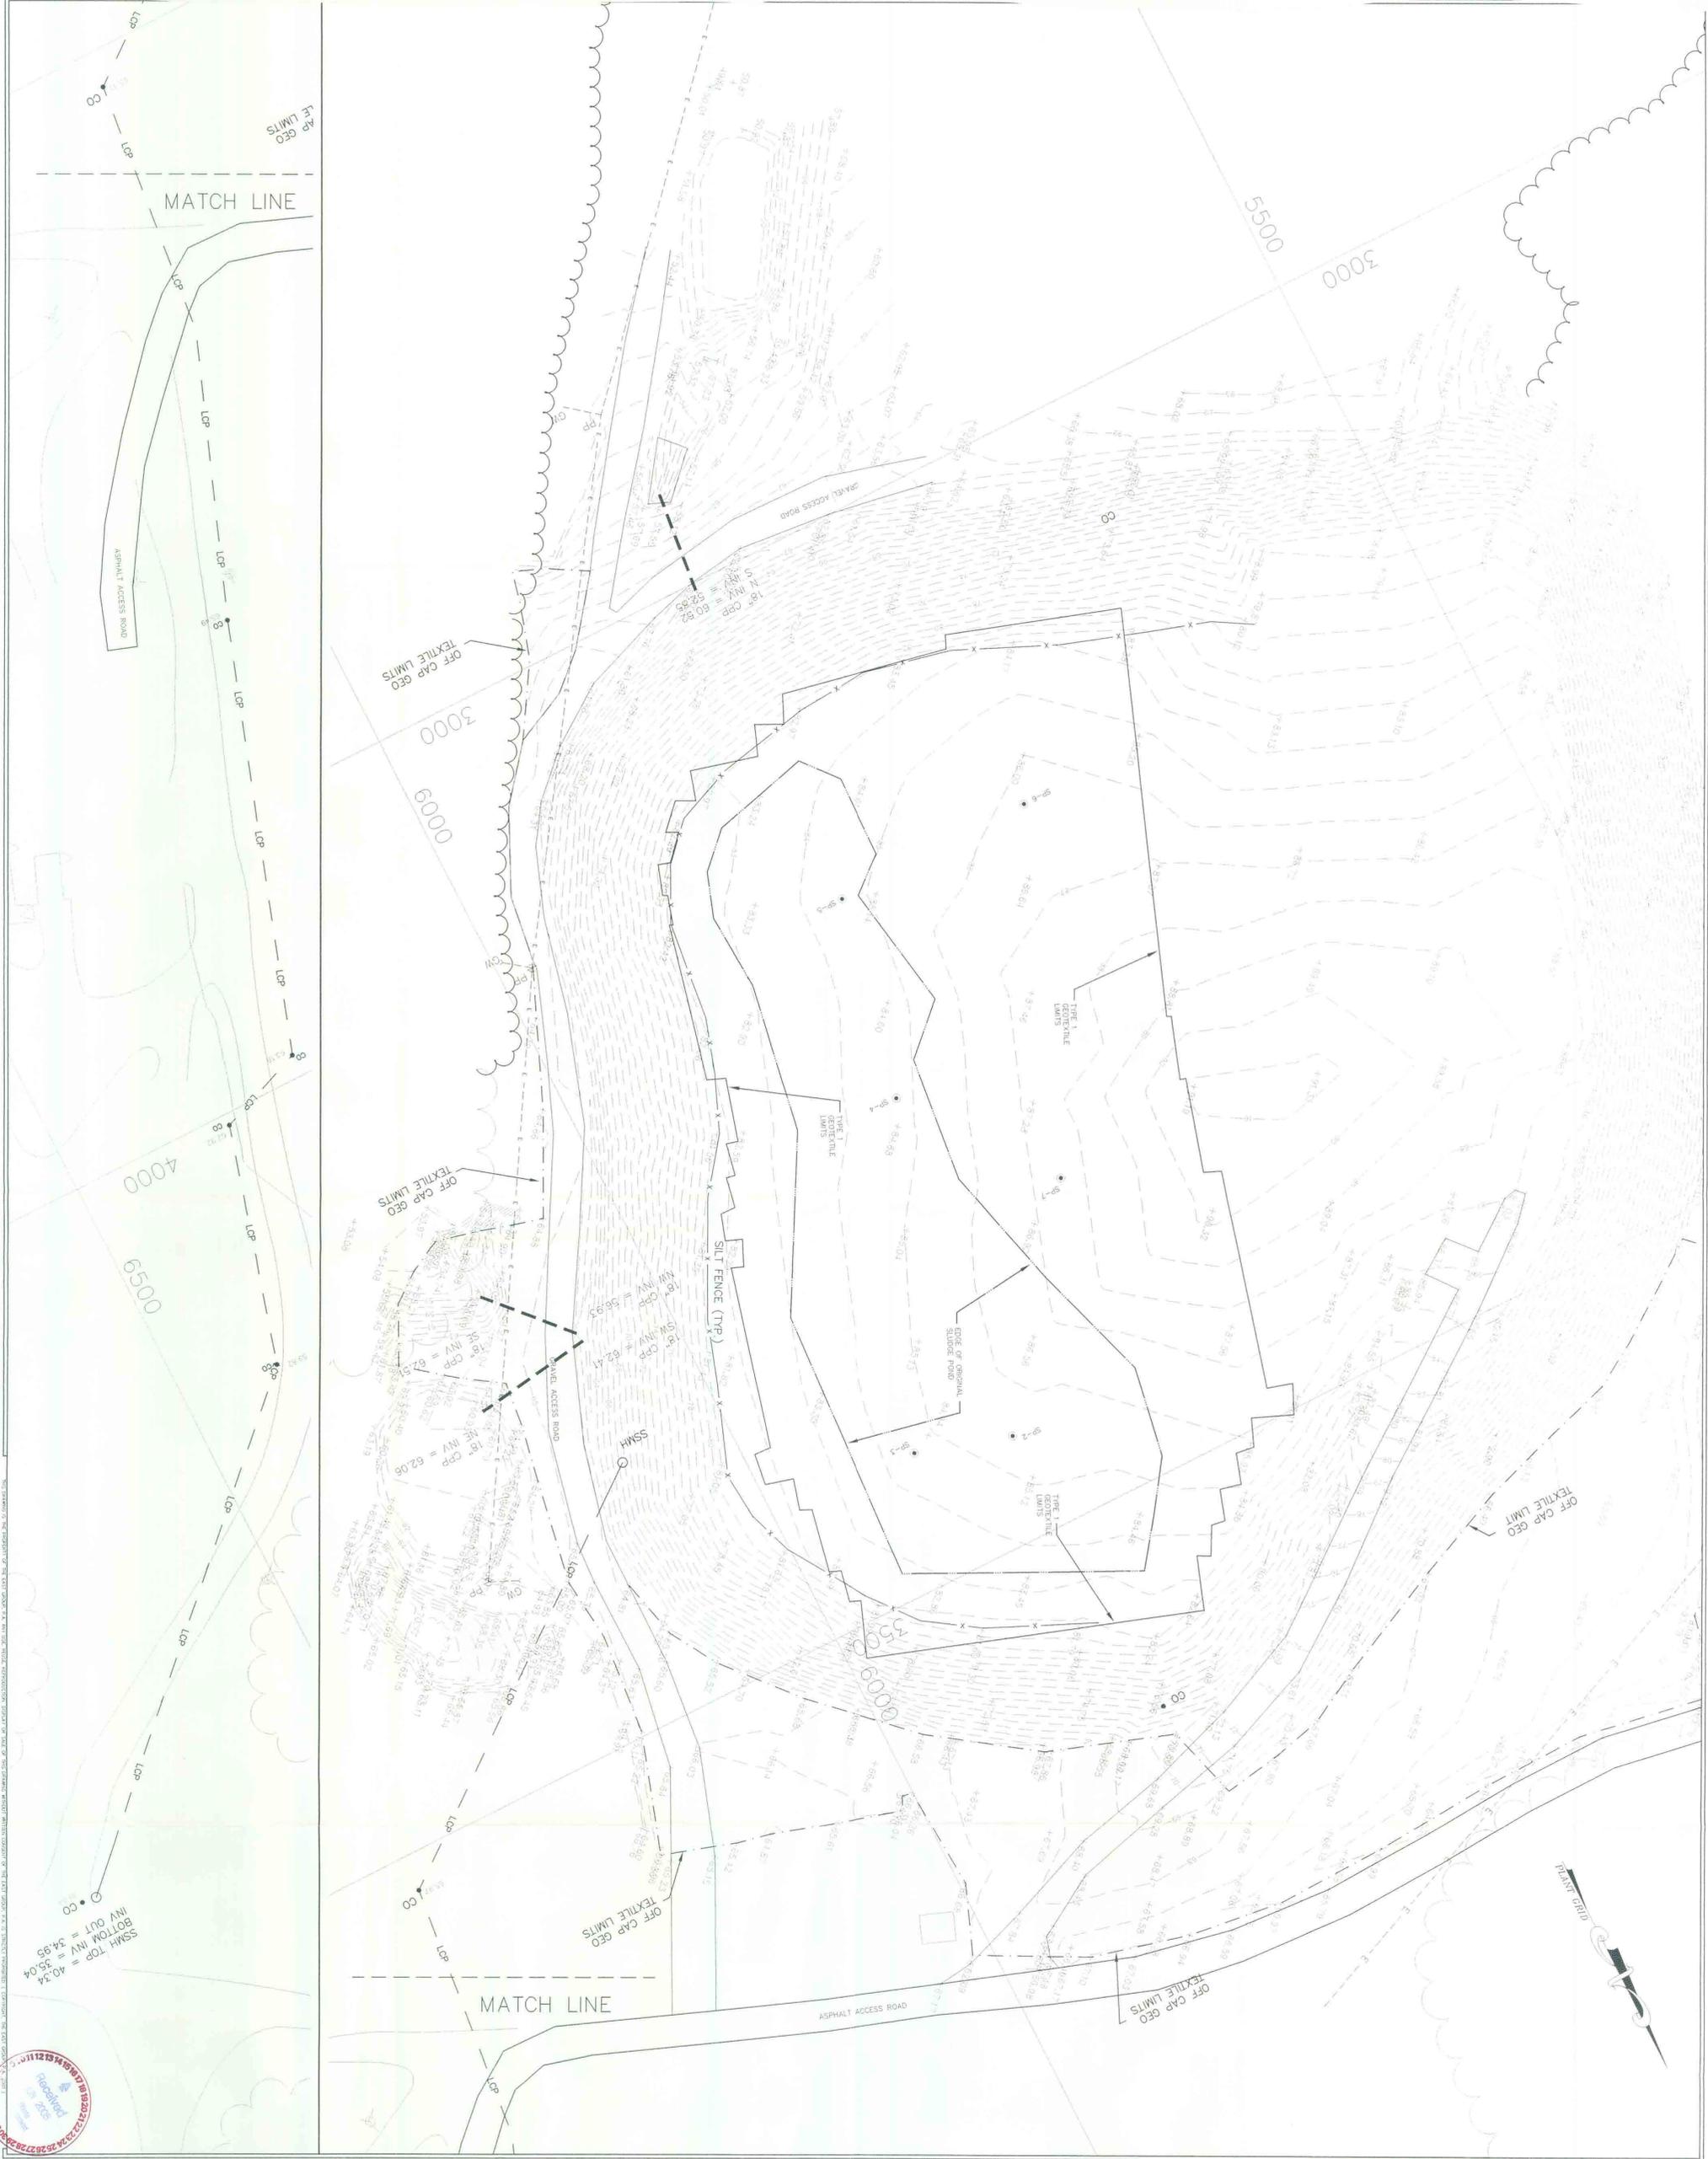
DATE: 1" = 30'  
 DRAWN BY: DVE THAYER  
 SHEET: SHEET 7 OF 7  
 PROJECT TITLE: DUPONT ASH LANDFILL CLOSURE CONDITIONS  
 APPROVED: AUGUST 2003 - MAY 2005  
 DRAWING NO: 20030187  
**SU4B**

NOTES:  
 1) THE LOCATION OF THE ASH LANDFILL CONCRETE IS LOCATED 0.5' BELOW THE LAMBERED ASH LANDFILL PERFORMED BY URS CORP AND OLIVER INC.

**THE EAST GROUP, P.A.**  
 4301 Rte 108, Suite 200, Greensboro, NC 27409  
 PROJECT TITLE  
 DUPONT  
 ASH LANDFILL  
 LANDFILL AREA  
 POST ASH LANDFILL  
 CLOSURE CONDITIONS

The settlement platforms were surveyed on a regular basis to document settlement in different areas of the sludge pond. After a reasonable monitoring period, the sludge pond was considered to be stable enough to bear the weight of the construction equipment and remaining cover material. The settlement platform locations are presented on Drawing SU4B.

The leachate collection and conveyance system installation was initiated on October 20 and completed on November 12, 2003. The system was constructed in accordance with the specifications and the contract drawings. The leachate collection and conveyance system collects leachate from the Ash Landfill and transports it by gravity flow to the on site wastewater treatment plant. The leachate collection trench was comprised of slotted and corrugated 4-inch diameter HDPE pipe embedded in AASHTO #57 crushed stone and surrounded by a geotextile to prevent sediment from clogging the pipe. The leachate conveyance pipe was constructed of 4-inch diameter PVC SDR-35 pipe and embedded in crushed stone to assure pipe stability. The conveyance pipe was pressure tested to verify that the conveyance system would not leak under the anticipated operating conditions. The conveyance system met the requirements of the pressure test, and the conveyance system alignment is presented on Drawing SU4B.

Post-closure condition surveys of the West Borrow Area, East Borrow Area, and Ash Landfill are presented on Drawings SU2B, SU3B, and SU4B respectively.
