Facility Name: Merck Sharpe & Dohme Corp.

**COMPLIANCE EVALUATION VISIT (CEI) REPORT
Small Quantity Generator**

4. DATE OF INSPECTION: January 29, 2016

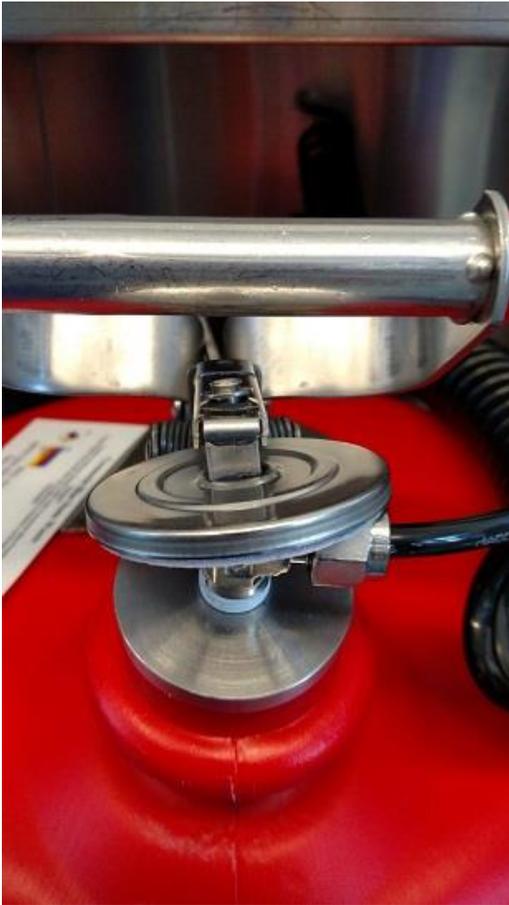
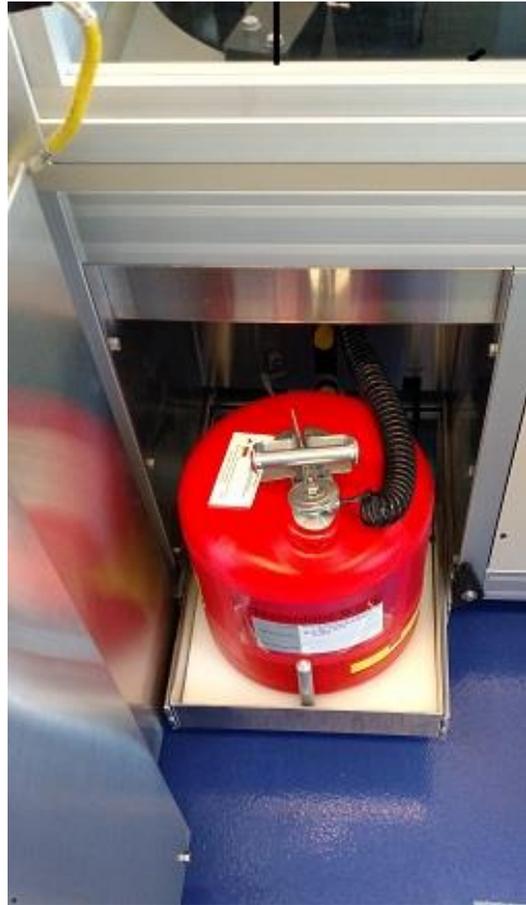
- C.** The connection used to run tubing from an instrument into a 5-gallon red safety can was discussed. The connection is shown below. The container was located in the Potency Lab, Room 2021, on a sliding tray and housed within the instrument. The connection device is held in place by the spring loaded safety can lid. The inspector judged the spring load lid was strong enough to hold the connection device in place. The location of the can also minimized the possibility that the can could be disturbed. As such, the can in the picture is considered a closed container and in compliance with the rule.
