STRUCTURAL FILL FACILITY DOCUMENTATION REPORT

**O.N. VAUGHAN PROPERTY
4752 HIGHWAY 301
HALIFAX, NORTH CAROLINA**

Subject: **Coal Ash Structural Fill Site Documentation Report
O.N. Vaughan Property at 4752 Highway 301 - Halifax, NC
36.3708 N Latitude; 77.595 W Longitude
URS Project No. 31826292**

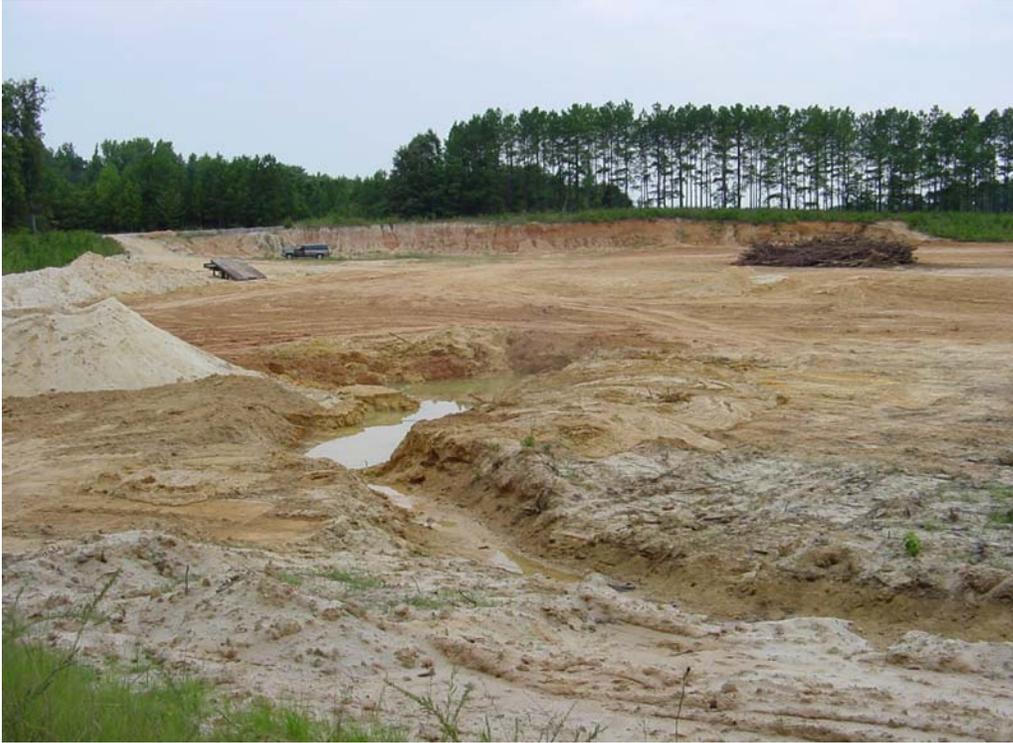
QA-1 Stormwater Stilling Basin at Northwest corner of borrow site. - 9/14/07

A stilling basin was constructed, prior to placement of the fill, in the northwest corner of the borrow area, see photo 1 in Appendix A. Discharge from the stilling basin is filtered through two stone check dams, see photo 2 in Appendix A. The base of the borrow site slopes at approximately 1% from the southeast corner to the stilling basin in the northwest corner. An earthen containment berm was constructed between the stilling basin and the floor of the borrow area to prevent fill material from entering the stilling basin.

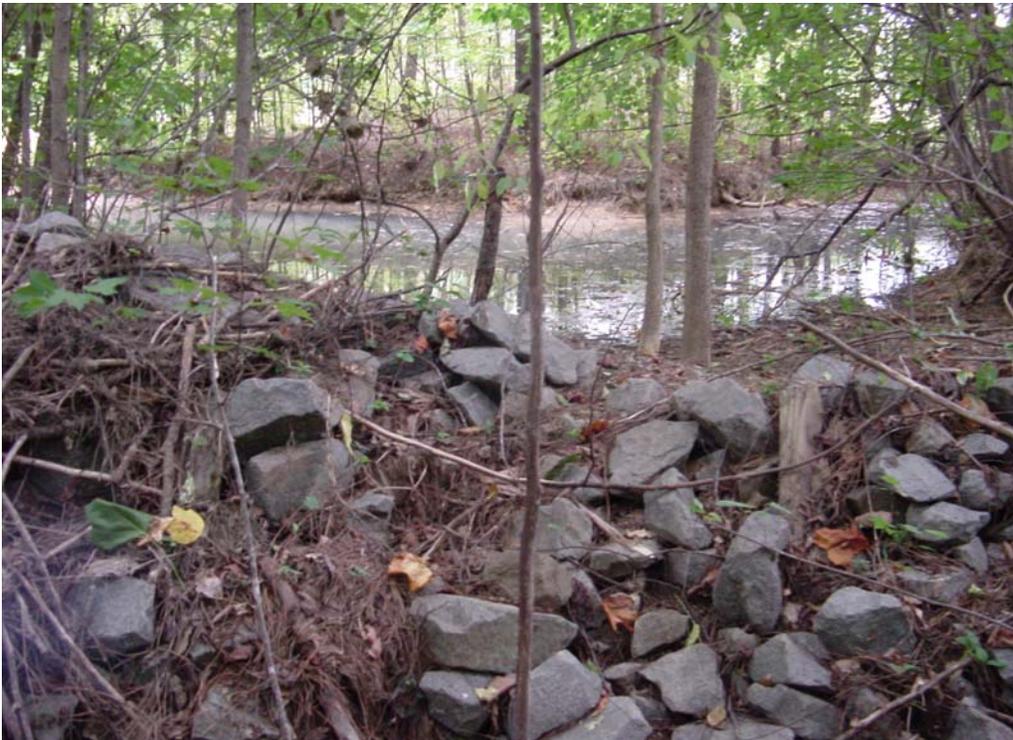
QA-2 Stone filter dam forming Stormwater Stilling Basin – 9/14/07

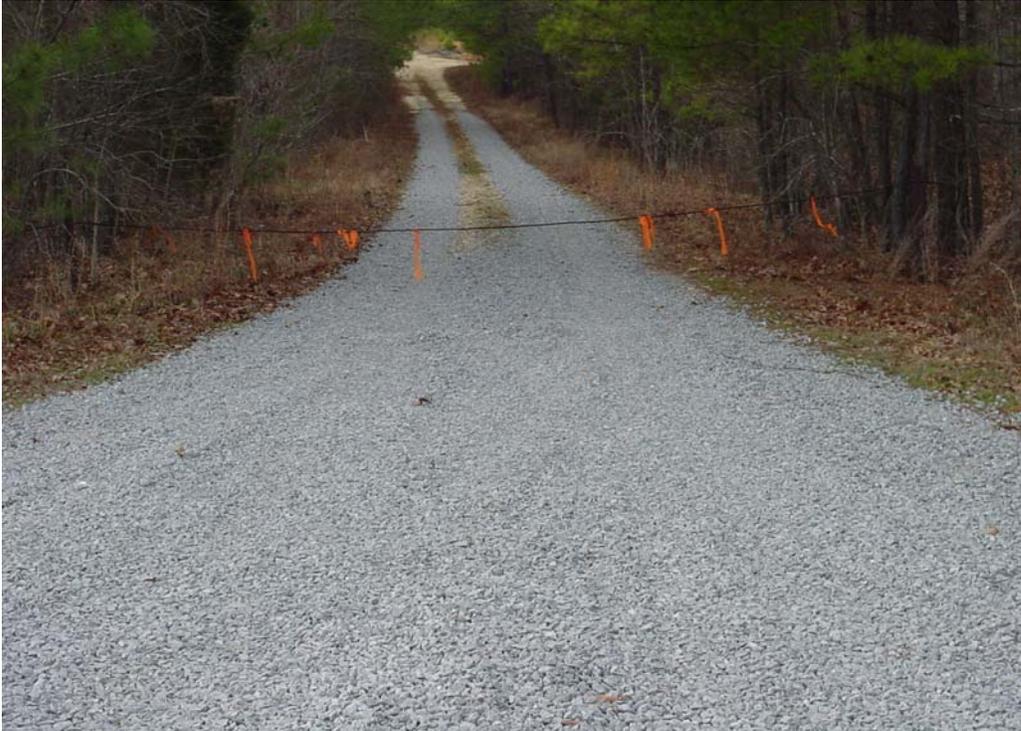
QA-3 The final 50' of gravel access road surfaced with coarse aggregate. – 2/6/08

A perimeter stormwater control ditch was constructed along the borrow site limits to divert stormwater away from the borrow area. The slope of the ditch varied from 2.6% to 1%. To reduce amount of soil being tracked onto Highway 301 the final 50-feet of gravel access road was surfaced with coarse aggregate (2” to 3” nominal size). These features and the earthen sediment trap near the active fill areas provided sufficient erosion control to limit sedimentation from migrating off site.

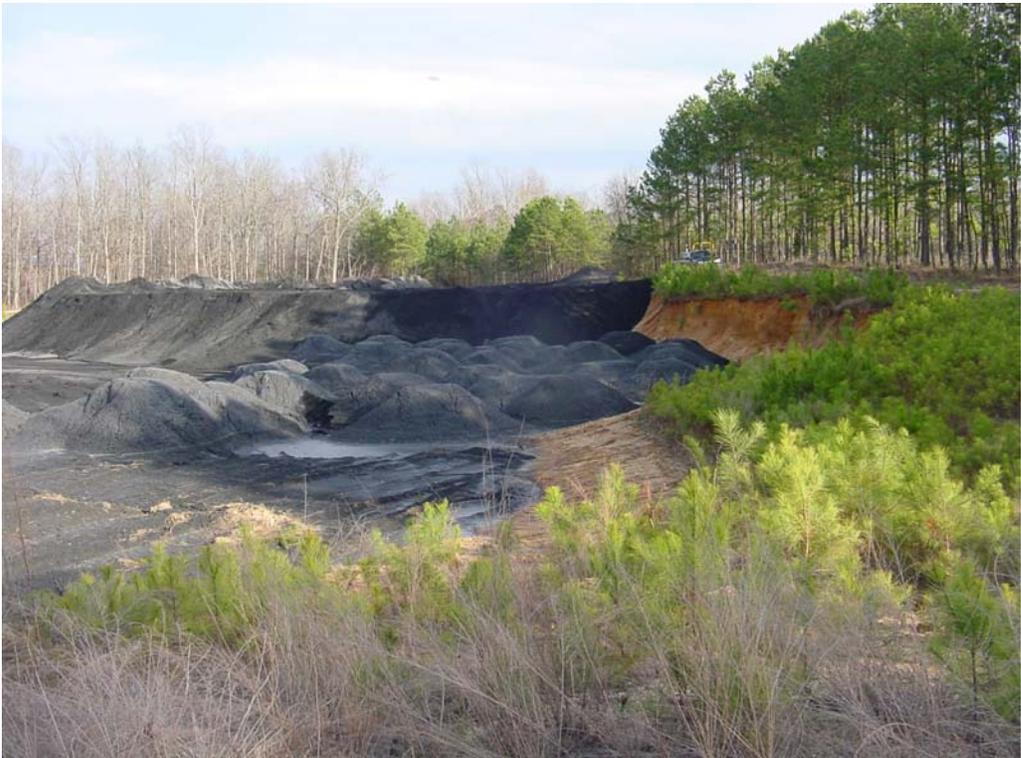
QA-4 Filling the southeast corner of the borrow site with structural fill. – 3/11/08

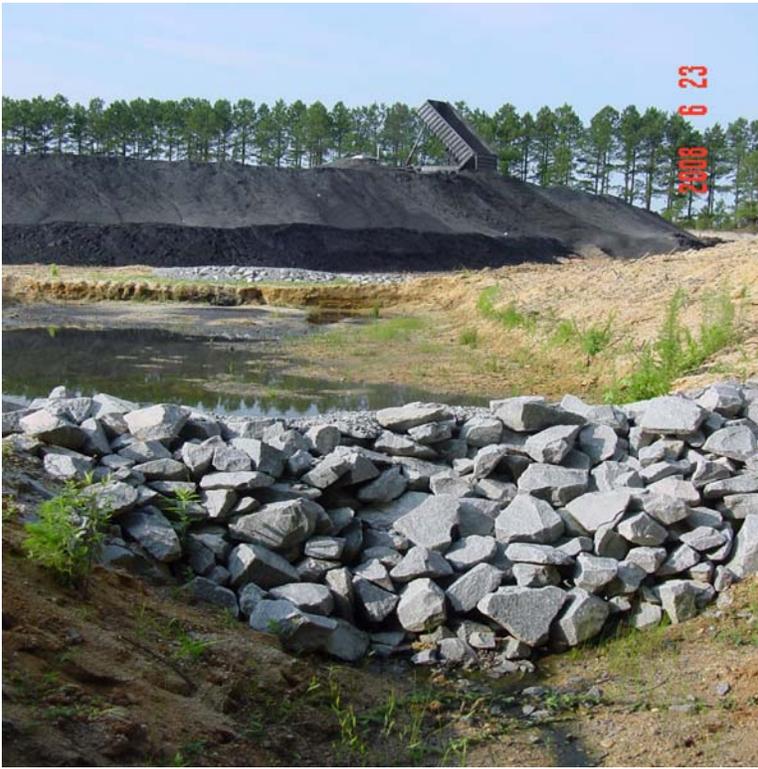
QA-5 Stormwater Stilling Basin and rock check dam at northwest corner – 6/23/08

The erosion control features were checked periodically throughout this project and especially during and after a major storm event. At times additional rock was added to the check dams and built-up sediment was removed from the channel and dams. During a storm event the drainage channels were checked to see if any water bearing sediment migrated off site. There was no visual evidence of the fill material migrating off site.

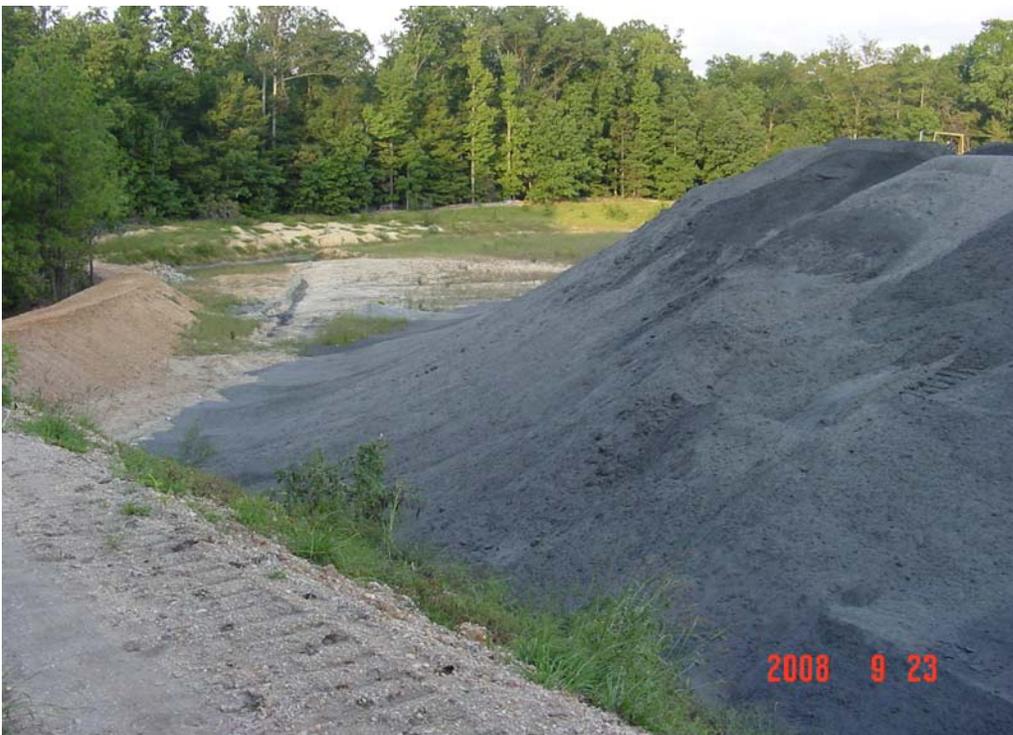
QA-6 Looking at the north end of the borrow site. – 9/23/08

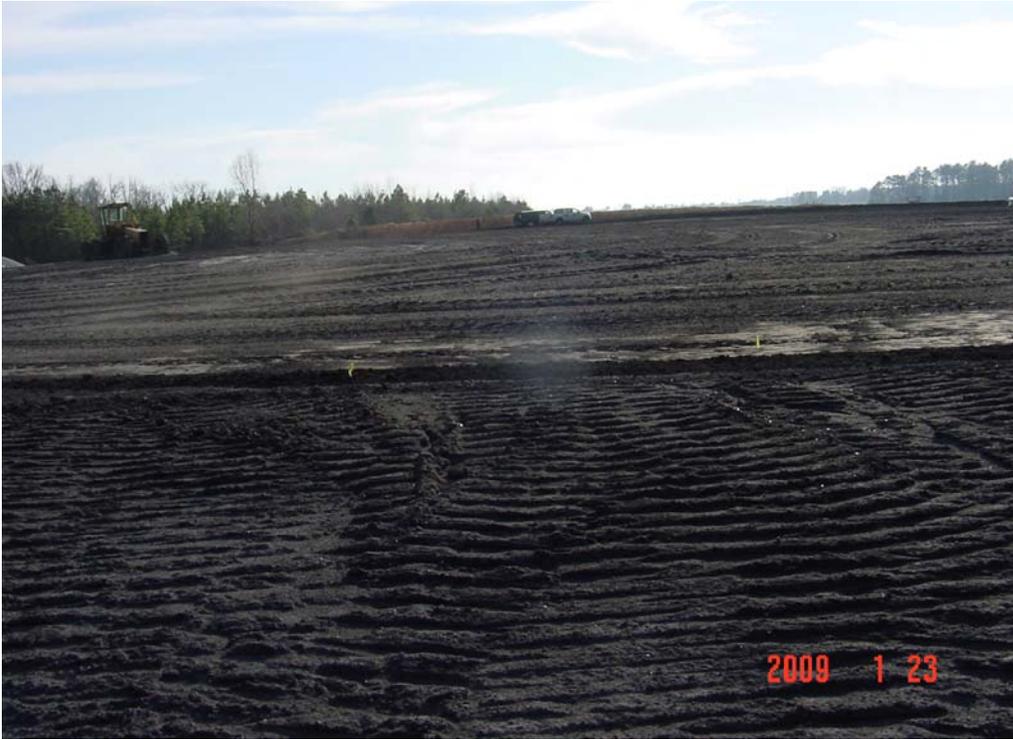
QA-7 Top of the structural fill material. (looking south) – 1/23/09

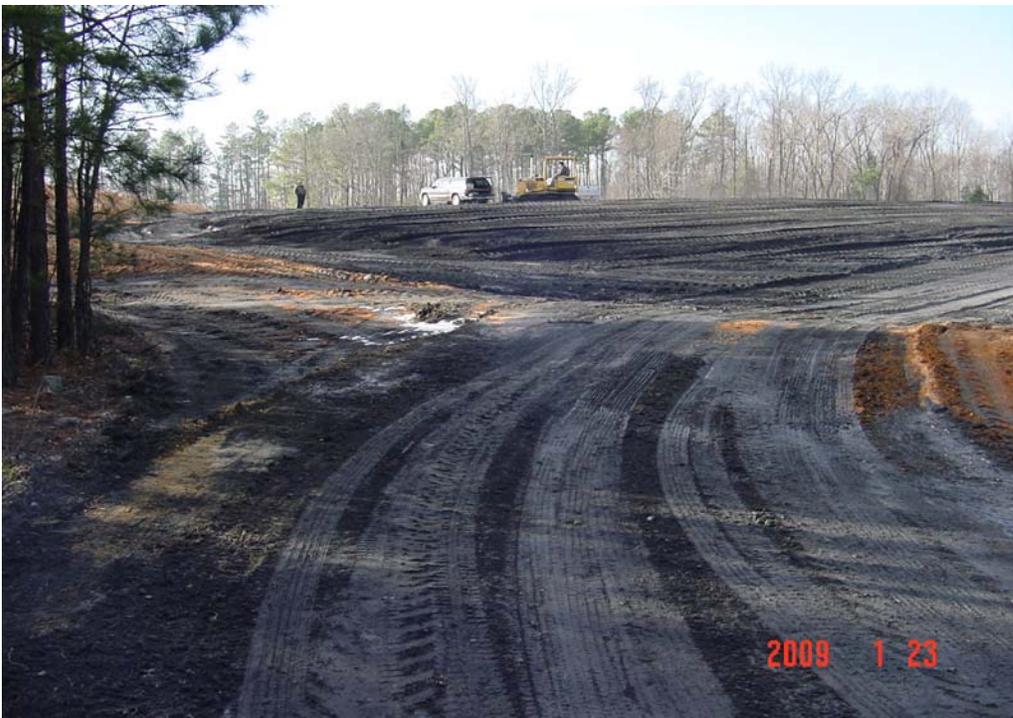
QA-8 Finalizing the grading of the structural fill. (looking northwest) – 1-23-09

The side slope was graded to a less than 4H:1V slope and the top of the fill material was graded at a 5% slope. These slopes comply with Section .1706 of the Rules intended to prevent ponding and infiltration, but at the same time being gentle enough to prevent erosion.

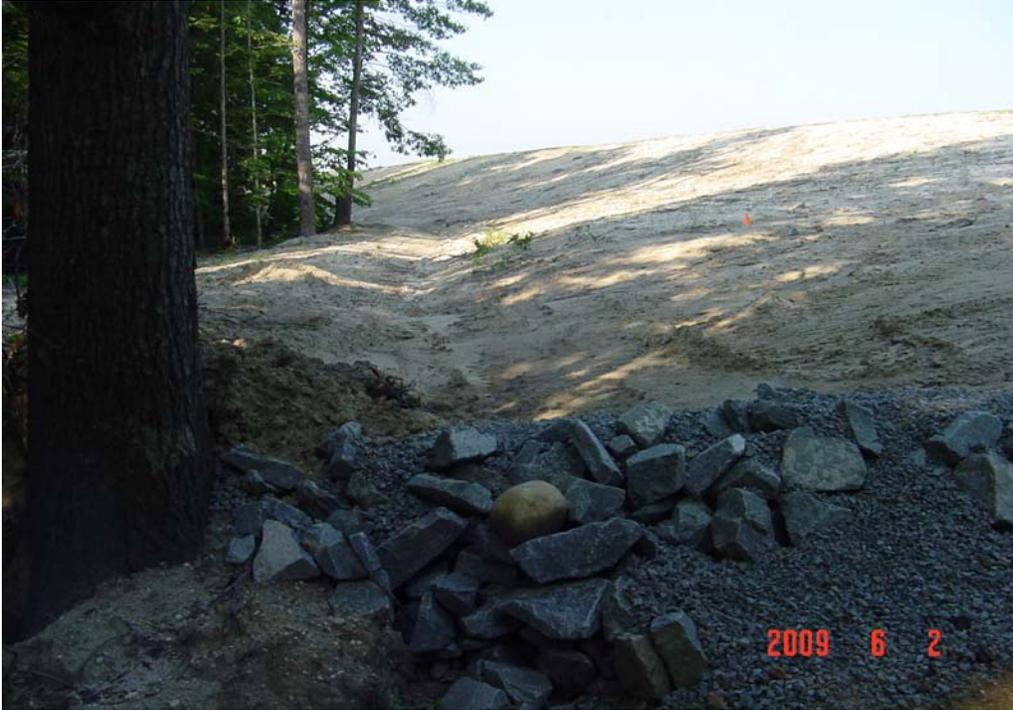
QA-9 Erosion control features on the east side of the borrow site. - 6/2/09

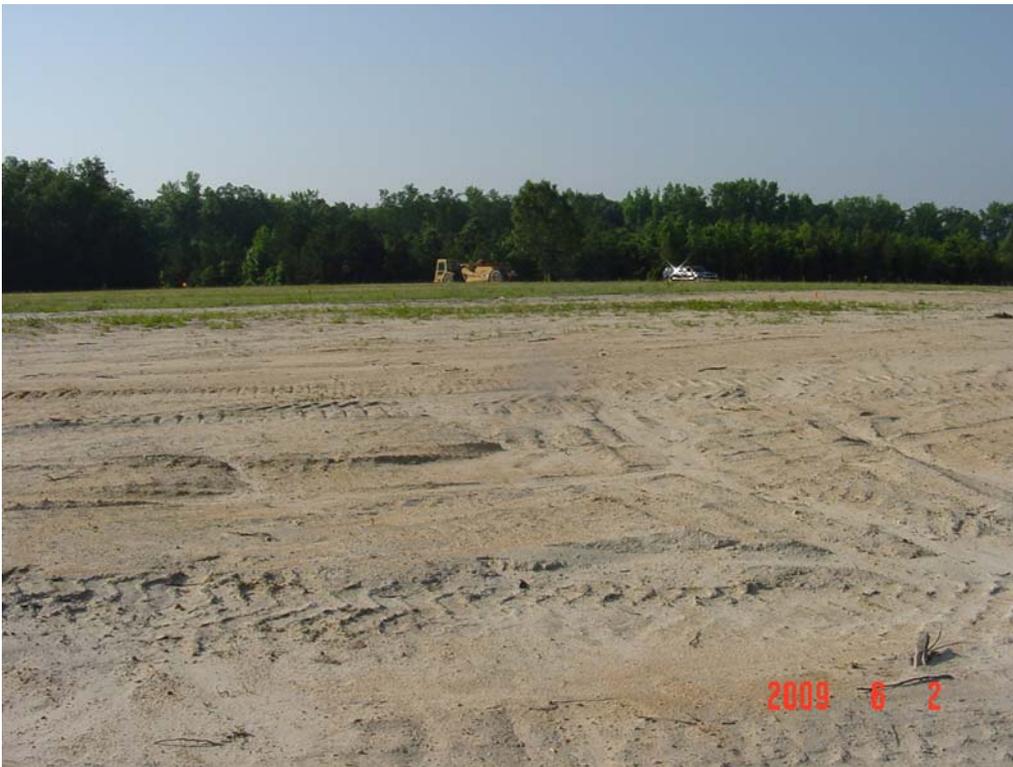
QA-10 Placement of cover material. (looking northwest) - 6/2/09

After the structural fill material reached final grades the area was covered with soil according to Section .1705 (j) of the North Carolina Solid Waste Management 15A NCAC 13B Rules. Twelve inches of cover soil, plus six inches of topsoil capable of supporting vegetation, was used to cap the structural fill material. Final cover placement was started within 30 working after the filling process has ceased.

While the cover material was being placed URS regularly probed the soil cover on a grid pattern to measure the cover material thickness. Cover soil thickness were field marked using flags. Not all areas where cover thickness were less than 18 inches in thickness were rechecked. The flags used as grade stakes were used by the contractor to control cover thickness. A map was created documenting URS's cover material thickness measurements (see Appendix D). After URS verified that the site was adequately cover with 18 inches of covered soil the Owner began liming, fertilizing and seeding. The site was seeded on June 23-25.

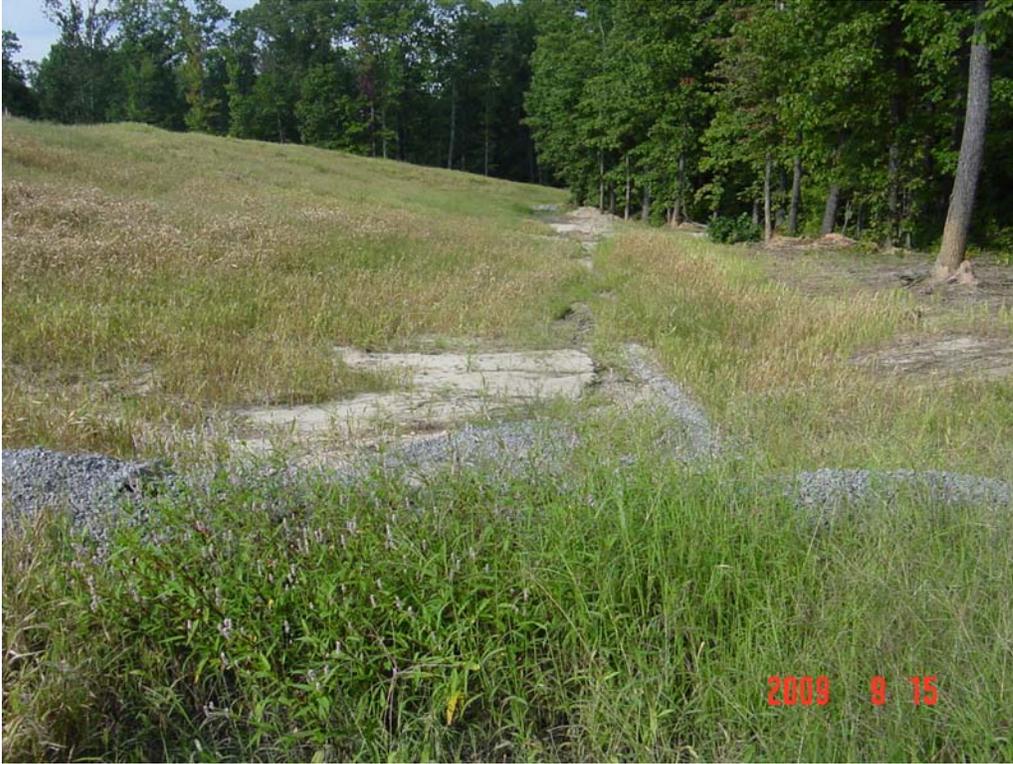
QA-11 Final cover with grass. (east ditch looking north) – 9/15/09

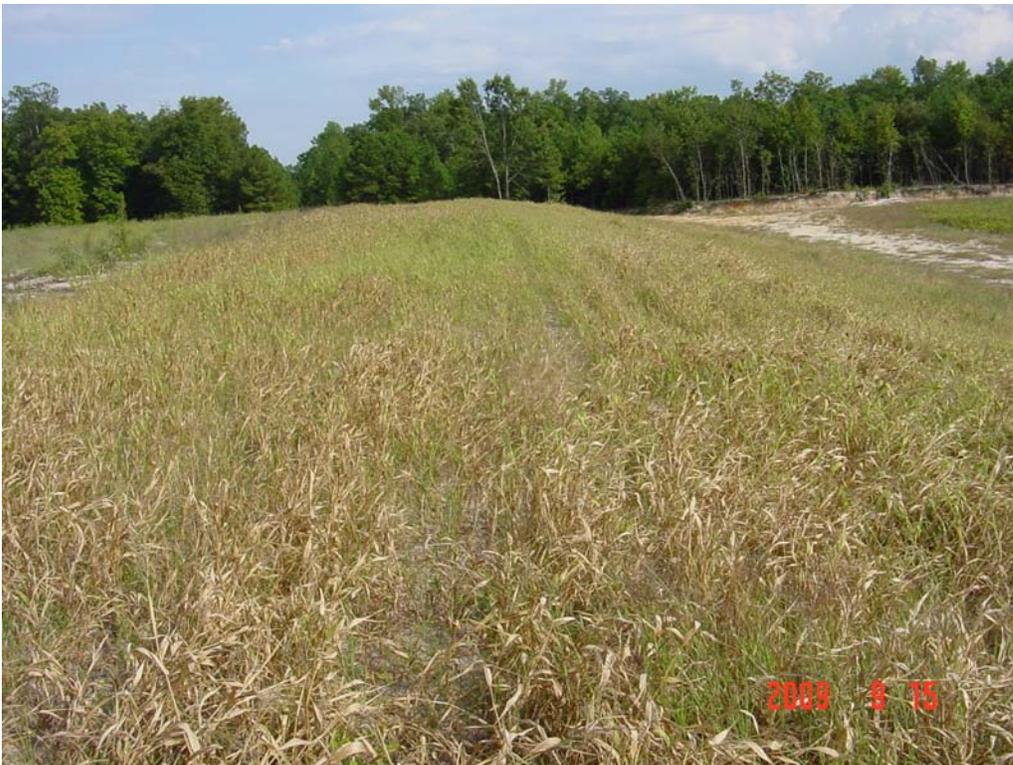
QA-12 Final cover with grass. (south slope looking east) - 9/15/09

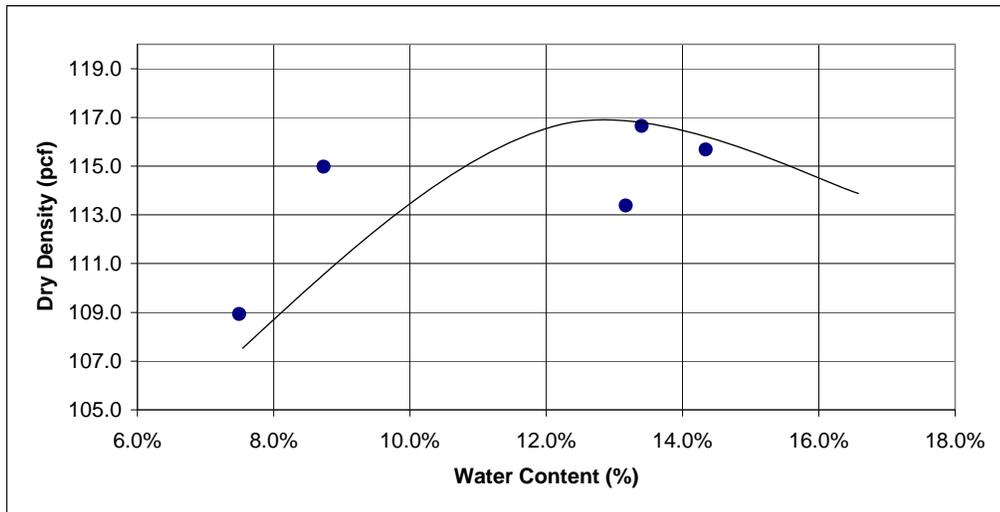
Project Name: ROVA Ash Structural Fill Boring No. _____
 Project Location: ON Vaughan on Hwy 301 Halifax, NC Sample No. _____
 Soil Description: Gravelly clayey fine to coarse sand (SC) Test Method ASTM D-698
 Tested By: RKL Layers/Blows 3layers/25blows
 Test Date: 2/22/2009 Mold Volume: 0.0334 cubic feet
 Project Number: 31826292

Max. Dry Density (pcf) = 116.6
 Optimum Water Content (%) = 13.4%

The structural fill was unloaded from the trucks in a controlled manner to prevent dust from becoming airborne. After the material was unloaded it was spread in approximately 24" thick lifts and compacted. URS personnel performed several standard Proctor tests (ASTM D 698), and the field density and moisture content tests (ASTM D 2937 & D 2216, respectively) on site. The test results indicated that the structural fill material was adequately compacted. A summary of the Proctor tests and the field moisture/density test results for the structural fill is presented in Appendix B and C, respectively.

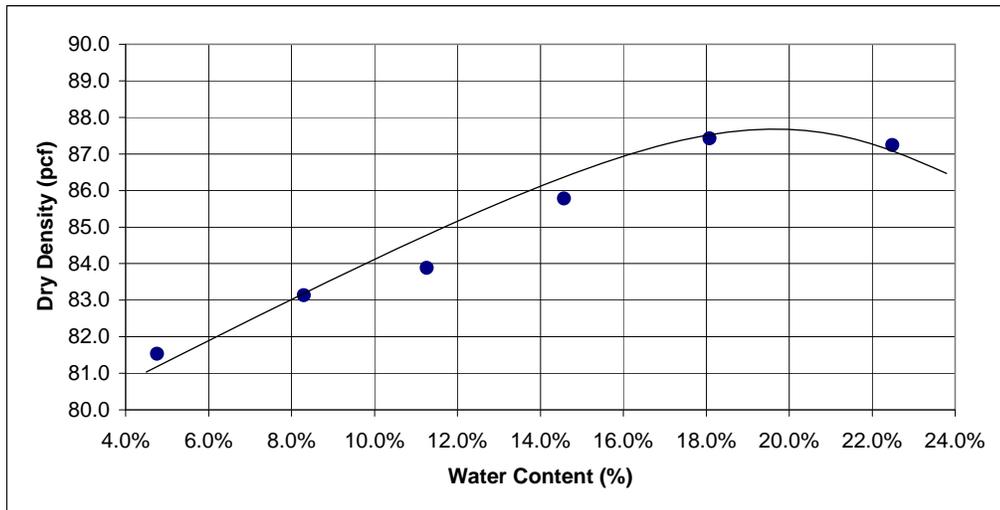
Project Name:	<u>ROVA Ash Structural Fill</u>	Boring No.	_____
Project Location:	<u>ON Vaughan on Hwy 301 Halifax, NC</u>	Sample No.	_____
Soil Description:	<u>Bottom Ash</u>	Test Method	<u>ASTM D-698</u>
Tested By:	<u>RKL</u>	Layers/Blows	<u>3layers/25blows</u>
Test Date:	<u>2/22/2009</u>	Mold Volume:	<u>0.0334</u> cubic feet
Project Number:	<u>31826292</u>

Max. Dry Density (pcf) = 87.4

Optimum Water Content (%) = 18.1%

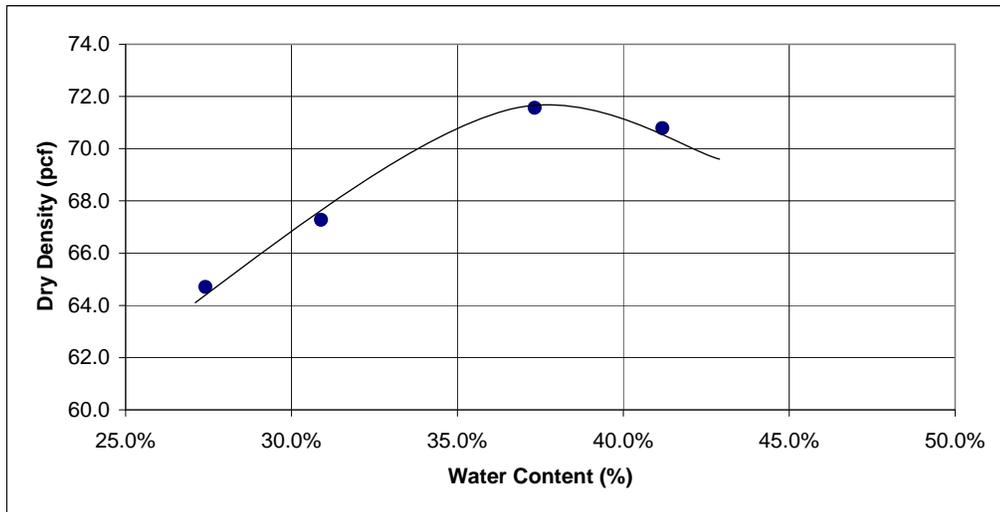
Project Name:	ROVA Ash Structural Fill	Boring No.	_____
Project Location:	ON Vaughan on Hwy 301 Halifax, NC	Sample No.	_____
Soil Description:	Flyash	Test Method	ASTM D-698
Tested By:	RKL	Layers/Blows	3layers/25blows
Test Date:	2/22/2009	Mold Volume:	0.0334 cubic feet
Project Number:	31826292

Max. Dry Density (pcf) = 71.6

Optimum Water Content (%) = 37.3%

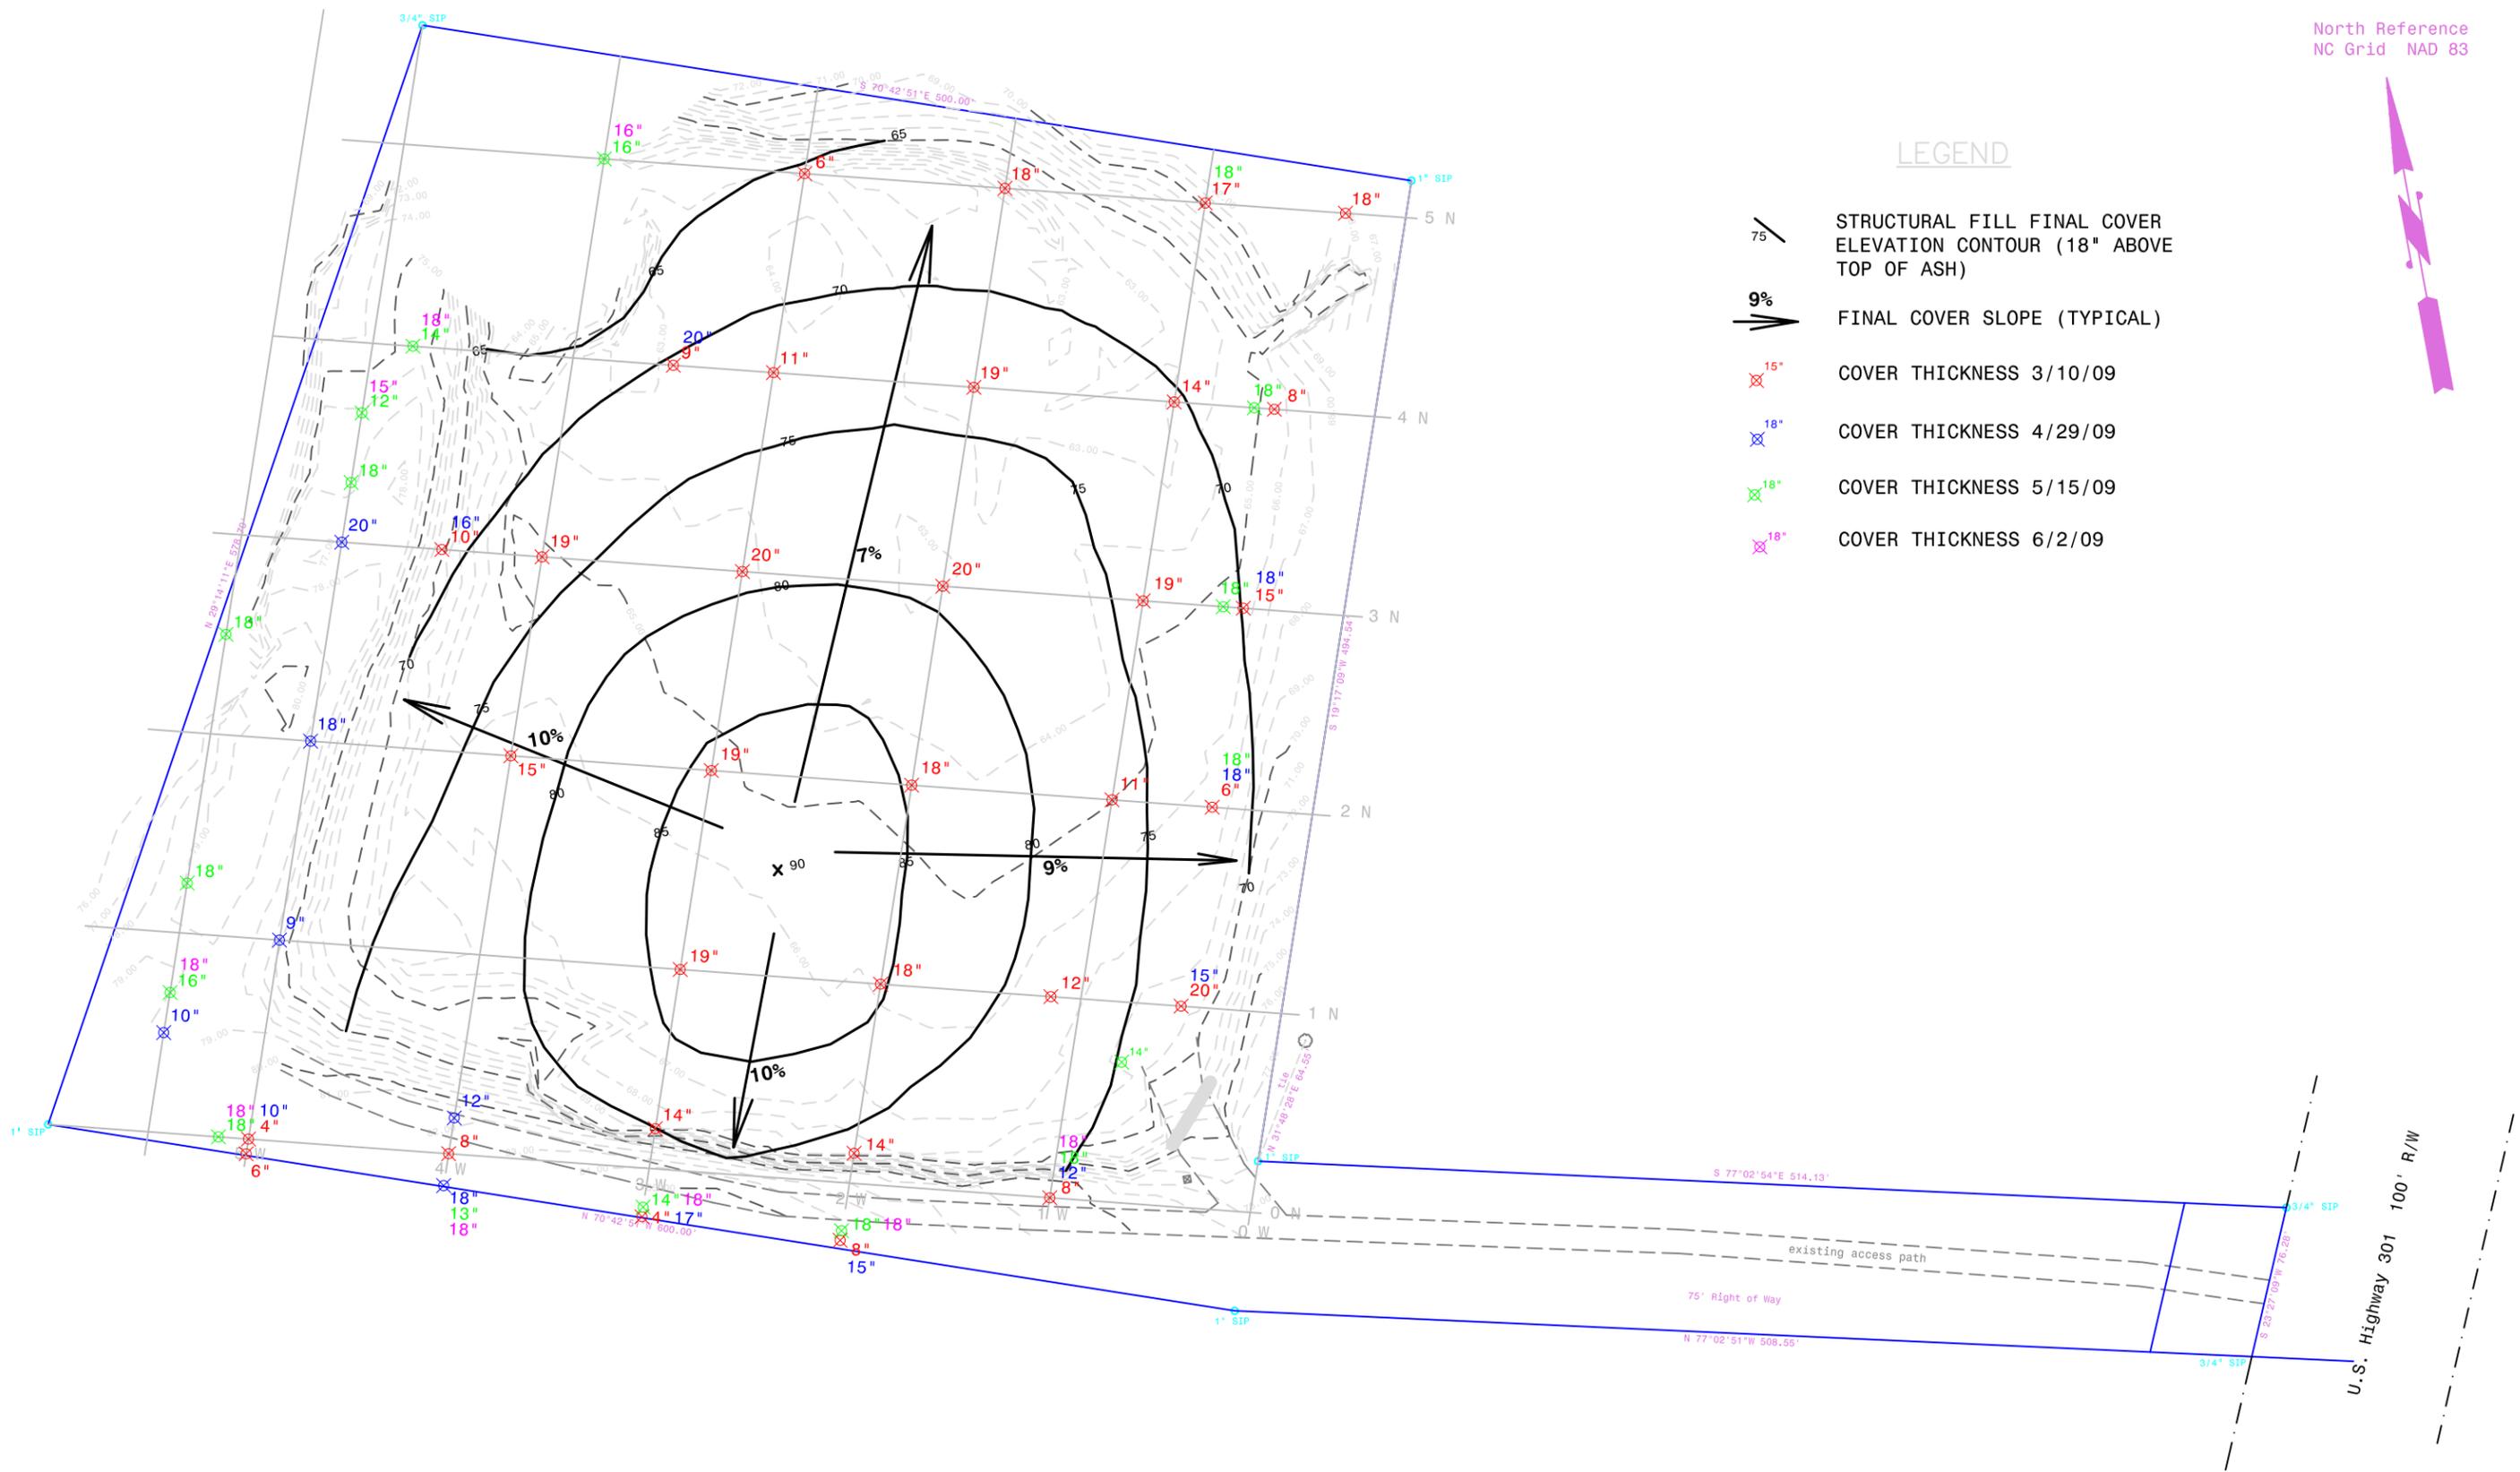
AS-BUILT DRAWING

ROANOKE VALLEY FLY ASH DISPOSAL SITE
OTIS N. VAUGHAN BORROW PIT, HALIFAX COUNTY, NC
