FACILITY COMPLIANCE INSPECTION REPORT
Division of Waste Management
Solid Waste Section

Coble's Sandrock, Inc. C&D Landfill
 5833 Foster Store Road
 Liberty, NC 27298

Comprehensive Audit

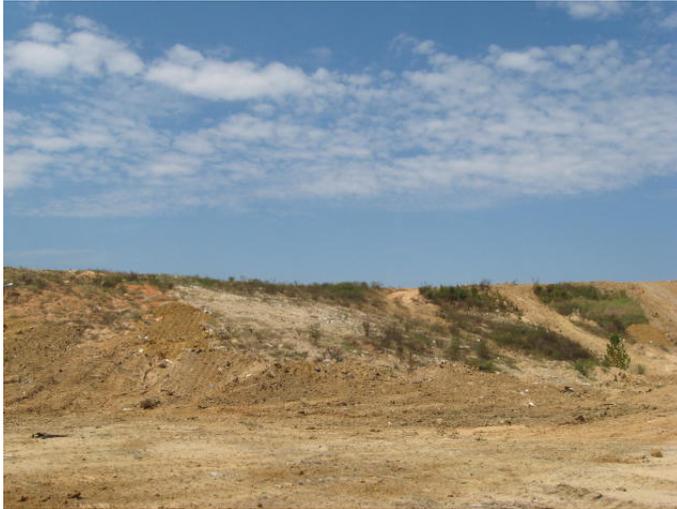
Southern external side slope of Phase 2A in need of
Appropriate grade and vegetative cover

25. Ensure that the hauler, not the facility, fills out the certification form on site per the shingle recycling operations plan.
26. The southern external side slope of Phases 1A and 2B, that had been recently worked, shall be graded such that water is not held and vegetative groundcover established. Mr. Coble stated that he will need ~ 1 week, once able to commence finalization of the repair, to grade appropriately and sow with grass seed.

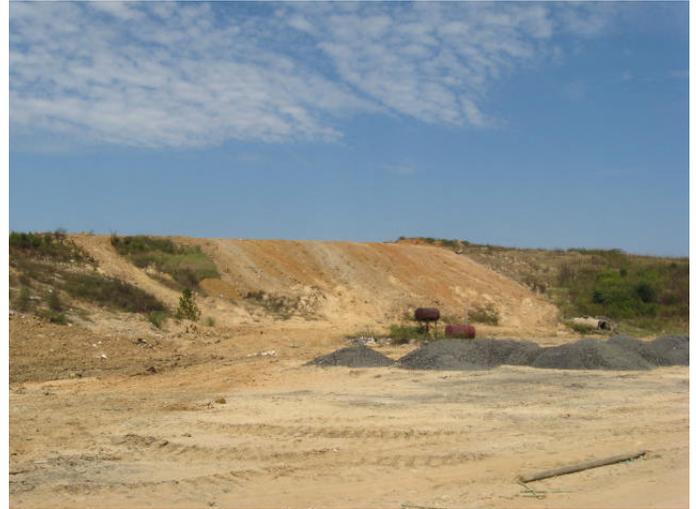
Southern external side slope of Phase 1A in need of
appropriate vegetative cover

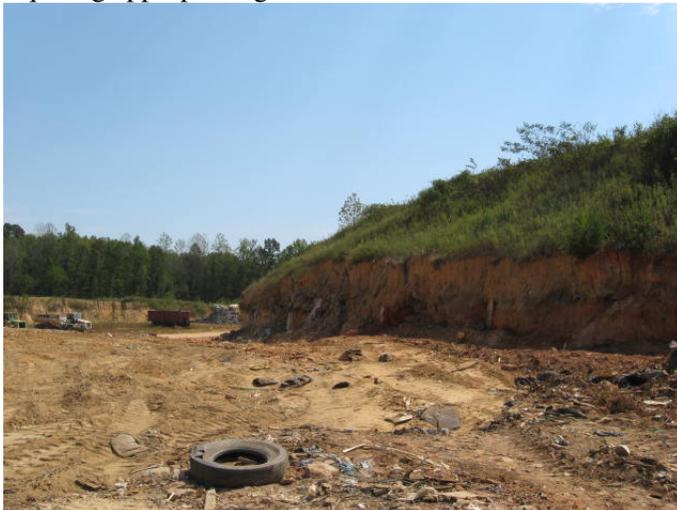
Eastern external side slope of Phase 1A vertical cut
requiring appropriate grade and cover material

27. The eastern and northern external side slope of Phase 1A that have been cut vertically shall be graded such that no indication of erosion or runoff is observed. Waste material protruding from the vertical cuts shall be covered with a minimum of six inches of soil.

29. Mr. Coble stated that at a minimum he would need ~ 20 days to spread out all the material needed to be moved, cover, and grade appropriately. And that he would need an additional 30 days to grade accordingly (to ensure proper slope and soil cover atop solid waste) the vertical cuts in the external side slope of Phase 1A.

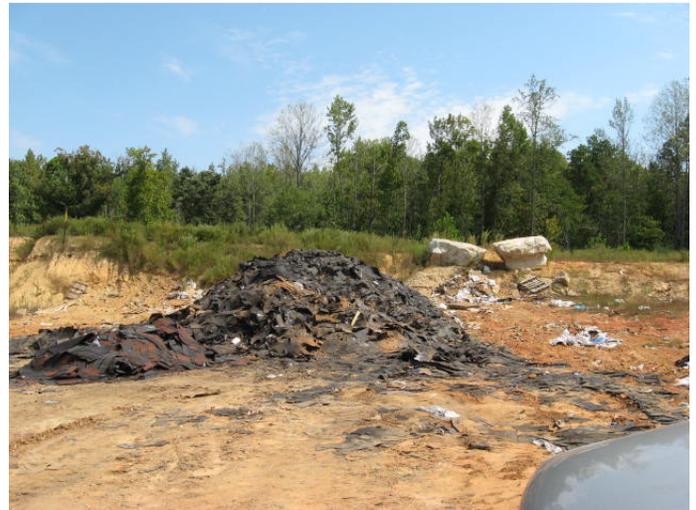
Asphalt single recycling storage requiring a sign, barrier,
and container for de minimis waste

24. Per the shingle recycling operations plan, the facility shall ensure that a sign is posted in the area the singles are stored, barriers are placed around the stored shingles, and de minimis waste sorted from the shingles be placed in a container.

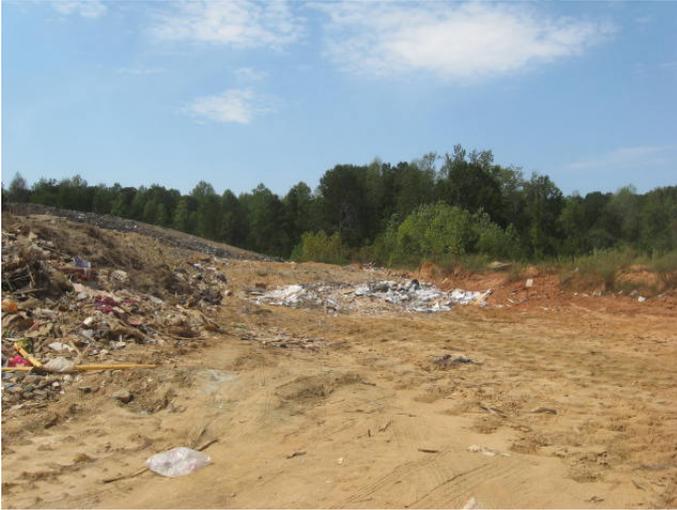
28. The facility had an area of uncovered waste equivalent to ~ 1 acre. Mr. Coble stated that he has been moving material from atop Phases 1A and 2B, which needs to be moved due to exceedance of landfill capacity in the phases. Material is being moved to the northern area of Phase 3A. Mr. Coble stated that he has been moving ~ 1 acre of material at a time in order that he could spread it out accordingly, cover, and grade at one time. And considering an acre of waste not graded appropriately would require numerous applications of cover material and increased cost, has not been applying a soil cover.

Northern section of Phase 3A: working face, lower level and acre of uncovered relocated solid waste, upper level

The facility is in violation of 15A NCAC 13B .0542(f)(1) in that solid waste being relocated from adjacent Phases 1A and 2B into Phase 3A is an acre in size and has not been covered with soil. The facility shall ensure that solid waste is covered with six inches of soil when the waste disposal area exceeds on-half acre and at least once weekly. The facility shall comply with the aforementioned within 30 days of receipt of the accompanying Warning Letter.

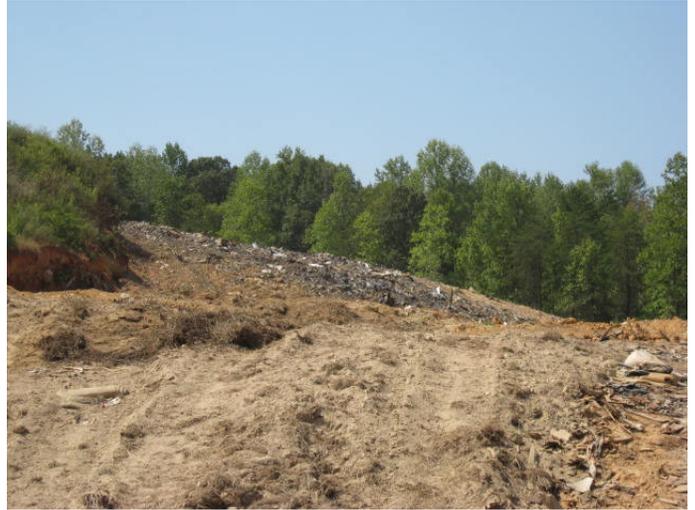
Northern section of Phase 3A: acre of uncovered relocated solid waste

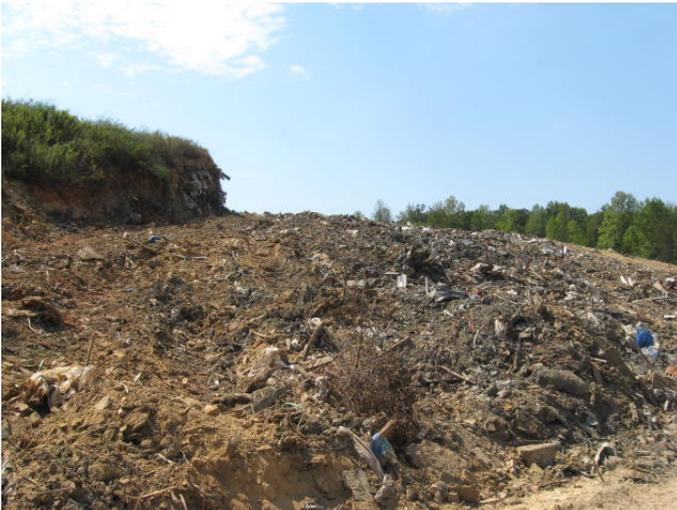
Northern section of Phase 3A: close view of acre of uncovered relocated solid waste

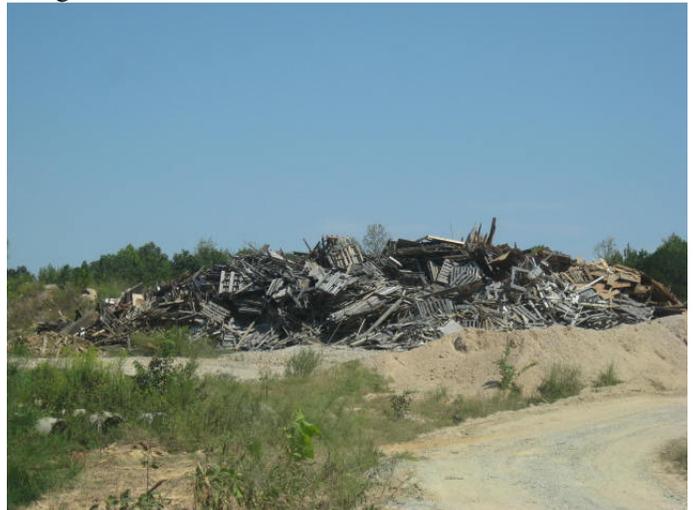
21. Mr. Coble stated that the facility grinds stored pallets and clean wood for mulch and boiler fuel and it grinds engineered wood for boiler fuel only. And that the facility has conducted the grinding operation for ~ 10 years. During the audit there was a large pile of pallets and clean wood. No mulch was observed on site. When the facility permit is updated this operation should be included.

Prior to landfill area: stored pallets and clean wood to be ground
