FACILITY COMPLIANCE AUDIT REPORT

Division of Waste Management Solid Waste Section

Avery Co. Transfer Station
 Brushy Creek Rd. (SR-1101)
 Ingalls, NC

Comprehensive Audit

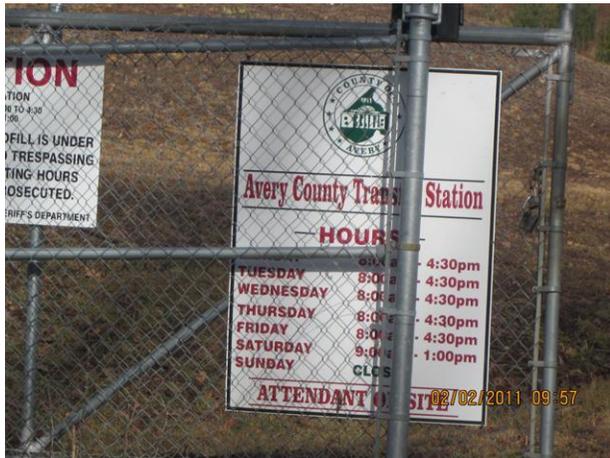
2. Proper signage displayed at the entrance to the facility. (photos #1 & #2)

1. Hours of operation sign at entrance to the facility.

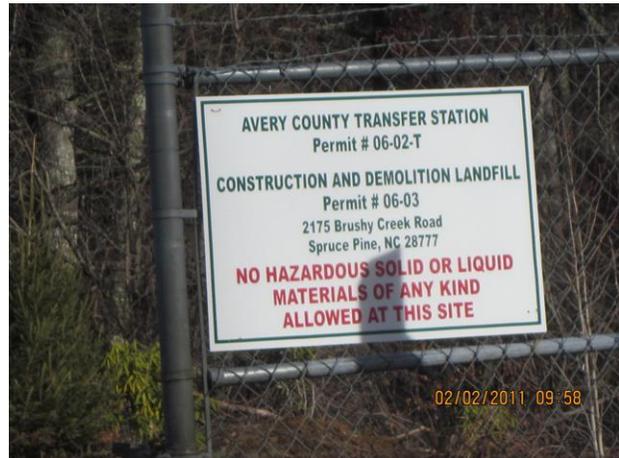
2. Prohibited materials and permit numbers sign at entrance to facilities.

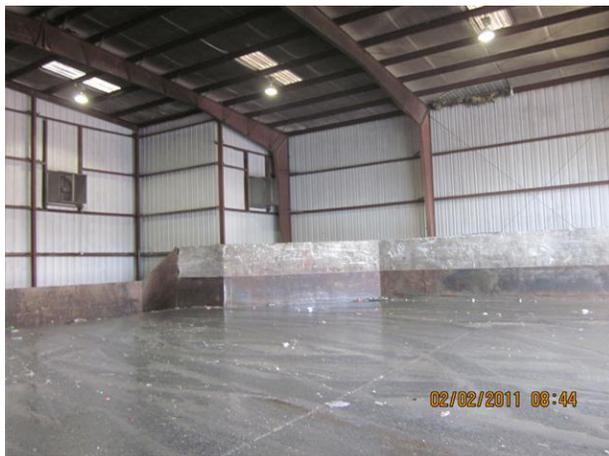
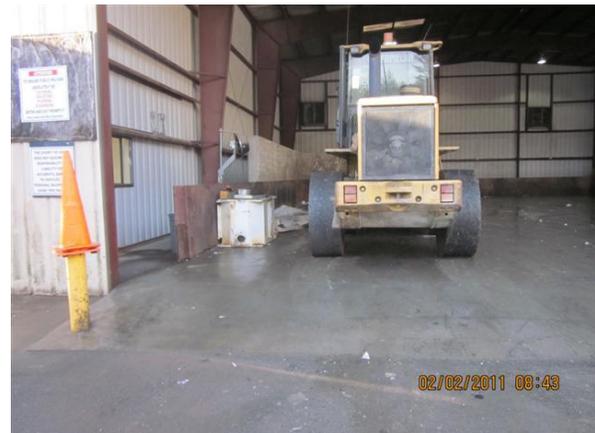
3. The tipping floor was free of debris and very clean. (Photos #3 & #4)

3. Tipping floor and interior walls of the transfer station were very clean and well maintained.

4. Looking into the transfer station. Front-end loader used to push waste into the receiving bay. Note the clean tipping floor and clean interior walls.

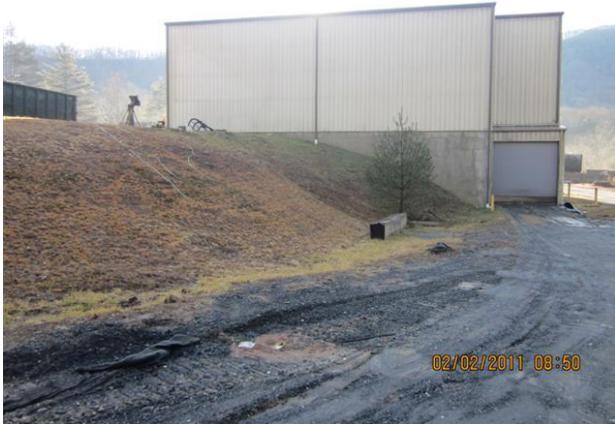
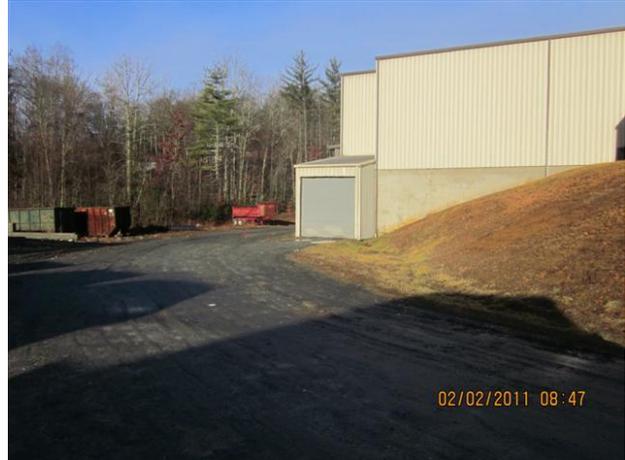
5. Looking at the exterior (W) side of the transfer station.

6. Looking at the exterior (E) side of the transfer station.

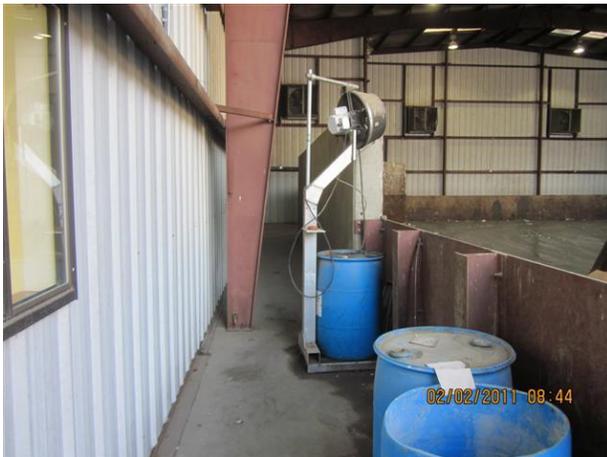
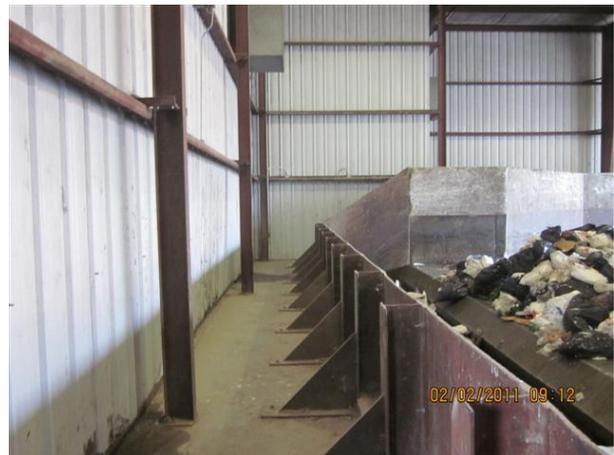
7. Area behind the (S) push wall. (Receiving bay and tipping floor are on the right.)

8. Area behind the (W) push wall. (Transfer trailer partially filled with waste on the right.)

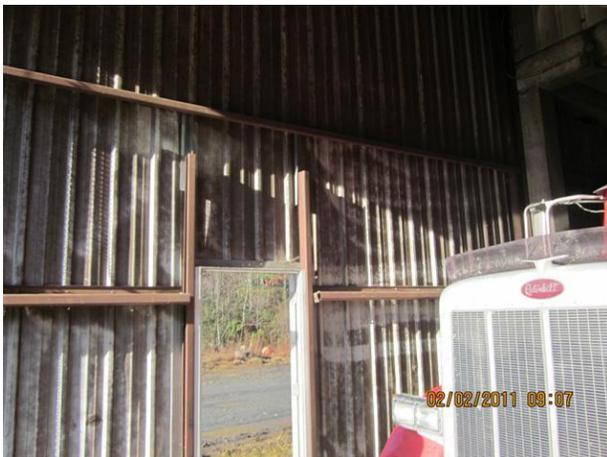
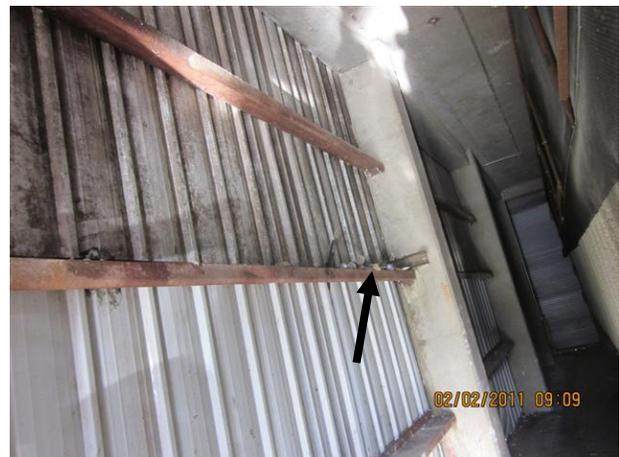
9. Interior back wall at the (S) end of the receiving bay in need of cleaning. (Transfer truck on the right.)

10. Interior back wall of the receiving bay - upper sections in need of cleaning. (Note the debris caught on the horizontal support beam.)

8. **The receiving bay walls are dirty and must be washed down. The receiving bay, (the horizontal cross beams in particular) must be kept clean and free of debris.** (Photos #9 and #10)

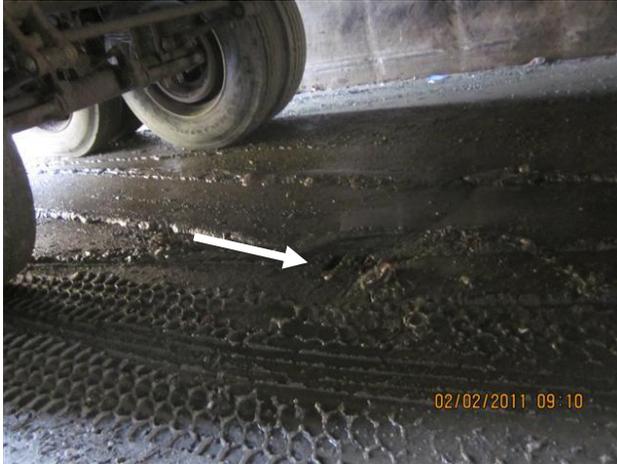
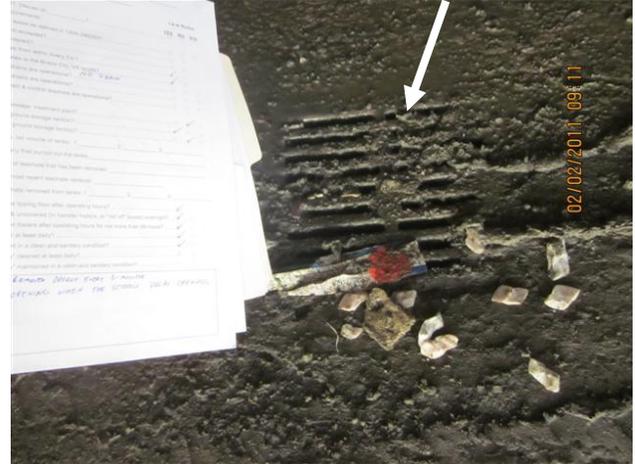
9. There are two floor drains in the receiving bay that feed one underground storage tank located behind the transfer station. Both of these drains were partially restricted with mud. (Photos #11 & #12) **The drains should be regularly checked to ensure that it is clear of any debris and is working properly.**

11. Floor drain in the (N) end of the receiving bay – restricted with mud and debris.

12. Floor drain in the (S) end of the receiving bay – restricted with mud and debris. (Note book paper on left for scale.)

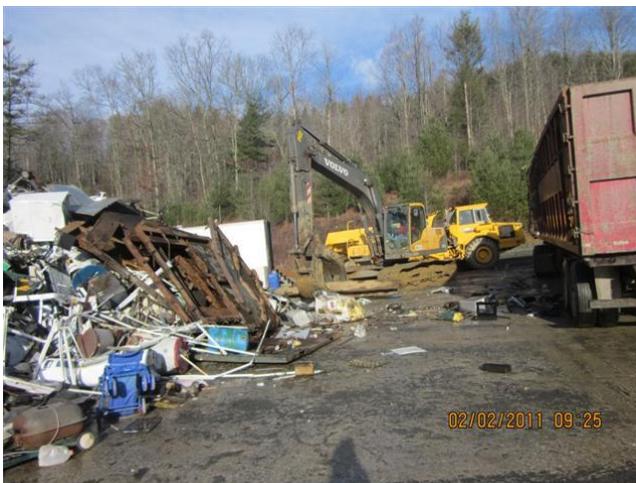
13. Scrap metal being loaded into transfer trailer for recycling.

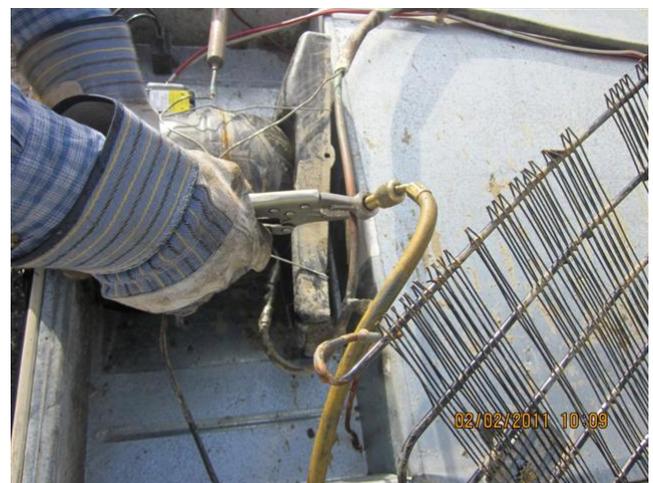
14. Technician puncturing gas line in order to recover the CFCs (refrigeration gas) from a refrigerator.
