FACILITY COMPLIANCE AUDIT REPORT

Division of Waste Management Solid Waste Section

Date of Audit: 5/18/11

Avery Co. Transfer Station
 Brushy Creek Rd. (SR-1101)
 Ingalls, NC

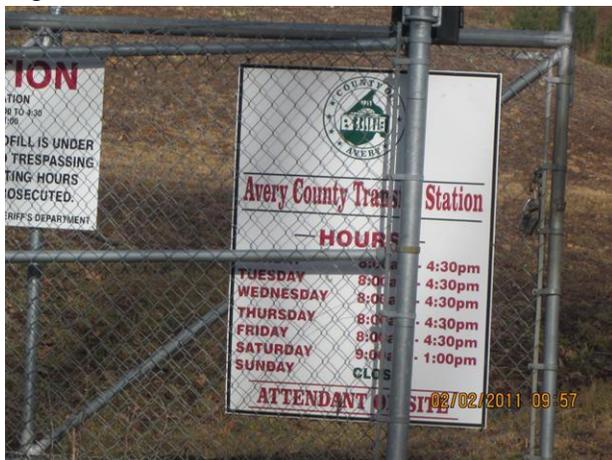
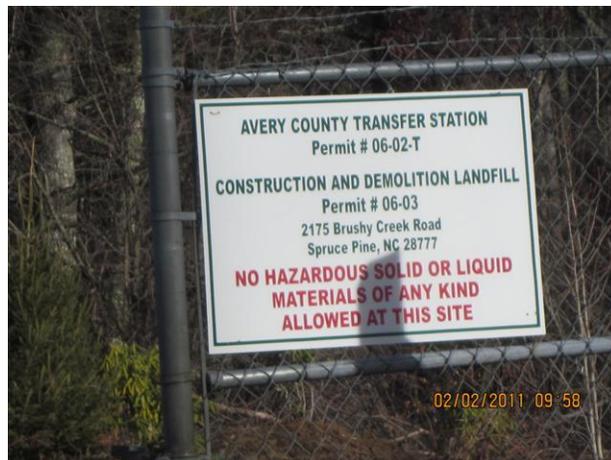
3. Proper signage is displayed at the entrance to the facility. (photos #1 & #2)

1. Hours of operation sign at entrance to the facility.
2. Prohibited materials and permit numbers sign at entrance to facilities.
4. Approximately 1/3 of the tipping floor was covered with municipal solid waste. (Photos #3 & #4) The transfer station owns four waste transfer trailers, two of which were being repaired at the time of the audit. Due to this temporary shortage of transfer trailers, there was more waste on the tipping floor than usual.

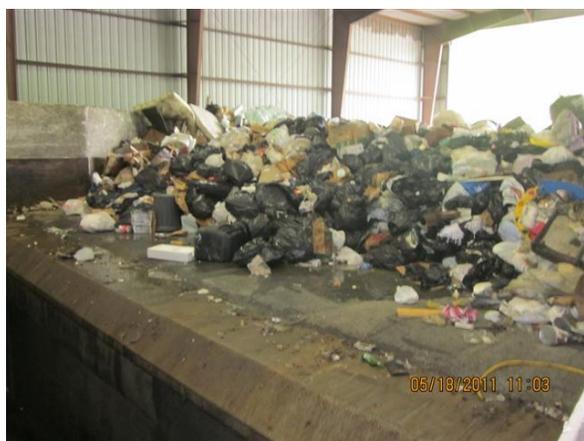
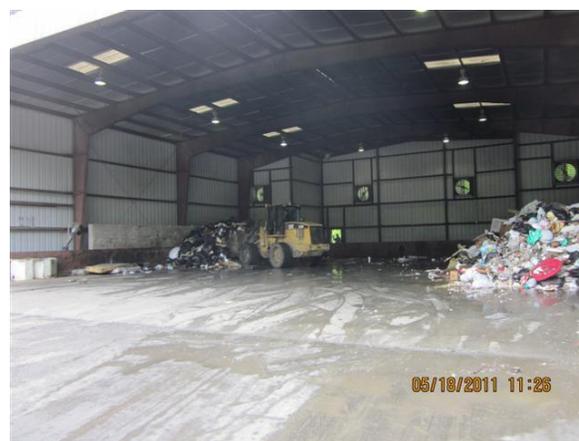
3. Looking across the top of the receiving bay at waste on the tipping floor.
4. Looking into the transfer station. Front-end loader used to push waste into the receiving bay

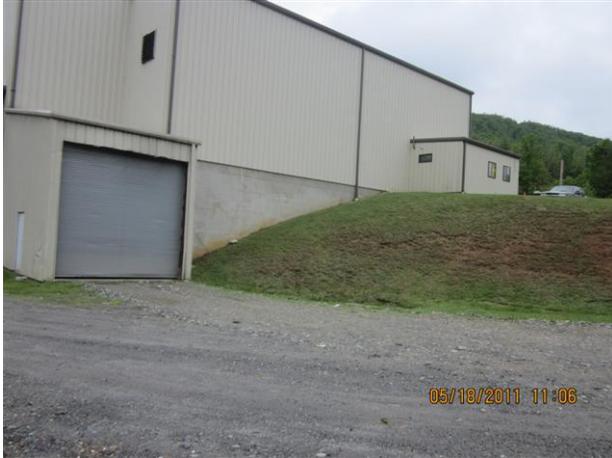
7. The area around the transfer station was very clean and free of windblown litter. (Photos #5 & #6)
8. There is no trench or floor drains of any type to collect and control any leachate or water on the tipping floor. A front-end loader with a flexible lip on the front bucket is used to push any liquids into the transfer trailer receiving bay which has two floor drains that feed one underground storage tank. (Photos #9 & #10)

5. Looking at the exterior (W) side of the transfer station.

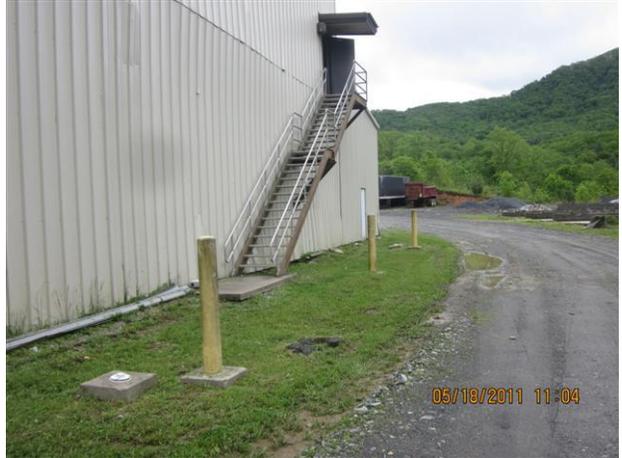
6. Looking at the exterior (E) side of the transfer station.

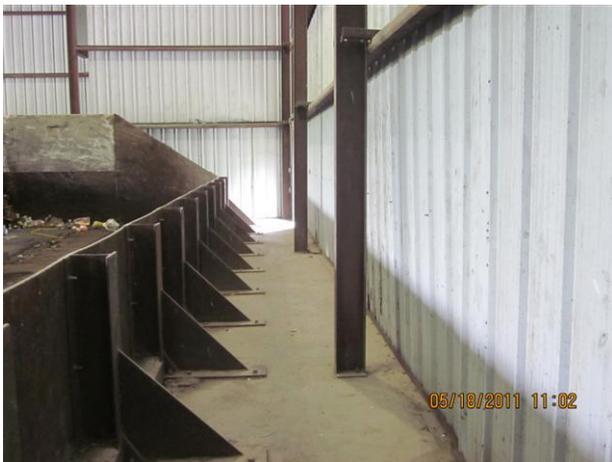
9. The areas behind all of the push walls in the transfer station were clean and free of debris. (Photos #7 & #8)
10. With the exception of small amounts of waste on the horizontal cross beams that support the back wall of the receiving bay, the walls and floor of the receiving bay were clean and well maintained.

7. Area behind the back (W) push wall.
(Receiving bay and tipping floor are on the left.)

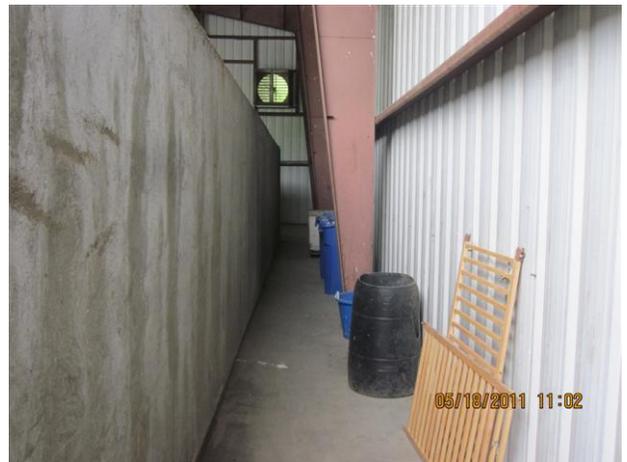
8. Area behind the (N) push wall. (Tipping floor is to the left.)

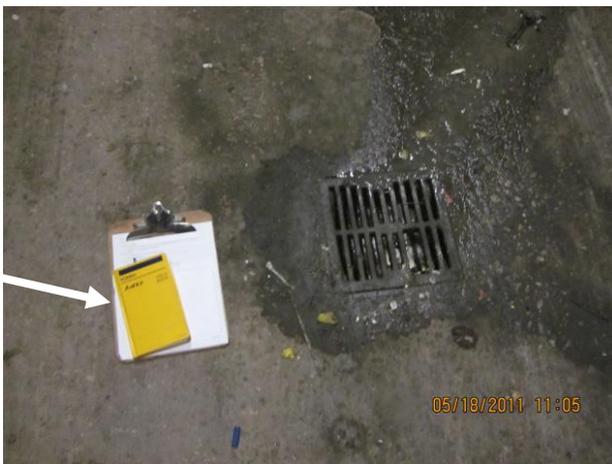
9. Floor drain at the (S) end of the receiving bay.
(Clipboard & yellow field book for scale.)

11. There are two floor drains in the receiving bay that feed one underground storage tank located behind the transfer station. Both of these drains appeared to be relatively free of debris and functioning properly. (Photos #9 & #10)
12. **Leachate management records were reviewed. The leachate holding tank is pumped out approximately once a month as needed, and the leachate is taken to the Boone wastewater treatment plant for final disposal.**
13. State Line Scrap Metal Inc. of Gastonia, NC collects scrap metal and white goods for recycling. State Line also recovers CFCs (refrigeration gas) on-site for recycling. (Photos #13)

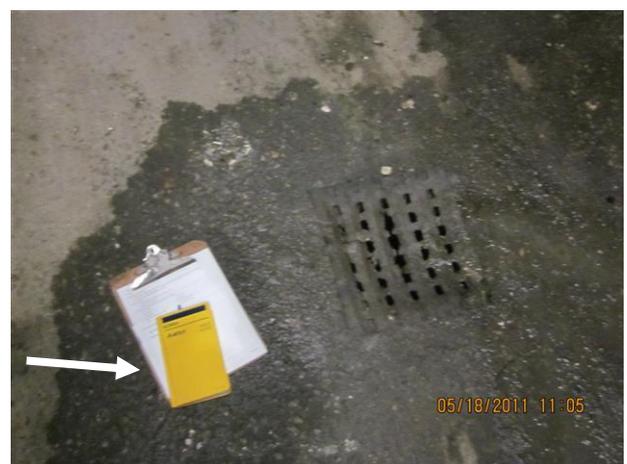
10. Floor drain at the (N) end of the receiving bay.
(Clipboard & yellow field book for scale.)

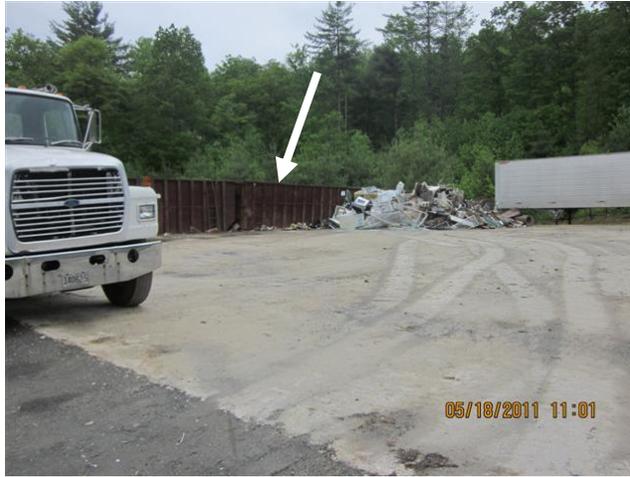
13. Looking (NW) across the scrap metal staging area. (Note the brown roll-off boxes used as "push walls".)

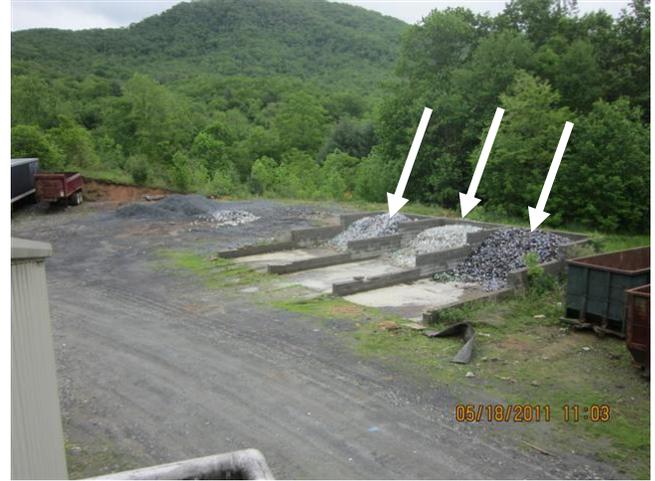
14. Looking down from the transfer station at the three recycling "bins" for green, clear, and brown glass.
