FACILITY COMPLIANCE AUDIT REPORT

Date of Audit: 07/06/11

Avery Co. C&D Landfill
2175 Brushy Creek Rd. (SR-1011)

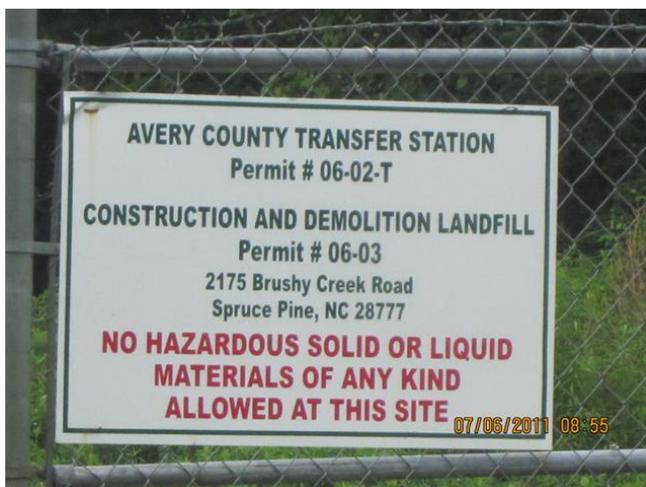
3. The C&D landfill is averaging approximately 300-tons of waste per month.
4. Tipping fee for C&D wastes is currently \$45 per ton.
5. Proper signage is displayed at the front gate. (Photo #1)

1. Signage at the front gate.

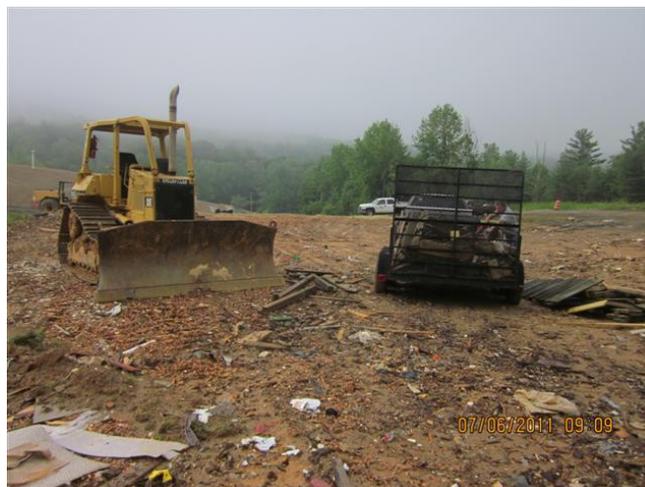
6. The facility was receiving waste during the audit. (Photos #2)
7. Phase 3 is in operation. The working face was small and well maintained. (Photos #2 & #4)

2. Looking (S) at the working face.

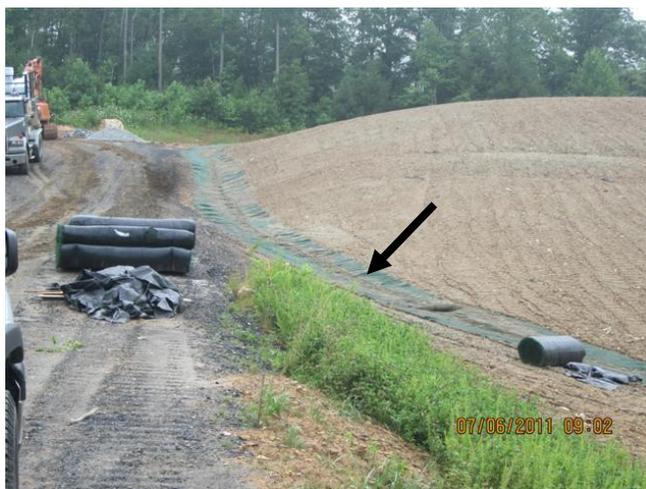
9. The access roads that cuts though the lower (southern) portion of the landfill from east to west, and is used to access the working face, is muddy but passable. (Photo #3.)

3. Looking (E) down the (S) side of the access road. Phase 2 is on the right. (Note the matting placed in the storm water diversion ditch on the right side of the road.)

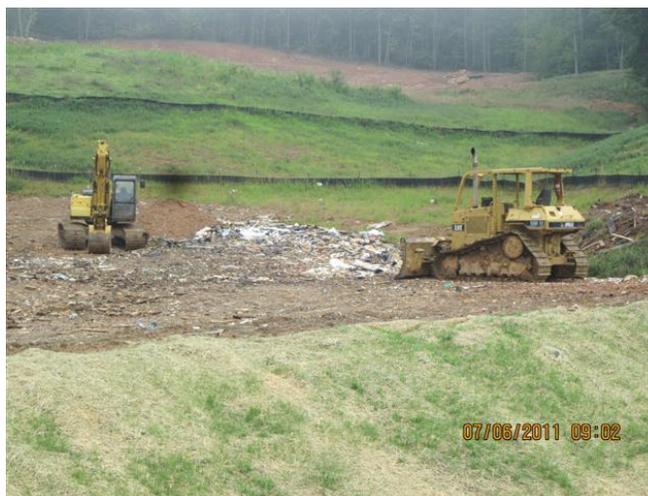
4. Looking (N) from the access road at the working face in Phase 3.

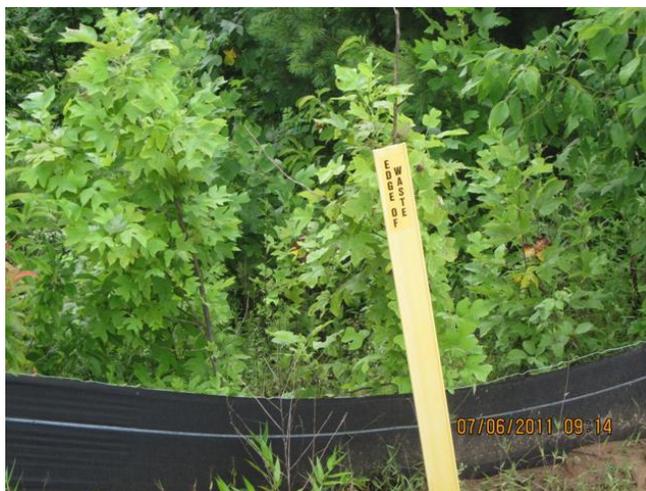
5. Permanent edge-of-waste marker on the (E) edge of Phase 1.

10. "Edge of Waste" markers are in place and well maintained. (Photos #5 & #6)

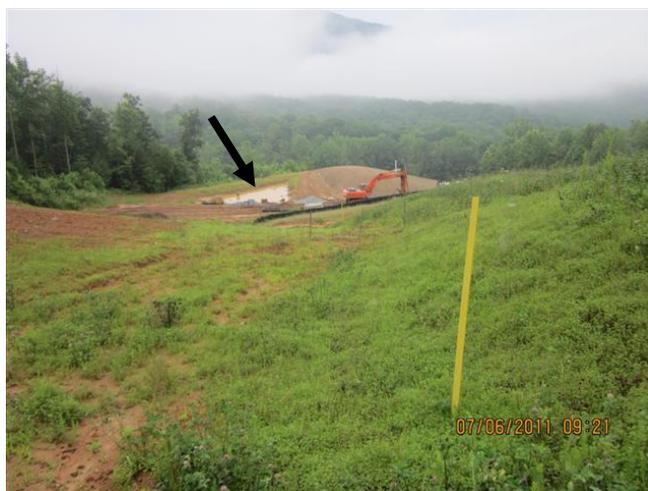
6. Looking (S) from upper reaches of Phase 2 at yellow edge-of-waste marker on the right. (Sediment basin #3 is in the background.)

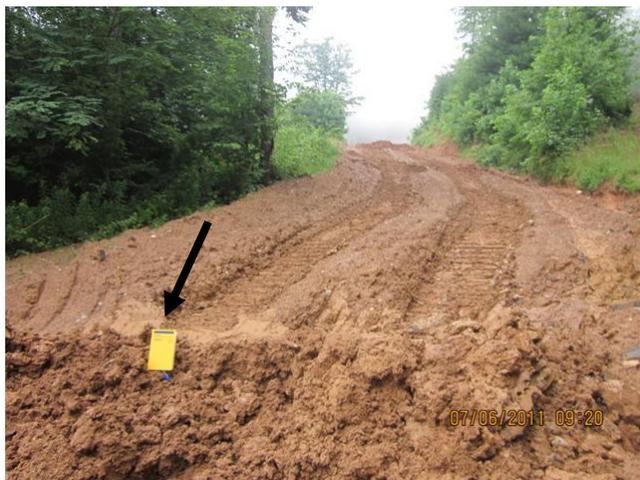
11. The access road running north and south, east side of Phase 2, is not passable. Several surface water diversion berms have been cut across this section of the access road. (Photos #7 & #8). **The access road must be properly maintained and passable at all times.**

7. Looking (N) up the access road located (E) of Phase 2. Note the yellow field book (for scale) resting on top of one of several surface water diversion berms that have been cut across the road.

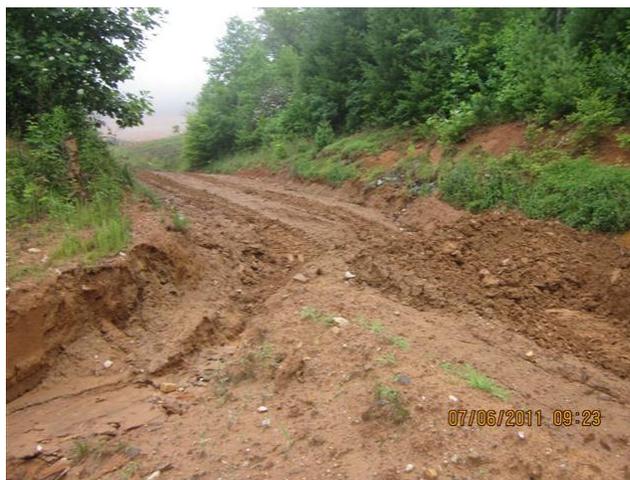
8. Looking (N) from the base of the access road located (E) of Phase 2.

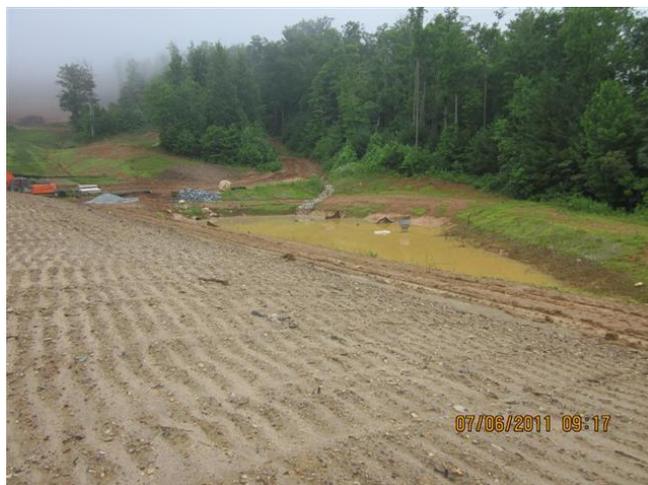
9. Looking (NE) from the southern section of Phase 2 at Sediment Basin 3. (Note the complete lack of vegetative cover or any type of erosion control material on this section of Phase 2.)

14. **Vegetative cover (or other approved erosion control measures) must be established on the lower section of Phase 2 (the area south of the central access road).** (Photos #9 & 10)

15. **The storm water control devices (sediment ponds, skimmers, storm water control ditches, etc.) are in need of repair. (Photos #9 - #12) Sediment basins need dredging; silt and debris need to be cleared from drop inlets and from overflow standpipes; skimmers in the sediment basins need to be repaired; burlap “baffles” in the sediment basins need to be repaired and silt needs to be removed from storm water diversion ditches.**

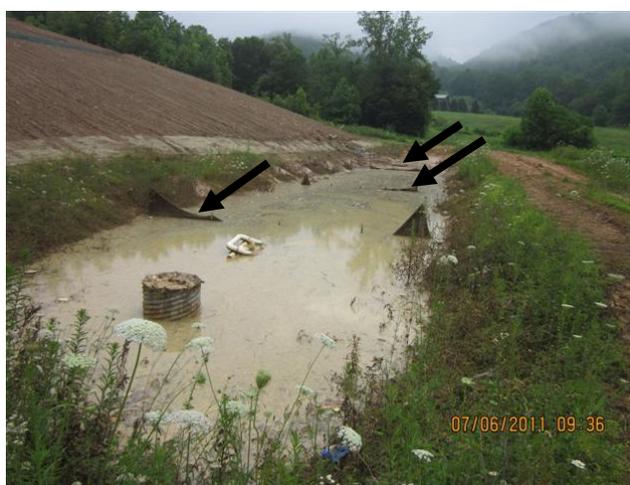
10. Looking (E) across Sediment Basin #4 located at the foot of the landfill. (Note the damaged burlap baffles.) The foot of Phase 2 is to the left of the sediment basin.

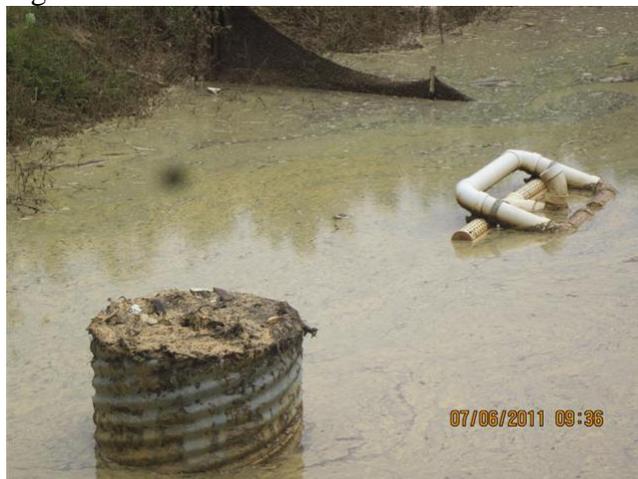
11. Sediment Basin #4: Damaged “skimmer” (on the right) and “overflow” standpipe filled with debris (on the left).

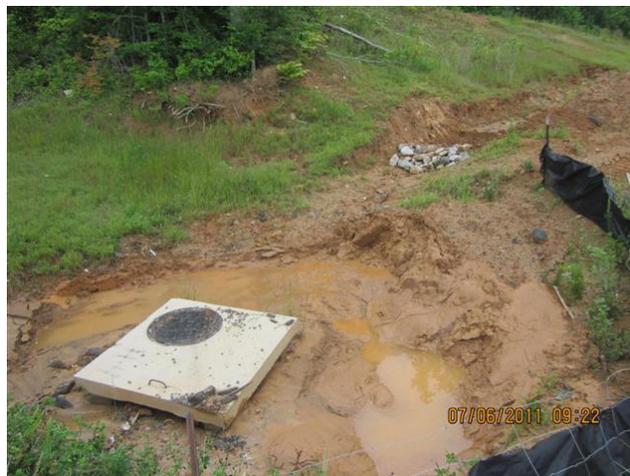
12. Drop-inlet for surface water collection & diversion located at the top (northern end) of Phase 3.

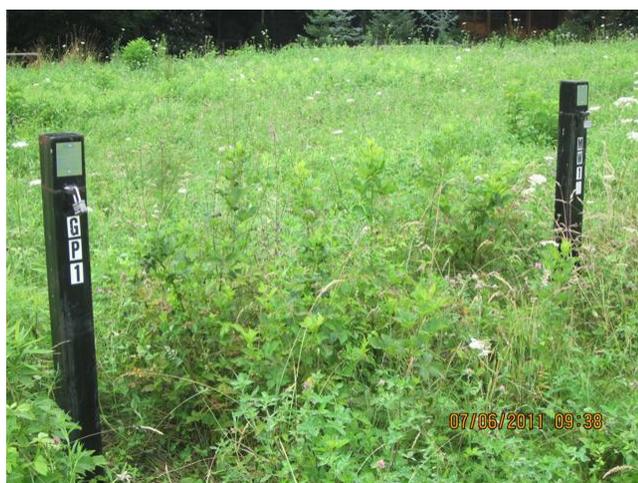
16. Groundwater monitoring wells and landfill gas wells are properly marked with a unique ID numbers and with a “Well Driller’s Tags” and secured with locks. (Photo #13)

13. Properly tagged, identified, and secured gas monitoring probe (on the left) and groundwater monitoring well (on the right).
