FACILITY COMPLIANCE AUDIT REPORT
Division of Waste Management
Solid Waste Section

Date of Audit: 3 February 2011

Beaufort County Closed MSW Landfill
 1342 Hawkins Beach Road
 Bath, NC 27808

Partial audit; Land Clearing Debris Treatment and Processing Notification and Tire Collection Elements reviewed only

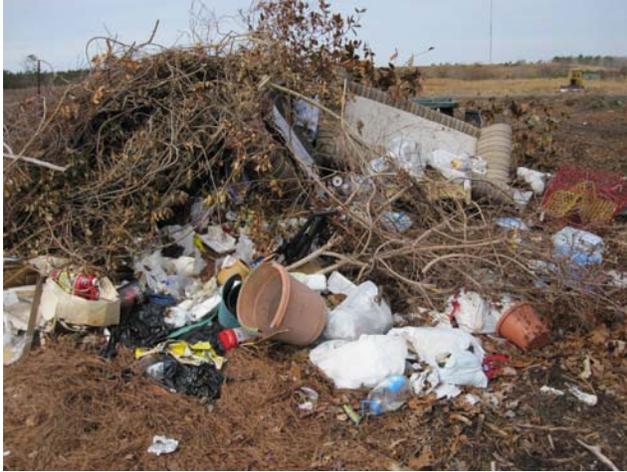
- 1) This facility is a closed MSW Landfill, Land Clearing Debris Treatment and Processing Notification, and tire collection site.
- 2) The site is secured by a locked gate at the facility entrance.
- 3) The facility access road is of all weather construction and is being well maintained.
- 4) Several loads of unpermitted waste consisting of household trash, furniture, construction and demolition

- materials, plastic buckets, and other miscellaneous refuse has been disposed at the yard waste site. *Please ensure that all unpermitted waste is removed from the facility and transported to a facility permitted to receive such wastes.

Unpermitted waste at the LCID T&P element

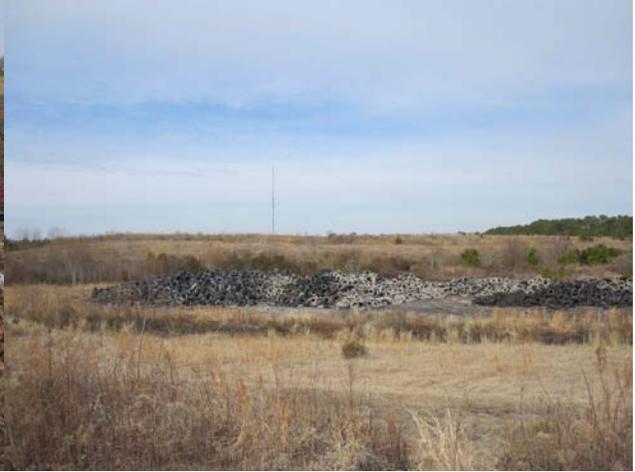
- 7) The tire collection area needs attention. The pile is too large and tires have been deposited in a disorderly manner throughout the facility. Tires were observed in the surface water ditch and in the storm water basin. *Please collect all tires from the surface water ditch and the storm water basin and return them to the tire management area. It is strongly recommended that transfer trailers be utilized at the site. All scrap tires should be placed directly into transfer trailers and stored there until transfer to the permitted tire management facility.

Scrap tire area

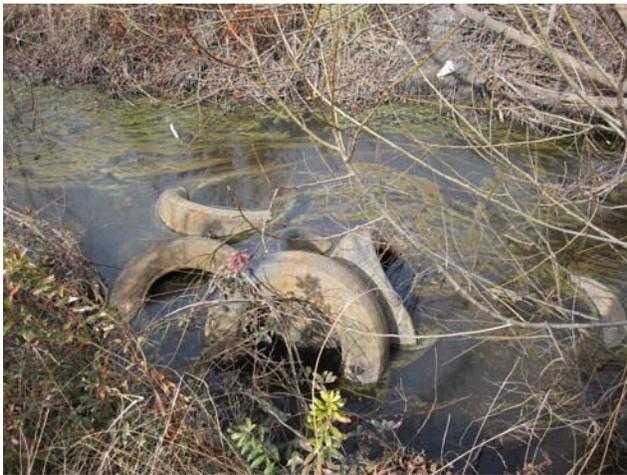
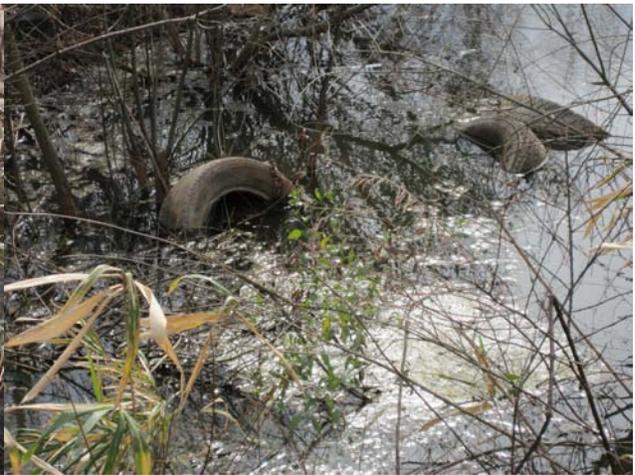
Tires placed in the surface water ditch and the storm water basin

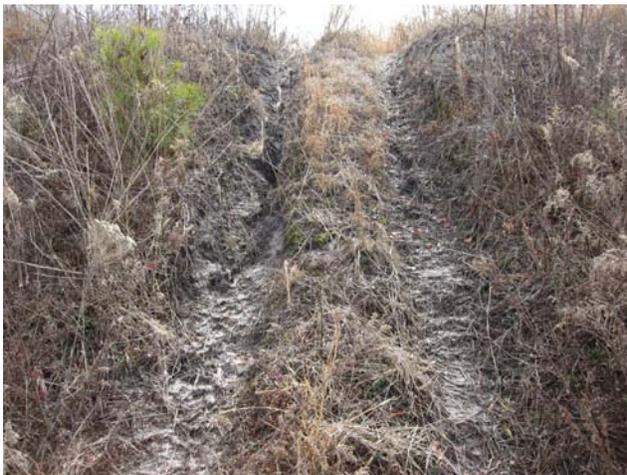
- 6) Evidence of trespass was noted during this audit. ATV trails were observed throughout the facility. Several of the trails are causing damage to the landfill cap system. *Within thirty days of receipt of this report, actions need to be underway to provide for more adequate site security.

ATV damage to landfill cap

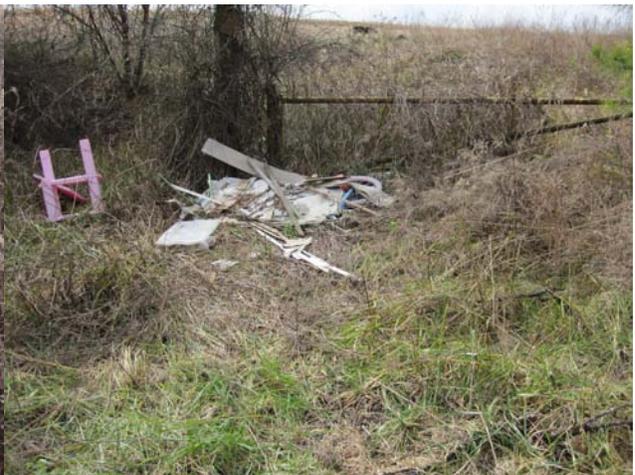
- 8) Household waste has been dumped outside of the old facility access gate along Hawkins Beach Road. *Please collect this waste and dispose of it properly.

Waste disposed at the old facility entrance
