FACILITY COMPLIANCE AUDIT REPORT
Division of Waste Management
Solid Waste Section

Date of Audit: 20 December 2010

ARS-Beaufort County Transfer Station
 500 Flanders Filters Road
 Washington, NC

07-03T, 122010

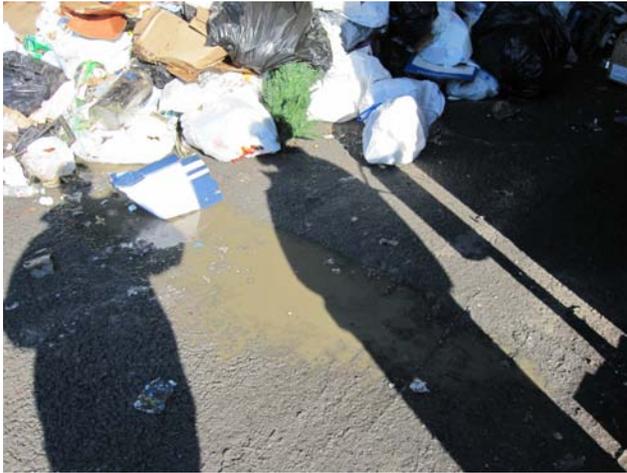
Entrance to tipping floor, drain installation recommended

- 24) The tipping floor is washed down weekly.
- 25) The facility walls are pressure washed twice a year.
- 26) There is one manhole present in the tipping floor for leachate drainage and collection. *The installation of a trench drain along the entrance to the tipping floor and connected to the leachate collection system is recommended.

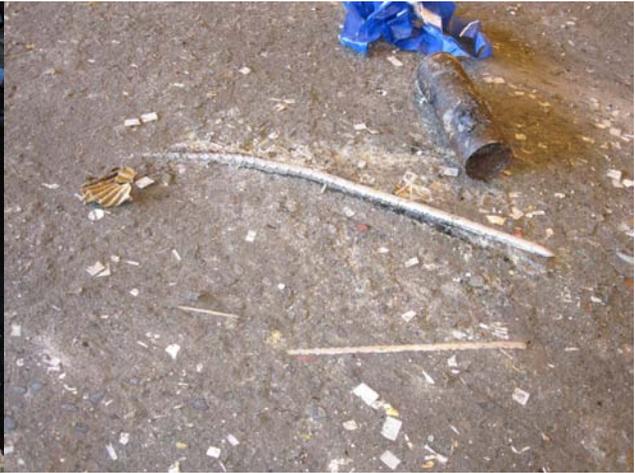
- 27) *The tipping floor is in need of repair. Erosion of the tipping surface within the Facility has occurred to such an extent that it will impede positive drainage of leachate into the collection system. The concrete is cracked and buckling at the junction of the access ramp and the pad.

Exposed re-bar in tipping floor

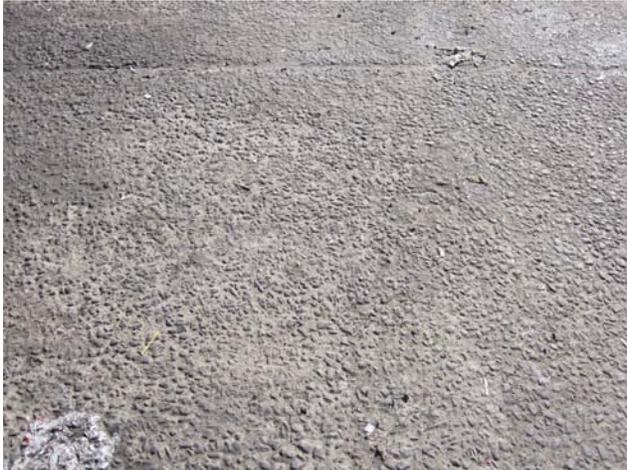
Eroded surface of tipping floor

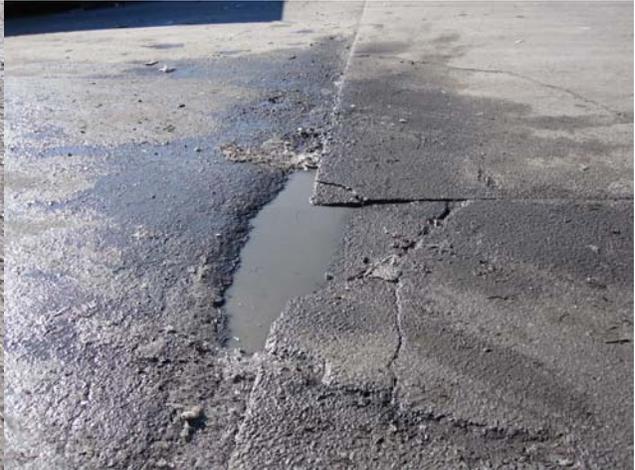
Buckled concrete at junction of ramp and pad

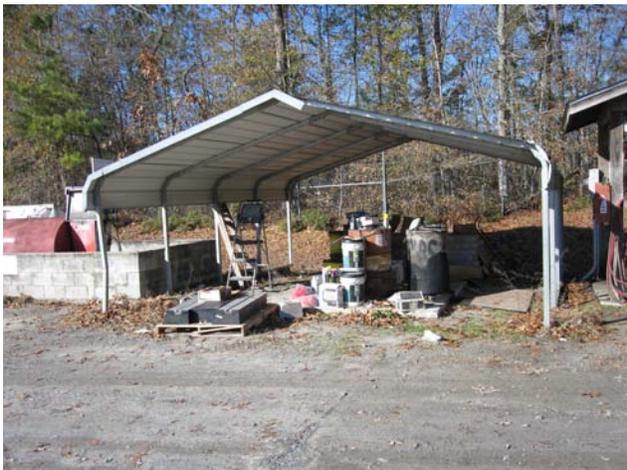
Oil storage area in need of better containment

- 30) The fuel and oil storage areas need to be better maintained. A concrete pad with secondary containment is recommended for the oil storage area and repairs need to be made to the fuel storage secondary containment system.

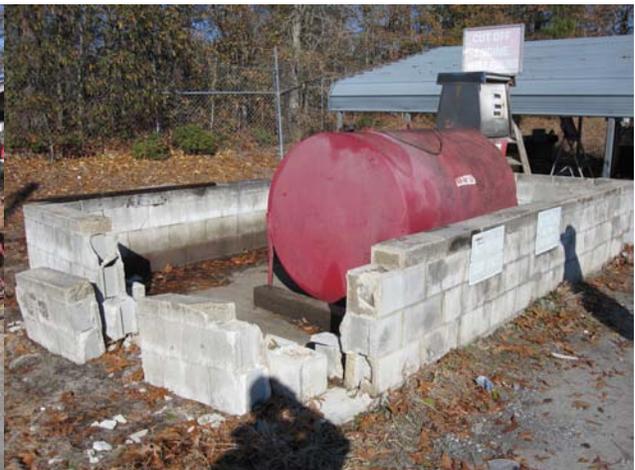
Fuel storage secondary containment needing repair
