FACILITY COMPLIANCE AUDIT REPORT
Division of Waste Management
Solid Waste Section

Date of Audit: 21 April 2011

ARS-Beaufort County Transfer Station
 500 Flanders Filters Road
 Washington, NC

Comprehensive

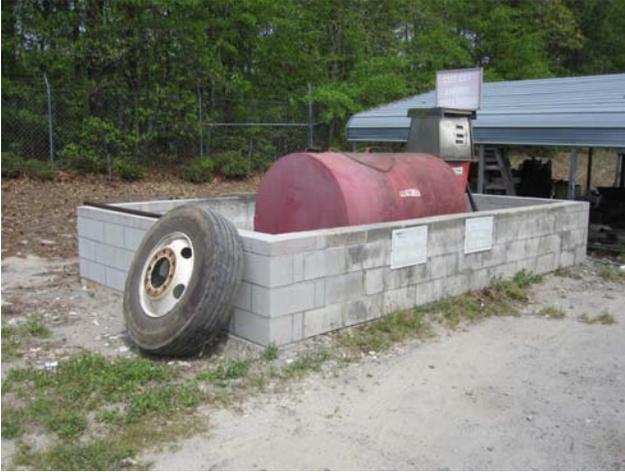
Fuel storage area secondary containment repaired

- 33) Safety meetings are conducted monthly at the facility by the Transfer Station Supervisor. *It is recommended that a log recording the meeting content and all attendees be maintained in the Transfer Station Supervisor's office.
- 34) The fuel and oil storage area needs to be better maintained. *The installation of a concrete pad with secondary containment is recommended for the oil storage area.
- 35) The secondary containment system of the fuel storage area has been repaired.
- 36) The vegetation growing along the facility roofline needs to be removed and the gutters cleared of debris.
- 37) Digital photographs were taken during this facility audit; *please see photographs attached below.*
- 38) *Additional personnel may be necessary for the proper operation of this facility.
- 39) *Corrective actions are required as a result of this audit.

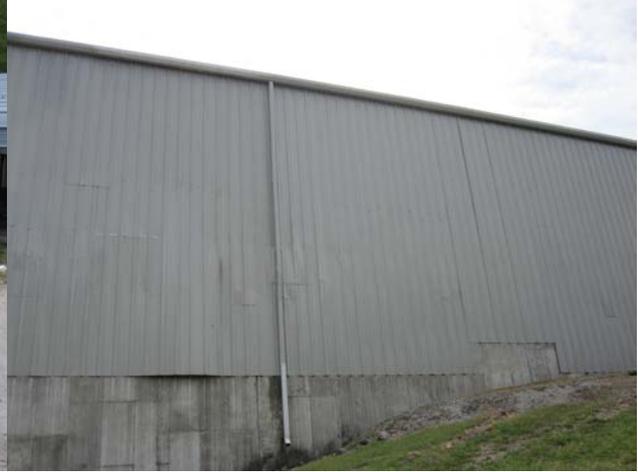
- 26) The facility walls have recently been pressure washed.
- 27) The damaged areas in the facility walls noted in the previous audit have been repaired.

Facility walls repaired

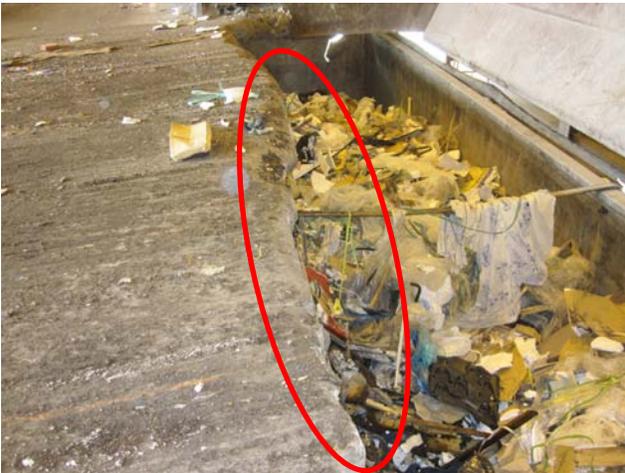
- 29) *The tipping floor is in need of repair. Erosion of the tipping surface within the Facility has occurred to such an extent that it will impede positive drainage of leachate into the collection system.

Loading bay edge of tipping floor in need of repair

- 30) *The concrete turnaround pad is cracked and buckling at the junction of the access ramp and the pad.
- 31) *The plans submitted for the repair of these areas should be initiated within thirty days of receipt of this report.

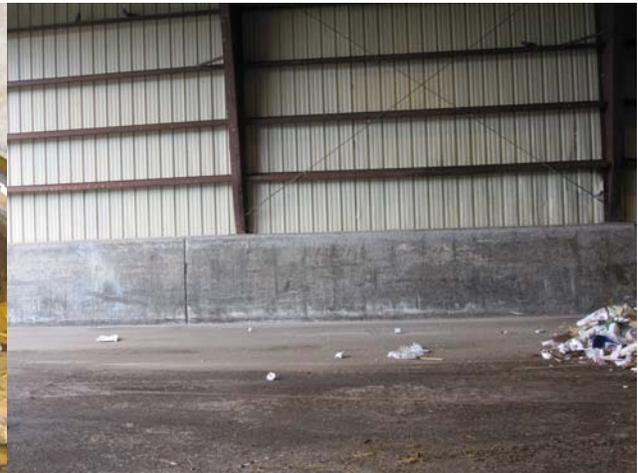
- 23) There are five fire extinguishers; three in the transfer station, one in the loader, and one in the yard dog, for fire control.
- 24) The concrete push walls are cleaned of waste daily.

Concrete push walls and facility walls washed and clear of waste

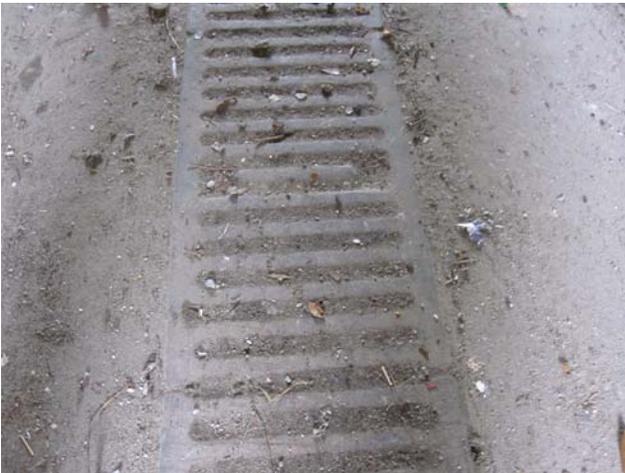
- 17) Approximately 75-80% of the leachate collection drain in the loading bay was blocked with sediment and other wastes. *To ensure proper function of your leachate collection and management system; within thirty days of receipt of this report, please clean the leachate collection drain and ensure this drain is cleaned regularly to maintain positive flow of leachate to the leachate holding tank.

Blocked leachate drain in trailer loading bay

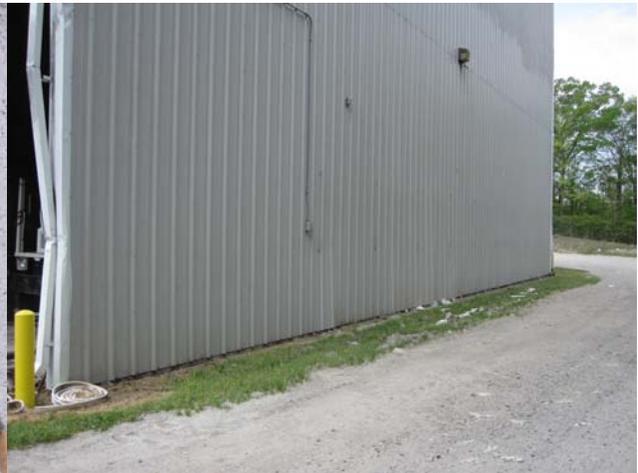
- 14) Policing of windblown debris has shown a marked improvement since the last facility audit. No windblown debris was noted outside of the perimeter fence and windblown debris along the inside of the fence was minimal. *Please ensure that all windblown debris is collected and properly disposed at the end of each workday.

Area behind transfer station with minimal debris
