FACILITY COMPLIANCE AUDIT REPORT
Division of Waste Management
Solid Waste Section

Date of Audit: 19 August 2011

ARS-Beaufort County Transfer Station
 500 Flanders Filters Road
 Washington, NC

Follow up visit to observe actions taken in response to FCAR 07-03T, 042111

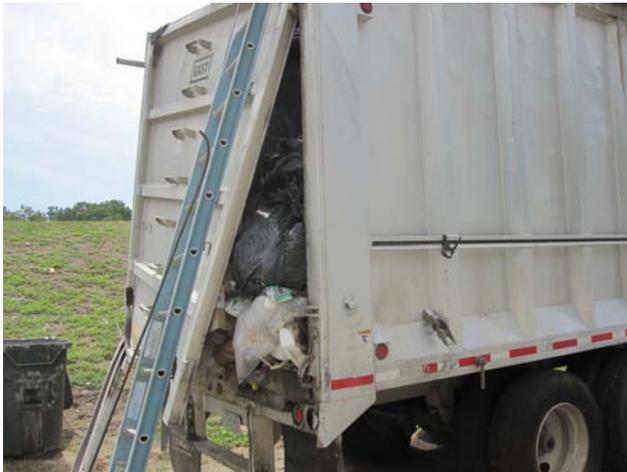
- 27) The concrete turnaround pad has been repaired.
- 28) The scale has been removed from the trailer loading bay and the area leveled with concrete.
- 29) A damaged transfer trailer loaded with solid waste was noted on-site. The damage to this trailer was severe enough to prevent the safe storage of solid waste without creating a nuisance, insanitary conditions, or vectors. Facility personnel indicated that the trailer had been on site in this condition for several days. Please note that your Approved Facility Permit; Attachment 3; Conditions Of The Permit; General Facility; #11 states that "Waste can be stored in transfer trailers, at the facility with covers in place, after operating hours, but no longer than 48 hours. *Please ensure that all loaded transfer trailers are secured, with covers in place, while on-site and maintained on-site for no longer than 48 hours.

Unsecured load stored on-site

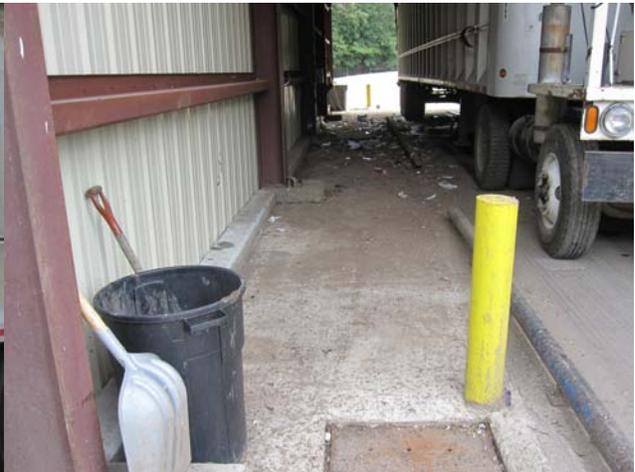
- 17) The leachate collection drain in the loading bay has been cleaned and no blockage was noted during this audit.
- 18) Access around the facility overall is stable and generally no areas of erosion were noted during this audit, however; an area of sparse cover was noted on the southern sideslope. *To maintain the integrity of the slope, please seed and mulch this area to establish a groundcover suitable to prevent erosion.

Well maintained trailer loading bay

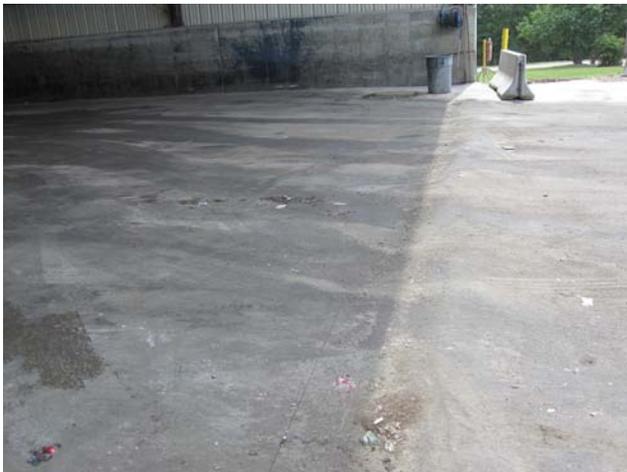
- 26) The tipping floor has been repaired. A small berm has been constructed at the entryway edge of the tipping floor which restricts leachate to the tipping floor and into the leachate management system.

Repaired tipping floor with berm installed at entry

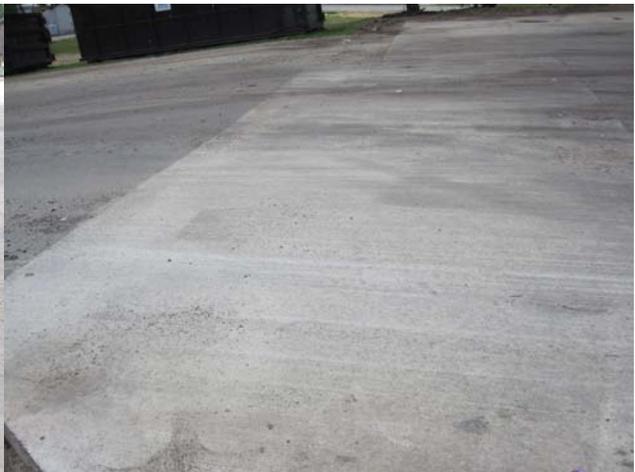
Repaired turnaround area in front of the transfer station
