REPORT OF GEOLOGIC OBSERVATION: CELL No. 9 CONSTRUCTION

**EAST CAROLINA REGIONAL MSW LANDFILL
 BERTIE COUNTY, NORTH CAROLINA**

BLE Project Number J00-1001-29

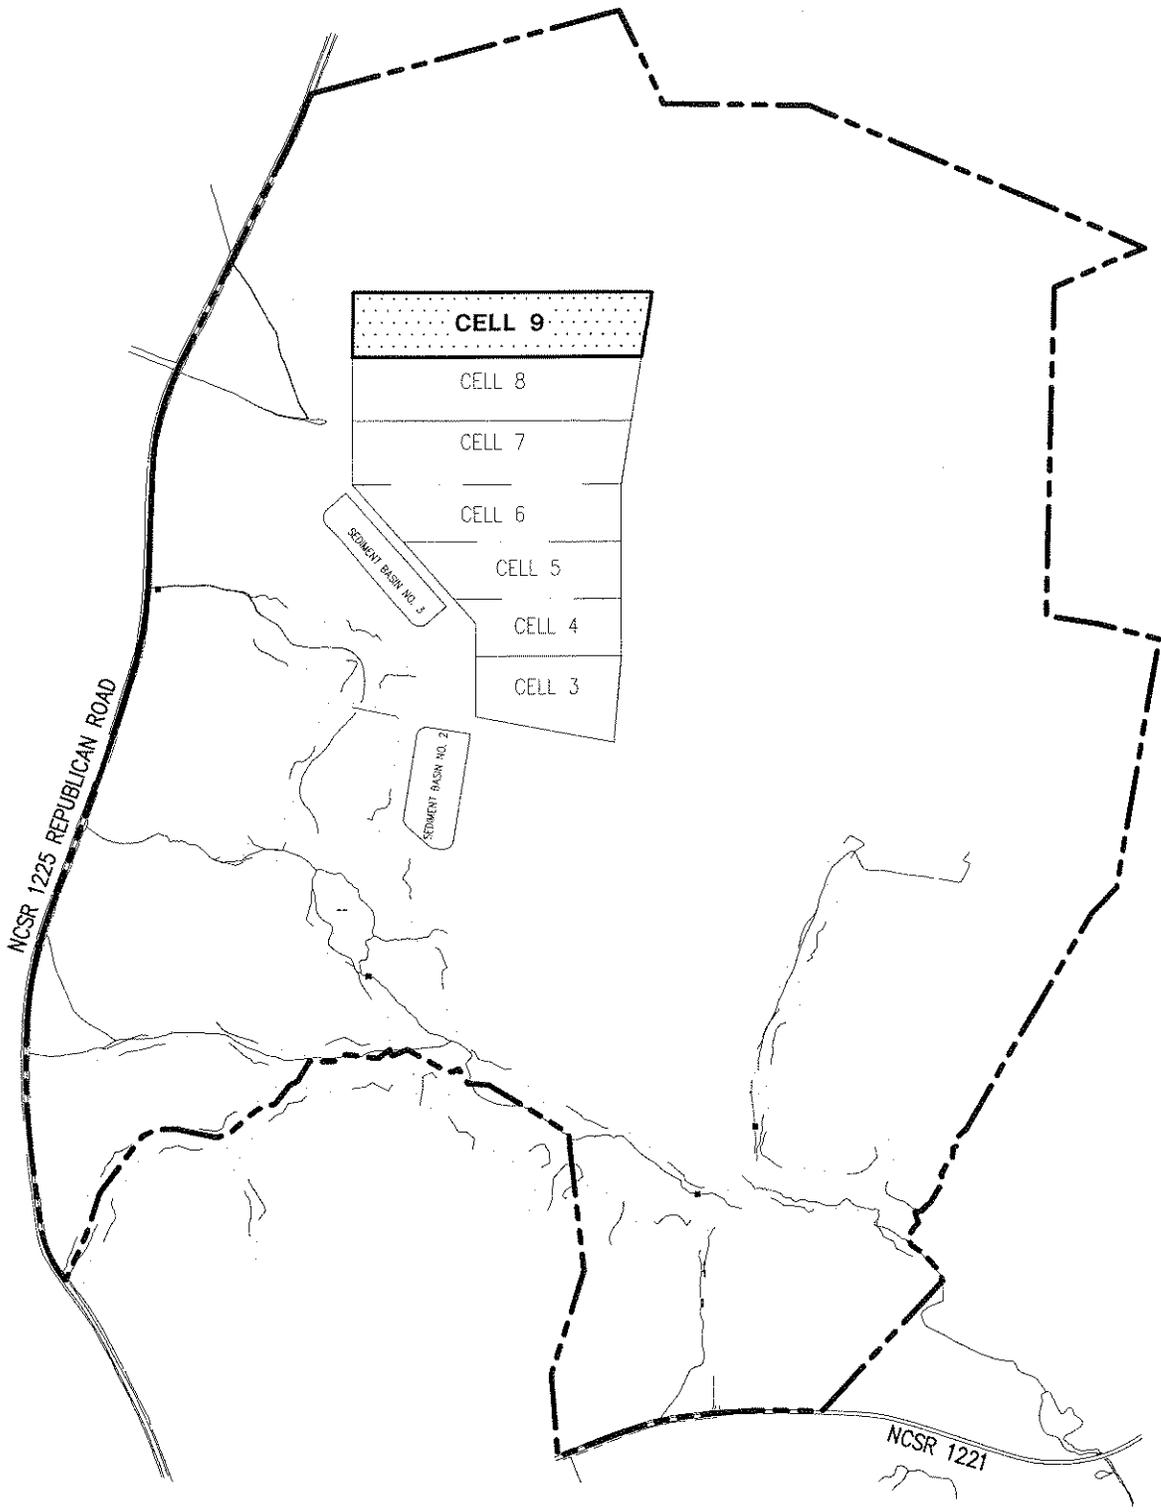
FIGURE
2

SITE LOCATION MAP
 CELL NO. 9
 EAST CAROLINA MSW LANDFILL
 BERTIE COUNTY, NORTH CAROLINA

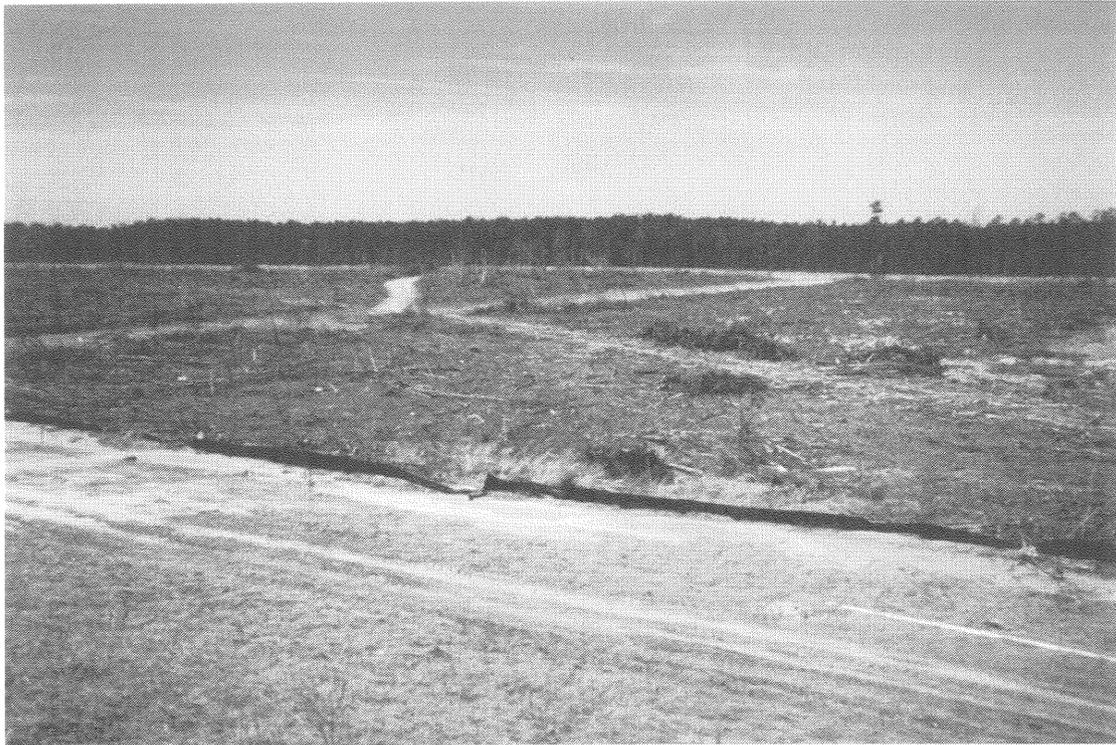
Photograph 1: 3/1/00 Facing northwest from the north side of Cell No. 8 after the trees have been logged and removed from the Cell No. 9 & 10 area.

The site visits during February and March were performed after the cell area was cleared of trees (Appendix, Photo 1). The site visit during April was performed during the removal of the organic "A horizon" soils. The removal of these organic soils was performed with minimal disturbance to

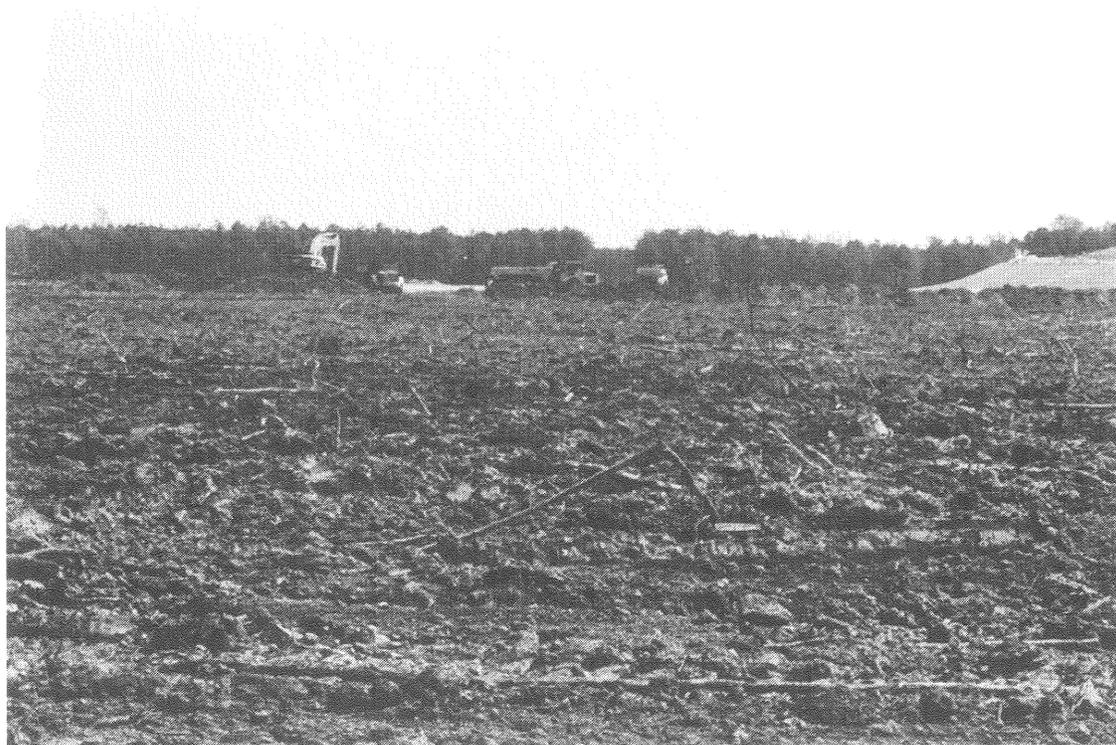
Photograph 2: 4/11/00 Facing east from the western end of Cell No. 9 during the removal of the "A horizon" organic soil.

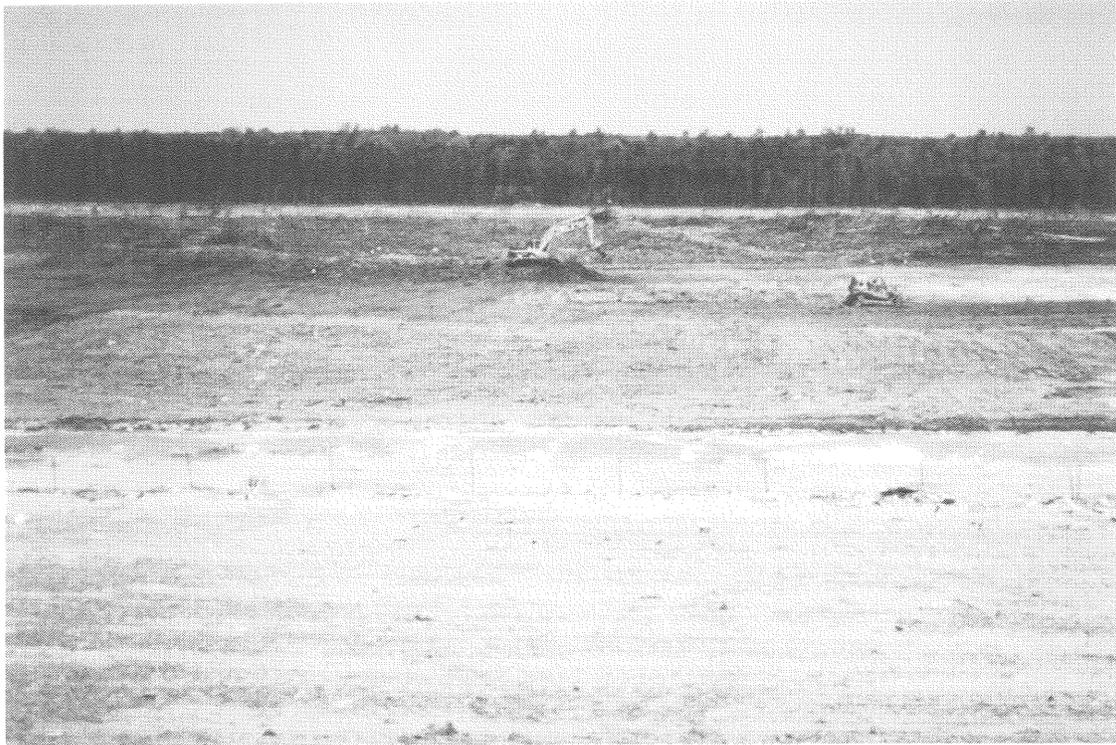
Photograph 3: 4/11/00 Facing north from the north side of Cell No. 8 during the removal of the “A horizon” organic soil. A bulldozer piles-up the organic soils and, a trackhoe loads the soil into trucks to be removed.

Layer I using a bulldozer and a trackhoe excavator (Appendix, Photo 3). The May site visit was performed during the start of fill soil placement on top of residual layer I soil (Appendix, Photo 9). The Layer I soil was observed to be consistent with the descriptions provided in the SHR and DHR.

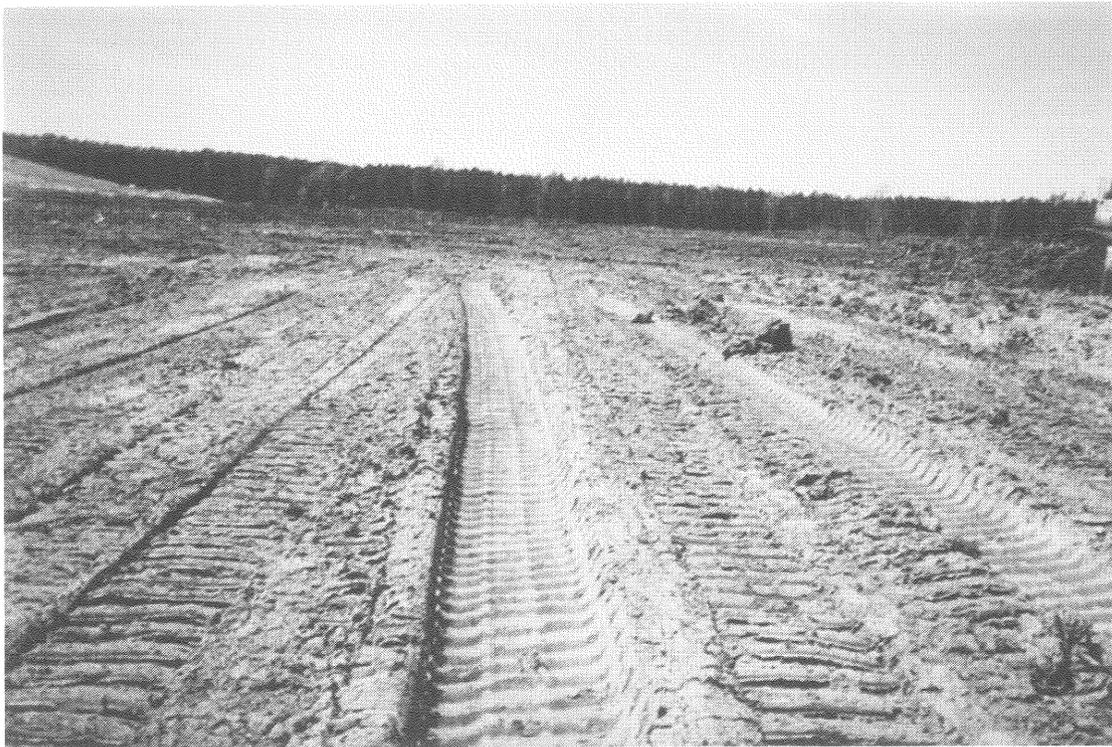
Photograph 4: 4/11/00 Facing west from the central portion of Cell No. 9 during organic soil removal. Layer I soil is exposed (brown fine sandy, silty clay and clayey silt).

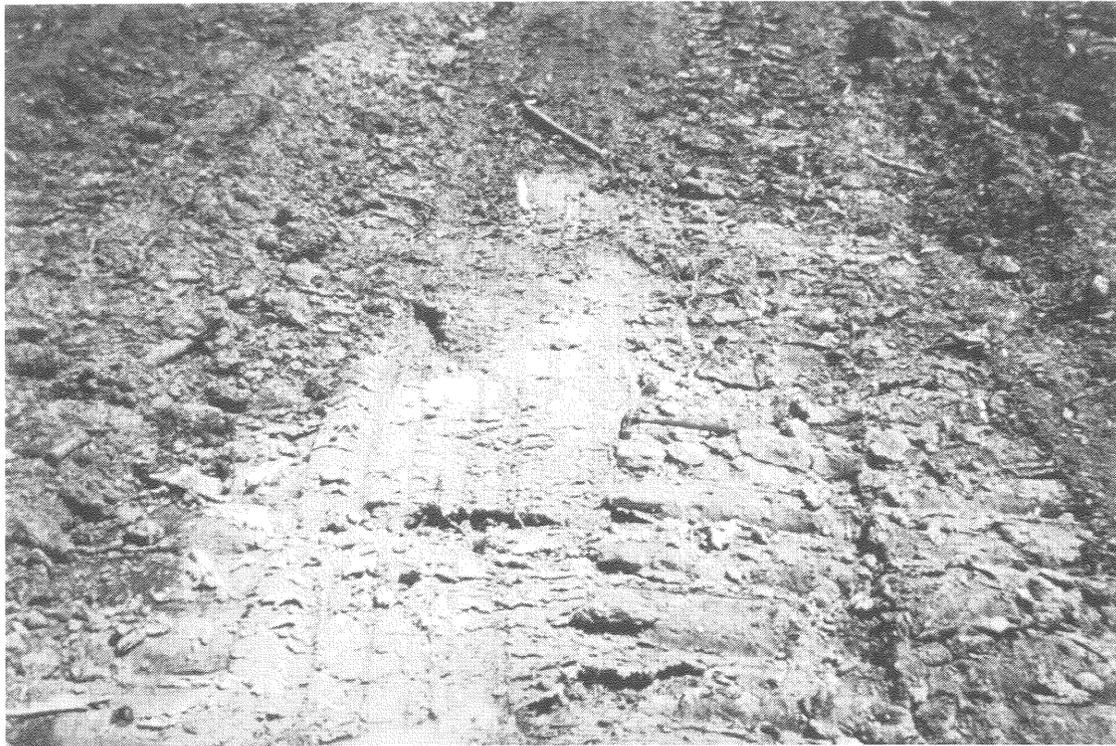
Photograph 5: 4/11/00 Western end of Cell No. 9 during organic soil removal. Layer I soil is exposed (brown fine sandy, silty clay and clayey silt).

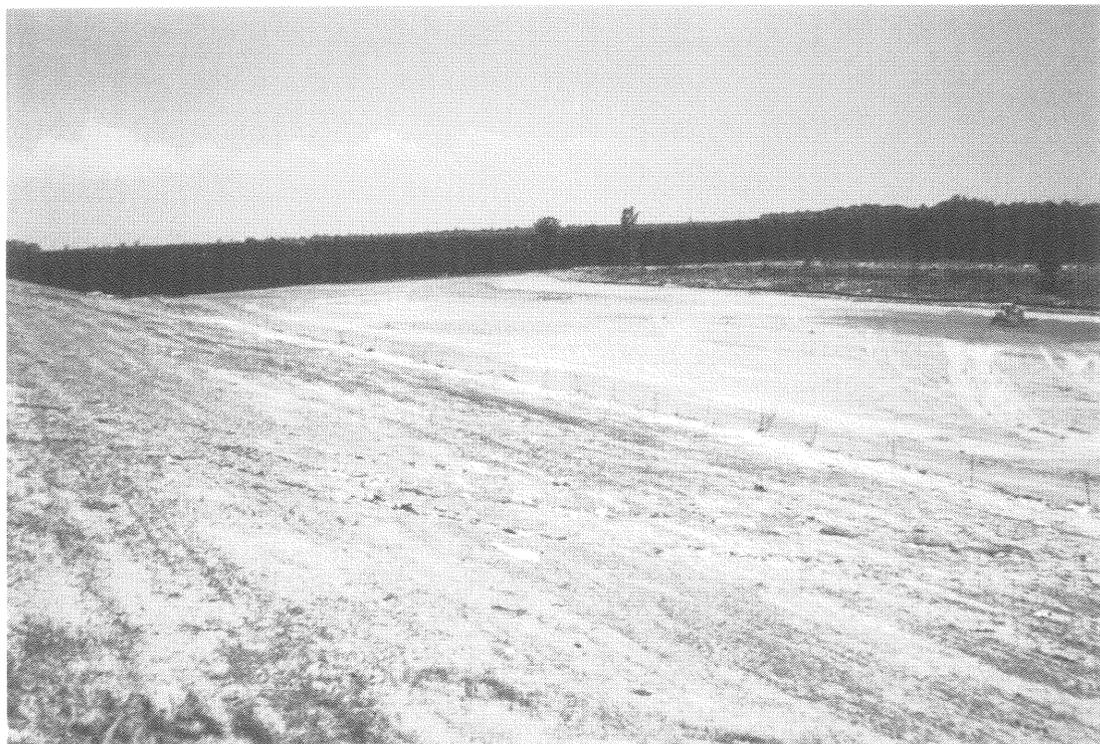
Photograph 6: 5/17/00 Facing northwest from the north side of Cell No. 8 after organic soil has been removed and before fill soil placement.

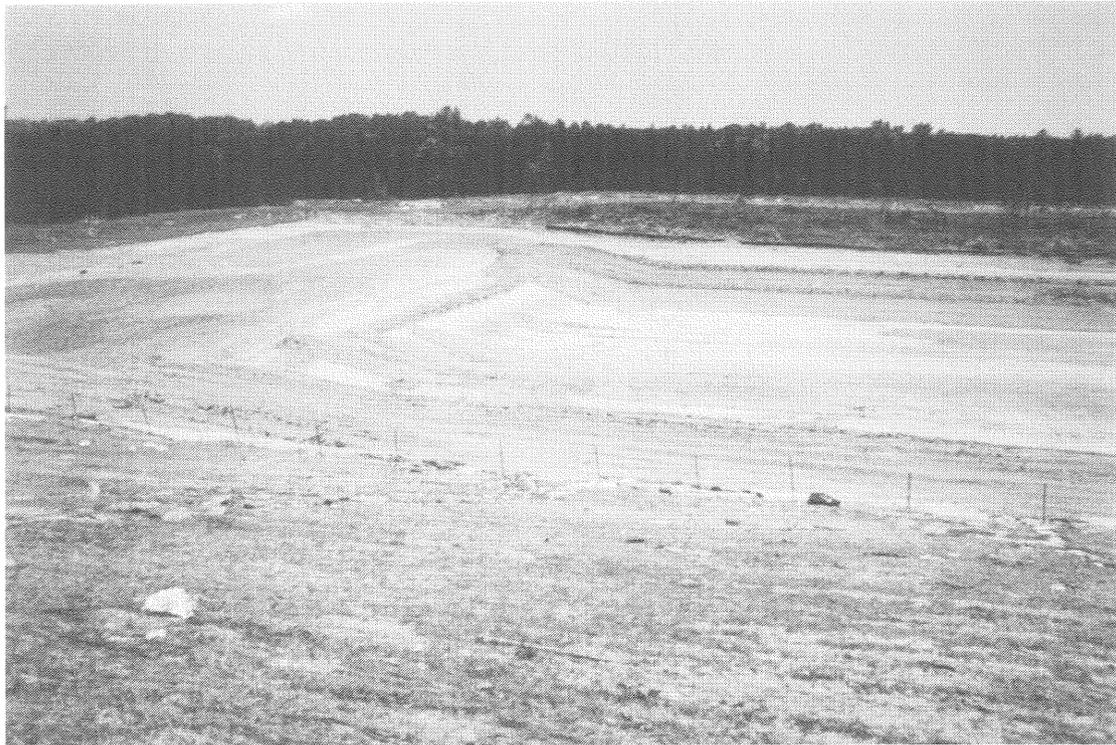
The deepest excavation into Layer I was at the cell's sump area, where the area was excavated to approximately eight feet below the original ground surface (Appendix, Photos 7-8). Based on the previous soil test borings, Layer I was interpreted to be approximately 17 feet thick in the vicinity of the sump location. The excavation into Layer I did not breach this confining layer. The Layer I soil was observed to be consistent across the Cell No. 9 area.

Photograph 7: 5/11/00 Western end of Cell No. 9 where the sump will be located.

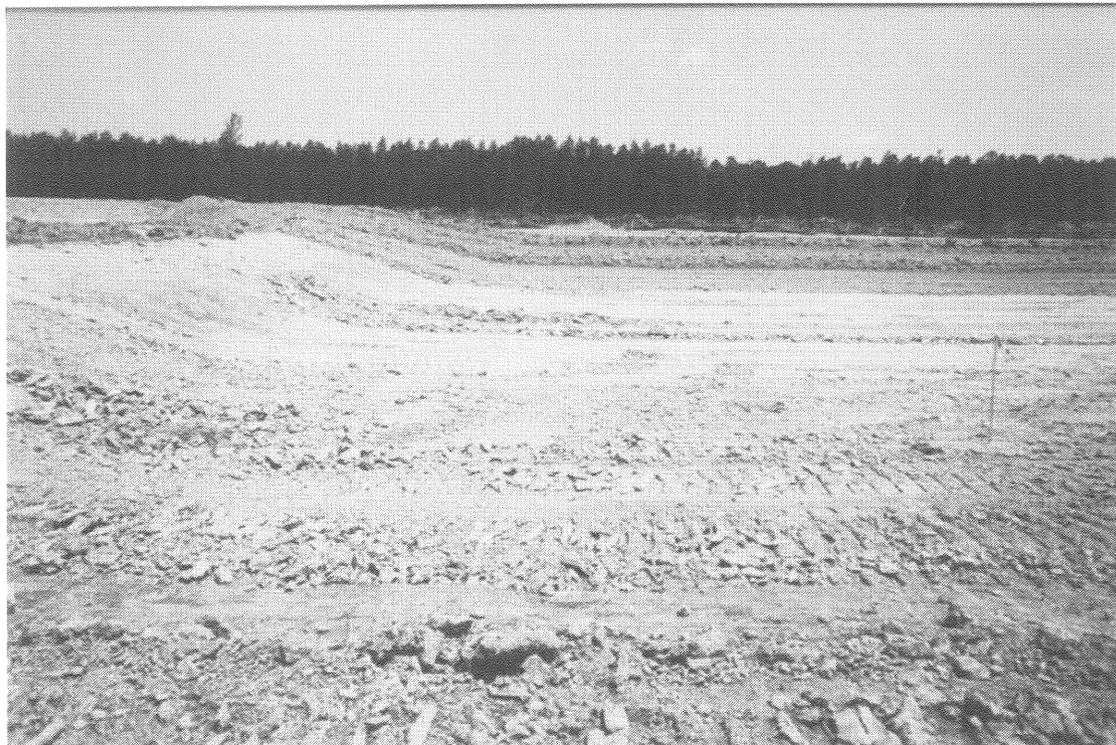
Photograph 8: 5/17/00 Facing north at the western end of Cell No. 9 (sump location). The Layer I soil is typical brown and gray fine sandy, silty clay and clayey silt.

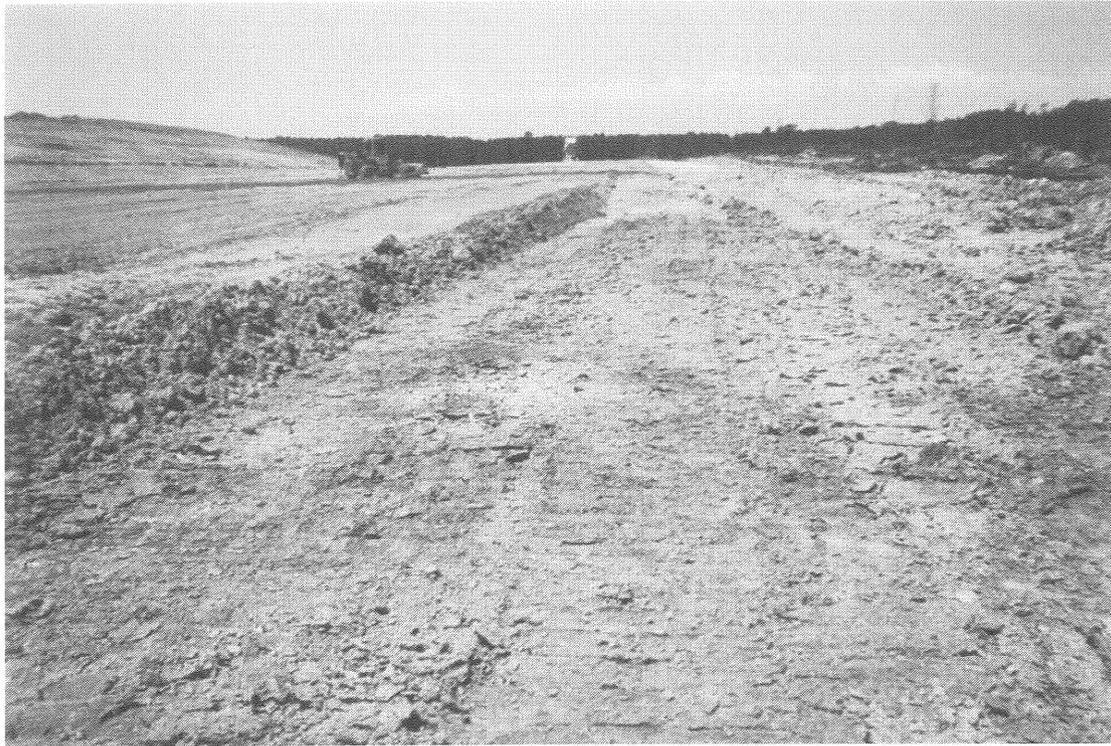
Photograph 9: 5/11/00 Eastern end of Cell No. 9 facing west during fill soil placement. Residual Layer I soil is exposed consisting of typical gray and brown fine sandy, silty clay and clayey silt.

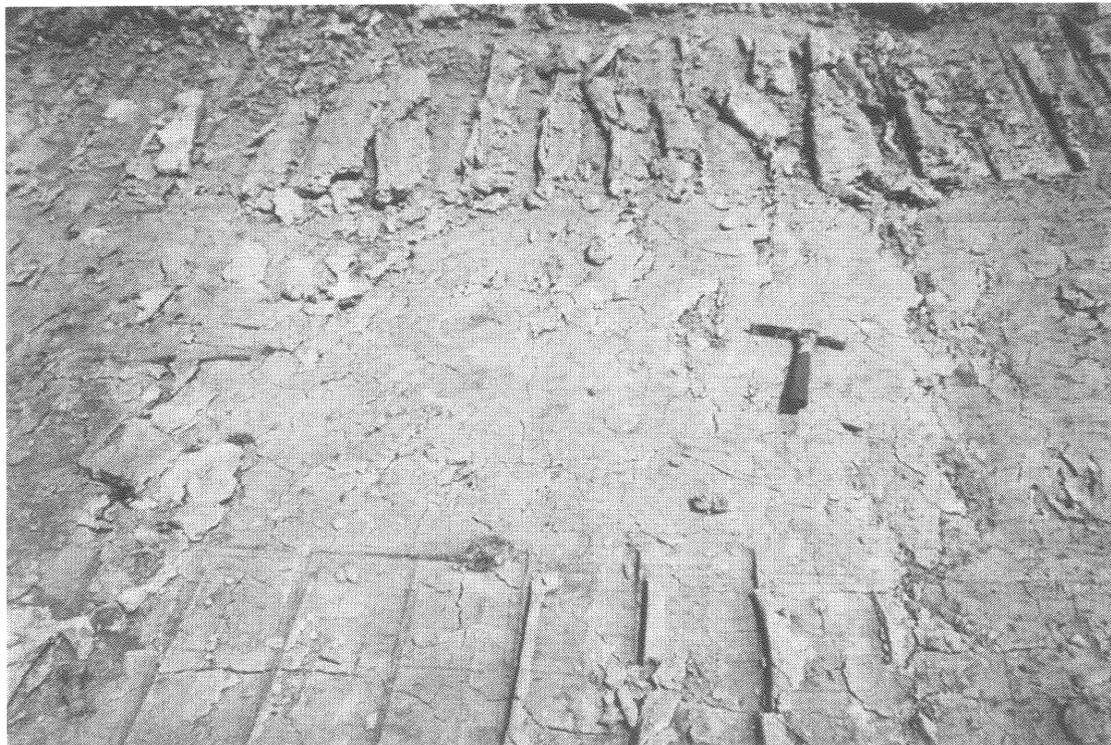
Photograph 10: 5/17/00 Residual Layer I soil, consisting of typical brown and gray fine sandy, silty clay and clayey silt.
