FACILITY COMPLIANCE INSPECTION REPORT
Division of Waste Management
Solid Waste Section

Date of Site Inspection: 12/06/2011

Yancey-Mitchell Transfer Station
 555 Landfill Road (SR-1440)
 Burnsville, NC 28714

A partial inspection was conducted to observe corrective measures underway at the Treatment and Processing area in response to the Notice of Violation issued on November 4, 2011.

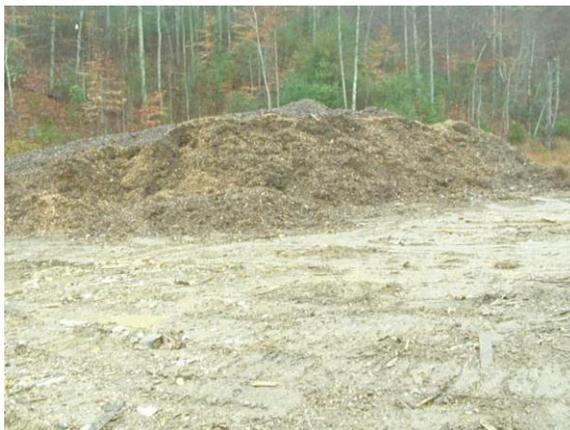
4. Since the previous inspection the piles of stored ground mulch in the Treatment and Processing area were investigated for the presence of unacceptable waste. After removing mulch mixed with ground unacceptable waste at the surface of the pile located near to the EnergyXchange facility, ground mixed waste was found within the interior of the pile. This mixed waste must also be removed for proper disposal. It was estimated by Mr. Miller that there may be 400 tons remaining to be removed if the entire pile is mixed with

unacceptable wastes. If there are of the areas of the pile that do not contain unacceptable waste then that material may be utilized as mulch.

View of the mulch pile mixed with ground unacceptable waste in the Treatment and Processing area.
Photograph taken by D. Aja on 12/6/2011.

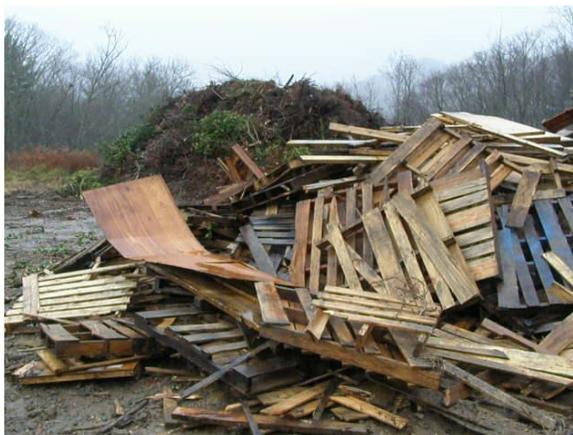
6. Wooden pallets have been segregated from land clearing debris for grinding.
7. It appeared that acceptable wastes [wooden pallets constructed of unpainted and untreated natural wood] were delivered to the Treatment and Processing area since the previous inspection. The photograph below shows a few incidental items of unacceptable waste in the pile of pallets (the pallets in the remainder of the pile not shown in the photograph appeared to be acceptable; constructed of unpainted and untreated natural wood). It was stated during the inspection that these items were scheduled to be removed from the pile. The facility must continue to manage the area so that any unacceptable wastes inadvertently unloaded in the Treatment and Processing area are removed for proper disposal.

View of segregated pallet pile [foreground] and clean land clearing debris pile [background] in the Treatment and Processing area.
Photograph taken by D. Aja on 12/6/2011.
