FACILITY COMPLIANCE AUDIT REPORT
Division of Waste Management
Solid Waste Section

Date of Audit: 06/24/10.

Buncombe County Solid Waste Management Facility
 85 Panther Branch Road,
 Alexander, NC 28701

Partial Audit

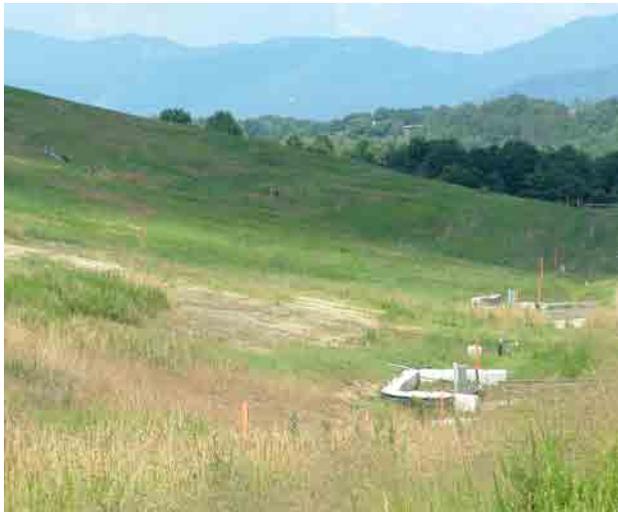
06/24/10

1. On site for partial audit of MSW/C&DLF facility. Current weather conditions were sunny, dry, high 80's.
2. Land Quality (LQ) had recently conducted an audit: erosion controls, sedimentation ponds, and the borrow area were inspected. No issues noted.
3. Several new edge of waste (EOW) markers had been installed around all disposal units. (see photo)

EOW Markers (orange posts) visible.

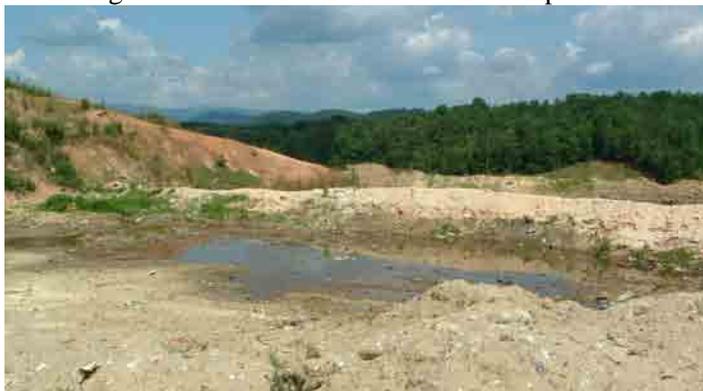
5. The working face of the MSWLF was inspected:
 - a. Fences for controlling windblown materials were in place, laborers were collecting windblown materials from the edge of the active cell (Cell 6) and the Cell 6 fencing was free of windblown debris.
 - b. The facility had been controlling leachate across the top of the working face with retention berms and a manual pump. Some ponding of water was observed over waste (no exposed waste was observed). The LF manager stated that it was done in an attempt to control snow/rain runoff over the winter months.

Note that 15A NCAC 13B .1626 (8)(b) requires drainage controls such that surface water is ***not impounded over or in waste***. Please address this issue immediately, and contact the Asheville Regional Office with any questions or concerns.
