FACILITY COMPLIANCE AUDIT REPORT
Division of Waste Management
Solid Waste Section

Date of Audit: 15 March 2011

Carteret County/CRSWMA Transfer Facility
 800 Hibbs Road
 Newport, NC

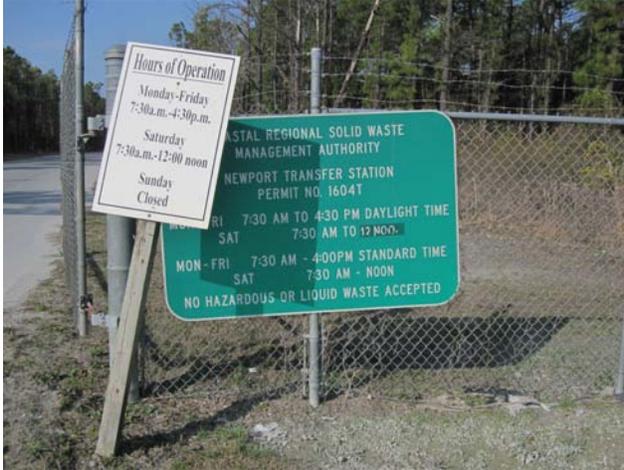
- 4) Proper signage including the facility permit number, accepted waste types, banned or excluded items, hours of operation, and the emergency contact number is posted at the facility entrance.

Signage posted at the facility entrance gate

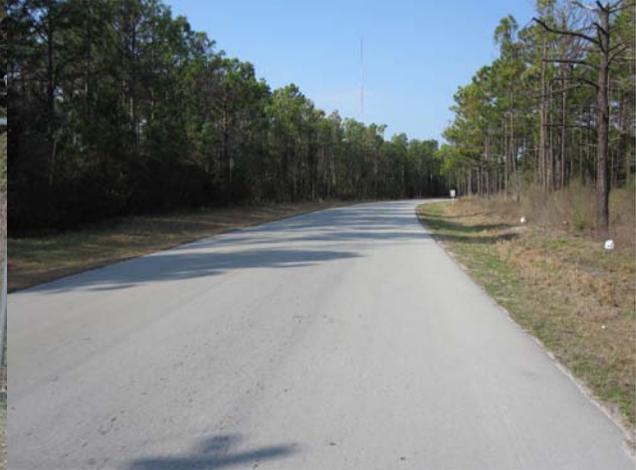
- 7) The facility access road is of all weather construction and is being maintained in overall good condition.
- 8) This facility is currently receiving +/- 375 tons of waste per day.

Facility access road

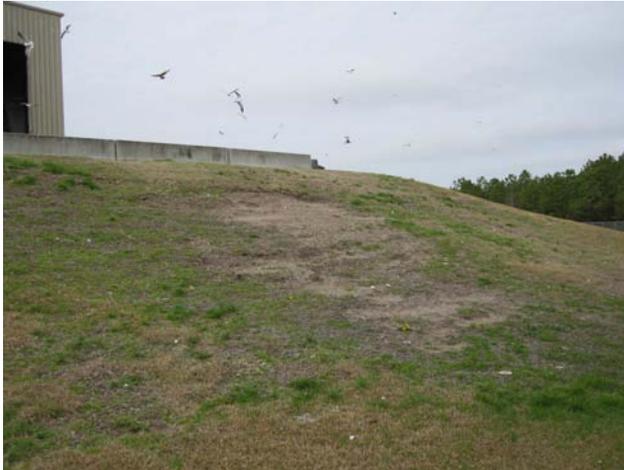
- 26) This facility maintains an adequate number of trailers on site to properly manage the volume of waste received during operating hours.
- 27) Access around the facility is generally stable; however, an area of sparse cover with minor erosion was noted near the center of the north eastern slope. Some areas of differential settlement were also noted on this

Area on northeastern slope needing grading seeding and mulching Concrete tipping floor needing maintenance-note exposed re-bar

- sideslope. *To maintain site stability; please grade, seed, and mulch these areas to establish a groundcover suitable to prevent erosion.
- 28) Windblown debris is collected and returned to the transfer station daily. No windblown debris was noted as leaving the facility during this audit.

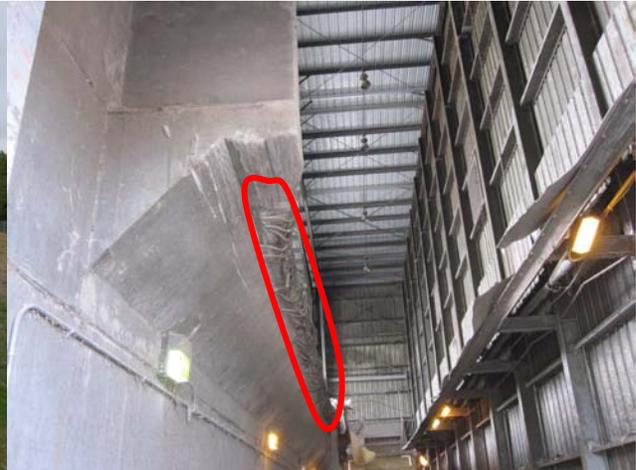
- 23) Recyclable metals and unacceptable waste streams are removed from the facility daily.
- 24) Areas of excessive wear were noted in various areas on the tipping floor; exposed re-bar was noted at the loading bay edge of the tipping floor. *Plans for maintenance/repair of the worn and eroded areas of the tipping floor should be initiated as soon as possible.

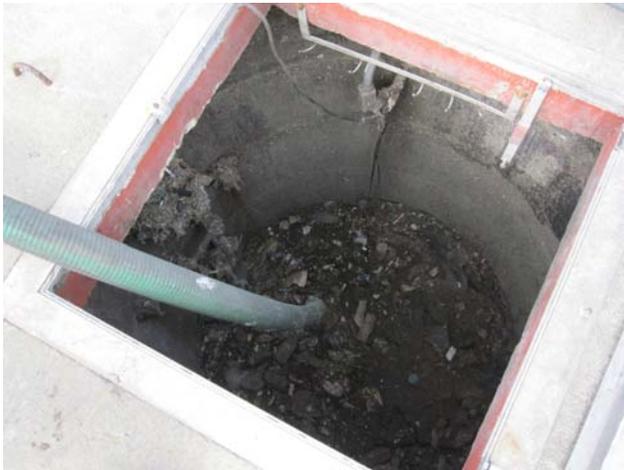
- 25) Leachate is collected on-site in an above ground storage tank and is pumped down and hauled for treatment as needed. Leachate and the leachate collection system appear to be well managed at this time. The underground collection tank was reviewed. *Please ensure that the solid waste that has accumulated through settlement in this tank is removed and disposed properly.

Underground leachate collection needing cleaning

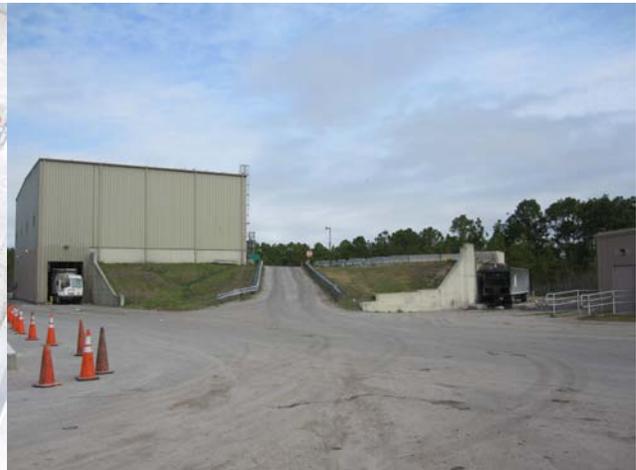
Overall well maintained facility
